**No.55 GENERAL CARGO SHIPS - Guidelines For  
(March  
1999) Surveys, Assessment and Repair of Hull  
Structure**

## **GENERAL CARGO SHIPS**

**Guidelines for Surveys,  
Assessment and Repair  
of Hull Structure**

## **IACS -International Association of Classification Societies, 1999**

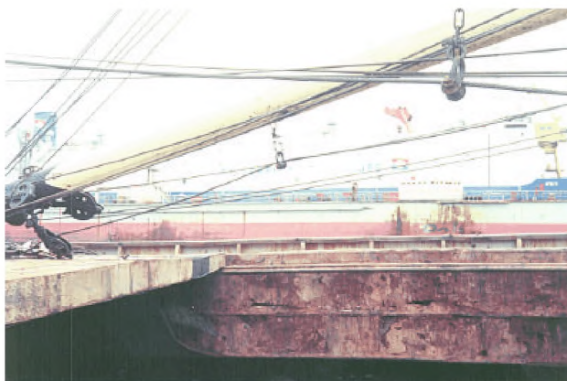
- 3.1.1 The level of wastage of under-deck stiffeners/structures may have to be established by means of thickness measurements. As mentioned previously the combination of the effects from the marine environment and the local atmosphere will give rise to high corrosion rates.
- 3.1.2 Severe corrosion of the hatch coaming from inside and of under deck girders may occur due to difficult access for maintenance of the protective coating. This may in turn lead to fractures (See **Photograph 1**).

**Photograph 1 Heavy corrosion of hatch coaming**

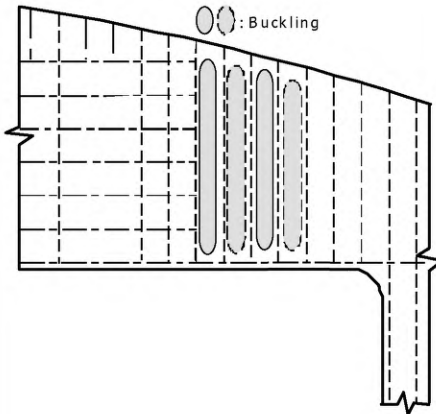
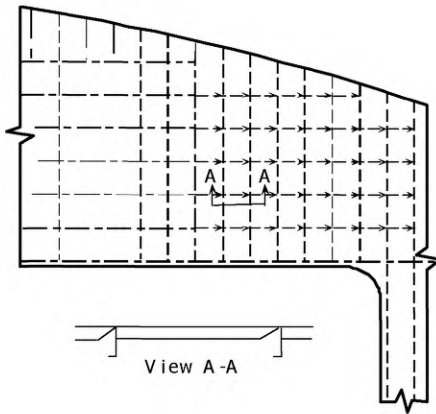
GENERAL CARGO SHIPS		Guidelines for Surveys, Assessment and Repair of Hull Structure	
Part 1	Cargo hold region	Example No.	
Area 1	Upper deck structure	1	
Detail of damage		Buckling of deck plating of transverse framing system	
Sketch of damage		Sketch of repair

<p><b>Notes on possible cause of damage</b></p> <ol style="list-style-type: none"> <li>Excessive compressive stress due to slamming or bow flare effect.</li> <li>Insufficient longitudinal stiffening of deck plating.</li> </ol>		<p><b>Notes on repairs</b></p> <ol style="list-style-type: none"> <li>Buckled plating should be cropped and renewed. Longitudinal internal stiffeners should be provided. (Instead of longitudinal stiffeners, renewal by thicker deck plating can be accepted.)</li> <li>Stress concentration may occur at the end of sniped stiffener resulting in fatigue fracture. For locations where high cyclic stress may occur, appropriate connection such as lug-connection should be considered.</li> </ol>

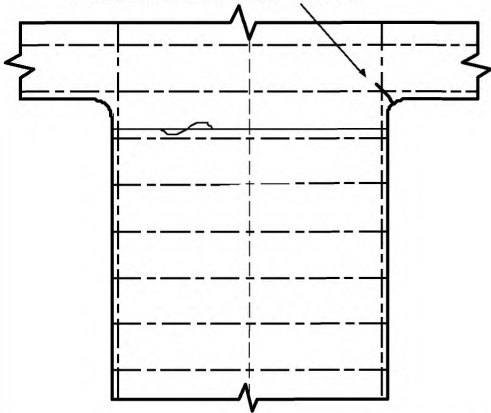
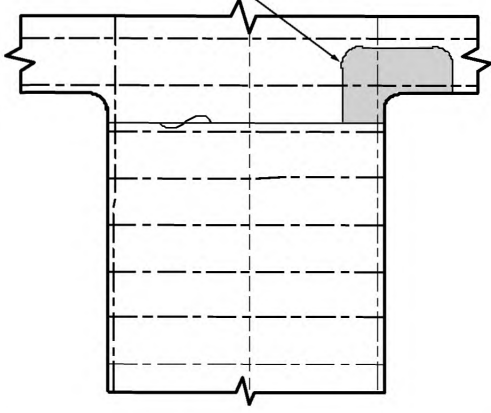
GENERAL CARGO SHIPS		Guidelines for Surveys, Assessment and Repair of Hull Structure	
Part 1	Cargo hold region	Example No.	
Area 1	Upper deck structure	2	
Detail of damage		Fractures at main cargo hatch corner	
<b>Sketch of damage</b>

<p>Fracture at hatch corner</p>		<b>Sketch of repair</b> Insert plate of enhanced steel grade and increased thickness

<b>Notes on possible cause of damage</b> <ol style="list-style-type: none"> <li>1. Stress concentration at hatch corners, i.e. radius of corner.</li> <li>2. Welded attachment of shedder plate close to edge of hatch corner.</li> <li>3. Wire rope groove.</li> </ol>		<b>Notes on repairs</b> <ol style="list-style-type: none"> <li>1. The corner plating in way of the fracture is to be cropped and renewed. If stress concentration is primary cause, insert plate should be of increased thickness, enhanced steel grade and/or improved geometry. Insert plate should be continued beyond the longitudinal and transverse extent of the hatch corner radius ellipse or parabola, and the butt welds to the adjacent deck plating should be located well clear of the butts in the hatch coaming. It is recommended that the edges of the insert plate and the butt welds connecting the insert plates to the surrounding deck plating be made smooth by grinding. In this respect caution should be taken to ensure that the micro grooves of the grinding are parallel to the plate edge.</li> <li>2. If the cause of fracture is welded attachment of shedder plate, the deck connection should be left unwelded.</li> <li>3. If the cause of the fracture is wire rope groove, replacement to the original design can be accepted.</li> </ol>

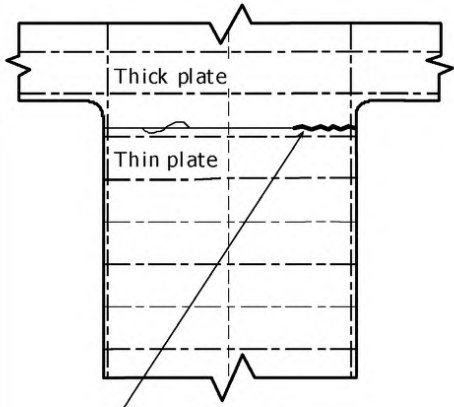
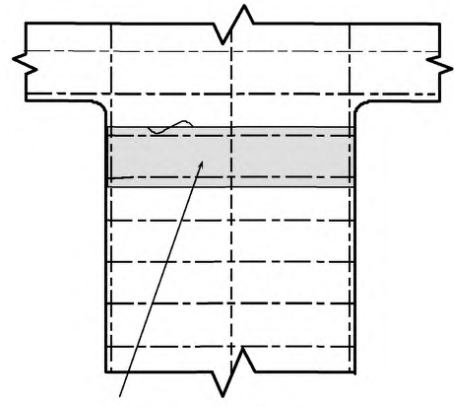
GENERAL CARGO SHIPS		Guidelines for Surveys, Assessment and Repair of Hull Structure	
Part 1	Cargo hold region	Example No.	
Area 1	Upper deck structure	3-a	
<b>Detail of damage</b>		Fracture of welded seam between thick plate and thin plate at cross deck	
<b>Sketch of damage</b>

<p>Thick plate</p> <p>Thin plate</p> <p>Fracture at welded seam</p>		<b>Sketch of repair</b>

<p>Insert plate of suitable intermediate thickness</p>	
<b>Notes on possible cause of damage</b> <ol style="list-style-type: none"> <li>1. Stress concentration created by abrupt change in deck plating thickness.</li> <li>2. In-plane bending in cross deck strip due to torsional (longitudinal) movements of ship sides.</li> <li>3. Welded seam not clear of tangent point of hatch corner.</li> </ol>		<b>Notes on repairs</b> <ol style="list-style-type: none"> <li>1. Insert plate of intermediate thickness is recommended.</li> <li>2. Smooth transition between plates (beveling) should be considered.</li> </ol>

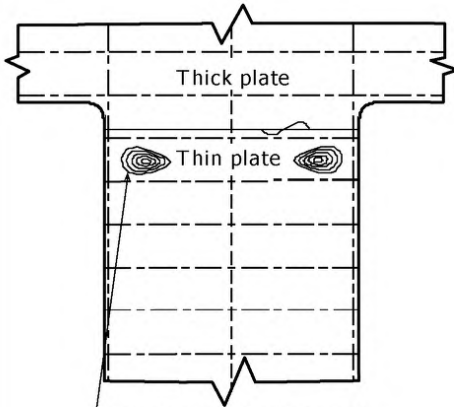
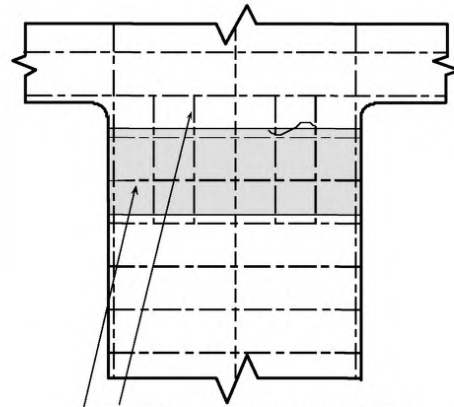
GENERAL CARGO SHIPS		Guidelines for Surveys, Assessment and Repair of Hull Structure	
Part 1	Cargo hold region	Example No.	
Area 1	Upper deck structure	3-b	
Detail of damage		Plate buckling in thin plate near thick plate at cross deck	
<p><b>Sketch of damage</b></p>

<p>Buckling of cross deck plating</p>		<p><b>Sketch of repair</b></p>

<p>Additional transverse stiffening and/or insertion of plate with suitable intermediate thickness</p>	
<p><b>Notes on possible cause of damage</b></p> <ol style="list-style-type: none"> <li>In-plane bending of cross deck strip due to torsional (longitudinal) movement of ship sides, often in combination with</li> <li>corrosion.</li> </ol> <p>Insufficient transverse stiffening.</p>		<p><b>Notes on repairs</b></p> <ol style="list-style-type: none"> <li>Transverse stiffeners extending from hatch sides towards centerline at least 10% of breadth of hatch, and/or increased plate thickness in the same area.</li> </ol>

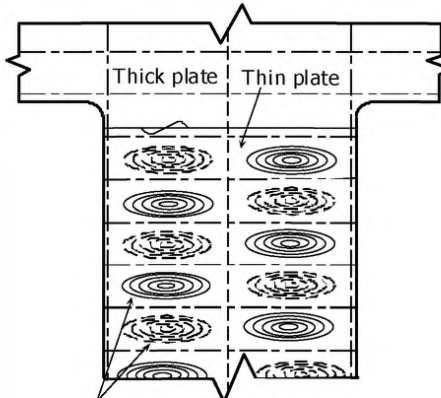
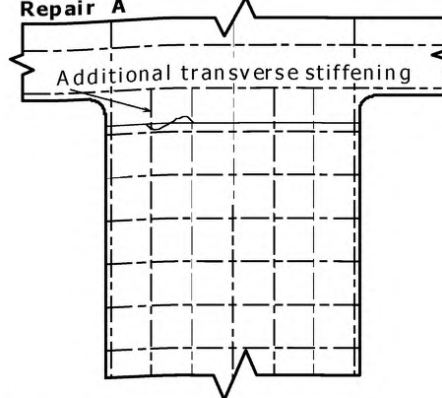
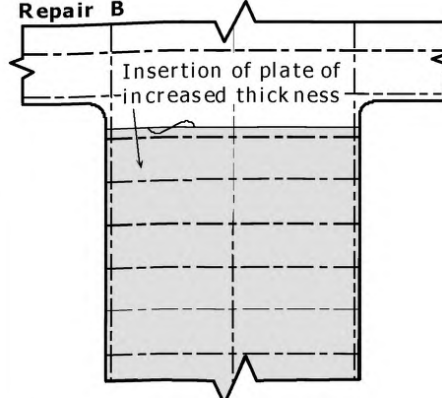
GENERAL CARGO SHIPS		Guidelines for Surveys, Assessment and Repair of Hull Structure	
Part 1	Cargo hold region	Example No.	
Area 1	Upper deck structure	3-c	
Detail of damage		Overall buckling of cross deck plating	
<p>Sketch of damage</p>

<p>Buckling of cross deck plating</p>		<p>Sketch of repair</p> <p><b>Repair A</b></p>

<p><b>Notes on possible cause of damage</b></p> <ol style="list-style-type: none"> <li>1. Transverse compression of deck due to sea load.</li> <li>2. Insufficient transverse stiffening.</li> </ol>		<p><b>Notes on repairs</b></p> <ol style="list-style-type: none"> <li>1. <b>Repair A</b> Plating of original thickness in combination with additional transverse stiffening.</li> <li>2. <b>Repair B</b> Insertion of plating of increased thickness.</li> </ol>

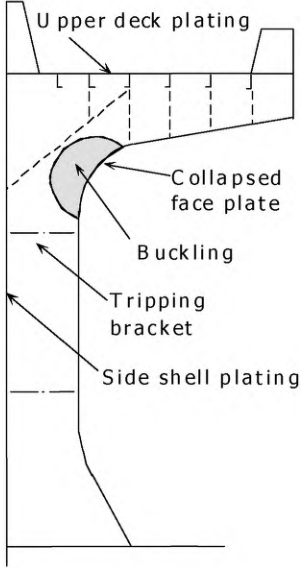
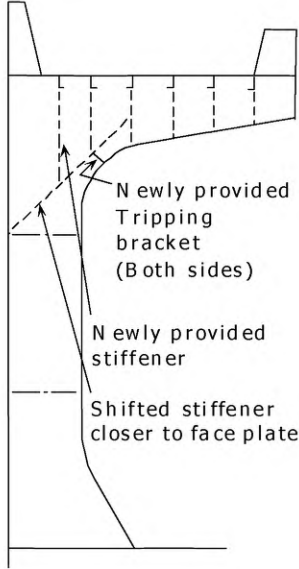
GENERAL CARGO SHIPS		Guidelines for Surveys, Assessment and Repair of Hull Structure	
Part 1	Cargo hold region	Example No.	
Area 1	Upper deck structure	4	
Detail of damage		Buckling of web beam	
<p><b>Sketch of damage</b></p>

<p><b>Notes on possible cause of damage</b></p> <ol style="list-style-type: none"> <li>1. Overloading by green sea on deck or by excessive deck cargo.</li> <li>2. Excessive corrosion.</li> <li>3. Insufficient/improper web stiffening.</li> </ol>		<p><b>Notes on repairs</b></p> <ol style="list-style-type: none"> <li>1. Buckled part is to be cropped and renewed.</li> <li>2. If corrosion is not the cause, renewal by thicker plate (web and/or face) and/or reinforcement by stiffener and tripping bracket should be considered.</li> </ol>

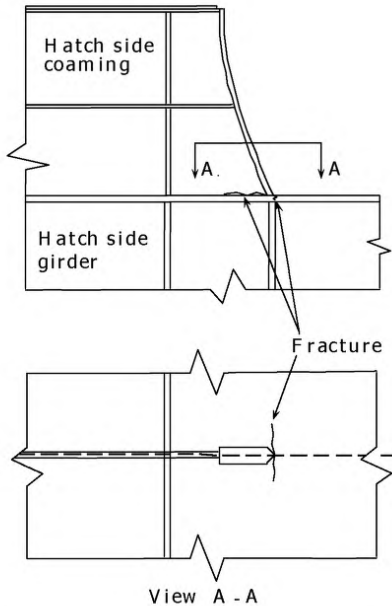
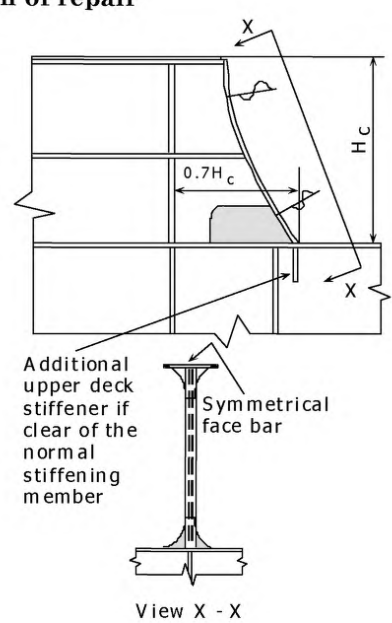
<p>Hatch side coaming</p> <p>Hatch side girder</p> <p>Fracture</p> <p>View A - A</p>

<p>Additional upper deck stiffener if clear of the normal stiffening member</p> <p>Symmetrical face bar</p> <p>View X - X</p>	
<b>Notes on possible cause of damage</b>		<b>Notes on repairs</b>	
<p>1. This damage is caused by stress concentrations attributed to the design of the bracket.</p>		<p>1. The design of the bracket can be altered as shown above, however, it is to be ensured that an additional under deck stiffener is provided at the toe of the termination bracket, where the toe is clear of the normal stiffening member.</p> <p>2. Full penetration weld for a distance of <math>0.15 H_c</math> from toe of side coaming termination bracket and for connection of athwartship gusset bracket to deck.</p> <p>3. The fracture in deck plating to be veed-out and rewelded or deck plating cropped and part renewed as appropriate, using low hydrogen electrodes for welding.</p>

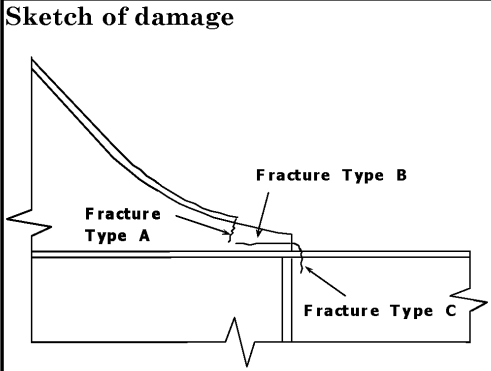
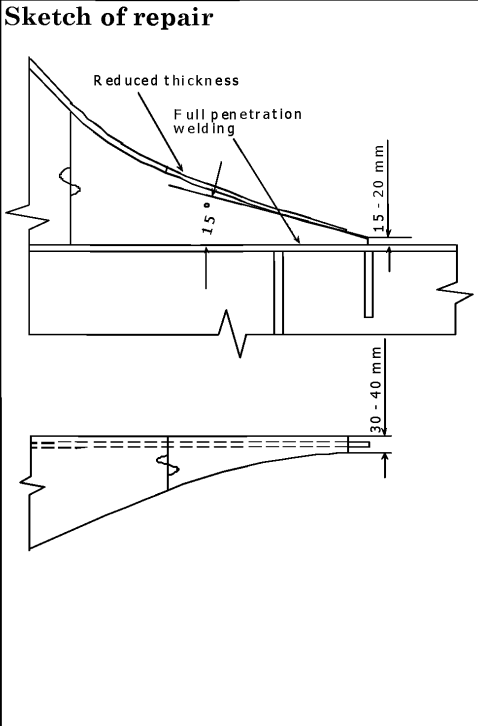
Notes on possible cause of damage		Notes on repairs	
<ol style="list-style-type: none"> <li>1. Flange force at the end of the flange too high due to insufficient tapering (<b>Fracture Type A</b>, propagating in the web).</li> <li>2. Shear force in the web plate too high due to insufficient reduction of the web height at the end (<b>Fracture Type B</b> propagating in the web at the undercut or HAZ of the fillet weld).</li> <li>3. Insufficient support of the extension bracket below the deck (<b>Fracture Type C</b>, starting from undercut or HAZ of the fillet weld and propagating in the deck plating).</li> </ol>		<ol style="list-style-type: none"> <li>1. Extend the extension bracket as long as possible to arrange a gradual transition.</li> <li>2. Reduce the web height at the end of the bracket; in case of high stress areas grind smooth the transition to the deck plating welding.</li> <li>3. Reduce the cross sectional area of the flange at the end as far as possible.</li> <li>4. Provide longitudinal structure in way of the web of the extension bracket to the next transverse structure or provide a new transverse structure.</li> </ol>

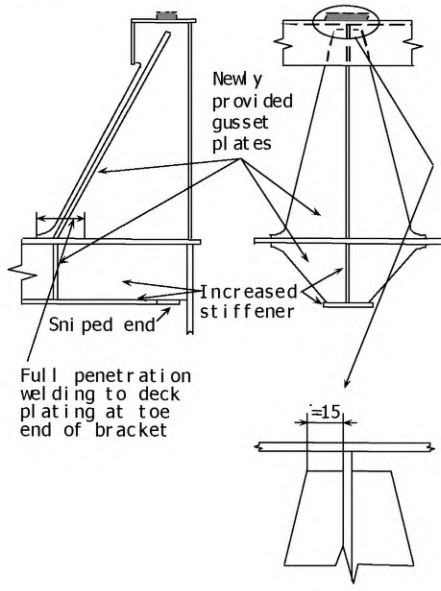
<p>Fracture</p>

<p>Newly provided gusset plates</p> <p>Increased stiffener</p> <p>Sloped end</p> <p>Full penetration welding to deck plating at toe end of bracket</p> <p>15</p>	
Notes on possible cause of damage	Notes on repairs	
<ol style="list-style-type: none"> <li>Insufficient consideration of the horizontal friction forces in way of the resting pads for hatch cover.</li> </ol>	<ol style="list-style-type: none"> <li>Modification of the design of the hatch coaming stay.</li> <li>Full penetration welding between gusset plates and deck plating.</li> <li>Strengthening and continuation of the structure below the deck.</li> <li>Use pads with smaller coefficient of friction.</li> </ol>

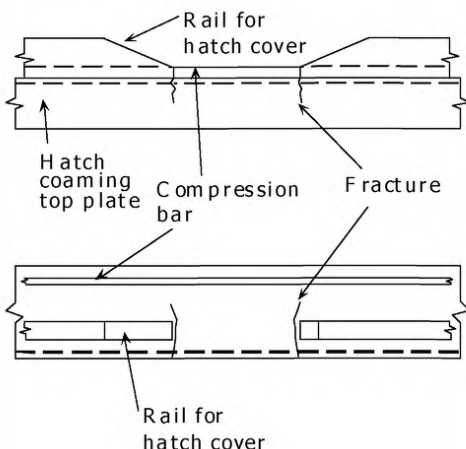
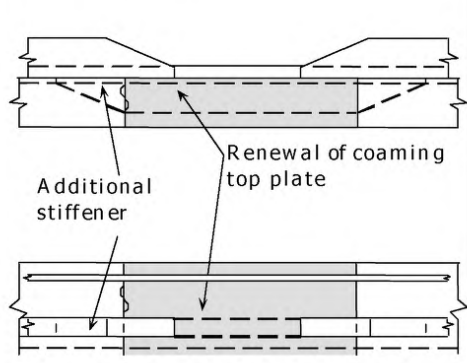
<b>Notes on possible cause of damage</b> <ol style="list-style-type: none"> <li>1. Stress concentration at the termination of the rail for hatch cover.</li> </ol>		<b>Notes on repairs</b> <ol style="list-style-type: none"> <li>1. Fractured plate is to be cropped and part renewed.</li> <li>2. Thicker insert plate and/or reinforcement by additional stiffener under the top plate should be considered. Also refer to <b>Example 7-b</b>.</li> </ol>

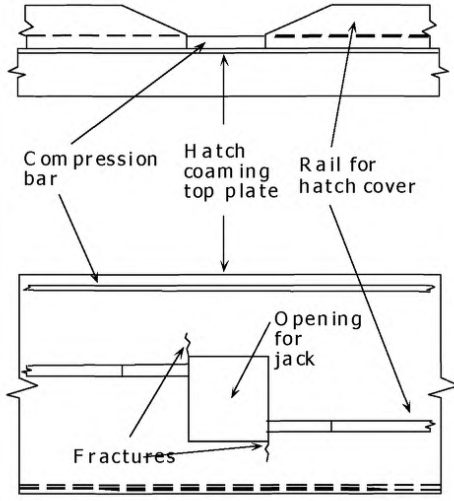
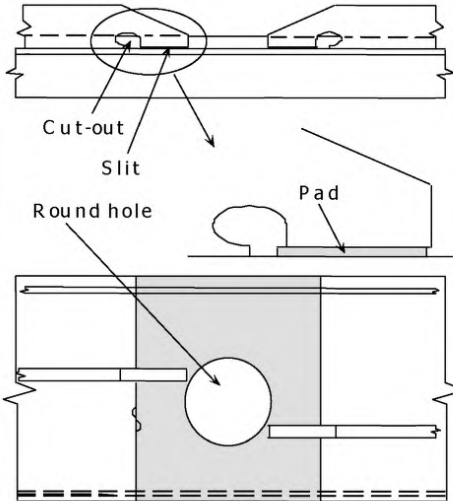
<p>Compression bar</p> <p>Hatch coaming top plate</p> <p>Rail for hatch cover</p> <p>Fractures</p> <p>Opening for jack</p>		<b>Sketch of repair</b>

<p>Cut-out</p> <p>Slit</p> <p>Round hole</p> <p>Pad</p>	
<b>Notes on possible cause of damage</b> 1. Stress concentration at the termination of the rail for hatch cover.		<b>Notes on repairs</b> 1. Fractured plate is to be cropped and part renewed. 2. Thicker insert plate and/or reduction of stress concentration adopting large radius should be considered. Or cut-out in the rail and detachment of the welds as shown in the above drawing should be considered in order to reduce the stress of the corner of the opening.

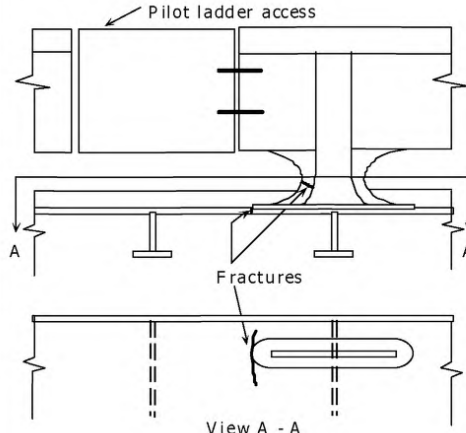
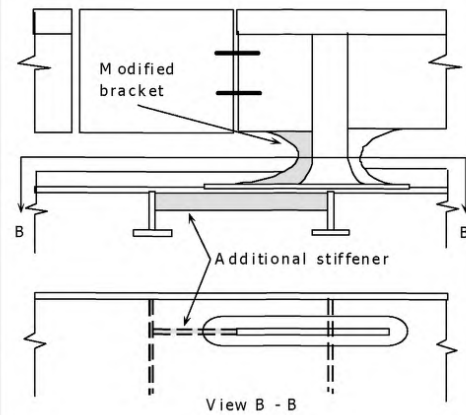
<b>Notes on possible cause of damage</b> 1. Stress concentration at the termination of bulwarks.		<b>Notes on repairs</b> 1. Fractured deck plating should be cropped and part renewed. 2. Reduction of stress concentration should be considered. In the above figure gusset plate was replaced with soft type for the fracture in gusset plate and pad plate was increased. Additional stiffeners were provided for the fracture in deck plating.

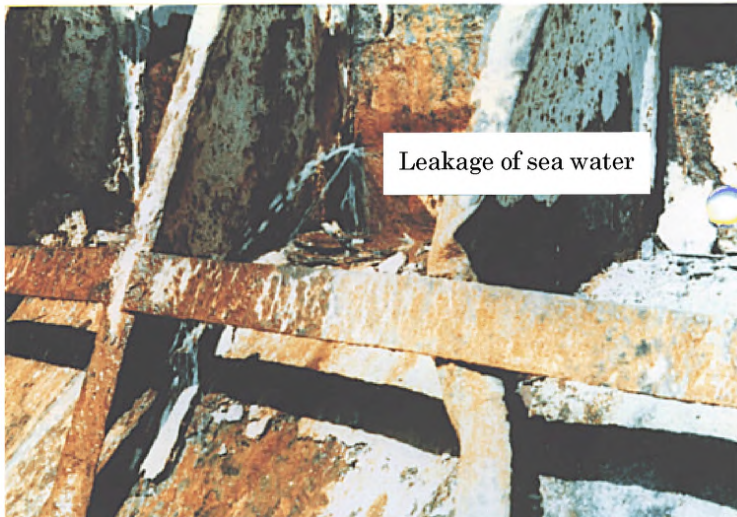
Photograph Leakage from side shell plating due to heavy corrosion

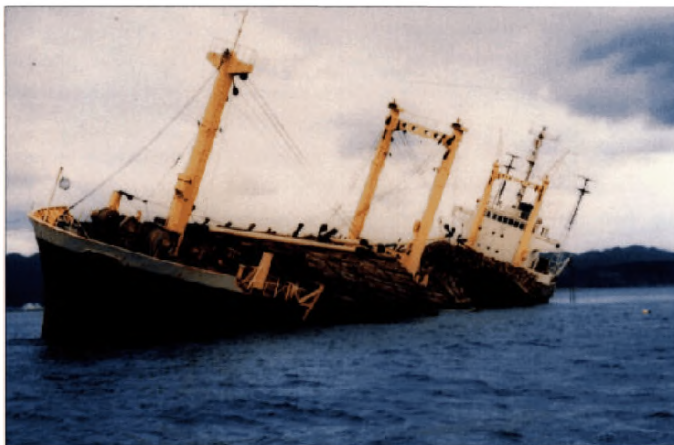
**Photograph 2 Timber carrier listing due to ingress of water**

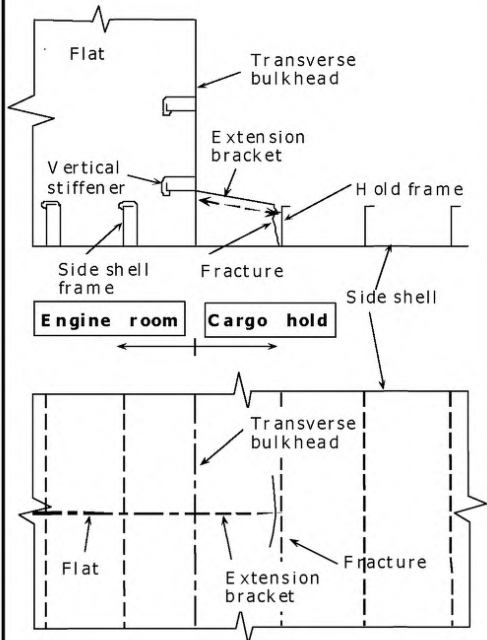
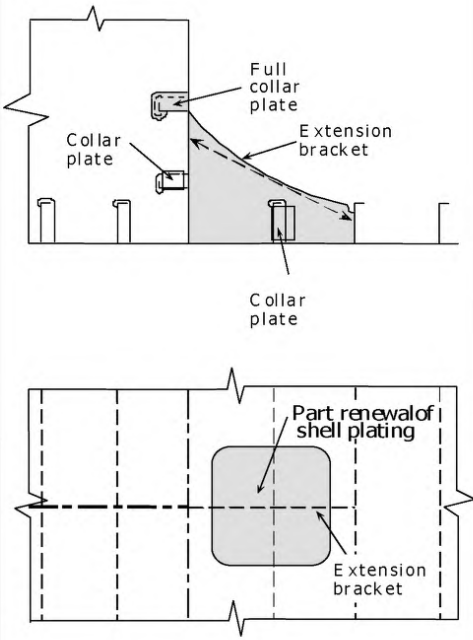
<b>Notes on possible cause of damage</b> 1. Damage caused by stress concentration leading to fatigue fracture on side shell. This will be exacerbated because of the greater flexibility of the hold structure in relation to the engine room structure.		<b>Notes on repairs</b> 1. The fractured shell plating is to be cropped and part renewed as necessary. 2. Extension bracket is to be modified and collar plates to cut-outs in engine room flat are to be installed.

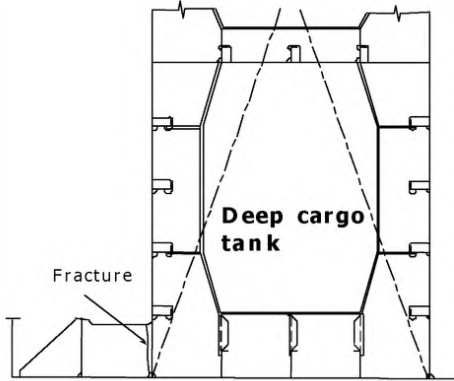
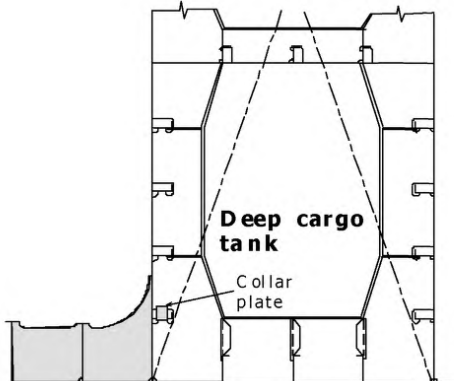
<p>The sketch shows a cross-section of a deep cargo tank. A dashed line indicates a fracture in the side shell, labeled 'Fracture'. The tank is labeled 'Deep cargo tank'.</p>		<p><b>Sketch of repair</b></p>

<p>The sketch shows the same cross-section of the deep cargo tank. A shaded area on the left side shell is labeled 'Collar plate', indicating the repair. The tank is labeled 'Deep cargo tank'.</p>	
<p><b>Notes on possible cause of damage</b></p> <p>1. Damage caused by stress concentration leading to fatigue fracture on side shell. This will be exacerbated because of the greater flexibility of the ordinary hold structure in relation to the deep cargo tank structure.</p>		<p><b>Notes on repairs</b></p> <p>1. The fractured shell plate is to be cropped and part renewed as necessary. 2. Brackets should be modified.</p>

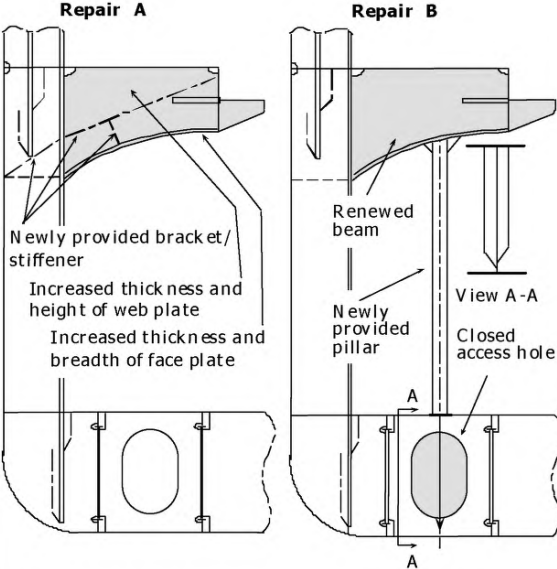
<p>Buckled cantilever beam</p>

<p><b>Repair A</b></p> <p>Newly provided bracket/stiffener Increased thickness and height of web plate Increased thickness and breadth of face plate</p> <p><b>Repair B</b></p> <p>Renewed beam Newly provided pillar View A-A Closed access hole</p>	
<b>Notes on possible cause of damage</b> 1. Poor design, overloading and/or excessive inertia force caused in heavy weather.		<b>Notes on repairs</b> 1. The affected structures are to be cropped and renewed. 2. <b>Repair A:</b> Reinforcement should be considered by increased scantlings of beam and/or additional stiffeners. 3. <b>Repair B:</b> Pillars may be provided for reinforcement subject to the approval of the owner. In such a case, reinforcement of the floor under the pillar should be considered. (In the above example, access hole was closed.)

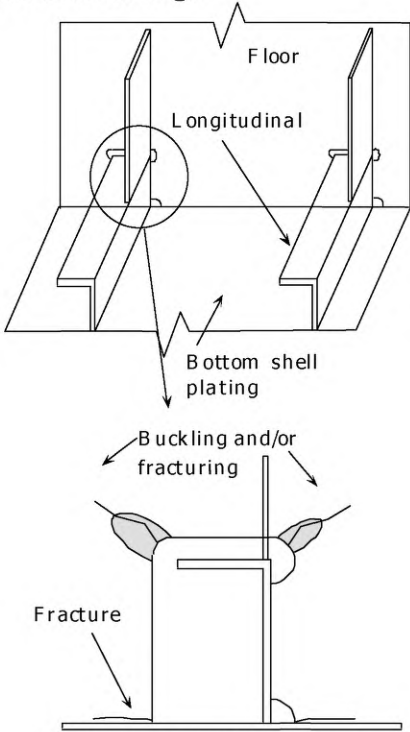
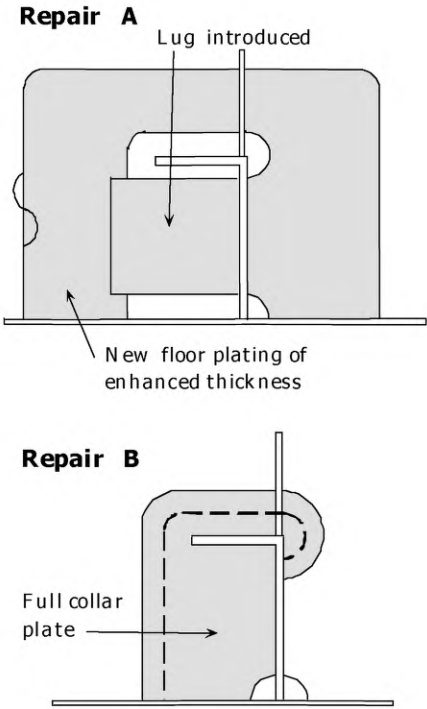
<p>Note: same type of damage may occur at similar connections to inner bottom</p>

<b>Notes on possible cause of damage</b> 1. Damage can be caused by general levels of corrosion and presence of stress concentration associated with the presence of a cut-out.		<b>Notes on repairs</b> 1. If fractures are significant then crop and part renew the floor plating otherwise the fracture can be veed-out and welded provided the plating is not generally corroded. 2. <b>Repair B</b> is to be incorporated if the lug proves to be ineffective.

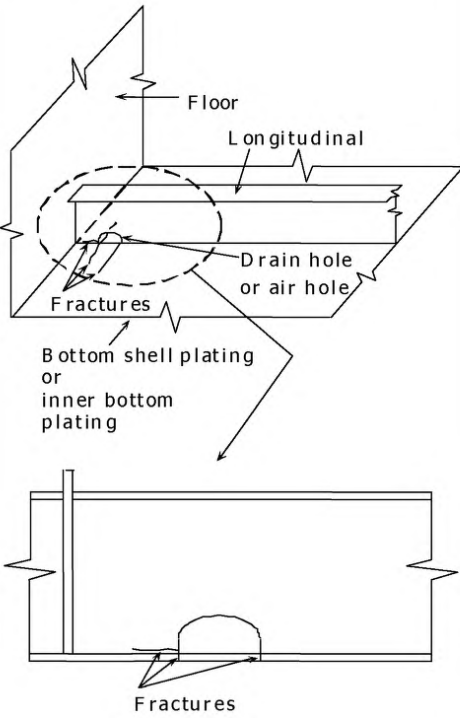
<b>Notes on possible cause of damage</b> <ol style="list-style-type: none"> <li>1. Stress concentration and/or corrosion due to stress concentration at the corner of drain hole/air hole.</li> </ol>		<b>Notes on repairs</b> <ol style="list-style-type: none"> <li>1. Fractured plating should be cropped and part renewed.</li> <li>2. If fatigue life is to be improved, change of drain hole/air hole shape is to be considered.</li> </ol>

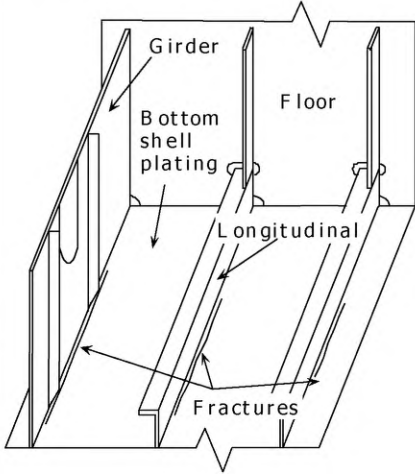
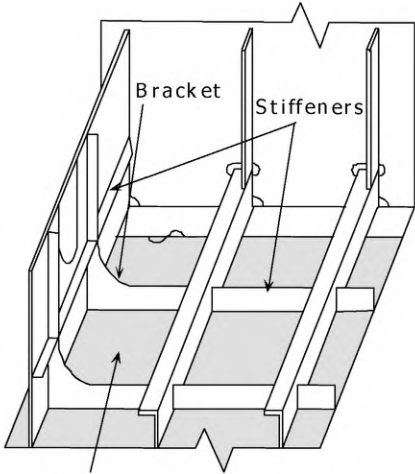
<b>Notes on possible cause of damage</b>		<b>Notes on repairs</b>	
1. Vibration.		<ol style="list-style-type: none"> <li>1. Fractured bottom shell plating should be cropped and renewed.</li> <li>2. Natural frequency of the panel should be changed, e.g. reinforcement by additional stiffener/bracket.</li> </ol>

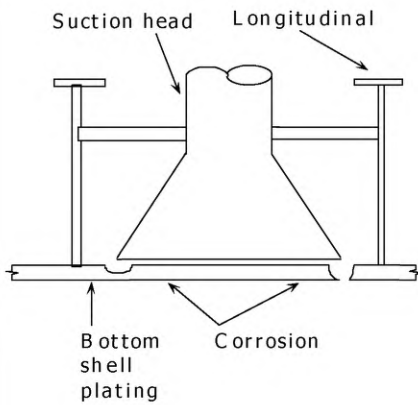
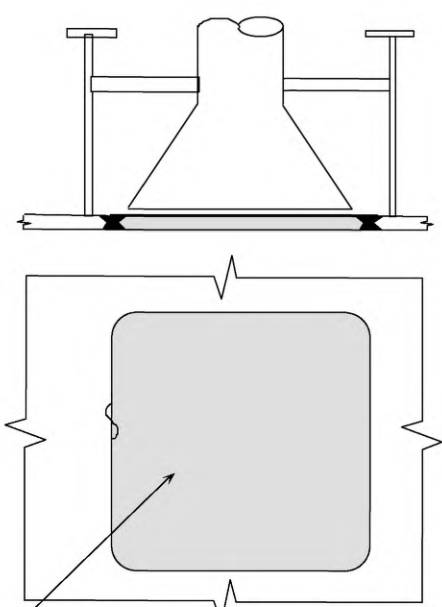
<p>Suction head    Longitudinal</p> <p>Bottom shell plating    Corrosion</p>		<p><b>Sketch of repair</b></p>

<p>1. Insert to have round corners 2. Non-destructive examination to be applied after welding based on the Society's rules</p>	
<p><b>Notes on possible cause of damage</b></p> <ol style="list-style-type: none"> <li>1. High flow rate associated with insufficient corrosion prevention system.</li> <li>2. Galvanic action between dissimilar metals</li> </ol>		<p><b>Notes on repairs</b></p> <ol style="list-style-type: none"> <li>1. Affected plating should be cropped and part renewed. Thicker plate and suitable beveling should be considered.</li> <li>2. If the corrosion is limited to a small area, i.e. pitting corrosion, repair by welding is acceptable.</li> </ol>

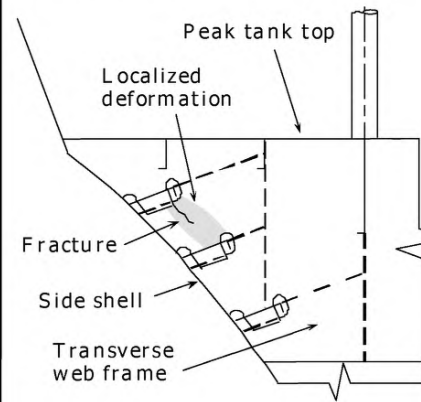
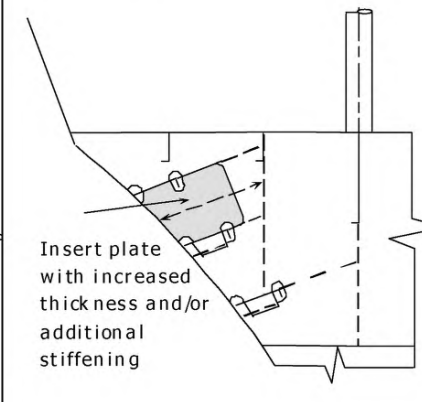
<b>Notes on possible cause of damage</b>		<b>Notes on repairs</b>	
<ol style="list-style-type: none"> <li>1. Localized material wastage in way of coating failure at cut-outs and sharp edges due to working of the structure.</li> <li>2. Dynamic seaway loading in way of bow flare.</li> </ol>		<ol style="list-style-type: none"> <li>1. Sufficient panel strength to be provided to absorb the dynamic loads enhanced by bow flare shape.</li> </ol>

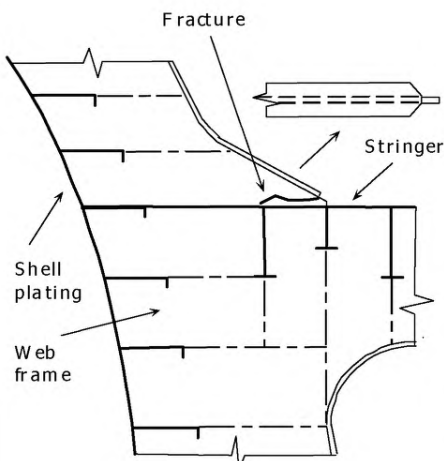
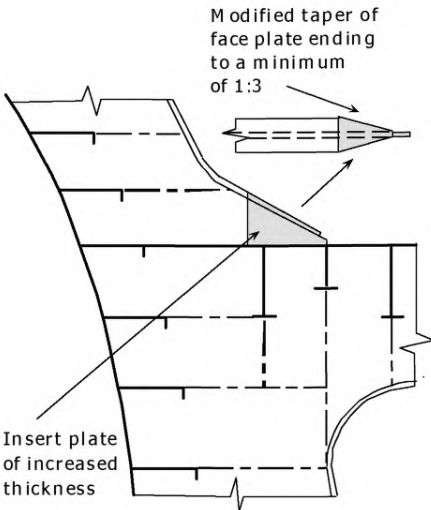
<b>Notes on possible cause of damage</b> <ol style="list-style-type: none"> <li>1. Inadequate bracket forming the web frame connection to the stringer.</li> <li>2. Localized material wastage in way of coating failure at bracket due to flexing of the structure.</li> <li>3. Dynamic seaway loading in way of bow flare.</li> </ol>		<b>Notes on repairs</b> <ol style="list-style-type: none"> <li>1. Adequate soft nose bracket endings with a face plate taper of at least 1 : 3 to be provided.</li> </ol>

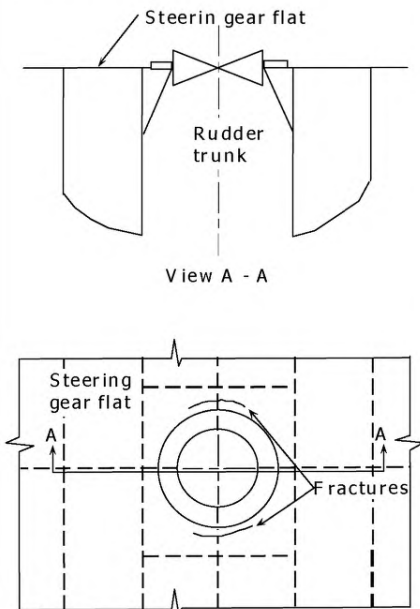
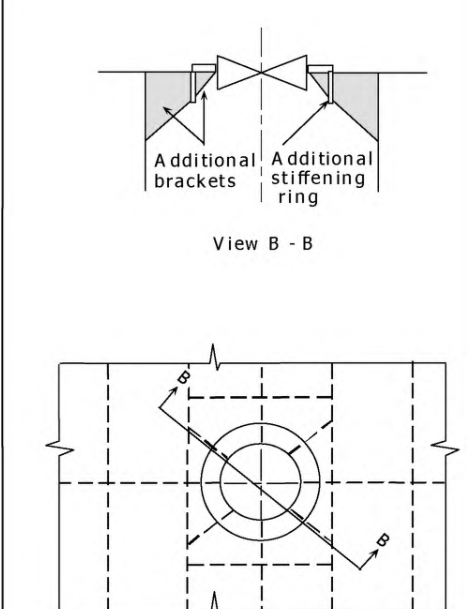
<p>Steerin gear flat</p> <p>Rudder trunk</p> <p>View A - A</p> <p>Steering gear flat</p> <p>Fractures</p>		<b>Sketch of repair</b>

<p>Additional brackets</p> <p>Additional stiffening ring</p> <p>View B - B</p>	
<b>Notes on possible cause of damage</b> 1. Inadequate design.		<b>Notes on repairs</b> 1. Fractured plating should be cropped and renewed. 2. Additional brackets and stiffening ring should be fitted for reinforcement.

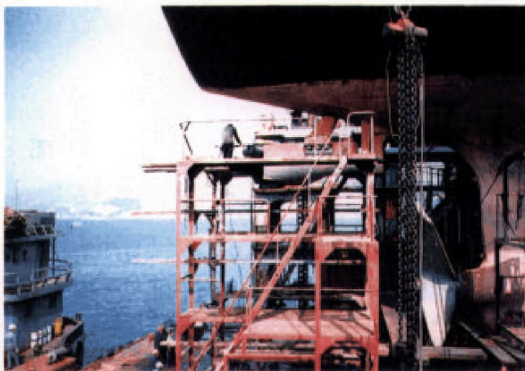
**Photograph 1  
Fractured rudder due to corrosion in rudder plating**

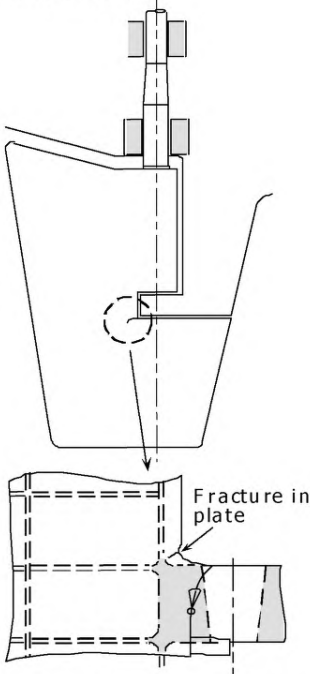
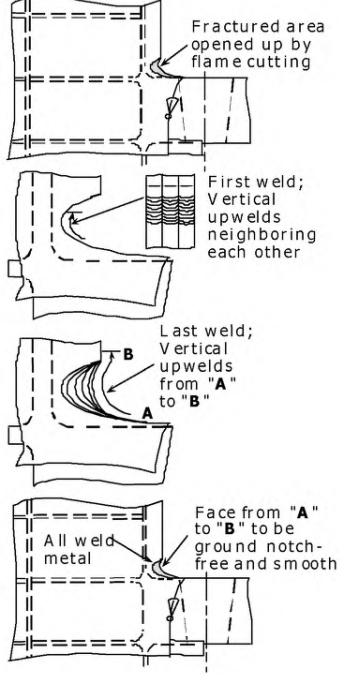
<b>Notes on possible cause of damage</b> <ol style="list-style-type: none"> <li>1. Stress concentration due to inadequate local design and/or fabrication notches in way of the butt weld between cast piece and plating.</li> </ol>	<b>Notes on repairs</b> <ol style="list-style-type: none"> <li>1. Grooving-out and welding of the fracture is not always adequate (metallurgical notch in way of a high stressed area).</li> <li>2. In the proposed repair procedure the metallurgical notches are shifted into a zone exposed to lower stresses.</li> <li>3. After welding a modification of the radius according to the proposal in <b>Example 5</b> is to be carried out.</li> <li>4. In case of very small crack it can be ground off by increasing the radius.</li> </ol>

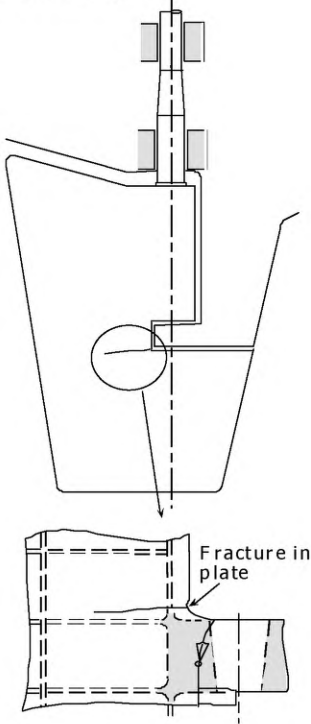
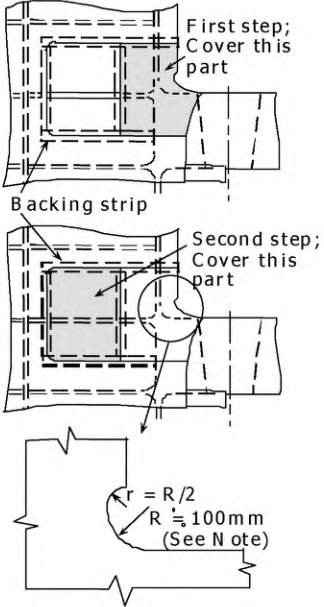
<p>First step; Cover this part</p> <p>Backing strip</p> <p>Second step; Cover this part</p> <p><math>r = R/2</math> <math>R \approx 100\text{mm}</math> (See Note)</p> <p>Note: <b>R</b> should be considered according to local detail</p>	
<b>Notes on possible cause of damage</b> <ol style="list-style-type: none"> <li>1. Stress concentration due to inadequate local design and/or fabrication notches in way of the butt weld between cast piece and plating.</li> </ol>		<b>Notes on repairs</b> <ol style="list-style-type: none"> <li>1. Fractured plating is to be cut-out.</li> <li>2. Internal structures are to be checked.</li> <li>3. Cut-out is to be closed by an insert plating according to the sketch (welding only from one side is demonstrated).</li> <li>4. Modification of the radius.</li> <li>5. In case of a new cast piece, connection with the plating is to be shifted outside the high stress area.</li> </ol>

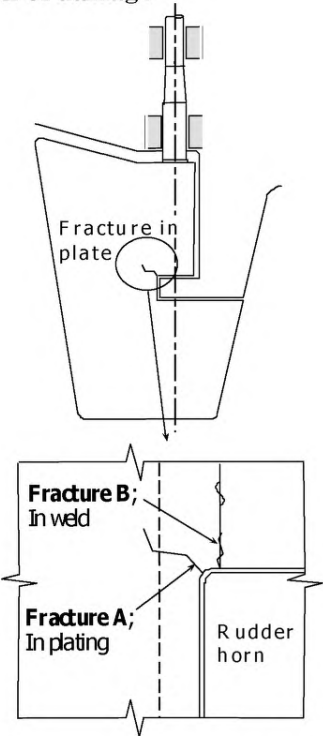
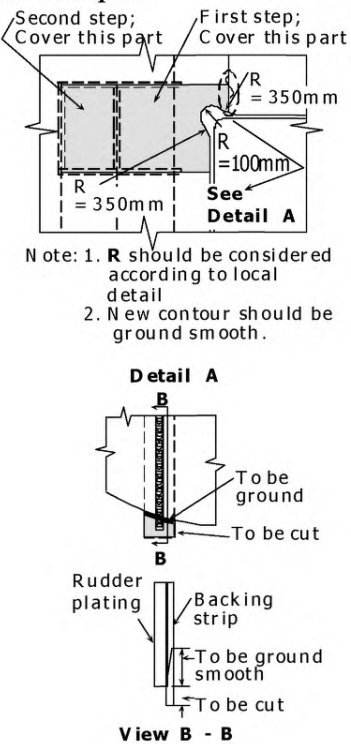
Notes on possible cause of damage	Notes on repairs	
<ol style="list-style-type: none"> <li>Inadequate design for stress concentration in way of pintle bearing</li> <li>(Fracture A). Imperfection in welding seam (Fracture B).</li> </ol>	<ol style="list-style-type: none"> <li>Fractured part to be cropped off.</li> <li>Repair by two insert plates of modified, stress releasing contour. For the vertical seam no backing strip is used 100mm off contour, welding from both sides, to be ground after welding.</li> <li>Variant (See Detail A): Repair as mentioned under 2 with the use of backing strip for the complete vertical seam. After welding backing strip partly removed by grinding.</li> </ol>

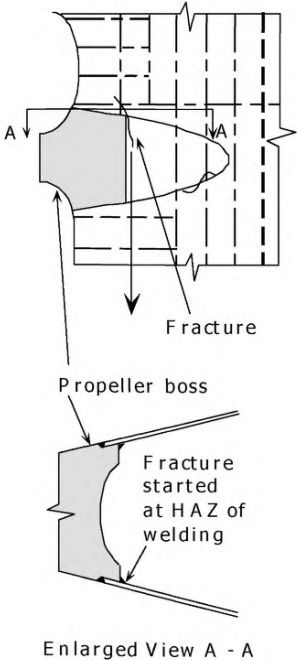
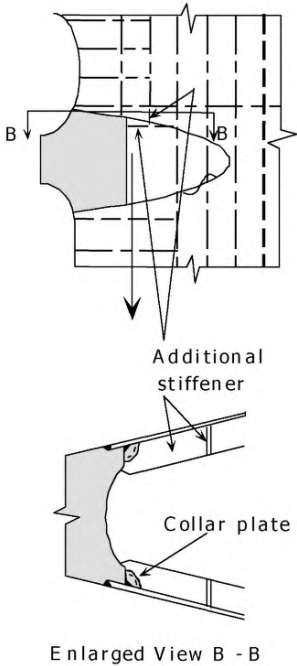
<p>Fracture</p> <p>Propeller boss</p> <p>Fracture started at HAZ of welding</p> <p>Enlarged View A - A</p>		<p><b>Sketch of repair</b></p>

<p>Additional stiffener</p> <p>Collar plate</p> <p>Enlarged View B - B</p>	
<p><b>Notes on possible cause of damage</b></p> <p>1. Fatigue fracture due to vibration.</p>		<p><b>Notes on repairs</b></p> <p>1. Fractured side shell plating is to be cropped and part renewed.</p> <p>2. Additional stiffeners are to be provided.</p> <p>3. Collar plate is to be provided.</p>

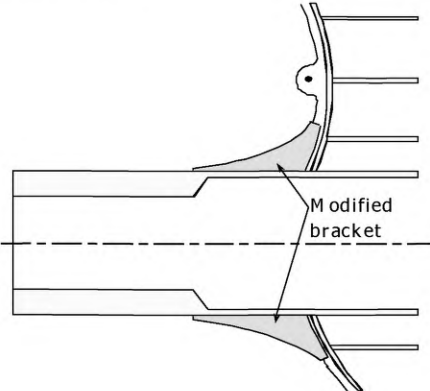
<b>Notes on possible cause of damage</b>		<b>Notes on repairs</b>	
<ol style="list-style-type: none"> <li>1. Fatigue fracture due to vibration.</li> </ol>		<ol style="list-style-type: none"> <li>1. Fractured tube is to be welded from both sides.</li> <li>2. Brackets are to be replaced by modified brackets with soft transition.</li> </ol>

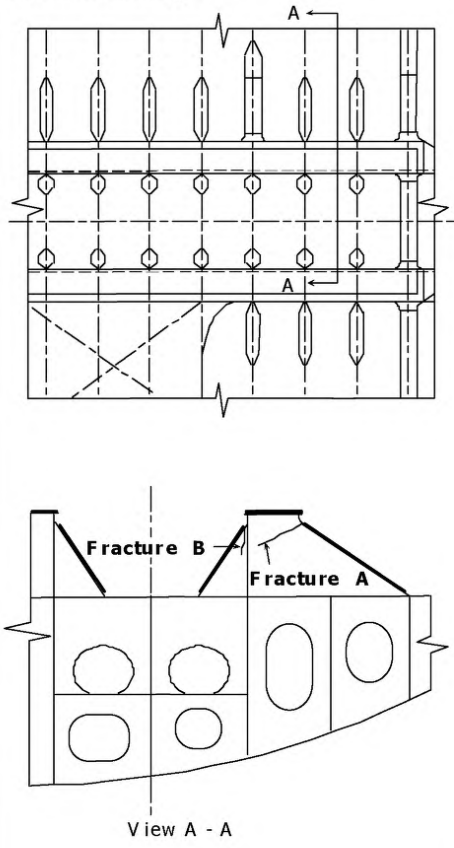
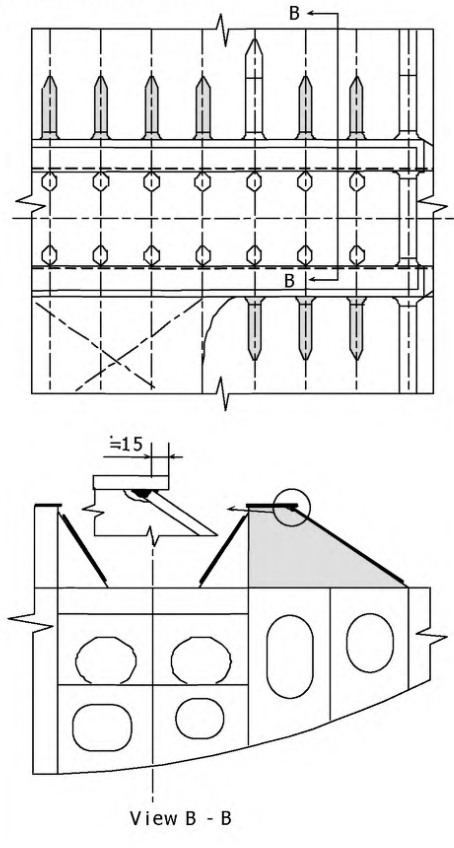
<p>View B - B</p>	
<b>Notes on possible cause of damage</b>		<b>Notes on repairs</b>	
<ol style="list-style-type: none"> <li>1. Vibration of main engine.</li> <li>2. Insufficient strength of brackets at main engine foundation.</li> <li>3. Insufficient pre-load of the bolts.</li> </ol>		<ol style="list-style-type: none"> <li>1. Fractures may be vee-d out and rewelded.</li> <li>2. New modified brackets at main engine foundation. Or insert pieces and additional flanges to increase section modulus of the brackets.</li> </ol>

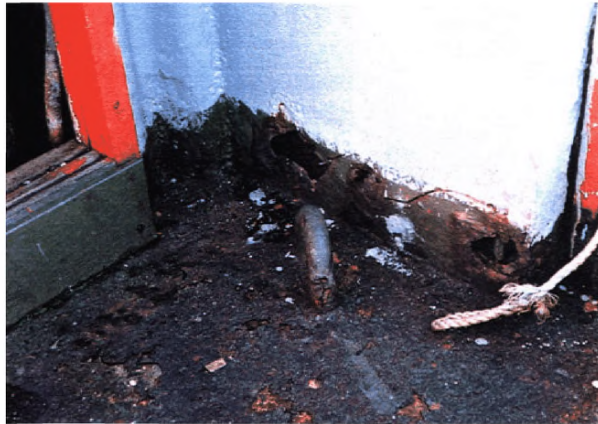
**Photograph 1 Corroded accommodation house structure**
