No. 96 **Double Hull Oil Tankers** - Guidelines for Surveys,
(April Assessment and Repair of Hull Structures
2007)

DOUBLE HULL OIL TANKERS

Guidelines for Surveys, Assessment and Repair
of Hull Structures

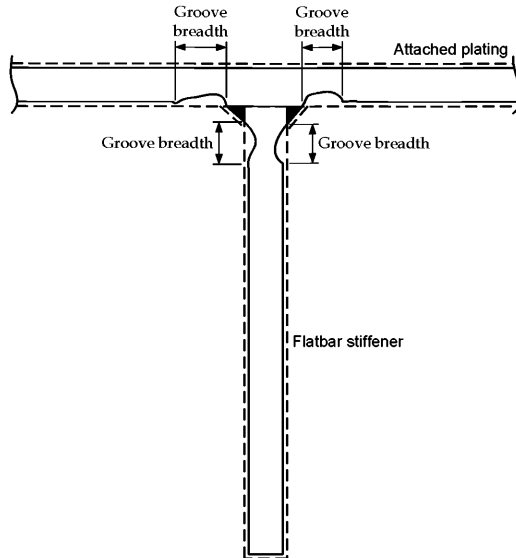
Figure 8 Grooving Corrosion

Grooving corrosion is often found in or beside welds, especially in the heat affected zone. This corrosion is sometimes referred to as 'inline pitting attack' and can also occur on vertical members and flush sides of bulkheads in way of flexing. The corrosion is caused by the galvanic current generated from the difference of the metallographic structure between the heat affected zone and base metal. Coating of the welds is generally less effective compared to other areas due to roughness of the surface, which exacerbates the corrosion. Grooving corrosion may lead to stress concentrations and further accelerate the corrosion process. Grooving corrosion may be found in the base material where coating has been scratched or the metal itself has been mechanically damaged. An example of grooving corrosion is shown in Figure 8.

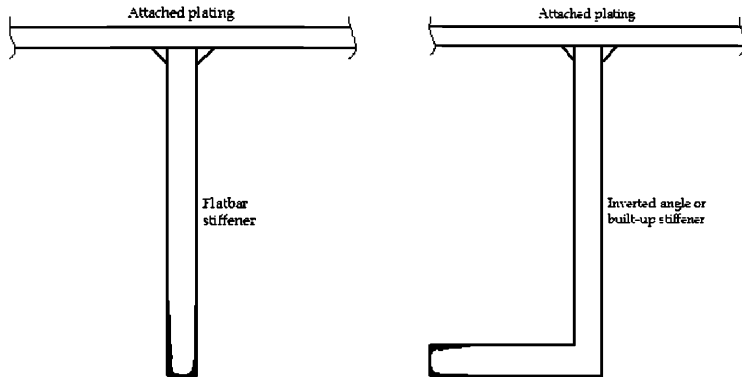
Figure 9 Edge Corrosion

Edge corrosion is defined as local corrosion at the free edges of plates, stiffeners, primary support members and around openings. An example of edge corrosion is shown in Figure 9.

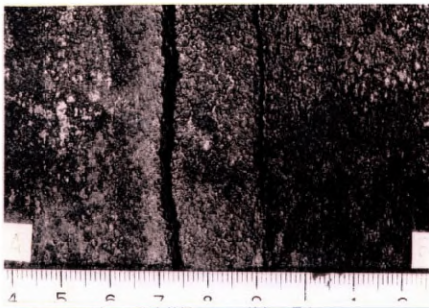
4.1.3 Bottom or “docking” plugs should be carefully examined for excessive corrosion along the edge of the weld connecting the plug to the bottom plating

Photograph 1
Grooving corrosion of welding of bottom plating

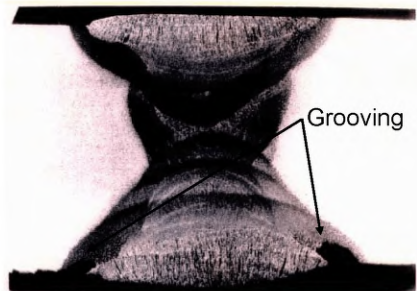
Photograph 2
Section of the grooving shown in Photograph 1

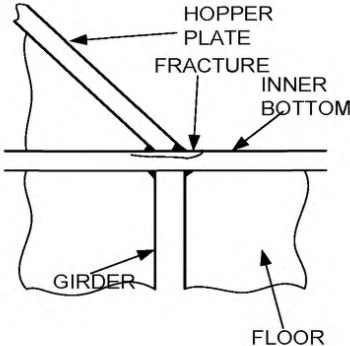
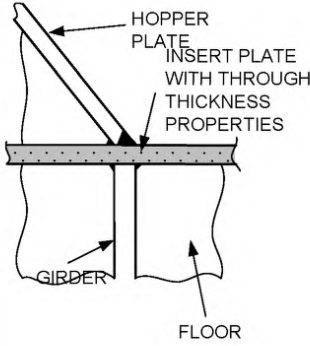
OIL Tankers		Guidelines for Surveys, Assessment and Repair of Hull Structure	
Group 1	Cargo area	Example No.	
	Hopper and double bottom ballast tank	2	
Detail of damage		Fracture at connection of bilge hopper plate and inner bottom	
<p>Sketch of damage</p>

<p>Notes: Plate midlines intersect</p>	
<p>Factors which may have caused damage</p> <p>1. Stress concentration at the knuckle.</p>		<p>Notes on repairs</p> <p>See Sketch.</p>

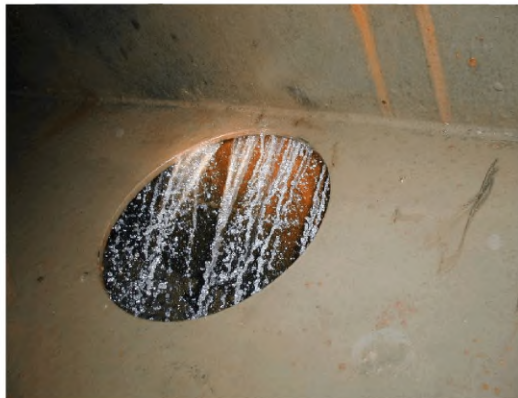
Photograph 1 Side shell fracture in way of horizontal stringer weld

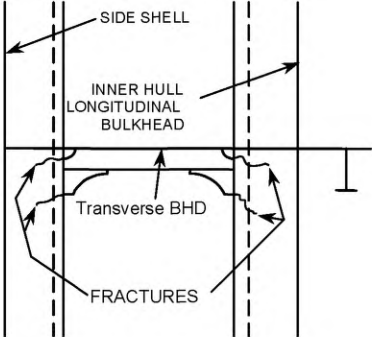
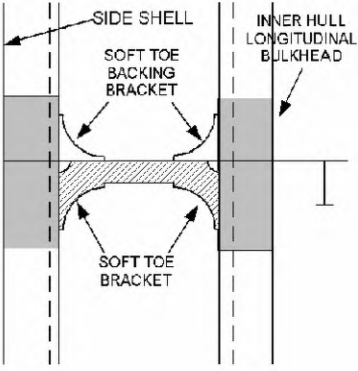
OIL Tankers		Guidelines for Surveys, Assessment and Repair of Hull Structure	
Group 2	Cargo area	Example No.	
	Wing ballast tank	1	
Detail of damage	Crack in way of connection of longitudinals to transverse bulkhead		
<p>Sketch of damage</p>

<p>Factors which may have caused damage</p> <ol style="list-style-type: none"> 1. Asymmetrical connection of bracket without backing bracket. 2. Relative deflection of adjoining transverse web against transverse bulkhead. 3. Additional biaxial bending stresses due to asymmetry of the angle bar longitudinal instead of symmetric T section. 4. Dynamic load in the vicinity of the water line. 5. Large upstand at bracket toe. 	<p>Notes on repairs</p> <p>See Sketch.</p>

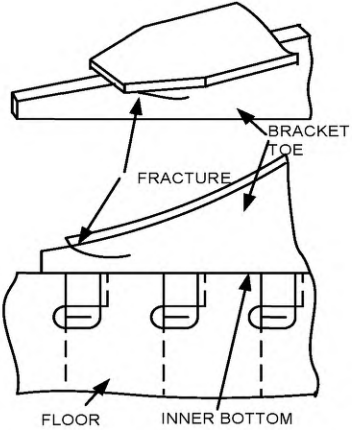
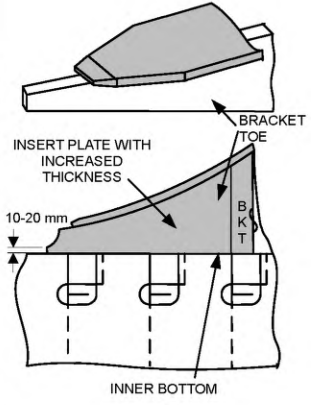
OIL Tankers		Guidelines for Surveys, Assessment and Repair of Hull Structure
Group 4	Cargo area	Example No.
	Web Frame in cargo tank	1
Detail of damage		Fracture at toe of web frame bracket connection to inner bottom.
<p>Sketch of damage</p>

<p>The sketch shows a perspective view of a bracket attached to a horizontal web frame. A crack, labeled 'FRACTURE', is shown at the 'BRACKET TOE' where the bracket meets the web frame. Below this, a plan view shows the 'FLOOR' and 'INNER BOTTOM' with three brackets attached. An arrow points from the fracture location in the perspective view to the corresponding bracket location in the plan view.</p>		<p>Sketch of repair</p> <p>Modify Face Taper</p> <ol style="list-style-type: none"> 1. Breadth taper 20 degrees. 2. Breadth at toe as small as practical. 3. Thickness taper 1 in 3 to 10mm.

<p>The repair sketch shows a perspective view of the bracket with a shaded 'INSERT PLATE WITH INCREASED THICKNESS' at the 'BRACKET TOE'. A dimension line indicates a thickness of '10-20 mm'. Below, a plan view shows the 'INNER BOTTOM' with three brackets. An arrow points from the repair location in the perspective view to the corresponding bracket location in the plan view.</p>

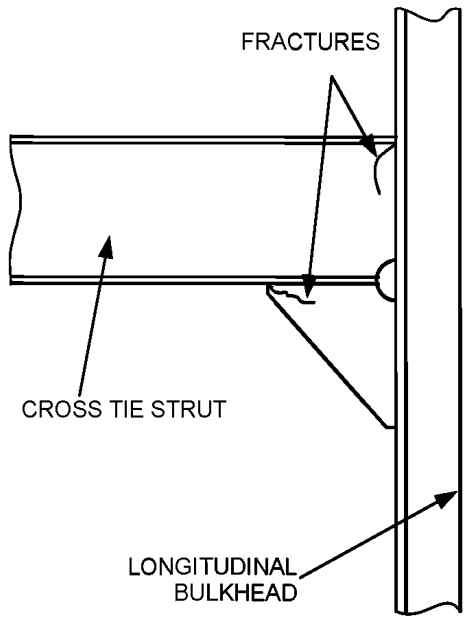
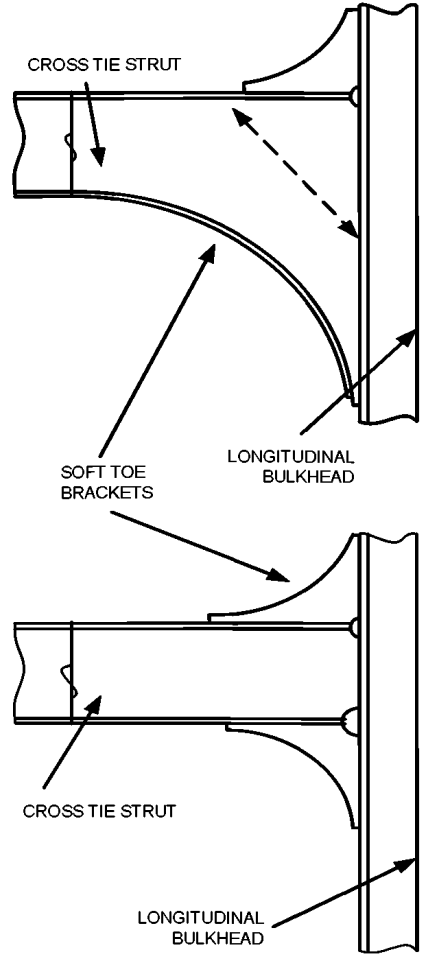
OIL Tankers		Guidelines for Surveys, Assessment and Repair of Hull Structure	
Group 4	Cargo area	Example No.	
	Web Frame in cargo tank	2	
Detail of damage		Cross ties and their end connections	
Sketch of damage		Sketch of repair

<p>The sketch shows a cross-section of a cross tie strut connected to a longitudinal bulkhead. Two arrows point to the connection points, labeled 'FRACTURES'. The cross tie strut is labeled 'CROSS TIE STRUT' and the longitudinal bulkhead is labeled 'LONGITUDINAL BULKHEAD'.</p>

<p>The sketch shows two views of the repair. The top view shows a cross tie strut connected to a longitudinal bulkhead with a curved 'SOFT TOE BRACKET' at the junction. Labels include 'CROSS TIE STRUT' and 'LONGITUDINAL BULKHEAD'. The bottom view shows a similar connection with a straight cross tie strut. Labels include 'CROSS TIE STRUT' and 'LONGITUDINAL BULKHEAD'.</p>	
Factors which may have caused damage		Notes on repairs

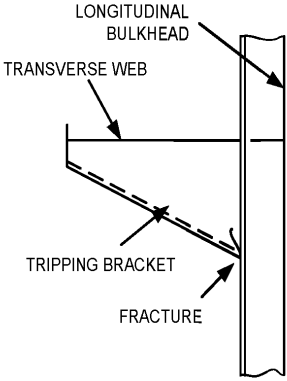
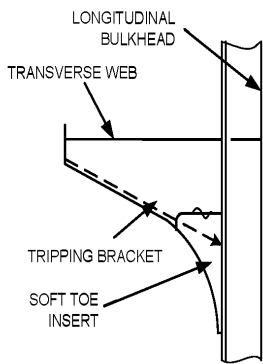
OIL Tankers		Guidelines for Surveys, Assessment and Repair of Hull Structure	
Group 4	Cargo area	Example No.	
	Web Frame in cargo tank	5	
Detail of damage	Fracture in way of connection of transverse web tripping brackets to longitudinal		
<p>Sketch of damage</p>

<p>Factors which may have caused damage</p> <ol style="list-style-type: none"> 1. Hard spot at the toe of bracket. 2. Vibration. 		<p>Notes on repairs</p> <p>See Sketch.</p> <ol style="list-style-type: none"> 1. Soft bracket may be added on upper side of web, to avoid fracture at the heel.

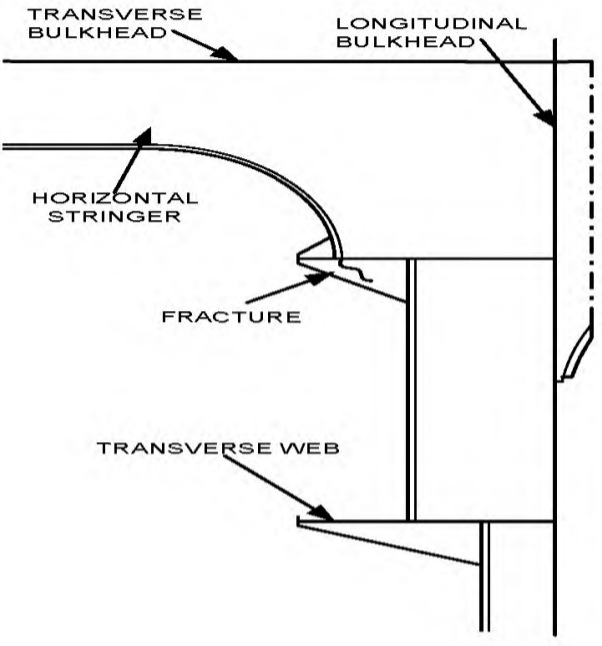
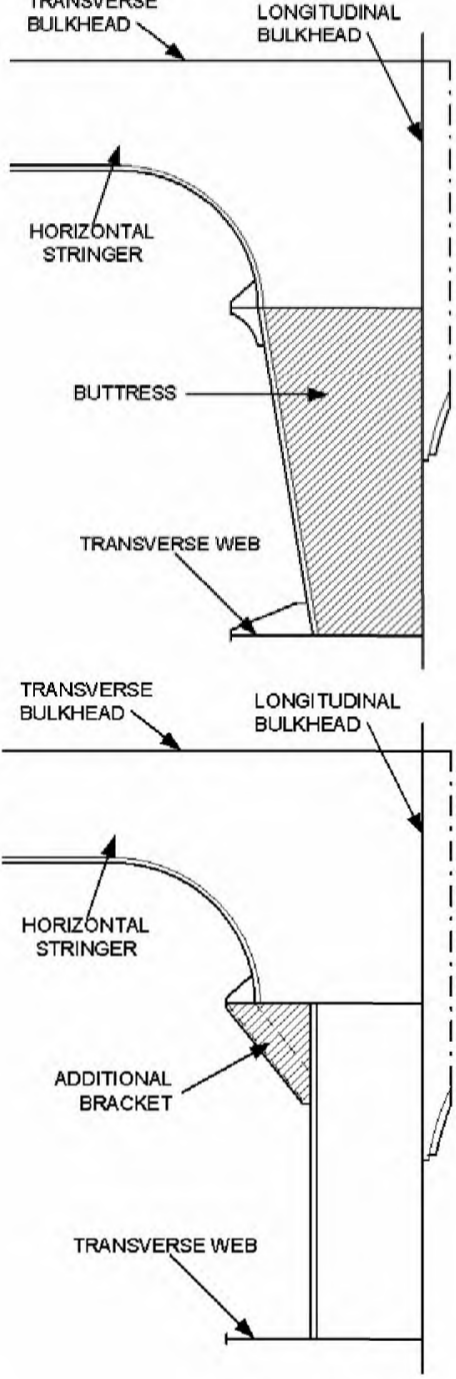
OIL Tankers	Guidelines for Surveys, Assessment and Repair of Hull Structure	
Group 5	Cargo area	Example No.
	Transverse Bulkhead in cargo tank	1
Detail of damage	Fracture in way of connection of transverse bulkhead stringer to transverse web frames and longitudinal bulkhead stringer	
Sketch of damage

Factors which may have caused damage	Notes on repairs	
<ol style="list-style-type: none"> 1. Stress concentration due to discontinuous structure. 2. High shear stress in the horizontal stringer. 	<p>See Sketch.</p>

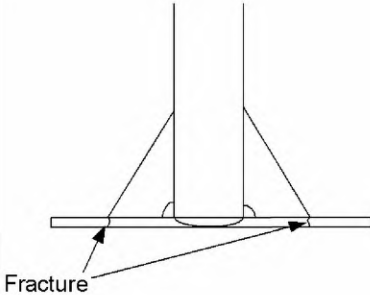
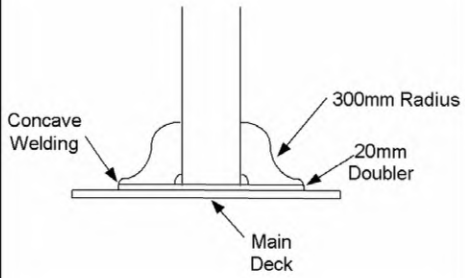
OIL Tankers		Guidelines for Surveys, Assessment and Repair of Hull Structure	
Group 6	Deck Structure		Example No.
			5
Detail of damage		Fractured deck plating in way of deck pipe support stanchions (midships)	
Sketch of damage		Sketch of repair

Factors which may have caused damage		Notes on repairs	
<p>1. Stanchions experience more severe relative displacements from hull girder bending.</p>		<p>See Sketch.</p>

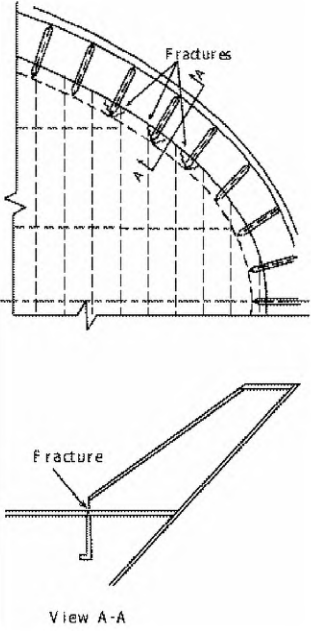
OIL Tankers		Guidelines for Surveys, Assessment and Repair of Hull Structure	
Group 7	Fore region	Example No.	
Area 1	Forecastle	1	
Detail of damage		Fracture in forecastle deck plating at bulwark	
Sketch of damage		Sketch of repair

Factors which may have caused damage		Notes on repairs	
<ol style="list-style-type: none"> 1. Bow Flare effect in heavy weather. 2. Stress concentration due to poor design. 		<ol style="list-style-type: none"> 1. Fractured deck plating should be cropped and renewed. 2. Bracket in line with the bulwark stay to be fitted to reduce stress concentration.

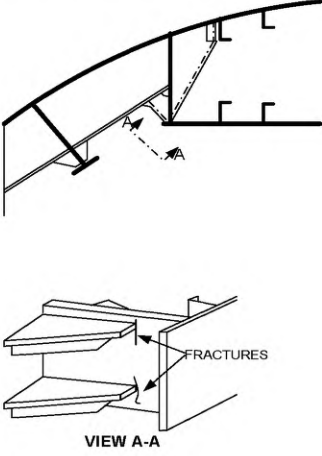
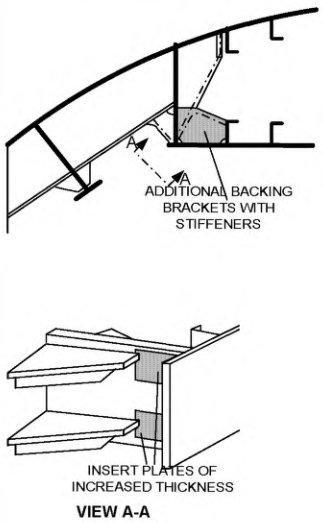
OIL Tankers		Guidelines for Surveys, Assessment and Repair of Hull Structure
Group 7	Fore region	Example No.
Area 1	Forepeak ballast tank	4
Detail of damage	Fractured vertical web at the longitudinal stiffener ending in way of the parabolic bow structure.	
Sketch of damage	Sketch of repair

Factors which may have caused damage <ol style="list-style-type: none"> 1. Stress concentrations at bracket ending due to inadequate support at bracket toes in way of connection to web frame members. 2. Localised thinning in way of coating failure at bracket endings due to flexing of the structure. 3. Dynamic seaway loadings at bow causing flexing at bracket endings. 	Notes on repairs See Sketch.

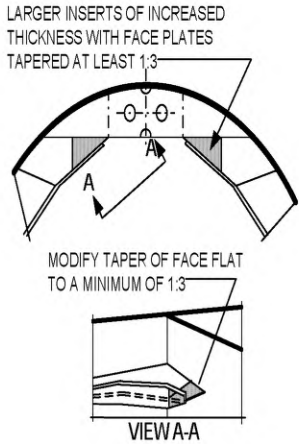
<p>A schematic diagram of the forepeak ballast tank structure. It shows a curved shell plating at the top. Below it, two side longitudinals are shown. Arrows point to the junctions between the shell plating and the side longitudinals, labeled 'FRACTURES'. The side longitudinals are labeled 'SIDE LONGITUDINALS'.</p>

<p>The repair sketch shows the same structure as the damage sketch, but with larger inserts of increased thickness and face plates tapered at least 1:3. A detail view labeled 'VIEW A-A' shows the taper of the face plate being modified to a minimum of 1:3.</p> <p>LARGER INSERTS OF INCREASED THICKNESS WITH FACE PLATES TAPERED AT LEAST 1:3</p> <p>MODIFY TAPER OF FACE FLAT TO A MINIMUM OF 1:3</p> <p>VIEW A-A</p>

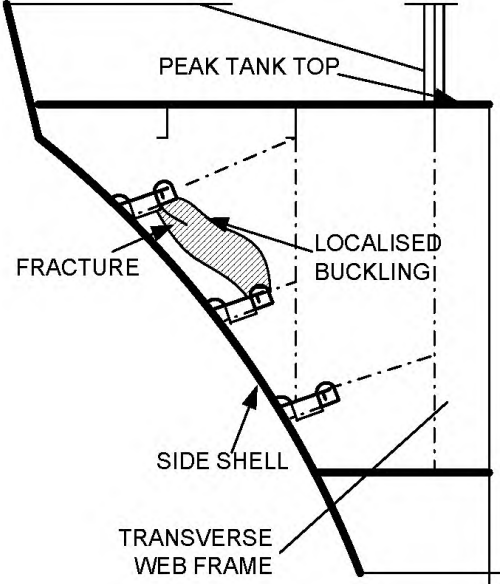
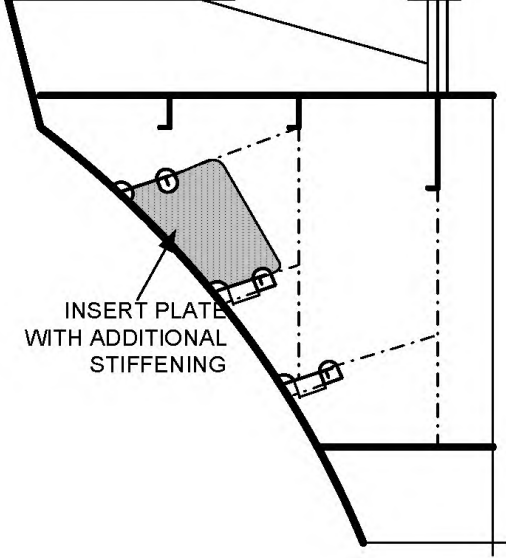
OIL Tankers		Guidelines for Surveys, Assessment and Repair of Hull Structure	
Group 7	Fore region	Example No.	
Area 1	Forepeak ballast tank	7	
Detail of damage		Fracture and buckle of bow transverse web frame in way of longitudinal cut-outs.	
Sketch of damage		Sketch of repair

Factors which may have caused damage 1. Localised thinning in way of coating failure at cut-outs and sharp edges due to working of the structure. 2. Dynamic seaway loadings in way of bow flare.		Notes on repairs See Sketch.

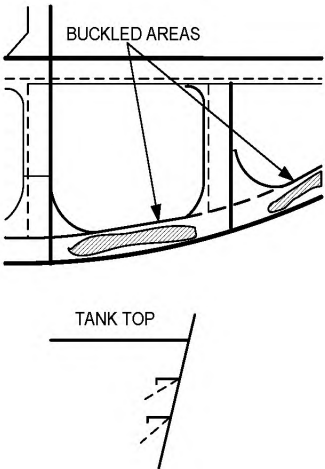
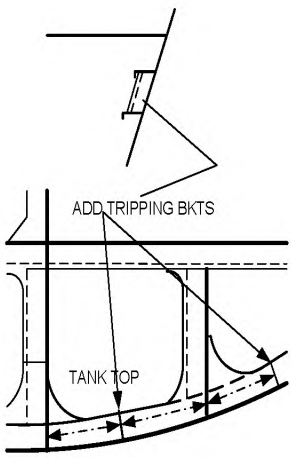
OIL Tankers		Guidelines for Surveys, Assessment and Repair of Hull Structure	
Group 7	Fore region	Example No.	
Area 1	Fore peak ballast tank	8	
Detail of damage		Buckled and tripped breathhooks	
Sketch of damage		Sketch of repair

<p>The sketch shows a cross-section of a fore peak ballast tank. A horizontal line at the top is labeled 'BUCKLED AREAS' with arrows pointing to the curved, distorted sections of the upper hull structure. Below this, a horizontal line is labeled 'TANK TOP' with arrows pointing to the bottom of the tank's internal structure.</p>

<p>The sketch shows the same cross-section as the damage sketch, but with repairs. A horizontal line at the top is labeled 'ADD. TRIPPING BKTS' with arrows pointing to newly added brackets on the upper hull structure. Below this, a horizontal line is labeled 'TANK TOP' with arrows pointing to the bottom of the tank's internal structure.</p>

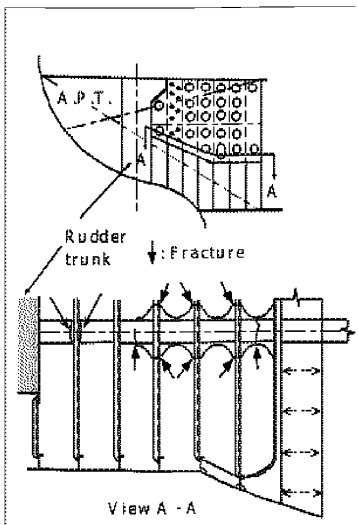
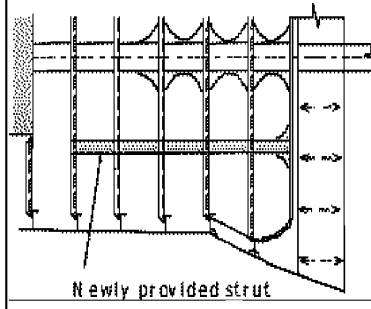
OIL Tankers		Guidelines for Surveys, Assessment and Repair of Hull Structure
Group 7	Aft region	Example No.
Area 2	Aft peak ballast tank	10
Detail of damage	Fractures at the connection of floors and girders/side brackets	
Sketch of damage	Sketch of repair

<p>The sketch shows a cross-section of the hull structure. At the top, a curved section is labeled 'A.P.T.'. Below it, a horizontal line represents the 'Rudder trunk'. A vertical line indicates a 'Fracture' at the connection of the floors and girders/side brackets. The view is labeled 'View A - A'.</p>

<p>The sketch shows the same cross-section as the damage sketch, but with a 'Newly provided strut' added to reinforce the structure. The strut is shown as a vertical member connecting the floor and girder/side bracket.</p>	
Factors which may have caused damage 1. Vibration.	Notes on repairs 1. The fractured plating should be cropped and renewed. 2. Natural frequency of the panel should be changed, e.g. reinforcement by additional strut.

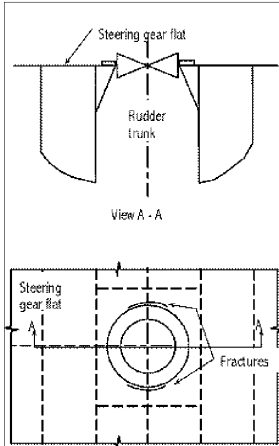
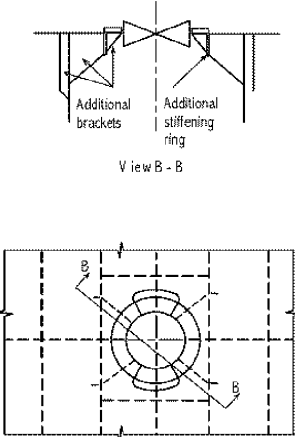
OIL Tankers		Guidelines for Surveys, Assessment and Repair of Hull Structure	
Group 7	Aft region	Example No.	
Area 2	Machinery space outside Engine room	11	
Detail of damage		Fractures in flat where rudder carrier is installed in steering gear room	
<p>Sketch of damage</p>

<p>Additional brackets</p> <p>Additional stiffening ring</p> <p>View B - B</p>	
<p>Factors which may have caused damage</p> <ol style="list-style-type: none"> 1. Inadequate design. 		<p>Notes on repairs</p> <ol style="list-style-type: none"> 1. Fractured plating should be cropped and renewed. 2. Additional brackets and stiffening ring should be fitted for reinforcement.

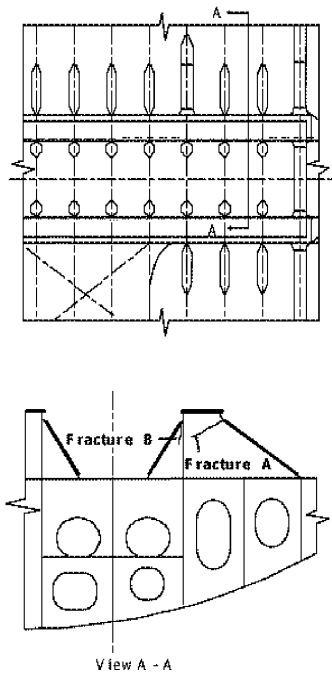
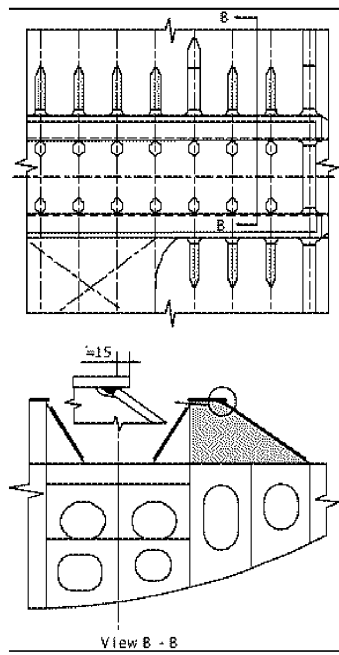
OIL Tankers		Guidelines for Surveys, Assessment and Repair of Hull Structure	
Group 8	Machinery and accommodation spaces	Example No.	
Area 1	Engine room	1	
Detail of damage		Fractures in brackets at main engine foundation	
<p>Sketch of damage</p>

<p>Factors which may have caused damage</p> <ol style="list-style-type: none"> 1. Vibration of main engine. 2. Insufficient strength of brackets at main engine foundation. 3. Insufficient pre-load of the bolts. 		<p>Notes on repairs</p> <ol style="list-style-type: none"> 1. Fractures may be veed-out and rewelded. 2. New modified brackets at main engine foundation. 3. Or insert pieces and additional flanges to increase section modulus of the brackets.

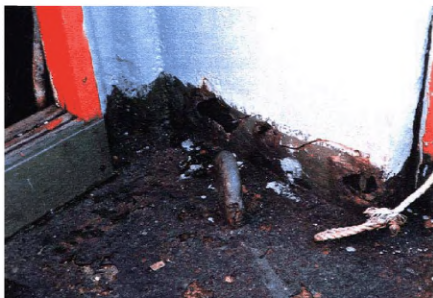
Photograph 1 Corroded accommodation house side structure
