**No.55 GENERAL CARGO SHIPS - Guidelines For  
(March  
1999) Surveys, Assessment and Repair of Hull  
Structure**

## **GENERAL CARGO SHIPS**

**Guidelines for Surveys,  
Assessment and Repair  
of Hull Structure**

## **IACS -International Association of Classification Societies, 1999**

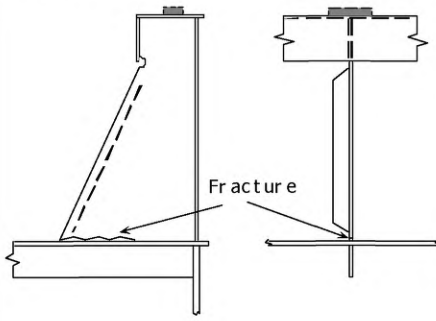
Notes on possible cause of damage		Notes on repairs	
<ol style="list-style-type: none"> <li>1. Flange force at the end of the flange too high due to insufficient tapering (<b>Fracture Type A</b>, propagating in the web).</li> <li>2. Shear force in the web plate too high due to insufficient reduction of the web height at the end (<b>Fracture Type B</b> propagating in the web at the undercut or HAZ of the fillet weld).</li> <li>3. Insufficient support of the extension bracket below the deck (<b>Fracture Type C</b>, starting from undercut or HAZ of the fillet weld and propagating in the deck plating).</li> </ol>		<ol style="list-style-type: none"> <li>1. Extend the extension bracket as long as possible to arrange a gradual transition.</li> <li>2. Reduce the web height at the end of the bracket; in case of high stress areas grind smooth the transition to the deck plating welding.</li> <li>3. Reduce the cross sectional area of the flange at the end as far as possible.</li> <li>4. Provide longitudinal structure in way of the web of the extension bracket to the next transverse structure or provide a new transverse structure.</li> </ol>

GENERAL CARGO SHIPS		Guidelines for Surveys, Assessment and Repair of Hull Structure
Part 1	Cargo hold region	Example No.
Area 1	Upper deck structure	6
Detail of damage	Fractures in web of transverse hatch coaming stay	
Sketch of damage	Sketch of repair

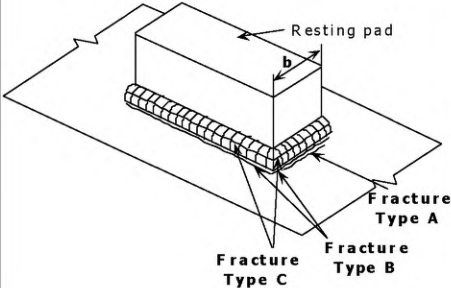
GENERAL CARGO SHIPS		Guidelines for Surveys, Assessment and Repair of Hull Structure	
Part 1	Cargo hold region	Example No.	
Area 1	Upper deck structure	8	
<b>Detail of damage</b>		Fractures in hatch coaming top plate around resting pad	
<p><b>Sketch of damage</b></p>

<p><b>Fracture Type A:</b> Starting in way of the undercut or HAZ of the transverse fillet weld and propagating in the top plating.</p> <p><b>Fracture Type B:</b> Starting in way of the undercut or HAZ of the longitudinal fillet weld and propagating in the top plating.</p> <p><b>Fracture Type C:</b> Starting and propagating in fillet weld</p>		<p><b>Sketch of repair</b></p> <p><b>Repair for "Fracture Type A"</b> Note: Cut, if the pad has enough area</p>

<p><b>Notes on possible cause of damage</b></p> <ol style="list-style-type: none"> <li><b>Fracture Type A:</b> Inappropriate transition from the hatch coaming top plating to the resting pad in respect to longitudinal stresses.</li> <li><b>Fracture Type B:</b> Insufficient support of the resting pad below the top plating.</li> <li><b>Fracture Type C:</b> Insufficient throat thickness of the fillet weld in relation to the vertical forces.</li> </ol>

<p><b>Notes on repairs</b></p> <ol style="list-style-type: none"> <li><b>Fracture Type A:</b> Modification of the transverse fillet weld according to the sketch; in some cases smoothing of the transition by grinding is acceptable.</li> <li><b>Fracture Type B:</b> Strengthening of the structures below the top plating according to the sketch.</li> <li><b>Fracture Type C:</b> Increasing the throat thickness corresponding to the acting vertical forces.</li> </ol>

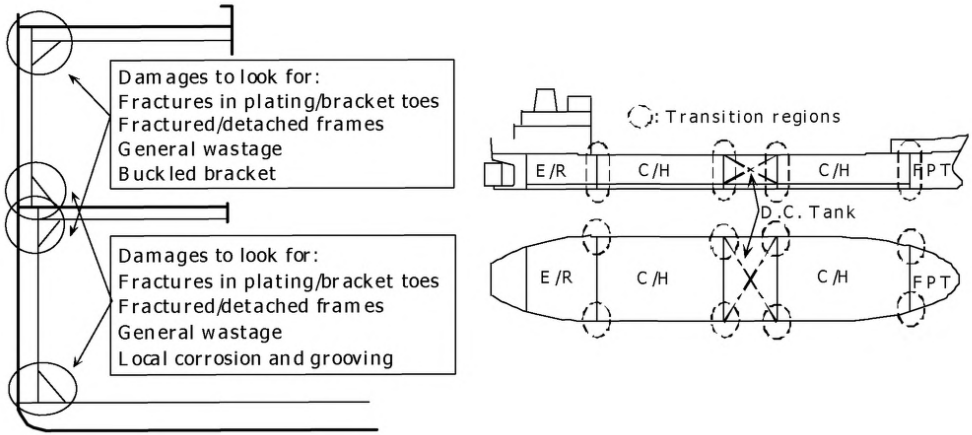
- 1.5 The transition regions are subject to stress concentrations due to structural discontinuities. The side shell plating in fore and aft transition regions is also subject to panting. The lack of continuity of the longitudinal structure, and the greater slenderness and flexibility of the side structure near the more rigid end structures, can result in damages.

- 1.6 A summary of potential problem areas is shown in **Figures 1 (a) and (b)**. Serious consequences of damaged ship sides are illustrated in **Photographs 1 and 2**.

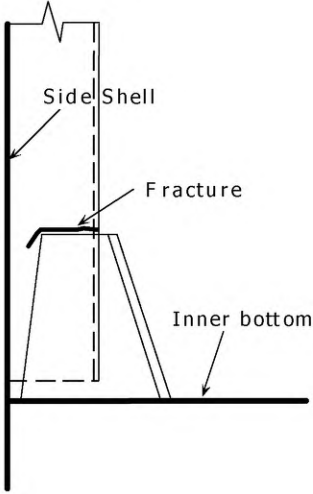
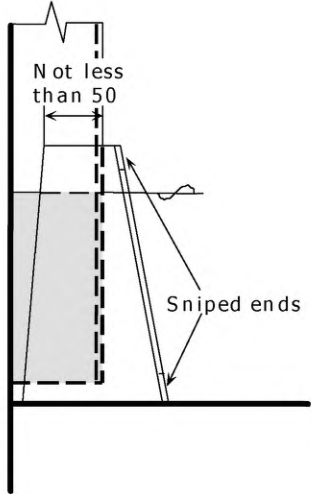
GENERAL CARGO SHIPS		Guidelines for Surveys, Assessment and Repair of Hull Structure	
Part 1	Cargo hold region	Example No.	
Area 2	Side structure	1	
Detail of damage		Fracture in side shell frame at lower bracket	
Sketch of damage		Sketch of repair

Notes on possible cause of damage		Notes on repairs	
<p>1. This type of damage is caused due to stress concentration.</p>		<p>1. For small fractures, e. g. hairline fractures, the fracture can be veed-out, welded up, ground, examined by NDT for fractures, and rewelded.</p> <p>2. For larger/significant fractures consideration is to be given to cropping and partly renewing/ renewing the frame brackets. If renewing the brackets, end of frames can be sniped to soften them.</p> <p>3. If felt prudent, soft toes are to be incorporated at the boundaries of the bracket to the inner bottom plating.</p>

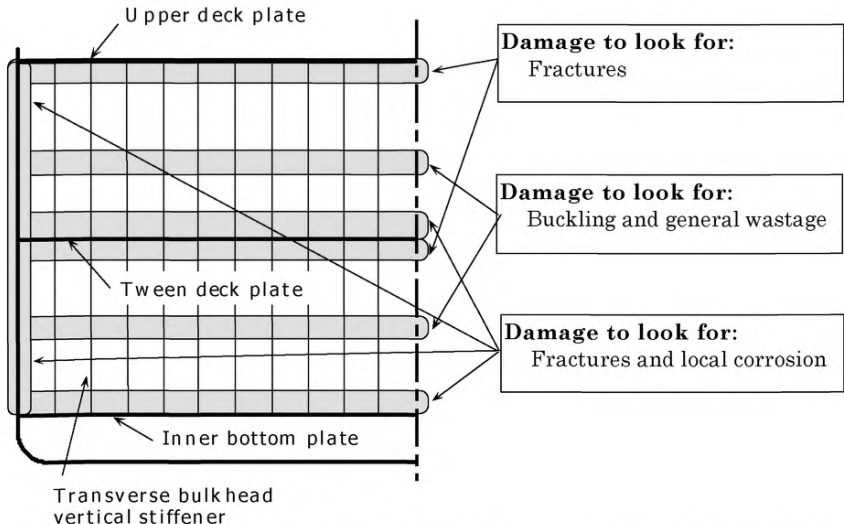
**Figure 1 Transverse bulkhead - potential problem areas**

- The structure may sometimes appear to be in good condition when it is in fact excessively corroded. In view of this, appropriate access arrangements as indicated in **Chapter 4 Survey planning, preparation and execution** of the guidelines, should be provided to enable a proper close-up inspection and thickness measurement (See **Figure 1**).

- 1.3 Deformation of the plating may lead to the failure and collapse of the bulkhead under water pressure in an emergency situation.
- 1.4 It is important to realize that in the event of one hold flooding, the transverse watertight bulkheads should prevent progressive flooding and possible consequent sinking.

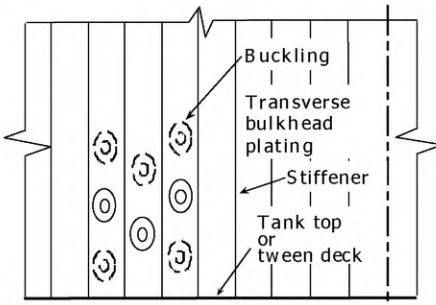
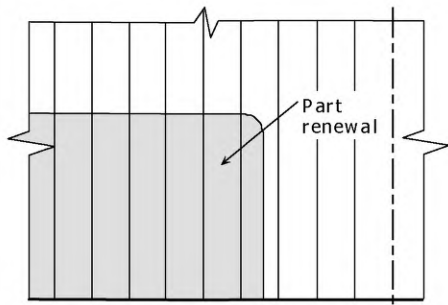
<b>GENERAL CARGO SHIPS</b>		<b>Guidelines for Surveys, Assessment and Repair of Hull Structure</b>	
<b>Part 1</b>	<b>Cargo hold region</b>	<b>Example No.</b>	
<b>Area 3</b>	<b>Transverse bulkhead structure</b>	<b>2</b>	
<b>Detail of damage</b>		Buckling in transverse bulkhead	
<b>Sketch of damage</b>		<b>Sketch of repair</b>

<b>Notes on possible cause of damage</b>		<b>Notes on repairs</b>	
<ol style="list-style-type: none"> <li>1. Heavy general corrosion.</li> </ol>		<ol style="list-style-type: none"> <li>1. The extent of the renewal should be determined carefully. If the renewal plating (original thickness) is welded to thin plating (corroded plating), it may cause stress concentration and fracture.</li> <li>2. Protective coating should be applied.</li> </ol>

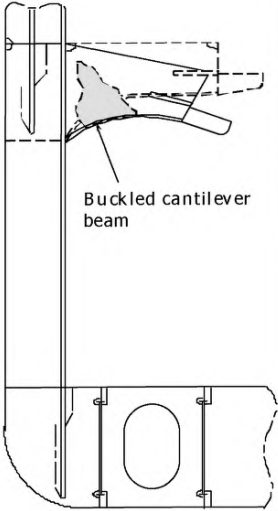
GENERAL CARGO SHIPS		Guidelines for Surveys, Assessment and Repair of Hull Structure	
Part 1	Cargo hold region	Example No.	
Area 4	Tween deck structure	1	
Detail of damage		Sagging of deck panel/buckling of cantilever beam	
Sketch of damage		Sketch of repair

<p>Buckled cantilever beam</p>

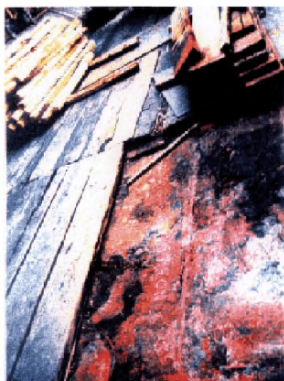
**Photograph 1**  
**Fractured inner bottom plating due to heavy corrosion on both sides**

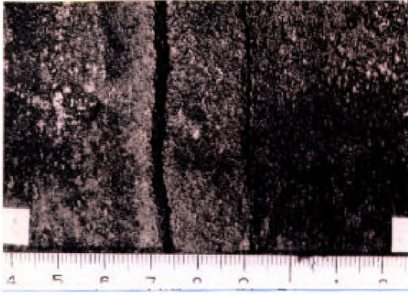
**4.1.2** Severe grooving along welding of bottom plating is often found (See **Photographs 2** and **3**). This grooving can be accelerated by poor maintenance of the protective coating and/or sacrificial anodes fitted to the bottom plating.

**Photograph 2**  
Grooving corrosion of welding  
of bottom plating

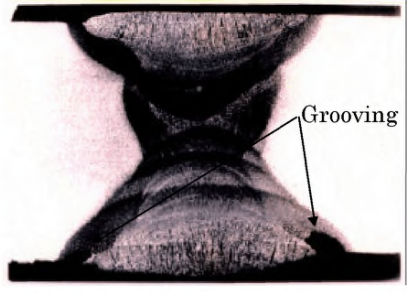
**Photograph 3**  
Section of the grooving shown  
in Photograph 2

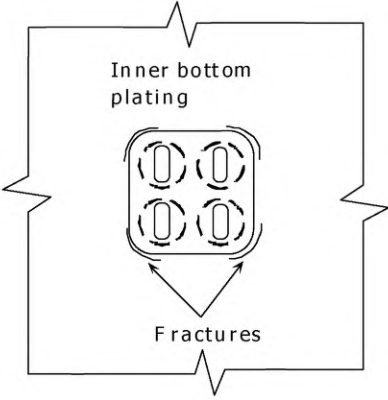
GENERAL CARGO SHIPS		Guidelines for Surveys, Assessment and Repair of Hull Structure	
Part 1	Cargo hold region	Example No.	
Area 5	Double bottom structure	1	
Detail of damage		Fractures in inner bottom plating around container bottom pocket	
<p><b>Sketch of damage</b></p>

<p>Girder</p> <p>Additional bracket</p> <p>Floor</p>	
<p><b>Notes on possible cause of damage</b></p> <ol style="list-style-type: none"> <li>1. Pocket is not supported correctly by floor, longitudinal and/or stiffener.</li> </ol>		<p><b>Notes on repairs</b></p> <ol style="list-style-type: none"> <li>1. Fractured plating should be cropped and part renewed.</li> <li>2. Adequate reinforcement should be considered.</li> </ol>

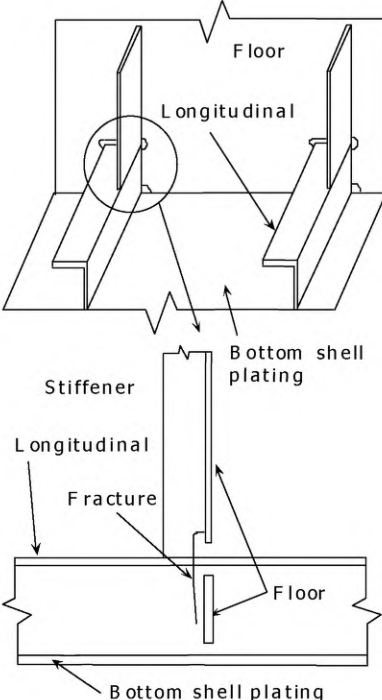
<p><b>Notes on possible cause of damage</b></p> <ol style="list-style-type: none"> <li>1. Damage can be caused by stress concentrations leading to accelerated fatigue in this region.</li> </ol>		<p><b>Notes on repairs</b></p> <ol style="list-style-type: none"> <li>1. If fracture extends to over one third of the depth of the longitudinal, then crop and part renew. Otherwise the fracture can be veed-out and welded.</li> </ol>

GENERAL CARGO SHIPS		Guidelines for Surveys, Assessment and Repair of Hull Structure	
Part 1	Cargo hold region	Example No.	
Area 5	Double bottom structure	3-b	
Detail of damage		Fractures at the connection of bottom/inner bottom longitudinal to floor stiffener	
<p><b>Sketch of damage</b></p>

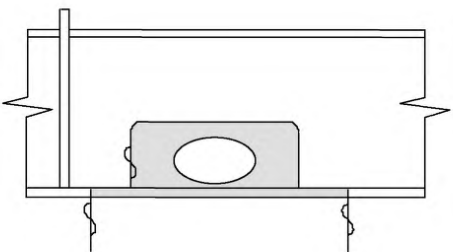
GENERAL CARGO SHIPS		Guidelines for Surveys, Assessment and Repair of Hull Structure	
Part 1	Cargo hold region	Example No.	
Area 5	Double bottom structure	5	
Detail of damage	Fractures in bottom shell plating/inner bottom plating at the corner drain hole/air hole in longitudinal		
Sketch of damage		Sketch of repair

<b>Notes on possible cause of damage</b> <ol style="list-style-type: none"> <li>1. Stress concentration and/or corrosion due to stress concentration at the corner of drain hole/air hole.</li> </ol>		<b>Notes on repairs</b> <ol style="list-style-type: none"> <li>1. Fractured plating should be cropped and part renewed.</li> <li>2. If fatigue life is to be improved, change of drain hole/air hole shape is to be considered.</li> </ol>

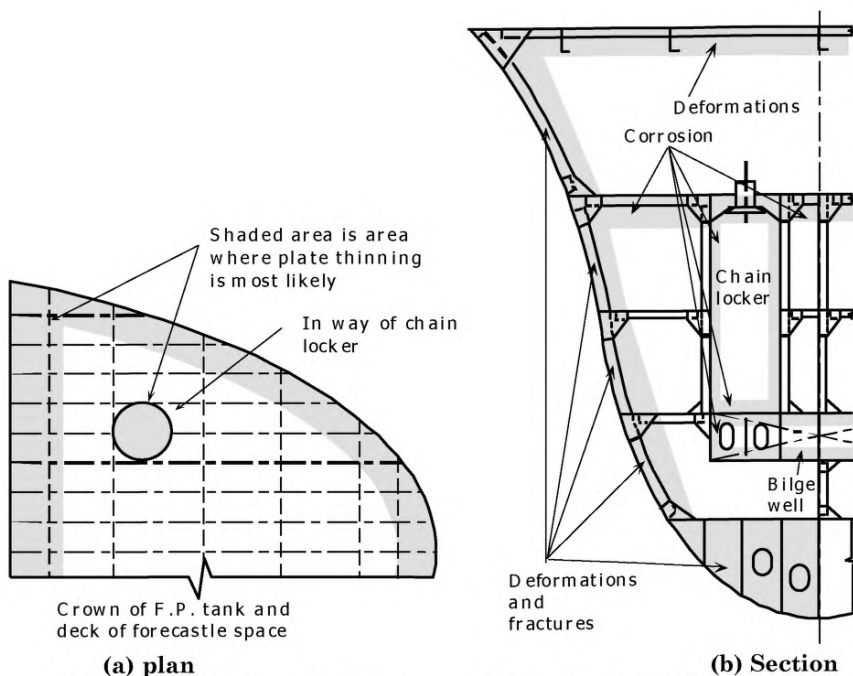
**Figure 1 Fore end structure - Potential problem areas**

### 2.3 Fractures

- 2.3.1 Fractures in the fore peak tank are normally found by close-up inspection of the internal structure.
- 2.3.2 Fractures that extend through the thickness of the plating or through the boundary welds may be observed during pressure testing of the double bottom tanks.

- 3.1.1 The necessary extent of steel renewal can be established when comparing the measured thickness to the original values, or the minimum acceptable values for this part of the structure. The repair work in the tank will require planning, to permit accessibility.

- 3.2.1 Deformed structure caused by contact should be cropped and part renewed or faired in place depending on the nature and extent of damage.

- 3.3.1 In the case of fractures caused by sea-loads the structure should be cropped and renewed. Increased thickness of plating and/or design modification to reduce stress concentrations should be considered (See **Examples 1, 2 and 6**).

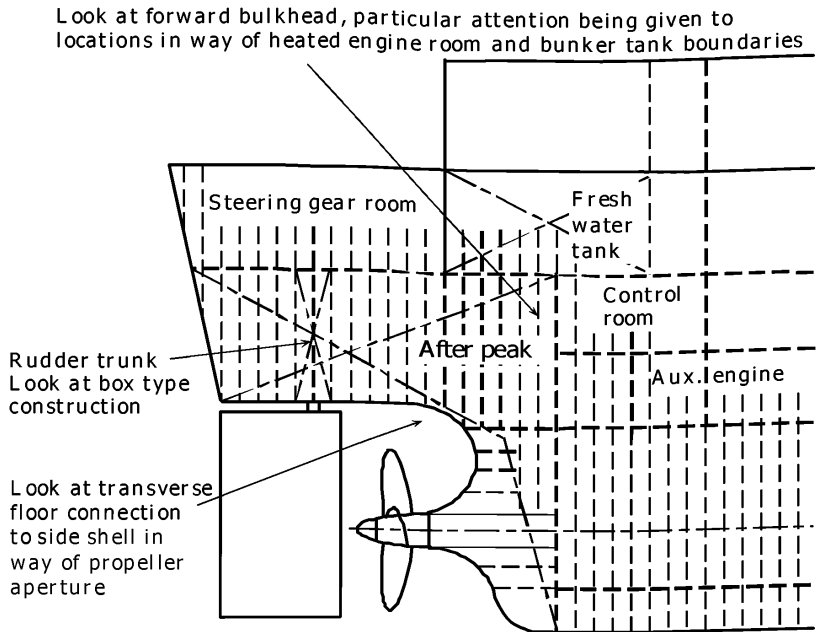
Figure 1 Aft end structure - Potential problem areas

- 2.1.1 Wastage (and possible subsequent fractures) is more likely to show initially in locations as indicated in **Figure 1**. A close-up inspection should be carried out. In addition, a representative selection of thickness measurements should be taken with particular attention being given to locations such as bunker tank boundaries and spaces adjacent to heated engine rooms.

### 2.3 Fractures

- 2.3.1 Fractures in floor connection welds and in other locations in the aft peak tanks and rudder trunk spaces are normally found by close-up inspection.
- 2.3.2 The structure supporting the rudder carrier may fracture and/or deform due to the rudder having suffered excessive loads. Bolts connecting the rudder carrier to the steering gear flat may also be damaged due to such loads.

3.2.1 Deformed structure caused by contact should be cropped and part renewed or faired in place depending on the extent of damage.

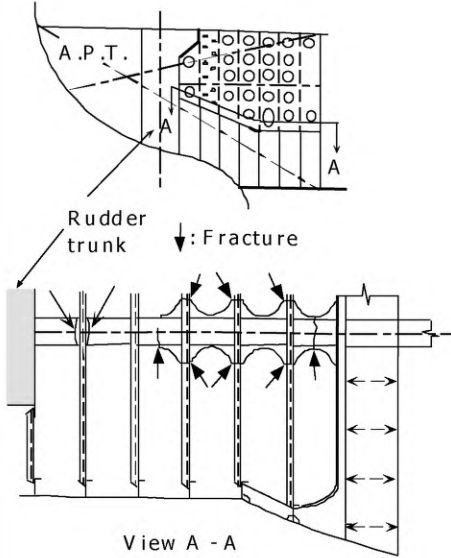
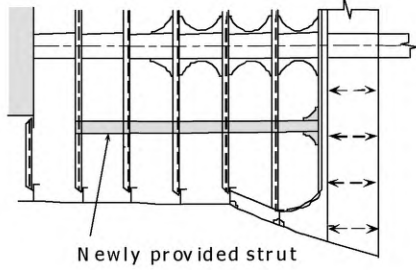
GENERAL CARGO SHIPS		Guidelines for Surveys, Assessment and Repair of Hull Structure	
Part 2	Fore and aft end regions		Example No.
Area 2	Aft end structure		2
Detail of damage		Fractures at the connection of floors and girders/side brackets	
Sketch of damage		Sketch of repair

<p>A.P.T.</p> <p>Rudder trunk</p> <p>↓: Fracture</p> <p>View A - A</p>

<p>Newly provided strut</p>	
<b>Notes on possible cause of damage</b> 1. Vibration.		<b>Notes on repairs</b> 1. The fractured plating should be cropped and renewed. 2. Natural frequency of the panel should be changed, e.g. reinforcement by additional strut.

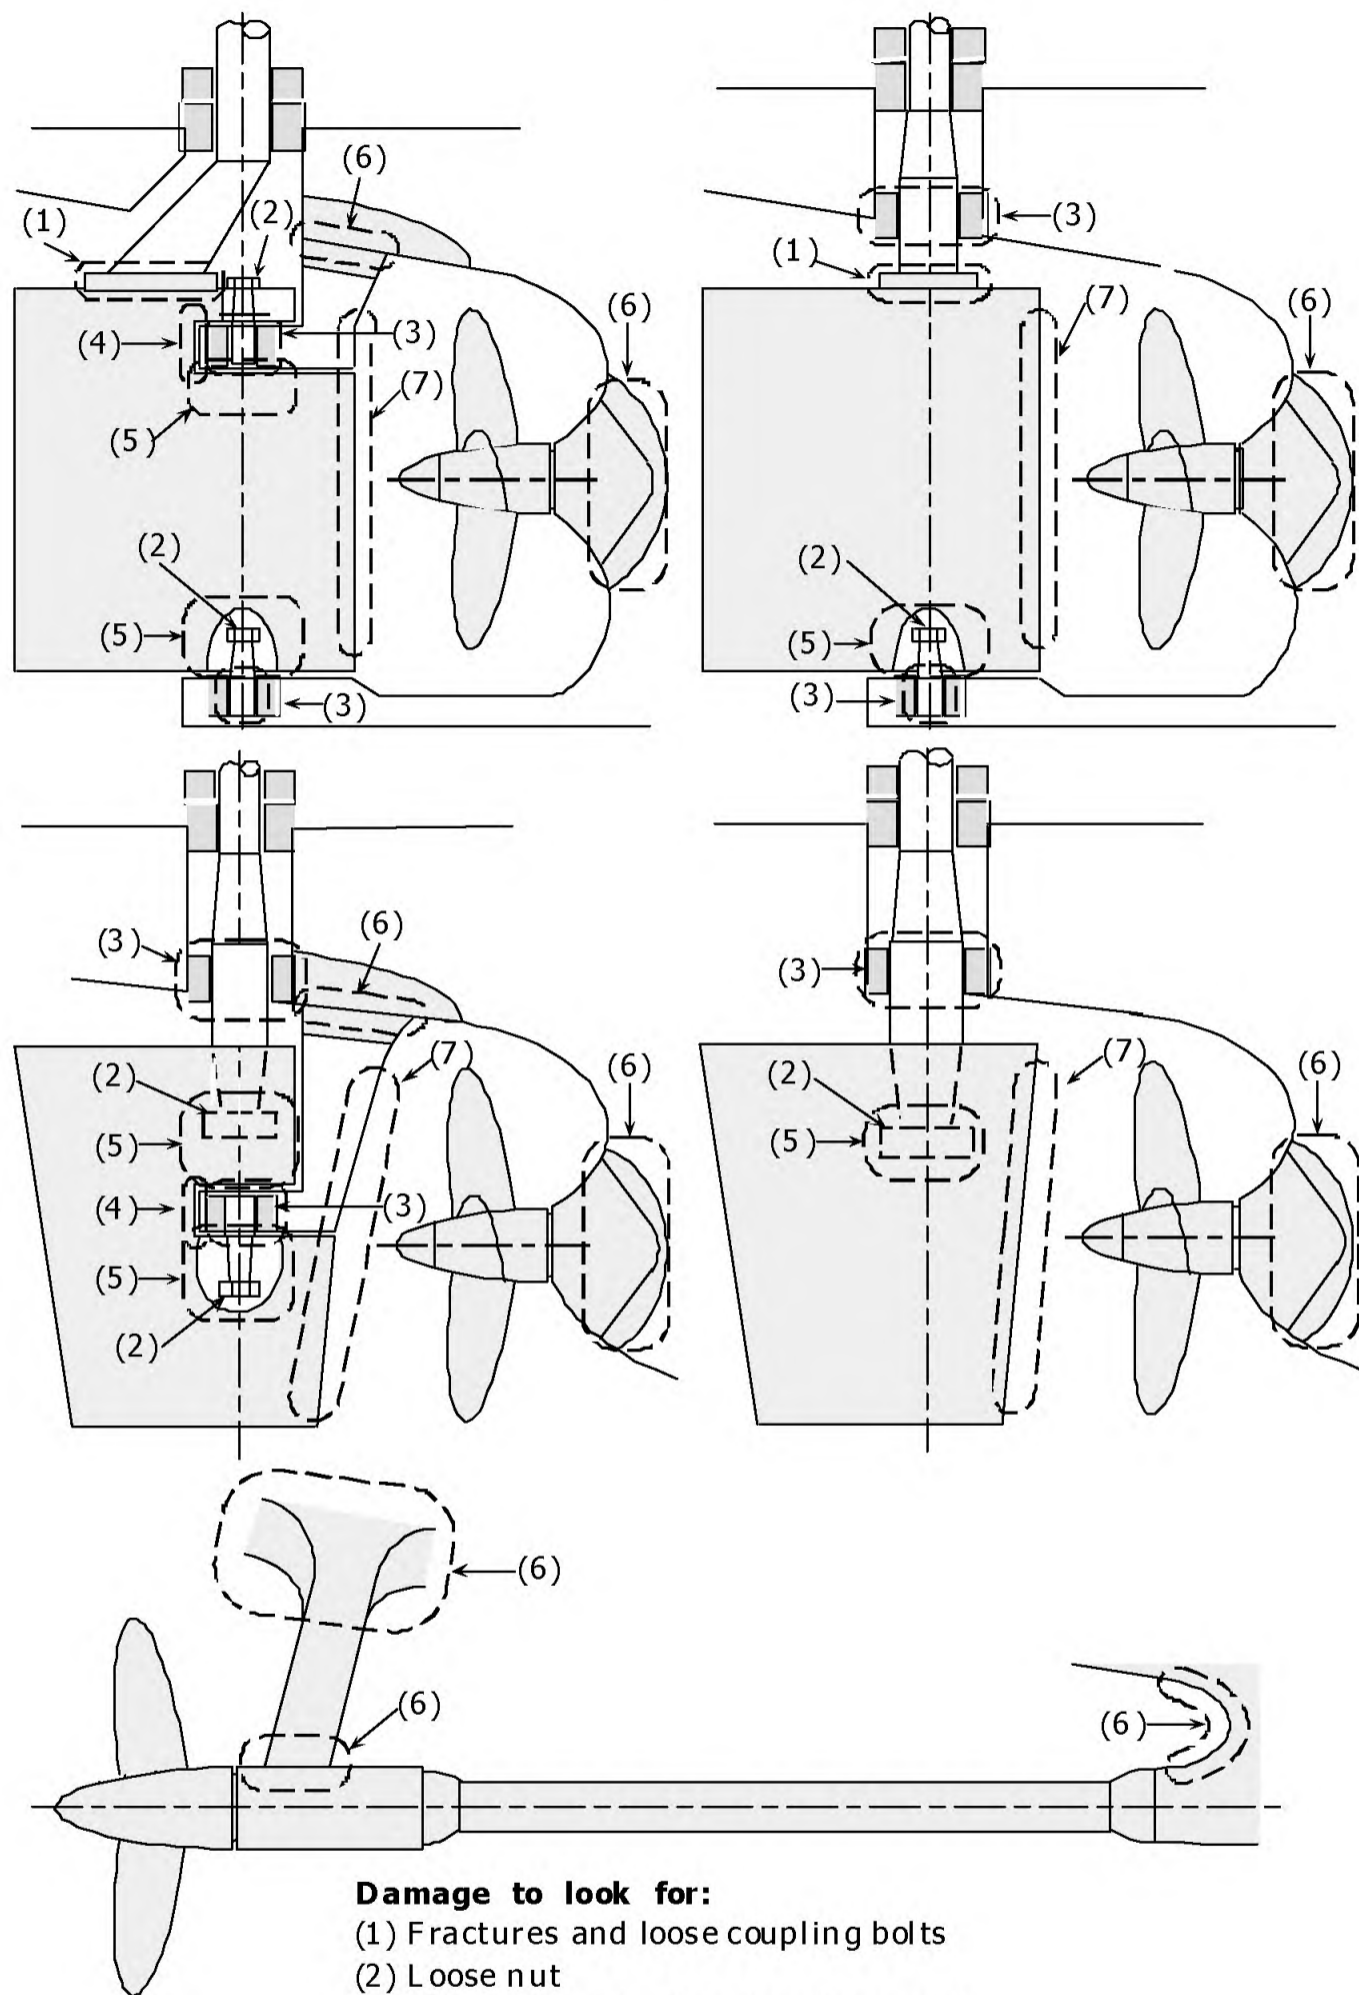
**Figure 2 Potential problem areas**

- 1.6 Pre-existing manufacturing internal defects in cast pieces may lead to fatigue cracking.
- 1.7 A summary of potential problem areas is shown in **Figure 2**.

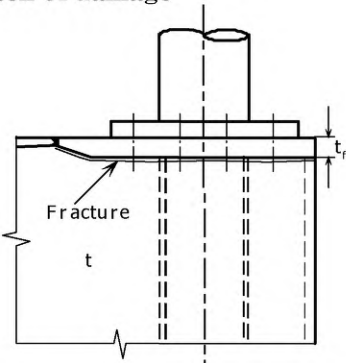
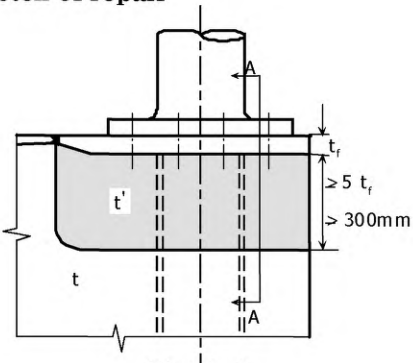
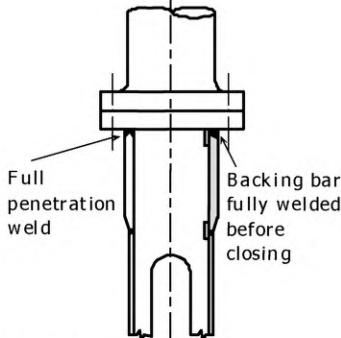
GENERAL CARGO SHIPS		Guidelines for Surveys, Assessment and Repair of Hull Structure	
Part 2	Fore and aft end regions	Example No.	
Area 3	Stern frame, rudder arrangement and propeller shaft support	2	
Detail of damage	Fracture in connection of palm plate to rudder blade		
Sketch of damage		Sketch of repair

1. Inadequate connection between palm plate and rudder blade plating (insufficient plating thickness and/or insufficient fillet weld).		1. Modification of detail design of the connection by increasing the plate thickness and full penetration welding.

<p>Full penetration weld      Backing bar fully welded before closing</p> <p> <math>t</math> = plate thickness, mm  <math>t_r</math> = actual flange thickness, mm  <math>t' = \frac{t_r}{3} + 5</math>, mm, where <math>t_r &lt; 50</math>mm  <math>t' = 3 \sqrt{t_r}</math>, mm, where <math>t_r \geq 50</math>mm </p>	
Notes on possible cause of damage		Notes on repairs

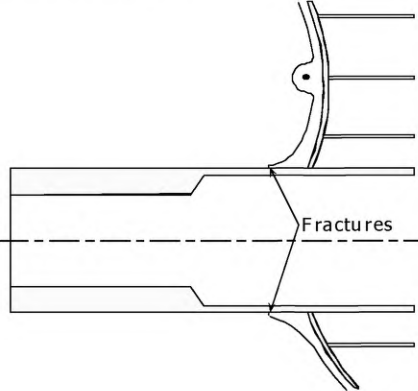
<b>GENERAL CARGO SHIPS</b>		<b>Guidelines for Surveys, Assessment and Repair of Hull Structure</b>	
<b>Part 2</b>	<b>Fore and aft end regions</b>	<b>Example No.</b>	
<b>Area 3</b>	<b>Stern frame, rudder arrangement and propeller shaft support</b>	<b>7</b>	
<b>Detail of damage</b>	Fracture in stern tube at the connection to stern frame		
<b>Sketch of damage</b>		<b>Sketch of repair</b>

<b>Notes on possible cause of damage</b>		<b>Notes on repairs</b>	
<ol style="list-style-type: none"> <li>1. Fatigue fracture due to vibration.</li> </ol>		<ol style="list-style-type: none"> <li>1. Fractured tube is to be welded from both sides.</li> <li>2. Brackets are to be replaced by modified brackets with soft transition.</li> </ol>

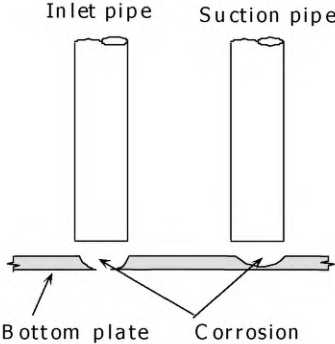
<b>GENERAL CARGO SHIPS</b>		<b>Guidelines for Surveys, Assessment and Repair of Hull Structure</b>	
<b>Part 3</b>	<b>Machinery and accommodation spaces</b>	<b>Example No.</b>	
<b>Area 1</b>	<b>Engine room structure</b>	<b>3</b>	
<b>Detail of damage</b>	Corrosion in bottom plating under inlet/suction/pipe in way of bilge tank in engine room		
<b>Sketch of damage</b>		<b>Sketch of repair</b>

<b>Notes on possible cause of damage</b>		<b>Notes on repairs</b>	
<ol style="list-style-type: none"> <li>1. Heavy corrosion of bottom plating under the inlet/suction pipe.</li> </ol>		<ol style="list-style-type: none"> <li>1. Corrode bottom plate is to be cropped and part renewed. Thicker plate is preferable.</li> <li>2. Replacement of pipe end by enlarged conical opening (similar to suction head in ballast tank) is preferable.</li> </ol>
