No. 96 **Double Hull Oil Tankers** - Guidelines for Surveys,
(April Assessment and Repair of Hull Structures
2007)

DOUBLE HULL OIL TANKERS

Guidelines for Surveys, Assessment and Repair
of Hull Structures

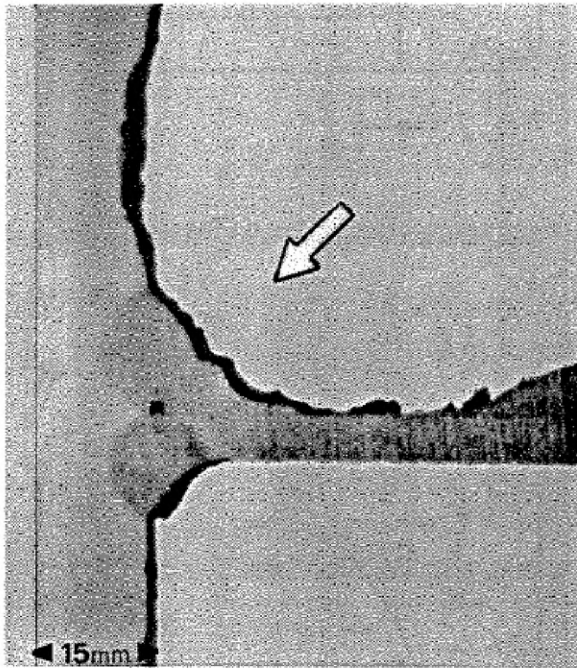
Figure 10 Detail of Necking Effect

- Necking occurs at the junction of the longitudinal bulkhead plating and longitudinals. The deflection of the bulkhead plating and longitudinals due to reverse, cyclic loading from cargo oil and water ballast plus the accumulated mixtures of water, mud and scale at their junctures accelerates the corrosion rate. As the steel thins and weakens, the flexing consequently increases and hence corrosion accelerates (see Figure 10). The similar necking effect could also occur in the transverse bulkhead plating and stiffeners, or in the inner bottom plating and longitudinals inside the double bottom space. In the coated water ballast tanks, the plating is the principally affected area due to local corrosion in way of coating failure.

One of the best methods of preventing corrosion within these spaces is that protective coatings be applied to the underdeck and inner bottom plating areas. In addition to

protecting the steel structure in these areas, this measure would also enable easier and more effective surveys and surveys to be carried out 'in service'.

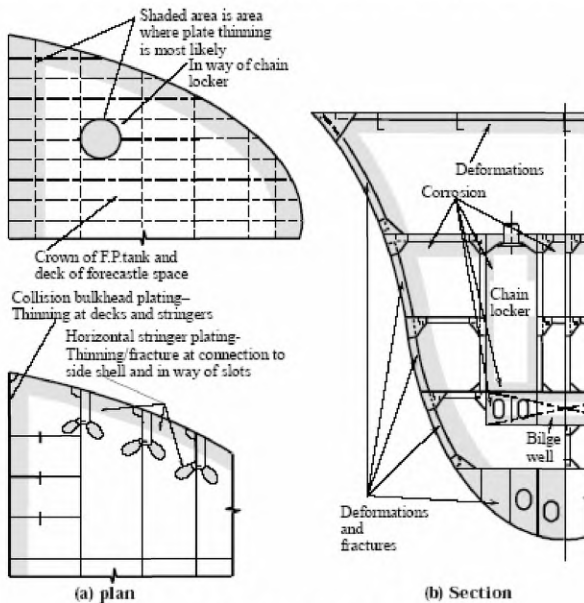
2.3.2 Fractures are often found in transition region and reference should be made to examples provided in the other Groups.

2.3.3 Fractures that extend through the thickness of the plating or through the boundary welds may be observed during pressure testing of tanks.

Fig 1 Fore end structure - Potential problem areas
