**РОССИЙСКИЙ МОРСКОЙ РЕГИСТР СУДОХОДСТВА
RUSSIAN MARITIME REGISTER OF SHIPPING**

**ПРИЛОЖЕНИЕ К ПРАВИЛАМ И РУКОВОДСТВАМ
РОССИЙСКОГО МОРСКОГО РЕГИСТРА СУДОХОДСТВА**

**ПРОЦЕДУРНЫЕ ТРЕБОВАНИЯ,
УНИФИЦИРОВАННЫЕ ТРЕБОВАНИЯ,
УНИФИЦИРОВАННЫЕ ИНТЕРПРЕТАЦИИ
И РЕКОМЕНДАЦИИ
МЕЖДУНАРОДНОЙ АССОЦИАЦИИ
КЛАССИФИКАЦИОННЫХ ОБЩЕСТВ**

ND No. 2-020101-135-R-E

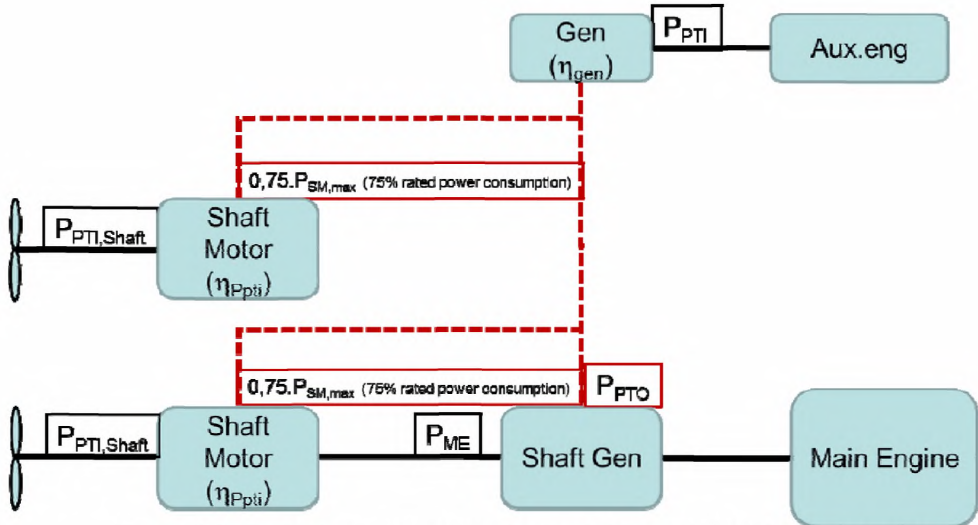
A diagram is inserted to highlight where the mechanical and electrical efficiencies or the related devices (PTI and Generator's) are located:

Figure 1.2: Typical arrangement of propulsion and electric power system

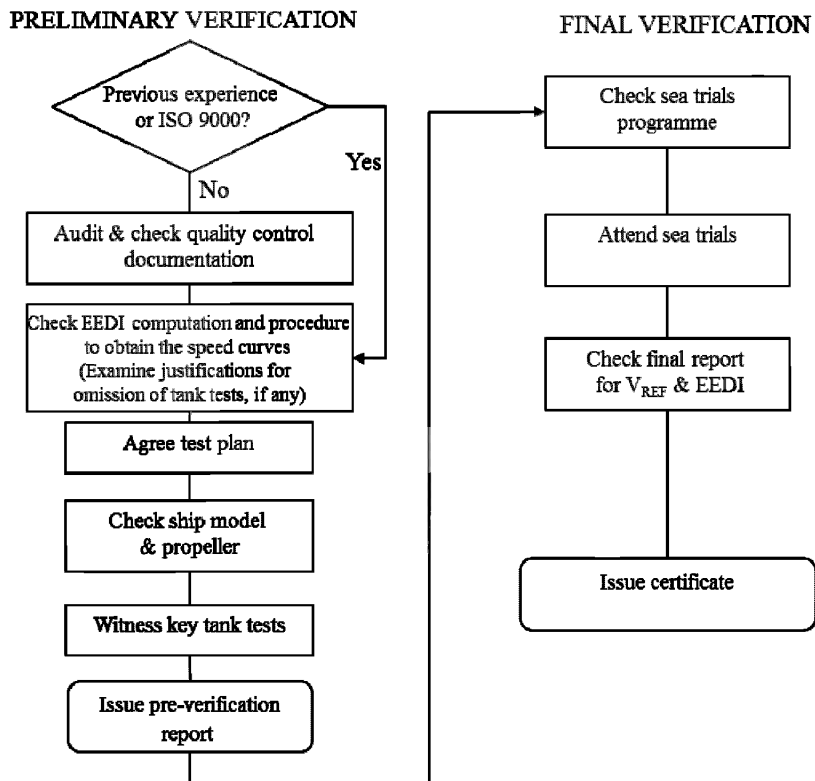
The flow of the survey and certification process is presented in Figure 2.

Figure 2: Flow of survey and certification process by verifier

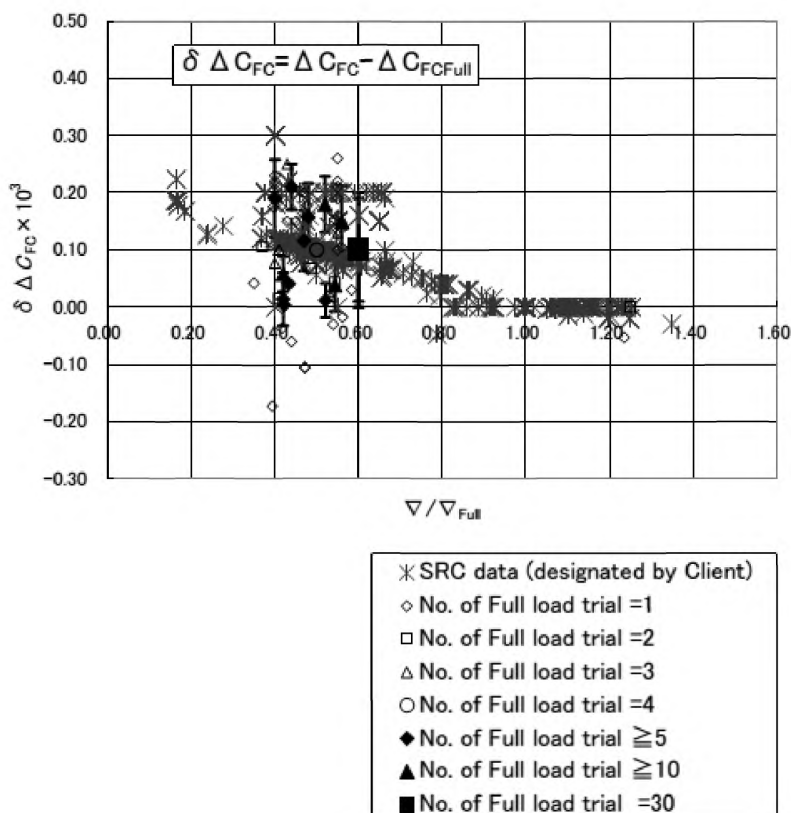
Figure 3.2: Variation of ΔC_{FC} as a function of the displacement ratio

NB: The trends in Figures 3.1 and 3.2 are based on limited data and may be revised in the future. The displayed trends depend on the method used to analyze the model tests behind the data including the form factor and other correlation factor relations. Other values may be accepted if based on sufficient number of data.

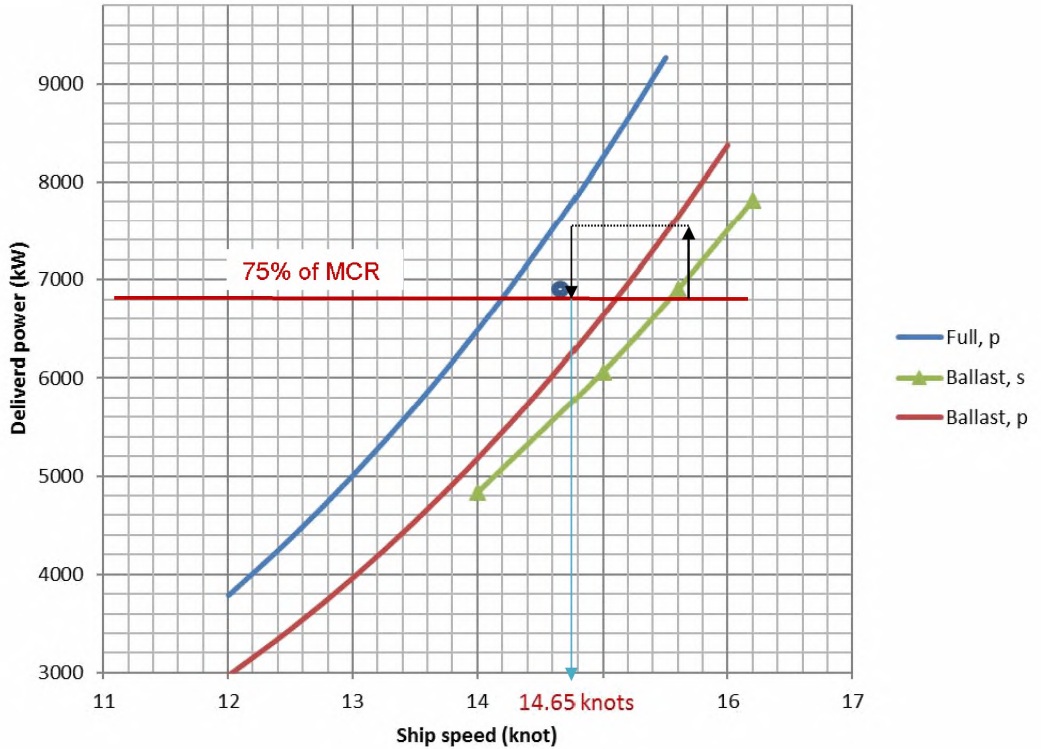
The power curves estimated at the design stage and modified after the sea trials are given in Figure 3.1.

Figure 3.1: Power curves

The predicted results are represented on the speed curves given in Figure 3.1. The EEDI condition results are indexed (Full, p), the sea trial condition results (Ballast, p).

The sea trial report is provided in annex 7. The results of the sea trial after corrections by BSRA and ITTC standard methods are given on curve *Ballast,s* on Figure 3.1.

EEDI quantity	Value	Remarks
C_{FME}	3.206	No change
P_{ME}	6900 kW	No change
SFC_{ME}	171 g/kWh	No change
CF_{AE}	3.206	No change
P_{PTI}	0	No change
P_{AE}	381 kW	The electric power table has been validated and endorsed (see the electric power table form in annex 8)
SFC_{AE} at 75% MCR	199 g/kWh	No change
P_{eff}	0	No change
P_{AEeff}	0	No change
f_{eff}		No change
f_j	1.0	No change
f_i	1.017	Deadweight and lightweight are computed from lightweight check: $f_{iCSR} = 1 + 0.08 * LWT_{CSR} / DWT_{CSR} = 1 + 0.08 * 11621 / 54550 = 1.017$ $f_i = f_{iICE} * f_{iVSE} * f_{iCSR} = 1.017$ (unchanged)
f_c	1.0	No change
Capacity	54550 DWT	Deadweight has been computed from the lightweight check. See 14.
V_{ref}	14.65 knots	The reference speed in EEDI condition has been adjusted according to the delivered power adjustment methodology defined in Industry Guidelines. The reference speed is read on the speed curves diagram in Figure 3.1 $V_{ref} = 14.65$ knots

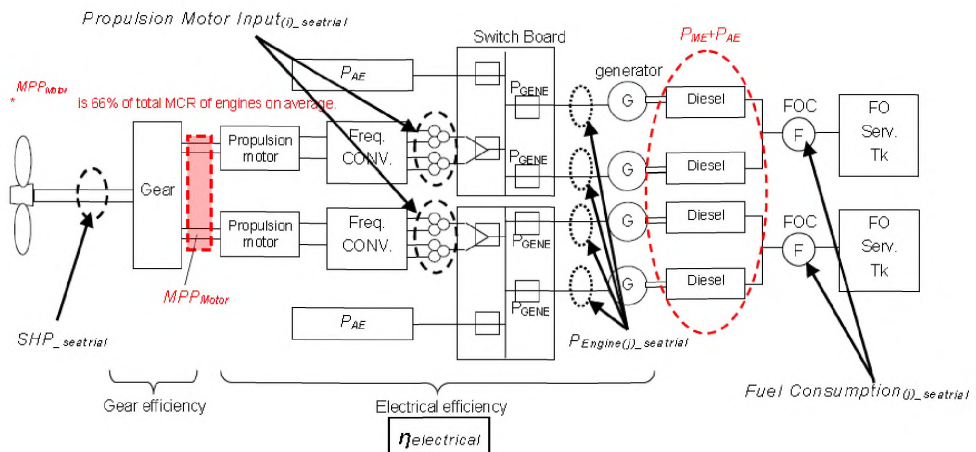
1) Typical configuration and example of measurement points at sea trial

MCR of main engines	10,000 (kW) x 3 + 6,400 (kW) x 1
MPP _{Motor}	24,000 (kW)
SFC _{ME(i)_electric, gas mode at 75% of MCR}	161.6 (g/kWh) (for 10,000 (kW)-Engines) (SFC of the test report in the NOx technical file) 162.2 (g/kWh) (for 6,400 (kW)-Engine) (Ditto)
SFC _{ME(i)_Pilotfuel}	6.0 (g/kWh) (for 10,000 (kW)-Engines), 6.1 (g/kWh) (for 6,400 (kW)-Engine)
Deadweight	75,500 (ton)

Attained EEDI for LNG carrier having diesel electric propulsion system at sea trial is calculated as follows.

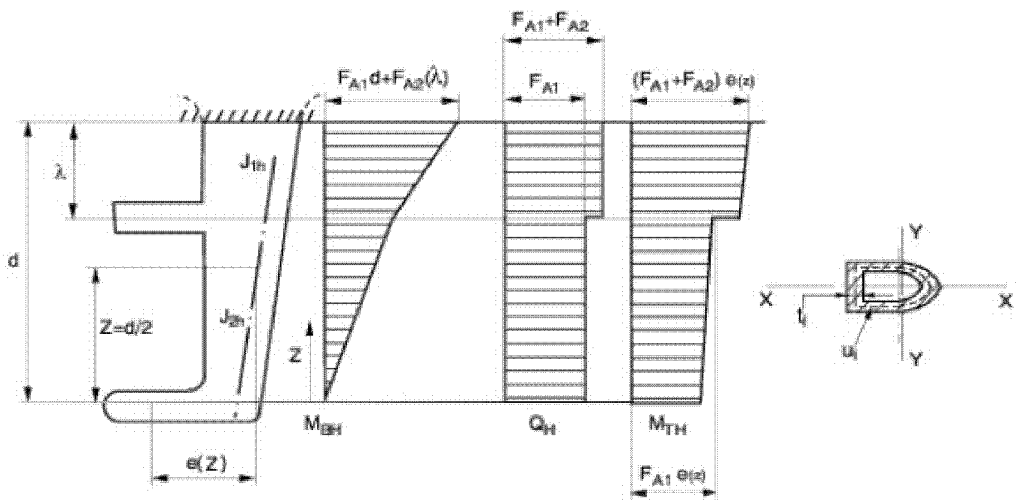
Figure A 7

W_X : Section modulus, in cm³, around the X-X-axis (see Figure A 7).

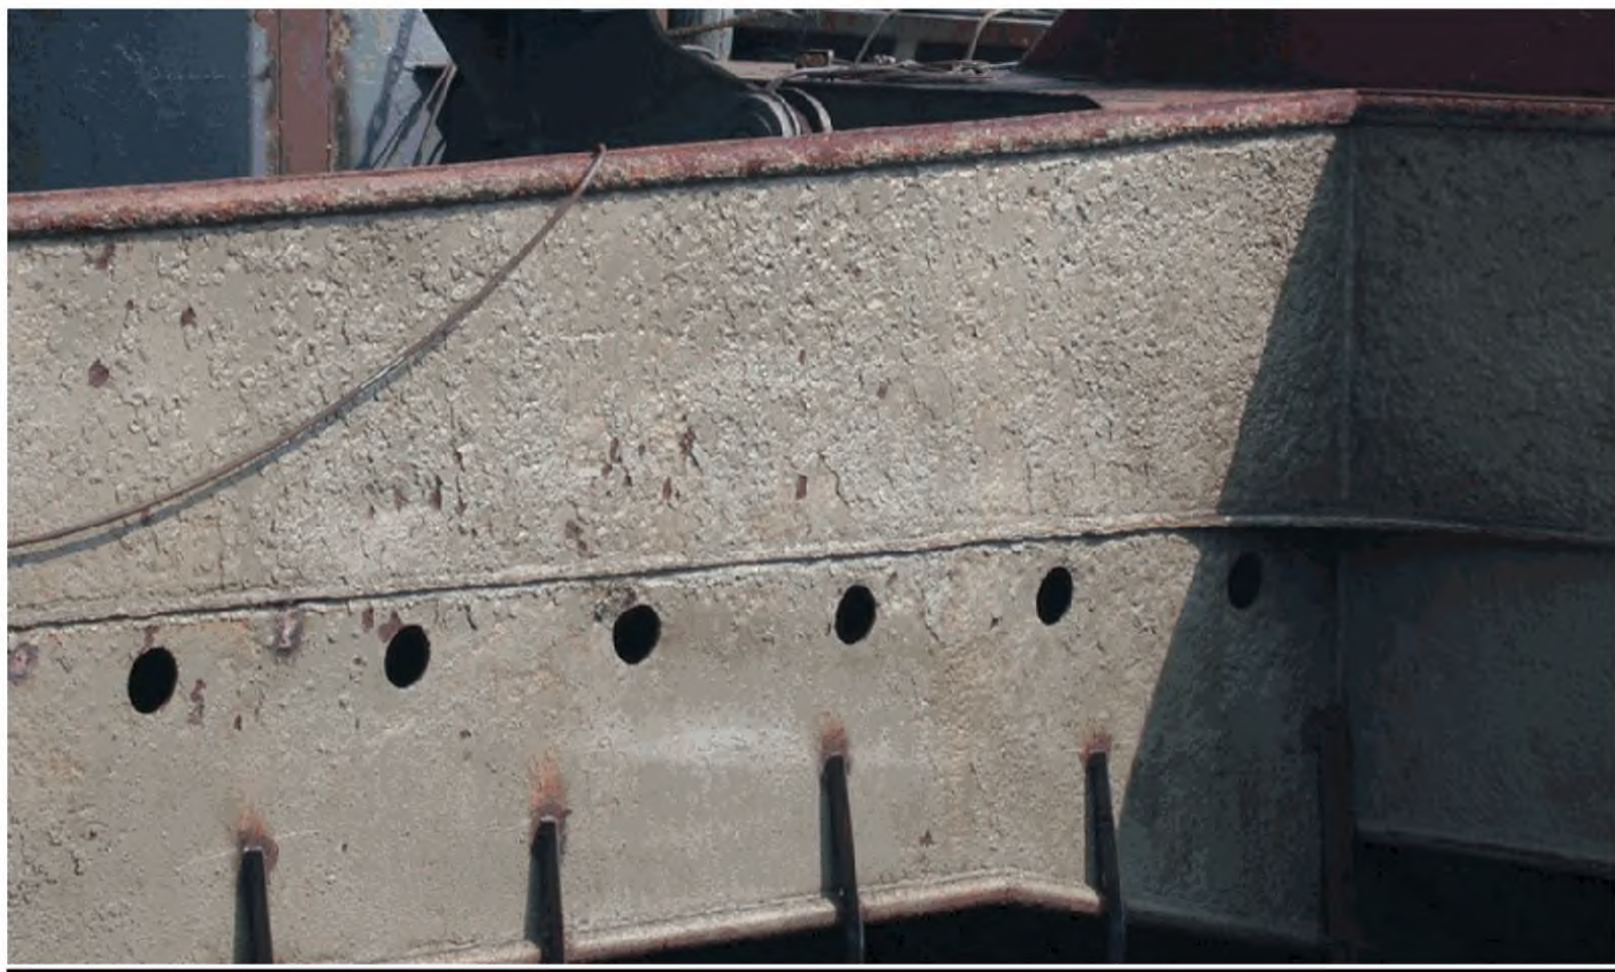
Photograph 1 Heavy corrosion of hatch coaming

- 3.1.1 The level of wastage of under-deck stiffeners/structures may have to be established by means of thickness measurements. As mentioned previously the combination of the effects from the marine environment and the local atmosphere will give rise to high corrosion rates.
- 3.1.2 Severe corrosion of the hatch coaming from inside and of under deck girders may occur due to difficult access for maintenance of the protective coating. This may in turn lead to fractures (See **Photograph 1**).

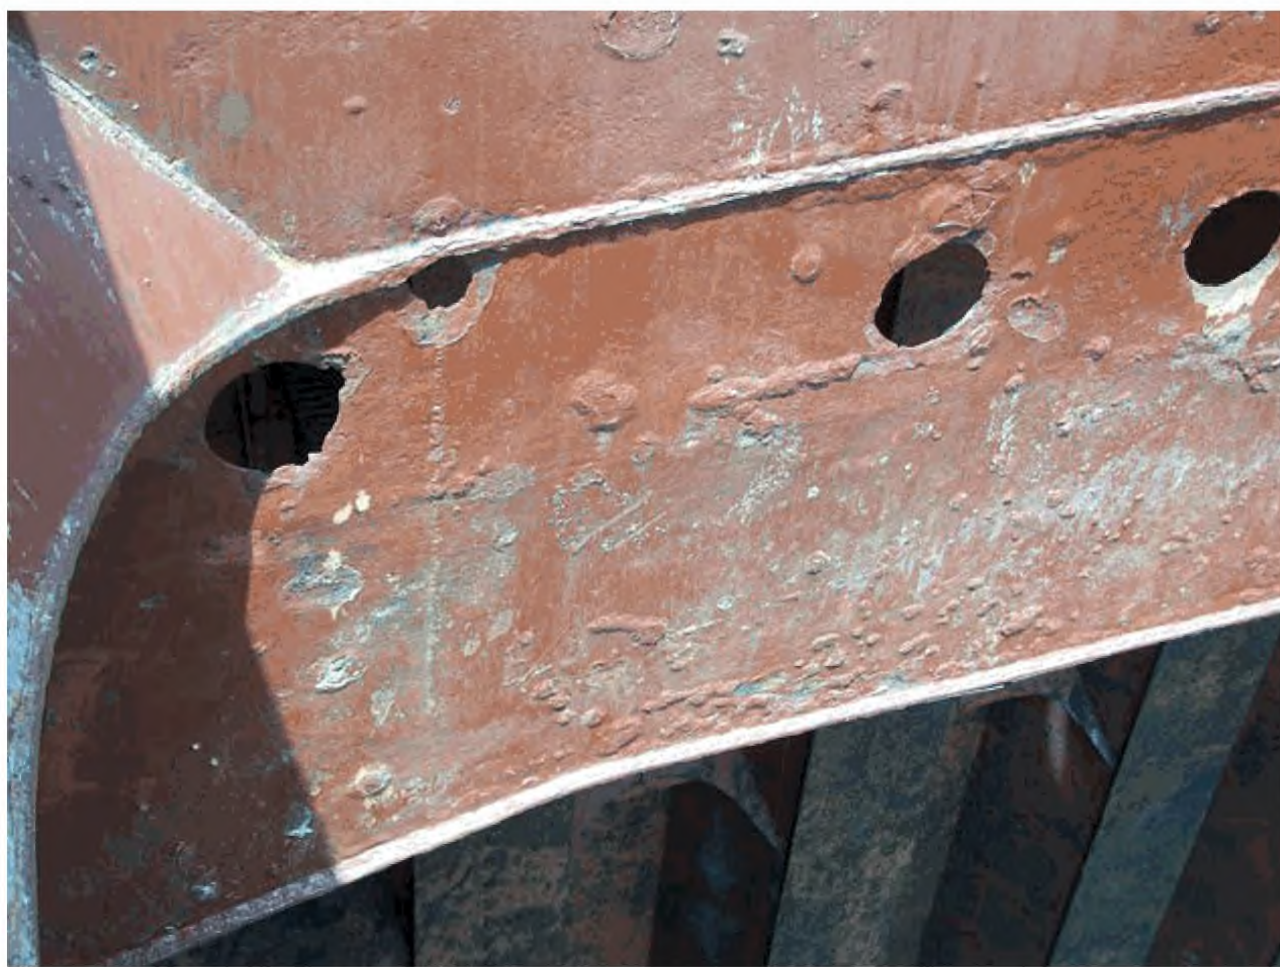
Photograph 2 Heavy corrosion of hatch coaming

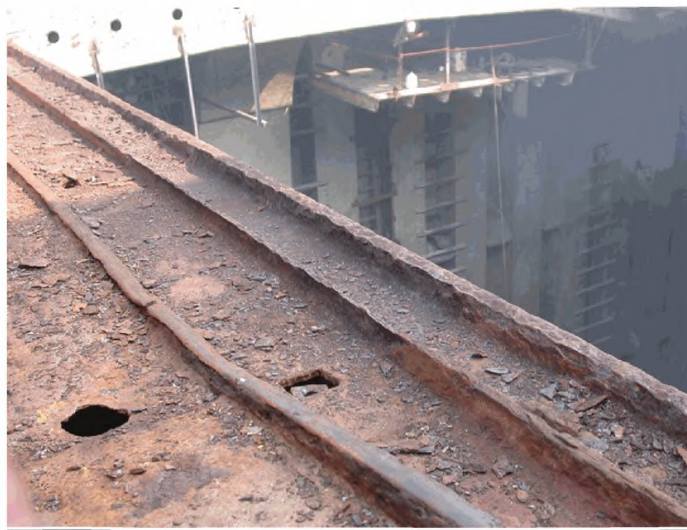
Photograph 4 Corrosion at the top of the hatch coaming

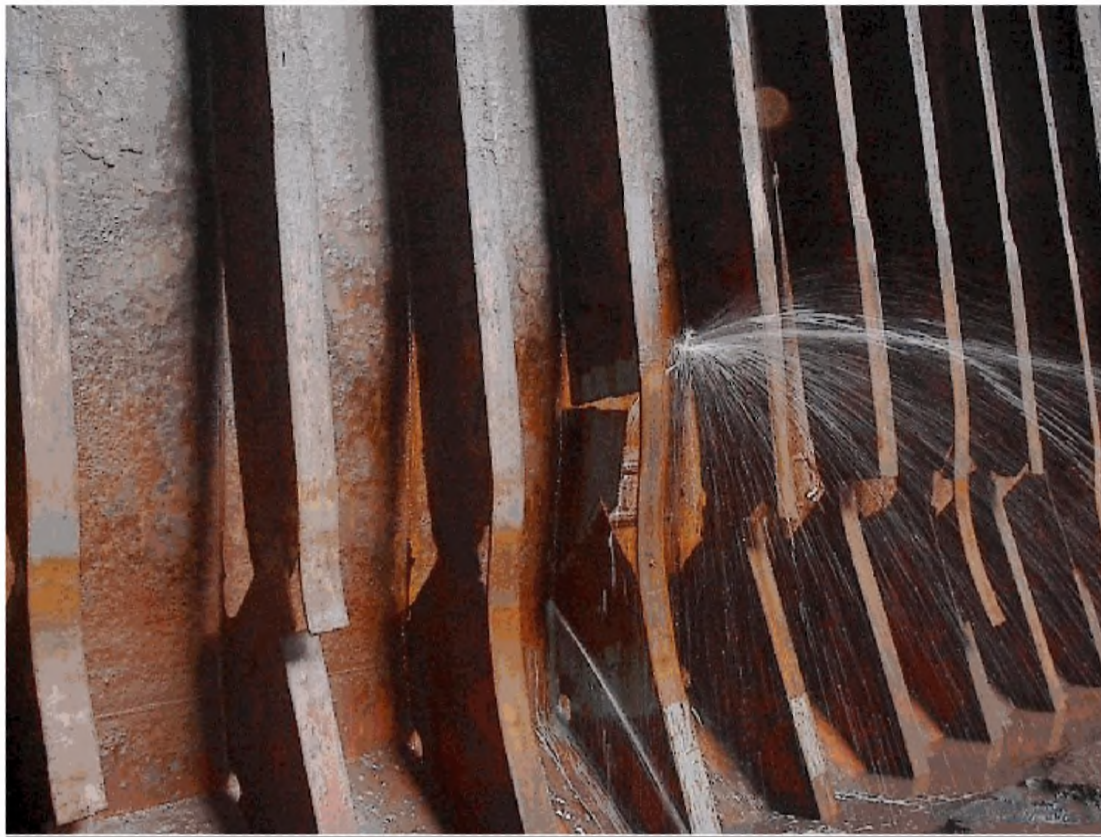
Photograph 1 Leakage from side shell plating due to heavy corrosion

- 1.6 A summary of potential problem areas is shown in **Figures 1 (a) and (b)**. Serious consequences of damaged ship sides are illustrated in **Photographs 1 and 2**.

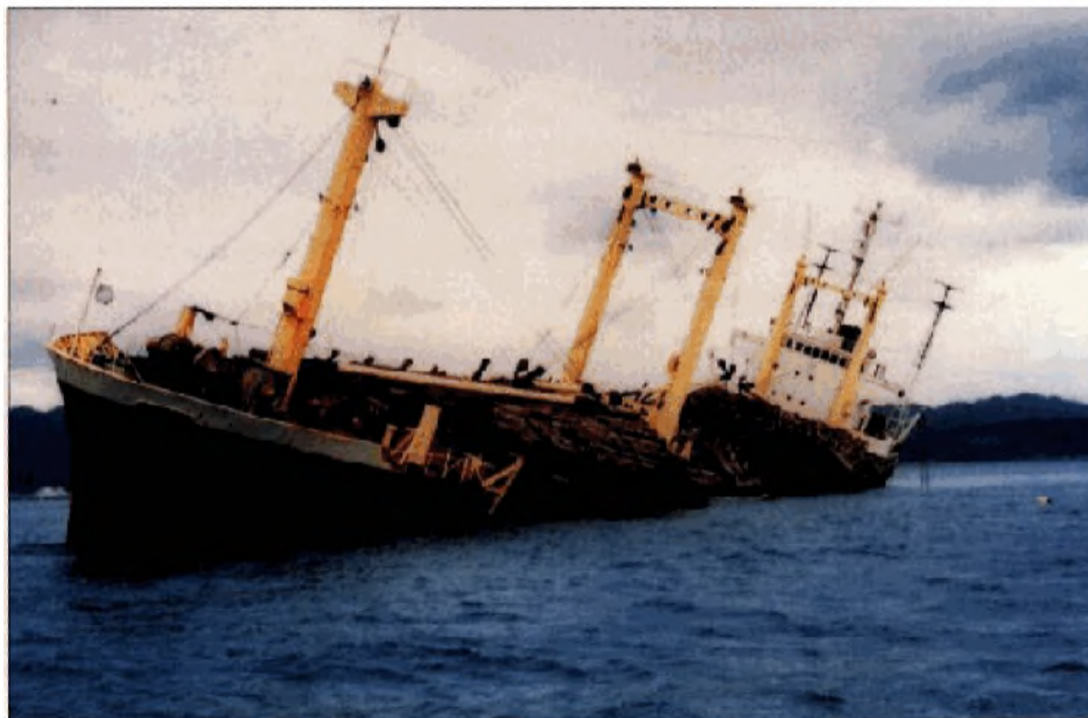
Photograph 2 Timber carrier listing due to ingress of water

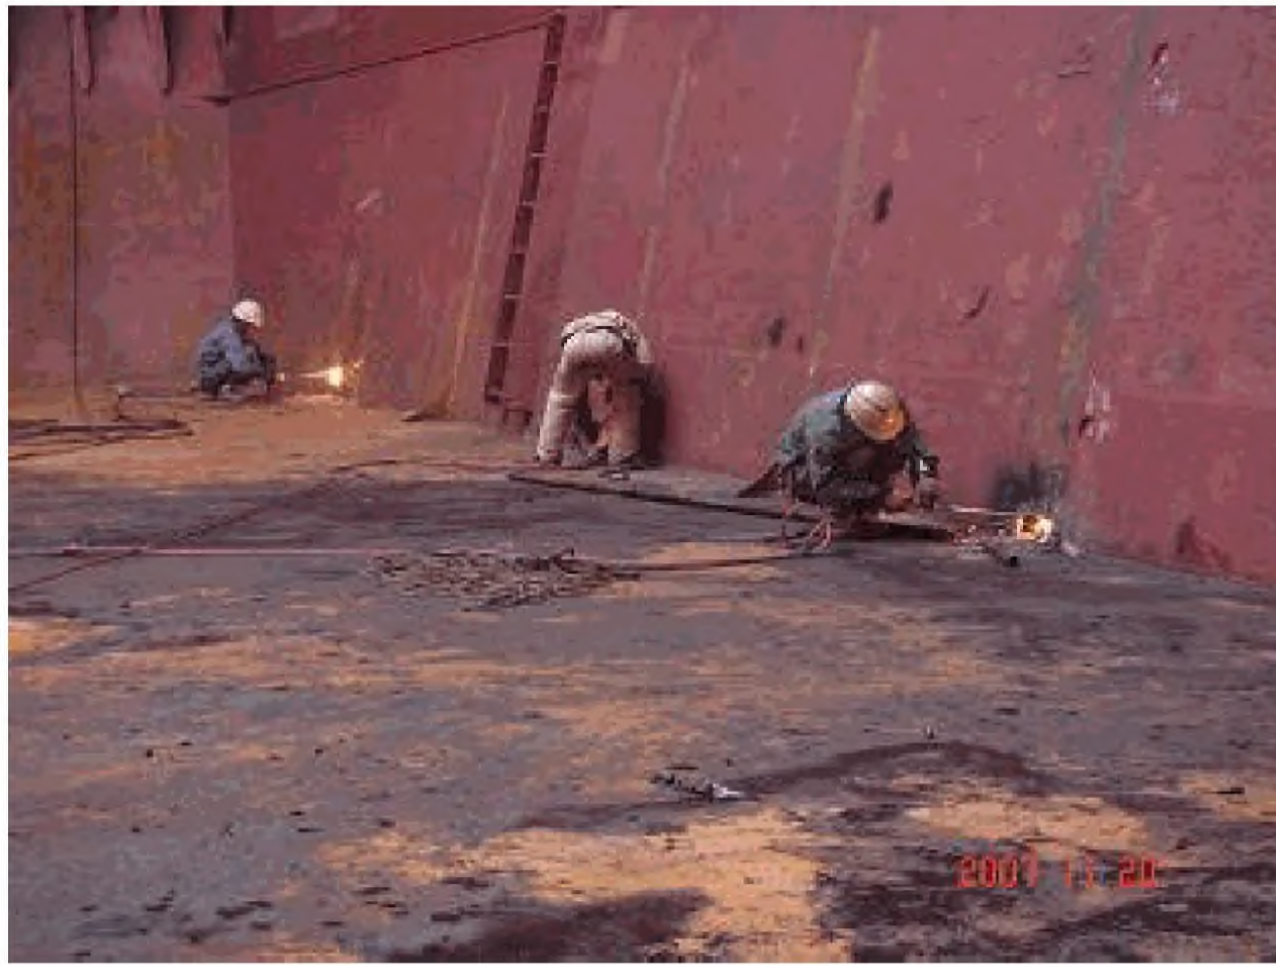
Photograph 1 Heavy corrosion affecting inner bottom plating

- 2.1.2 When the tank top plating has been covered with dunnage or ceiling the plating may have suffered heavy corrosion, due to high humidity, and lack of proper maintenance (See **Photograph 1**).

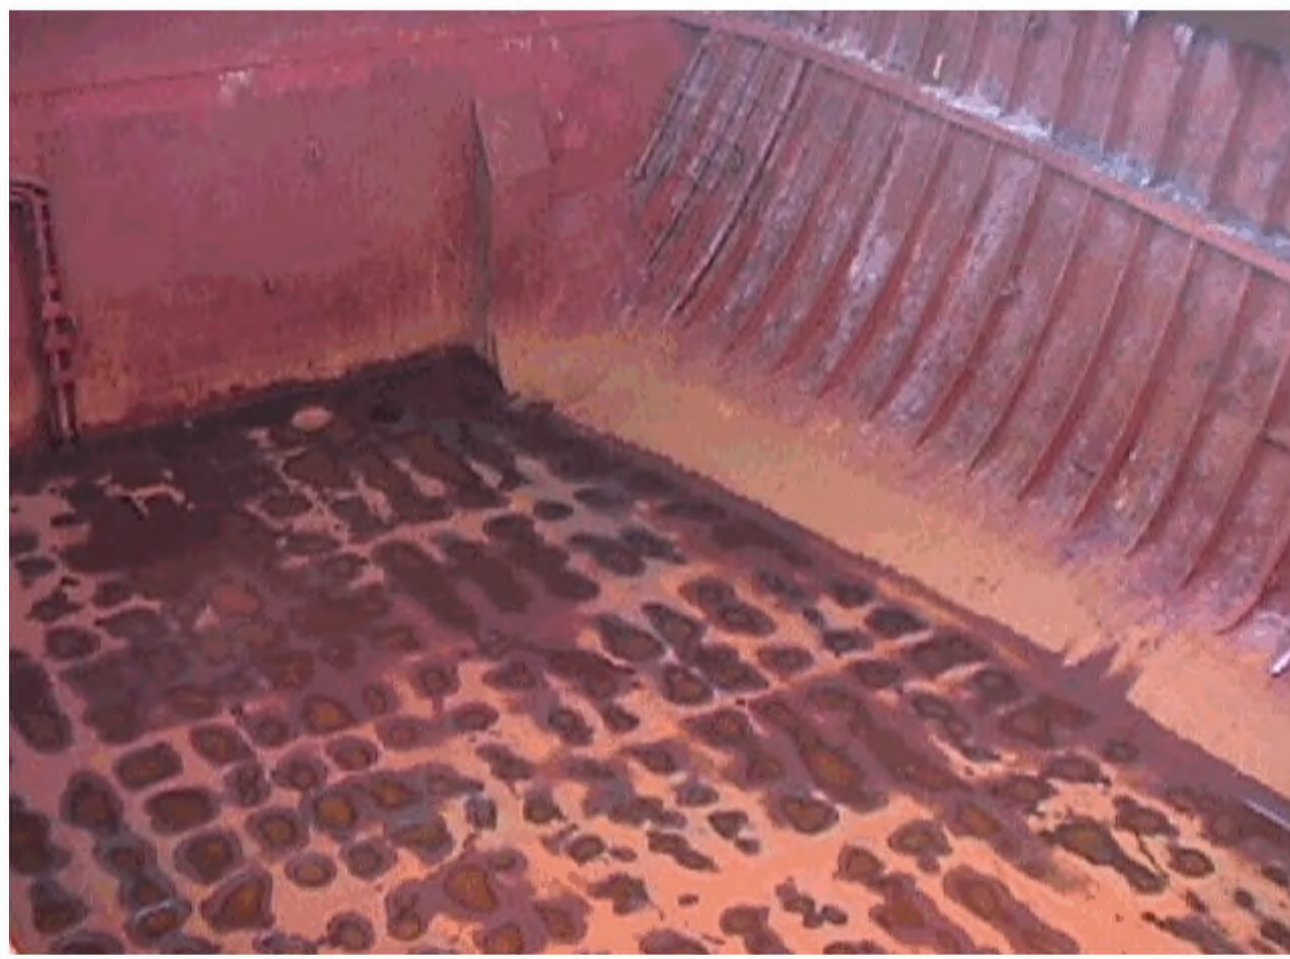
Photograph 2 Damaged inner bottom plating

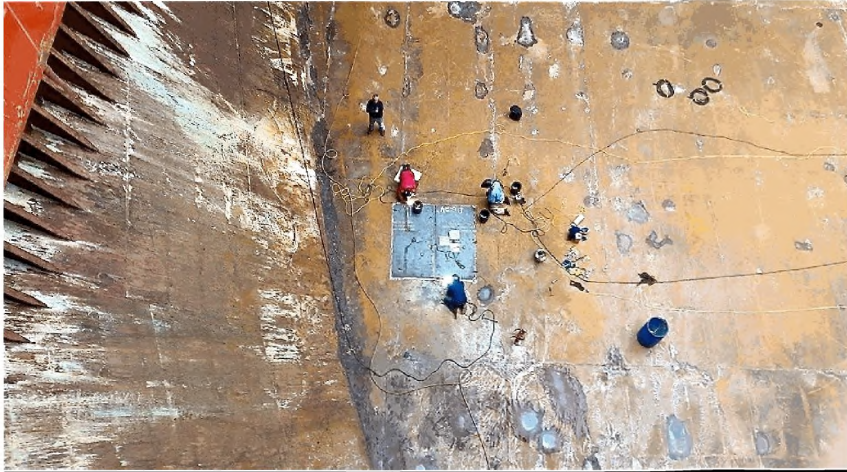
Photograph 3 Repairs of damaged inner bottom plating

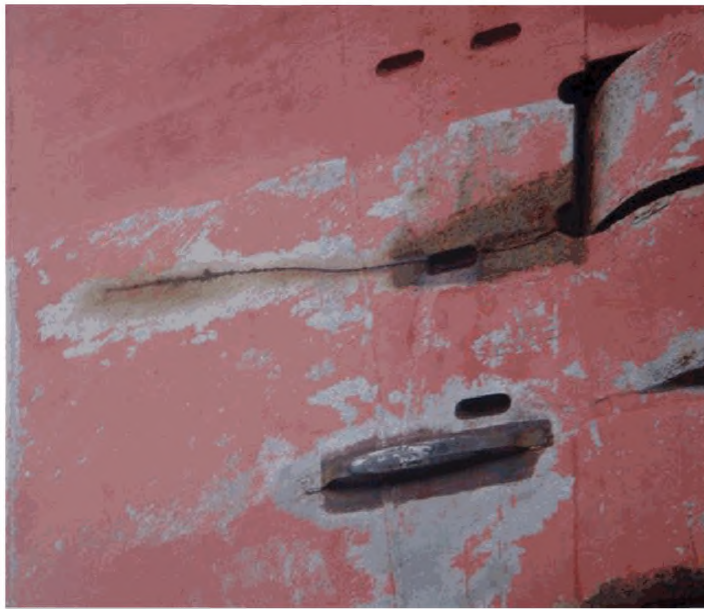
Photograph 1
Fractured rudder due to corrosion in rudder plating

Photograph 1 **Fractured rudder due to corrosion in rudder plating**

Corrosion/erosion (such as deep pitting corrosion) should be looked for in rudder/rudder horn, especially in welds. In extreme cases the corrosion /erosion may cause a large fracture as shown in **Photograph 1**.

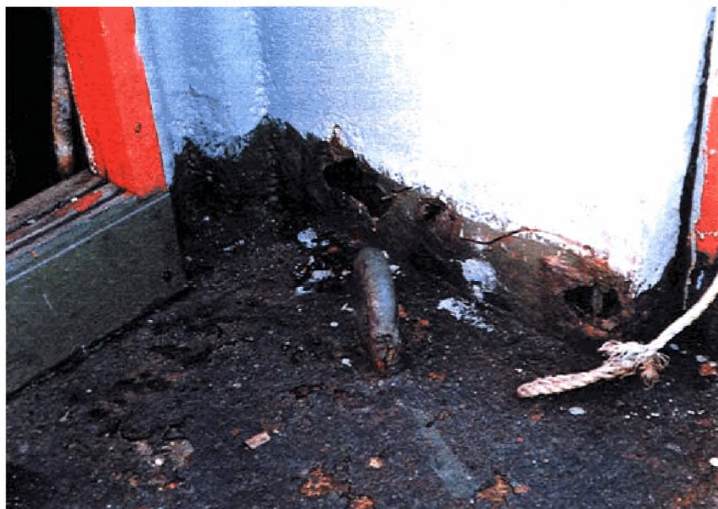
Photograph 1 Corroded accommodation house structure

The main damage is corrosion which may cause serious problems since the structure is relatively thin. Serious corrosion may be found in exposed deck plating and its adjoining accommodation house structure where water is liable to collect (See **Photograph 1**). Corrosion is also found in accommodation bulkheads where fittings such as doors, side scuttles, ventilators, etc. are fitted and proper maintenance of the area is relatively difficult. Deterioration of the bulkheads including fittings may impair the integrity of weathertightness.

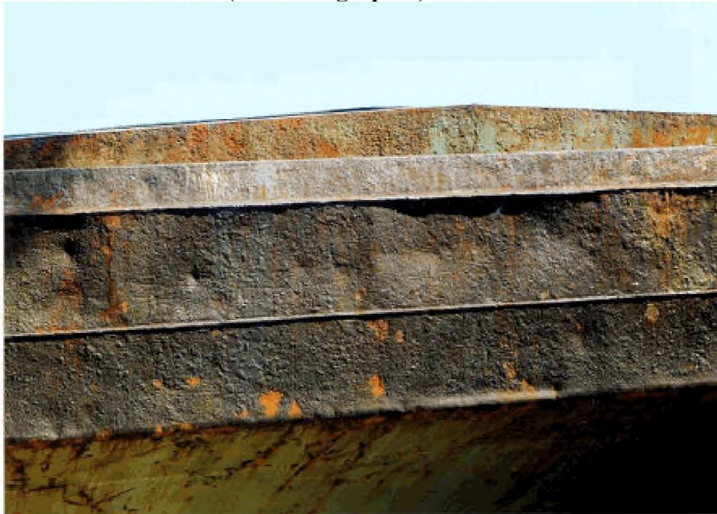
Photograph 1 **Heavy corrosion of hatch coaming and topside tank plating vertical strake**

- 3.1.1 The level of wastage of under-deck stiffeners/structure in cross deck may have to be established by means of thickness measurements. The combined effect of the marine environment and the high humidity atmosphere within cargo hold s will give rise to a high corrosion rate.
- 3.1.2 Severe corrosion of the hatch coaming plating inside cargo hold and topside tank plating vertical strake may occur due to difficult access for the maintenance of the protective coating. This may lead to fractures in the structure (See **Photograph 1**).

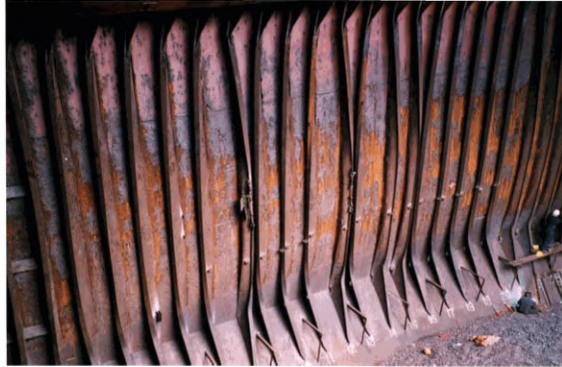
Photograph 1 Collapsed side shell frames (See Example 4)

- 1.6 A summary of potential problem areas is shown in **Figures 1 - 4**. Examples of failure and damaged ship side structure are illustrated in **Photographs 1 - 2**.

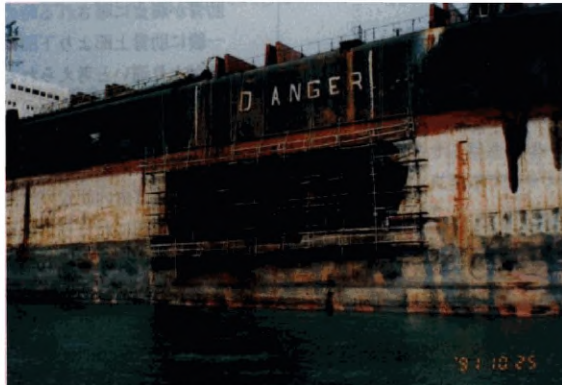
Photograph 2 Missing side shell structure (See Examples 4 and 5)

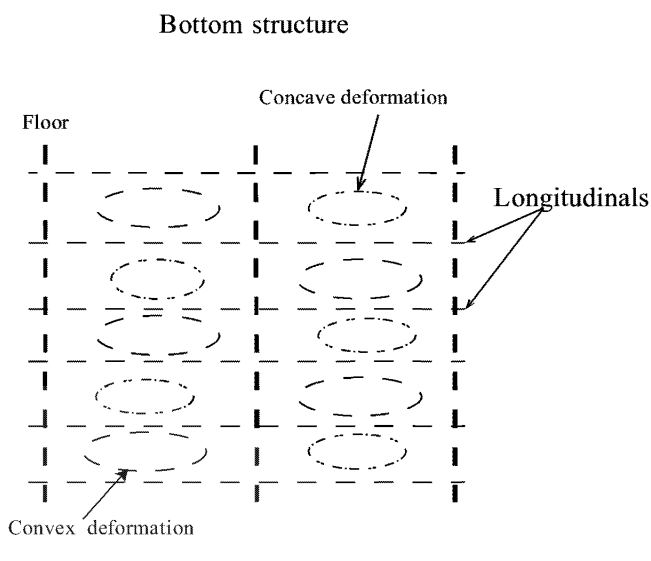
Figure 1- Buckling deformation observed in the bottom shell plating in way of cargo hold amidships

No.	Title
<u>Figure 1</u>	<u>Example of buckling deformation observed in the bottom shell plating under cargo hold amidships</u>
<u>Figure 12</u>	<u>Grooving corrosion of weld of bottom plating</u>
<u>Figure 23</u>	<u>Section of the grooving shown in Figure 1</u>

3.2.2 For large container ships (8,000 TEU or over), even if no obvious deformations are identified during external bottom inspection, if small concave and convex deformations of bottom plates are detected during the in tank inspection, the adjacent areas of bottom plates should be carefully inspected for the similar deformations, which might be caused by the effect of the lateral loads which induce bi-axial stress of bottom shell plates. In such cases a strength assessment of the hull girder should be undertaken by the Classification Society.

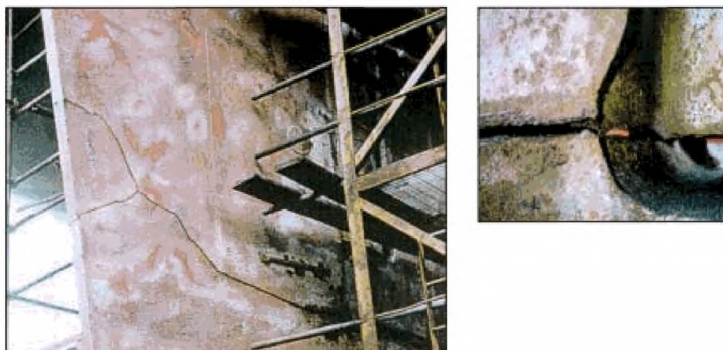
Photograph 1 Fractured rudder

2.3.1 Corrosion/erosion (such as deep pitting corrosion) should be looked for in rudder/rudder horn plating, especially in welds. In extreme cases the corrosion /erosion may cause a large fracture as shown in

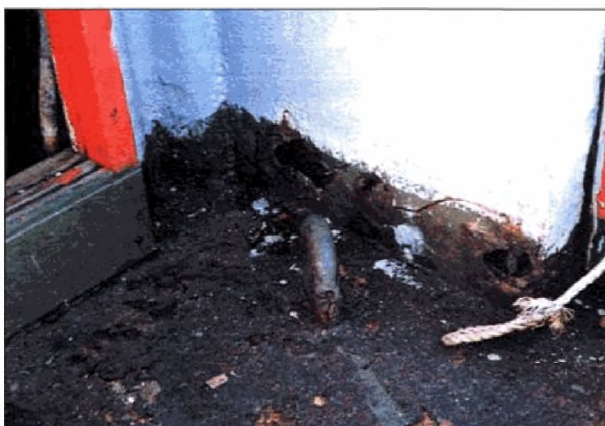
Photograph 1 Corroded accommodation house side structure

Severe corrosion may be found in exposed deck plating and the deck house side structure adjacent to the deck plating where water is liable to accumulate (See **Photograph 1**). Corrosion may also be found in accommodation bulkheads around the cutout for fittings, such as doors, side scuttles, ventilators, etc., where proper maintenance of the area is relatively difficult. Deterioration of the bulkheads including fittings may impair the integrity of weathertightness.

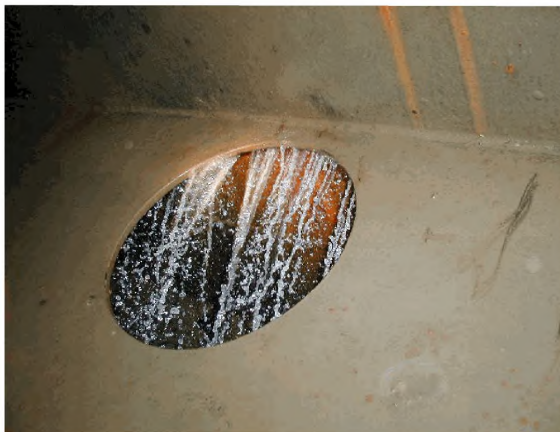
Photograph 1 Side shell fracture in way of horizontal stringer weld

- Areas subjected to stress concentration
 - Welded joints of faceplate of transverse at corners
 - Connection of the lowest longitudinal to transverse web frame, especially with reduced scantlings.
 - Termination of longitudinal in fore and aft wing tanks
- Areas subjected to dynamic wave loading
 - Connection of side longitudinal to watertight bulkhead
 - Connection of side longitudinal to transverse web frame

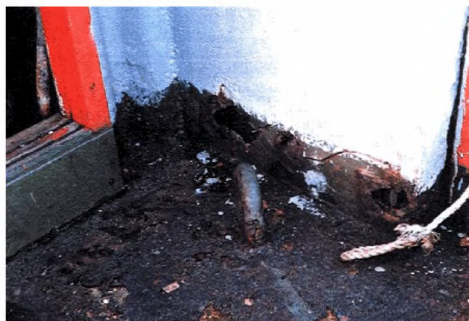
Photograph 1 Corroded accommodation house side structure

Severe corrosion may be found in exposed deck plating and deck house side structure adjacent to the deck plating where water is liable to accumulate (See **Photograph 1**). Corrosion may also be found in accommodation bulkheads around cut-out for fittings, such as doors, side scuttles, ventilators, etc., where proper maintenance of the area is relatively difficult. Deterioration of the bulkheads including fittings may impair the integrity of weathertightness.

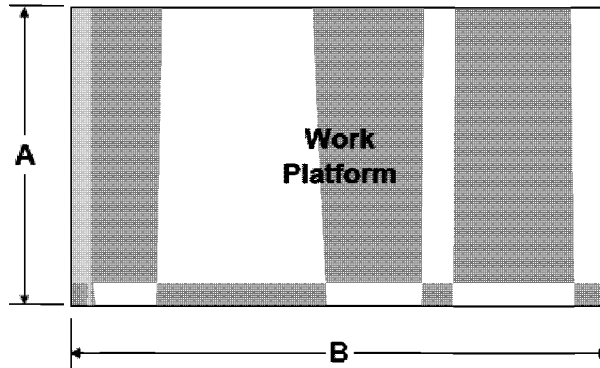
Figure 6 Work Platform Dimensions

<i>Dimension</i>		<i>Recommendation</i>
A	Work platform width	≥ 750 mm (29.5 in.)
	Work platform width (if used for standing only)	≥ 380 mm (15.0 in.)
B	Work platform length	≥ 925 mm (37.0 in.)
	Work platform length (if used for standing only)	≥ 450 mm (18.0 in.)

In addition to the recommendations for Work Platforms presented in Section 4.6 Access & Egress Design, the following recommended dimensions relating to the design of Work Platforms are presented in Figure 6 'Work Platform Dimensions'.

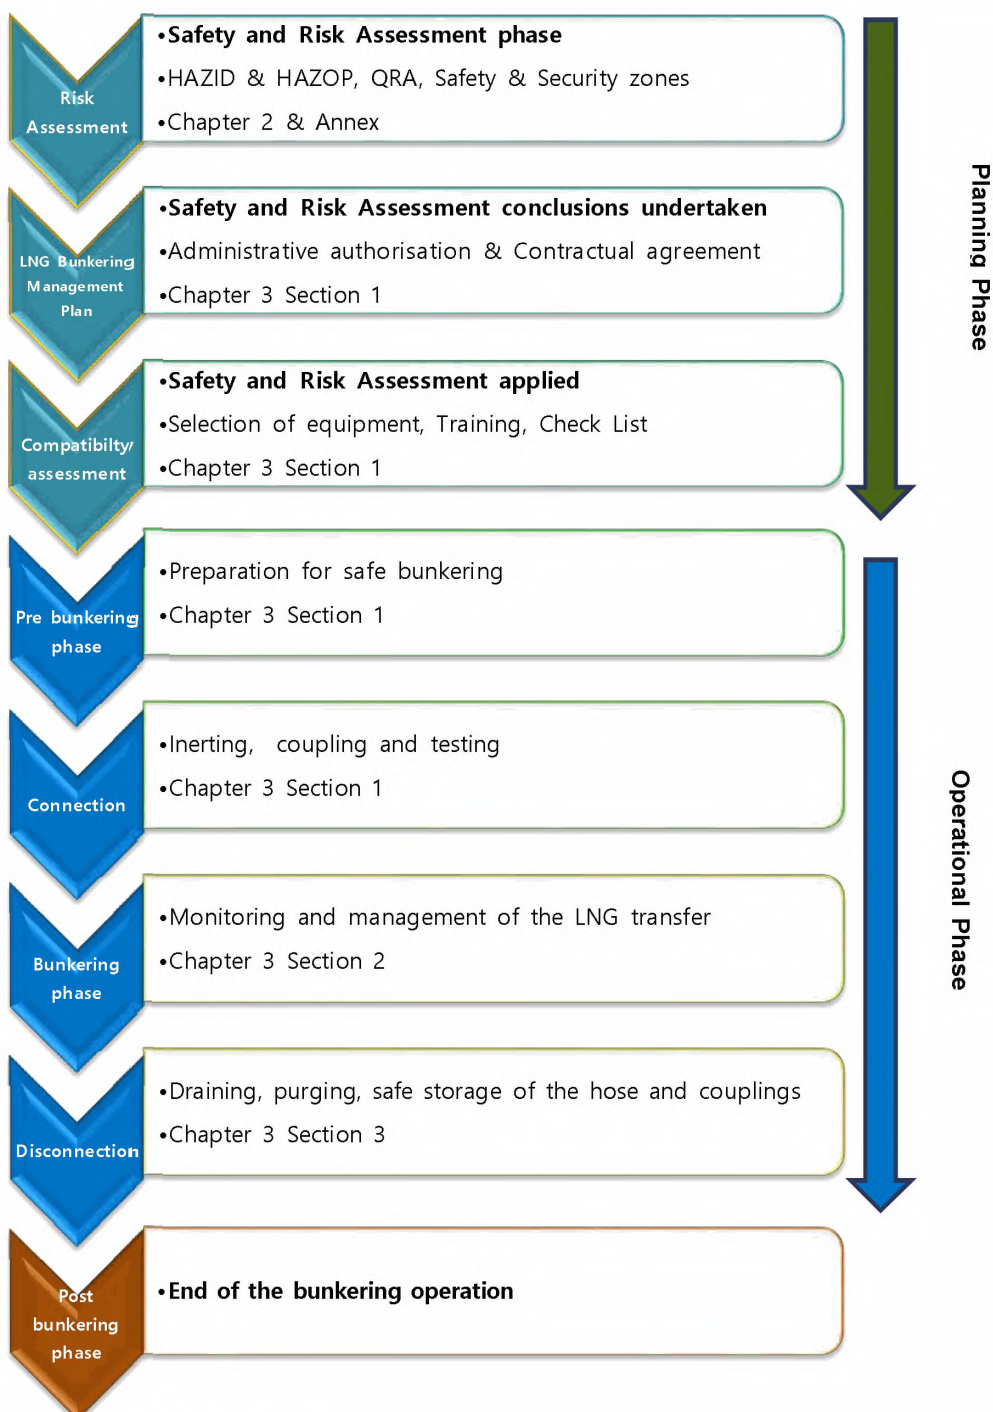
Figure 1: Bunkering process

The sequence for a bunkering operation carried out between two parties for the first time is described in the following diagram; the references identify the applicable sections of the guideline.

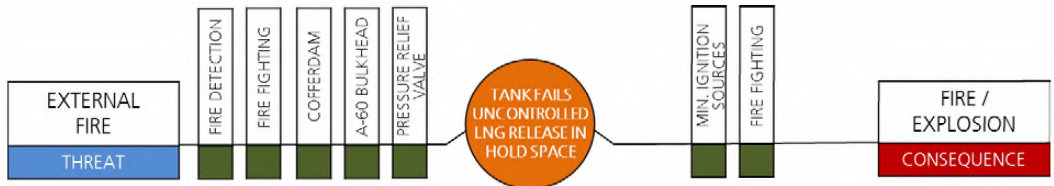
- Threat** – A cause that can potentially lead to the unwanted event.
- Barrier** – A mitigation measure that can potentially prevent the unwanted event or its consequences.
- Unwanted Event** – A situation to be avoided e.g. a release of fuel or a loss of ship propulsion.
- Consequence** – An outcome of a threat and an unwanted event not being mitigated by the barriers.

In respect of 'mitigation measures' (i.e. barriers) those prior to the unwanted event are often referred to as preventative barriers or prevention measures.
