**РОССИЙСКИЙ МОРСКОЙ РЕГИСТР СУДОХОДСТВА**  
**RUSSIAN MARITIME REGISTER OF SHIPPING**

**SUPPLEMENT TO RULES AND GUIDELINES  
OF RUSSIAN MARITIME REGISTER OF SHIPPING**

**IACS PROCEDURAL REQUIREMENTS,  
UNIFIED INTERPRETATIONS  
AND RECOMMENDATIONS**

НД № 2-020101-091-R-E

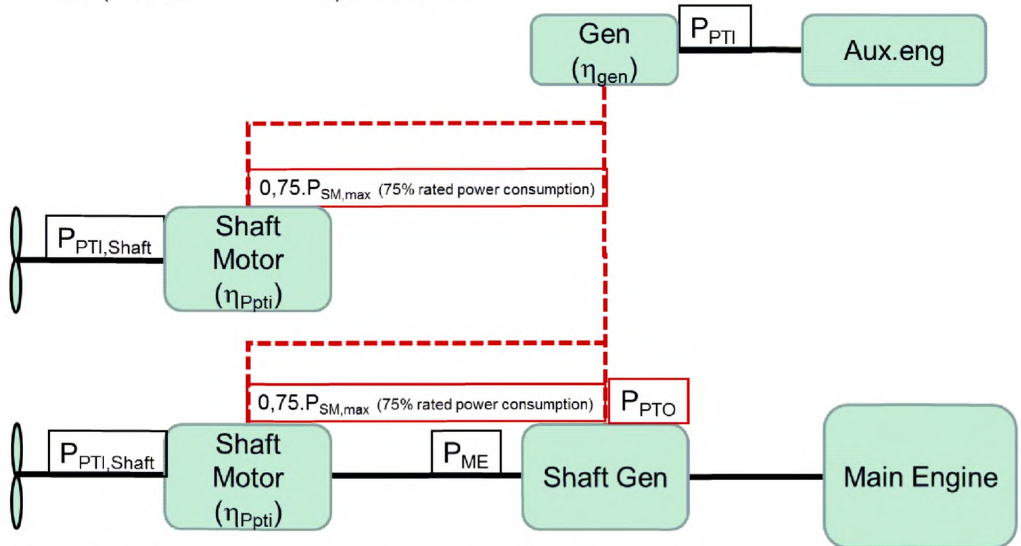
A diagram is inserted to highlight where the mechanical and electrical efficiencies or the related devices (PTI and Generator's) are located:

Figure 1: Typical arrangement of propulsion and electric power system

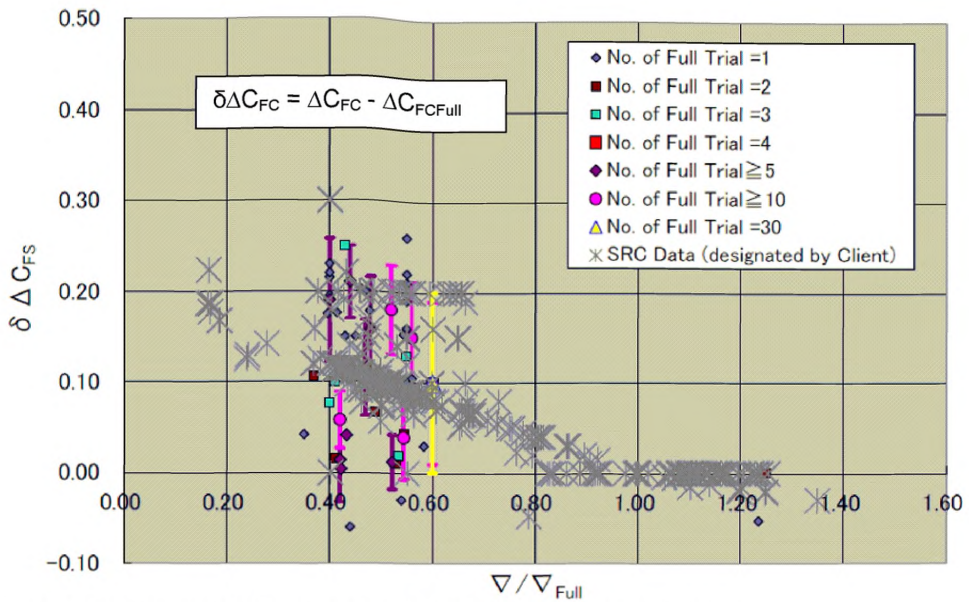
Figure 3.2: Variation of  $\Delta C_{FC}$  as a function of the displacement ratio

The verifier will check that the power-speed curves obtained for the EEDI condition and sea trial condition are obtained using the same calculation process and properly documented as requested in Appendix 4 "Witnessing of model test procedures". In particular, the verifier will compare the differences between experience based coefficients  $C_p$  and  $\Delta C_{FC}$  between the EEDI condition ( $\nabla_{full}$ ) and sea trial condition if different from EEDI condition ( $\nabla$ ) with the indications given in Figures 3.1 and 3.2 extracted from a SAJ-ITTC study on a large number of oil tankers. If the difference is significantly higher than the values reported in the Figures, a proper justification of the values is to be submitted to the verifier.

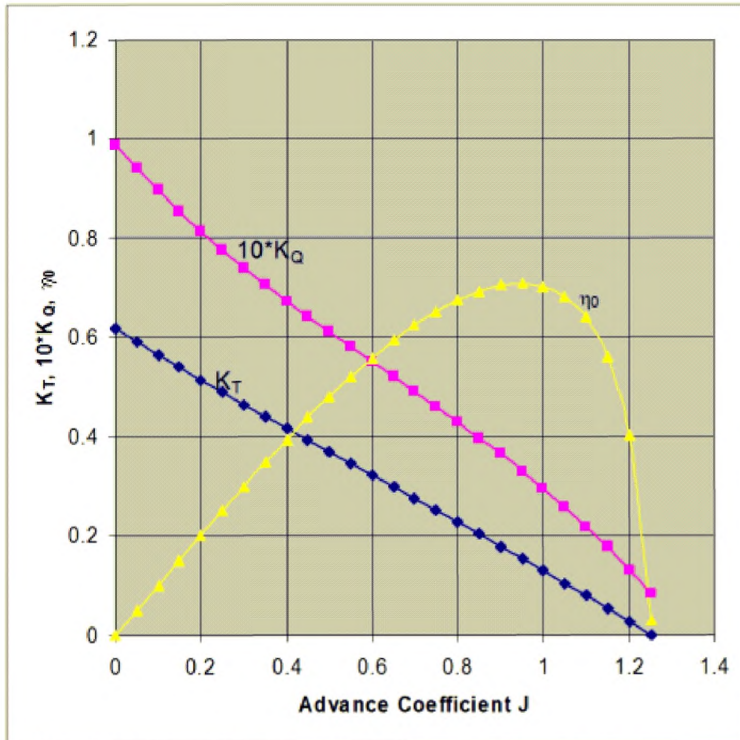
The open water characteristics of the stock model propeller are given in annex 2. The open water characteristics of the ship propeller are given in Figure 7.1.

Figure 7.1: open water characteristics of ship propeller

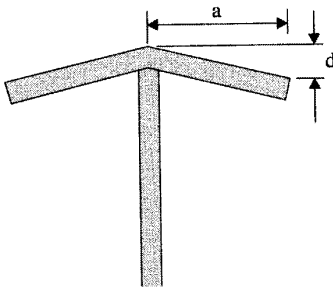
<p><math>d \leq 3 + a/100</math> mm</p>	<p><math>d \leq 5 + a/100</math> mm</p>	
<p>Distortion in plane of web and flange of built up longitudinal frame, transverse frame, girder and transverse web.</p>

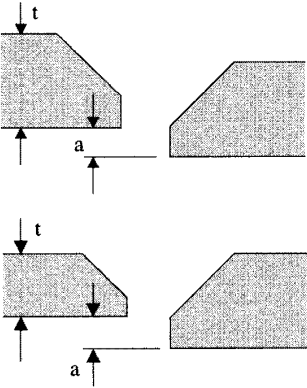
Detail	Standard	Limit	Remarks
<p>Alignment of butt welds</p>

<p><math>a \leq 0.15t</math> strength member  <math>a \leq 0.2t</math> other but maximum 4.0 mm</p>	<p><math>t</math> is the lesser plate thickness</p>
<p>Alignment of fillet welds</p>

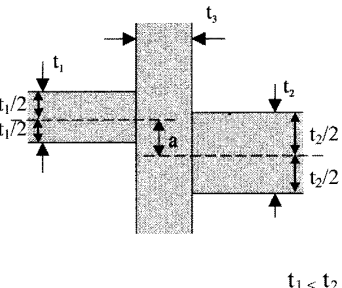
<p style="text-align: center;"><math>t_1 &lt; t_2</math></p>		<p>Strength member and higher stress member:  <math>a \leq t_1/3</math></p> <p>Other:  <math>a \leq t_1/2</math></p>	<p>Alternatively, heel line can be used to check the alignment.</p> <p>Where <math>t_3</math> is less than <math>t_1</math>, then <math>t_3</math> should be substituted for <math>t_1</math> in the standard.</p>
<p>Alignment of fillet welds</p>

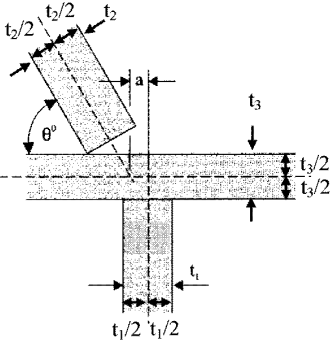
<p>Strength member and higher stress member:  <math>a \leq t_1/3</math></p> <p>Other:  <math>a \leq t_1/2</math></p>	<p>Alternatively, heel line can be used to check the alignment.</p> <p>Where <math>t_3</math> is less than <math>t_1</math>, then <math>t_3</math> should be substitute for <math>t_1</math> in the standard.</p>

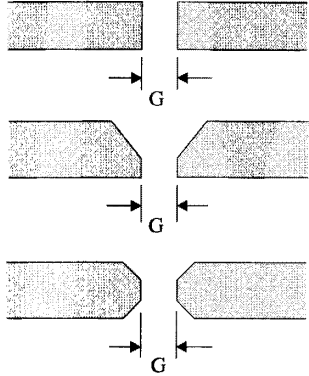
Detail	Standard	Limit	Remarks
<p>Submerged Arc Welding (SAW)</p>

$0 \leq G \leq 0.8 \text{ mm}$	$G = 2 \text{ mm}$	See Note 1.
<p><b>NOTE 1</b></p> <p>Different plate edge preparation may be accepted or approved by the Classification Society in accordance with URW28 or other recognized standard accepted by the Classification Society.</p> <p>For welding procedures other than manual welding, see paragraph 3.2 Qualification of welding procedures.</p>

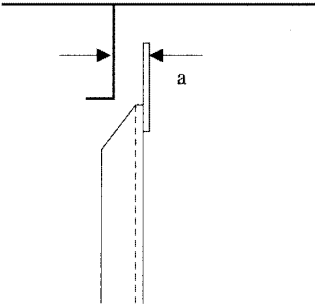
<p data-bbox="610 1017 901 1045"><math>b = (2t + 25) \text{ mm, min. } 50 \text{ mm}</math></p>	
<p data-bbox="130 1131 414 1159">Gap between beam and frame</p>

<p data-bbox="543 1131 967 1238"><math>3 \text{ mm} &lt; a \leq 5 \text{ mm}</math>: weld leg length to be increased by the same amount as increase in gap in excess of 3 mm</p> <p data-bbox="543 1294 813 1322"><math>a &gt; 5 \text{ mm}</math> release and adjust</p>

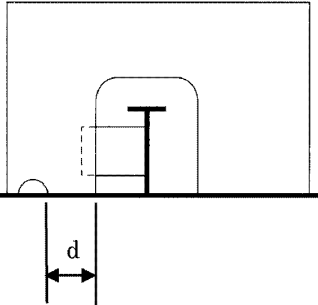
Detail	Remedial standard	Remarks
<p>Position of scallop</p>

<p>When <math>d &lt; 75</math> mm web plate to be cut between scallop and slot, and collar plate to be fitted</p>

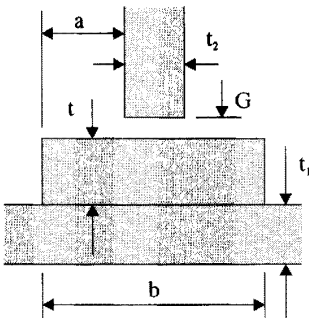
<p>Liner treatment</p>

<p><math>t_2 \leq t \leq t_1</math>  <math>G \leq 2 \text{ mm}</math>  <math>a = 5 \text{ mm} + \text{fillet leg length}</math></p>	<p>Not to be used in cargo area or areas of tensile stress through the thickness of the liner</p>

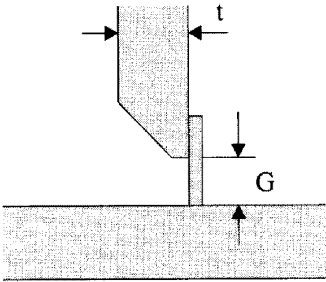
<p data-bbox="537 369 715 425">3 mm &lt; G ≤ 5 mm build up weld</p> <p data-bbox="537 483 988 592">5 mm &lt; G ≤ 16 mm - build up with welding, with backing strip if necessary, remove backing strip if used, back gouge and back weld.</p>

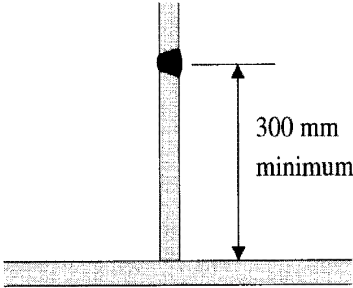
<p data-bbox="537 1015 907 1071">G &gt; 16 mm new plate to be inserted of minimum width 300 mm</p>

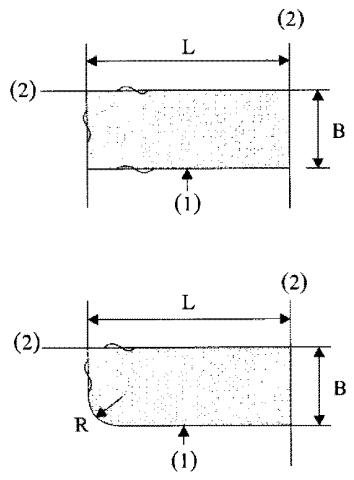
**TABLE 9.12 – Remedial by Insert Plate**

Detail	Remedial standard	Remarks
<p>Remedial by insert plate</p>

<p> <math>L = 300 \text{ mm minimum}</math>  <math>B = 300 \text{ mm minimum}</math>  <math>R = 5t \text{ mm}</math>  <math>100\text{mm minimum}</math> </p> <p>(1) seam with insert piece is to be welded first</p> <p>(2) original seam is to be released and welded over for a minimum of 100 mm.</p>	
<p>Remedial of built section by insert plate</p>

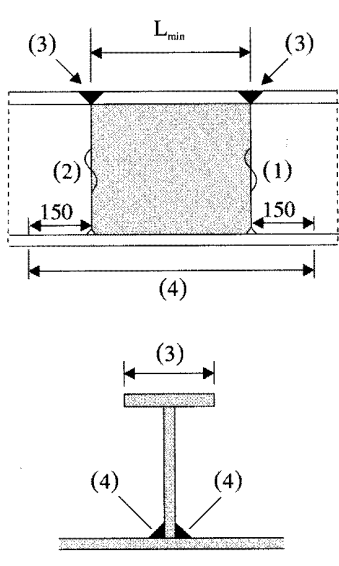
<p> <math>L_{min} \geq 300 \text{ mm}</math> </p> <p>Welding sequence  <math>(1) \rightarrow (2) \rightarrow (3) \rightarrow (4)</math> </p> <p>Web butt weld scallop to be filled during final pass (4)</p>

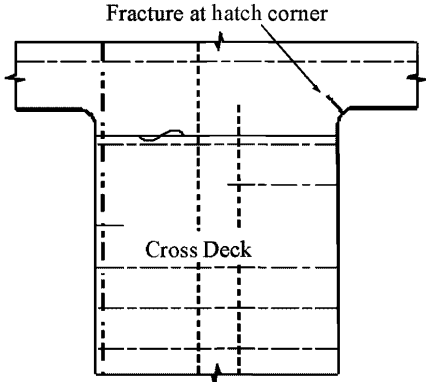
<b>BULK CARRIERS</b>		<b>Guidelines for Surveys, Assessment and Repair of Hull Structure</b>	
<b>Part 1</b>	<b>Cargo hold region</b>	<b>Example No.</b>	
<b>Area 1</b>	<b>Deck structure</b>	<b>1</b>	
<b>Detail of damage</b>		Fractures at main cargo hatch corner	
<b>Sketch of damage</b>

<b>Notes on possible cause of damage</b> <ol style="list-style-type: none"> <li>1. Stress concentration at hatch corners, i.e. radius of corner.</li> <li>2. Welded attachment of shedder plate close to edge of hatch corner.</li> <li>3. Wire rope groove.</li> </ol>		<b>Notes on repairs</b> <ol style="list-style-type: none"> <li>1. The corner plating in way of the fracture is to be cropped and renewed. If stress concentration is primary cause, insert plate should be increased thickness, enhanced steel grade and/or improved geometry. Insert plate should be continued beyond the longitudinal and transverse extent of the hatch corner radius ellipse or parabola, and the butt welds to the adjacent deck plating should be located well clear of the butts in the hatch coaming. It is recommended that the edges of the insert plate and the butt welds connecting the insert plates to the surrounding deck plating be made smooth by grinding. In this respect caution should be taken to ensure that the micro grooves of the grinding are parallel to the plate edge.</li> <li>2. If the cause of fracture is welded attachment of shedder plate, the deck connection should be left unwelded.</li> <li>3. If the cause of the fracture is wire rope groove, replacement to the original design can be accepted.</li> </ol>

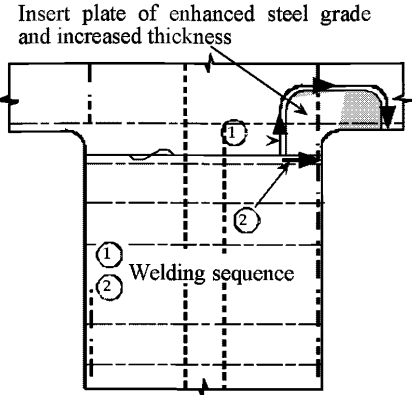
<b>Sketch of repair</b> Insert plate of enhanced steel grade and increased thickness

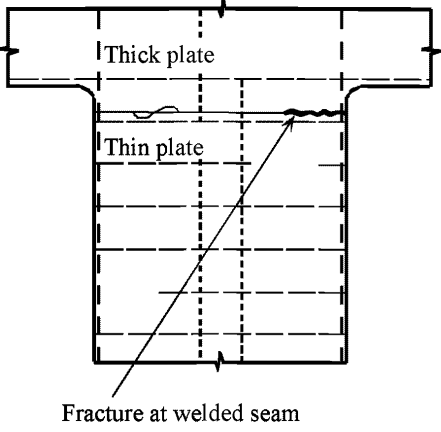
<b>BULK CARRIERS</b>		<b>Guidelines for Surveys, Assessment and Repair of Hull Structure</b>	
<b>Part 1</b>	<b>Cargo hold region</b>	<b>Example No.</b>	
<b>Area 1</b>	<b>Deck structure</b>	<b>2-a</b>	
<b>Detail of damage</b>	Fractures of welded seam between thick plate and thin plate at cross deck		
<b>Sketch of damage</b>		<b>Sketch of repair</b>

<p>Thick plate</p> <p>Thin plate</p> <p>Fracture at welded seam</p>

<p>Insert plate of suitable intermediate thickness</p>	
<b>Notes on possible cause of damage</b>		<b>Notes on repairs</b>	
<ol style="list-style-type: none"> <li>1. Stress concentration created by abrupt change in deck plating thickness.</li> <li>2. In-plane bending in cross deck strip due to torsional (longitudinal) movements of ship sides.</li> <li>3. Welded seam not clear of tangent point of hatch corner.</li> </ol>		<ol style="list-style-type: none"> <li>1. Insert plate of intermediate thickness is recommended.</li> <li>2. Smooth transition between plates (beveling) should be considered.</li> </ol>

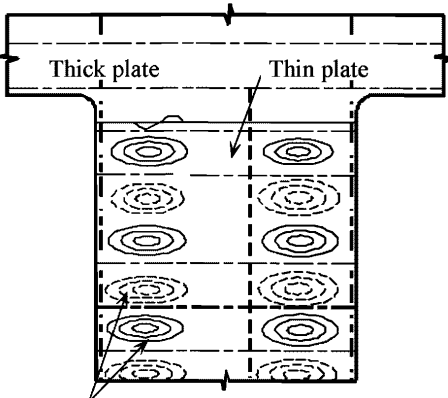
BULK CARRIERS		Guidelines for Surveys, Assessment and Repair of Hull Structure	
Part 1	Cargo hold region	Example No.	
Area 1	Deck structure	2-c	
<b>Detail of damage</b>		Overall buckling of cross deck plating	
<p><b>Sketch of damage</b></p>

<p>Buckling of cross deck plating (Buckling of hatch end structure should be examined. Refer to Example 7-a.)</p>		<p><b>Sketch of repair</b></p> <p><b>Repair A</b></p>

<p><b>Notes on possible cause of damage</b></p> <ol style="list-style-type: none"> <li>1. Transverse compression of deck due to sea load.</li> <li>2. Transverse compression of deck due to excessive loading in two adjacent holds.</li> <li>3. Insufficient plate thickness and/or transverse stiffening.</li> </ol>		<p><b>Notes on repairs</b></p> <ol style="list-style-type: none"> <li>1. <b>Repair A</b> Plating of original thickness in combination with additional transverse stiffening.</li> <li>2. <b>Repair B</b> Insertion of plating of increased thickness.</li> </ol>

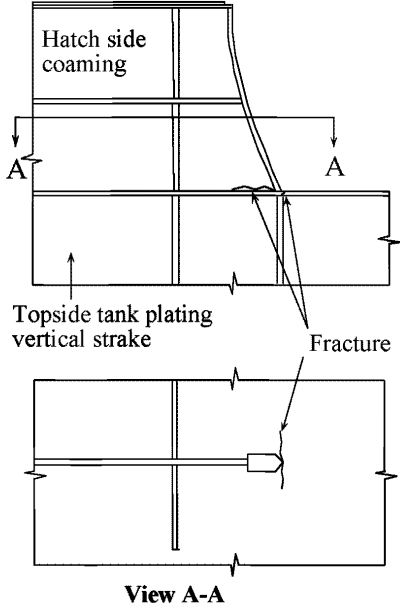
<b>BULK CARRIERS</b>		<b>Guidelines for Surveys, Assessment and Repair of Hull Structure</b>	
<b>Part 1</b>	<b>Cargo hold region</b>		<b>Example No.</b>
<b>Area 1</b>	<b>Deck structure</b>		<b>3-a</b>
<b>Detail of damage</b>		Fractures in the web or in the deck at the toes of the longitudinal hatch coaming termination bracket	
<p><b>Sketch of damage</b></p>

<p><b>Notes on possible cause of damage</b></p> <ol style="list-style-type: none"> <li>1. This damage is caused by stress concentrations attributed to the design of the bracket.</li> </ol>		<p><b>Notes on repairs</b></p> <ol style="list-style-type: none"> <li>1. The design of the bracket can be altered as shown above, however, it is to be ensured that an additional under deck stiffener is provided at the toe of the termination bracket, where the toe is clear of the normal stiffening member.</li> <li>2. Full penetration weld for a distance of <math>0.15 H_c</math> from toe of side coaming termination bracket and for connection of athwartship gusset bracket to deck.</li> <li>3. The fracture in deck plating to be veed-out and rewelded or deck plating cropped and part renewed as appropriate, using low hydrogen electrodes for welding.</li> </ol>

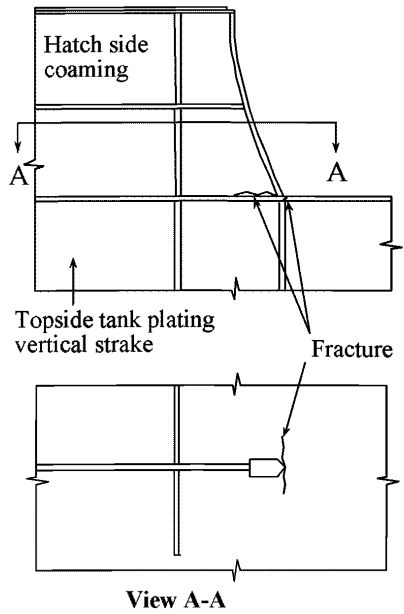
BULK CARRIERS		Guidelines for Surveys, Assessment and Repair of Hull Structure	
Part 1	Cargo hold region	Example No.	
Area 1	Deck structure	3-b	
<b>Detail of damage</b>		Fractures in the web or in the deck at the toes of the longitudinal hatch coaming termination bracket	
<p><b>Sketch of damage</b></p>

<p>Hatch side coaming</p> <p>Topside tank plating vertical strake</p> <p>Fracture</p> <p>View A-A</p>		<p><b>Sketch of repair</b></p>

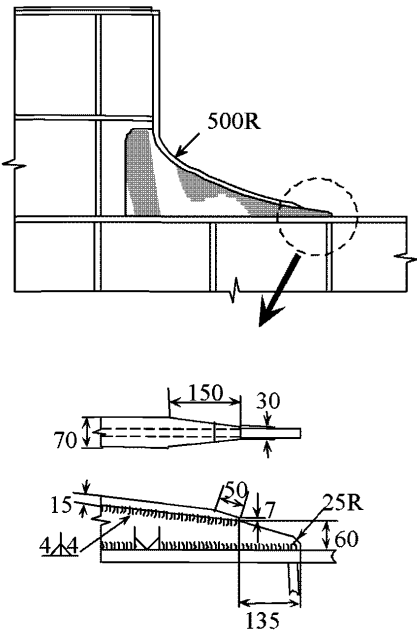
<p>500R</p> <p>150 30 70</p> <p>15 50 7 25R 60 135</p>	
<p><b>Notes on possible cause of damage</b></p> <p>1. This damage is caused by stress concentrations attributed to the design of the bracket.</p>		<p><b>Notes on repairs</b></p> <p>1. The design of the bracket can be altered as shown above, however, it is to be ensured that an additional under deck stiffener is provided at the toe of the termination bracket, where the toe is clear of the normal stiffening member.</p> <p>2. The fracture in deck plating to be veed-out and rewelded or deck plating cropped and part renewed as appropriate, using low hydrogen electrodes for welding.</p>

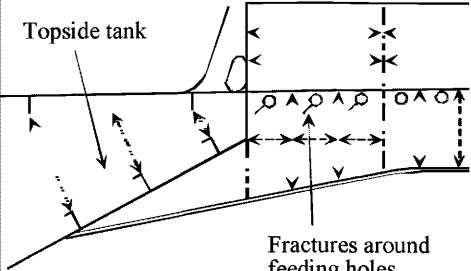
<b>BULK CARRIERS</b>		<b>Guidelines for Surveys, Assessment and Repair of Hull Structure</b>	
<b>Part 1</b>	<b>Cargo hold region</b>	<b>Example No.</b>	
<b>Area 1</b>	<b>Deck structure</b>	<b>9</b>	
<b>Detail of damage</b>		Fractures in hatch end beam around feeding holes	
<p><b>Sketch of damage</b></p>

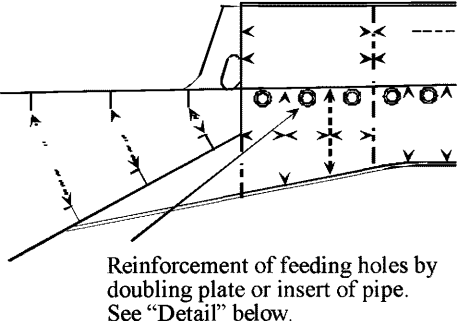
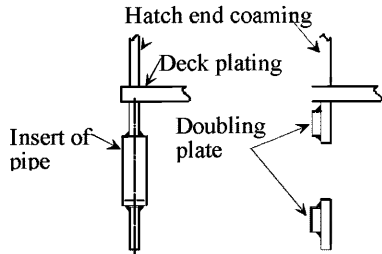
<p><b>Sketch of repair</b></p>

<p><b>Notes on possible cause of damage</b></p> <ol style="list-style-type: none"> <li>1. Inadequate reinforcement around feeding hole.</li> <li>2. Corrosion.</li> </ol>		<p><b>Notes on repairs</b></p> <ol style="list-style-type: none"> <li>1. Fractured part to be veed-out or cropped and renewed.</li> <li>2. If the fractured part is free from corrosion, reinforcement should be considered.</li> </ol>

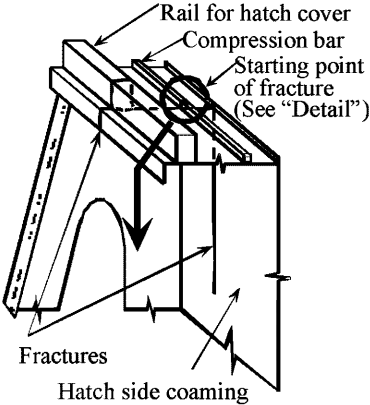
BULK CARRIERS		Guidelines for Surveys, Assessment and Repair of Hull Structure	
Part 1	Cargo hold region	Example No.	
Area 1	Deck structure	11	
<b>Detail of damage</b>		Fractures in hatch coaming top plate initiated from butt weld of compression bar	
<p><b>Sketch of damage</b></p>

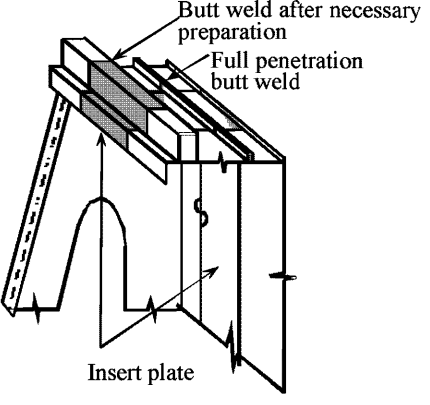
<p><b>Sketch of repair</b></p>

<p><b>Notes on possible cause of damage</b></p> <ol style="list-style-type: none"> <li>1. Heavy weather</li> <li>2. Insufficient preparation of weld of compression bar and/or rail (Although the compression bar and rail are not longitudinal strength members, they subject same longitudinal stress as longitudinal members)</li> <li>3. Crack may initiate from insufficient penetration of weld of rail for hatch cover.</li> </ol>		<p><b>Notes on repairs</b></p> <ol style="list-style-type: none"> <li>1. Loading condition of the ship and proper welding procedure should be carefully considered.</li> <li>2. Fractured structure is to be cropped and renewed if considered necessary. (Small fracture may be veed-out and rewelded.)</li> <li>3. Full penetration welding should be applied to the butt weld of compression bar and rail.</li> </ol>

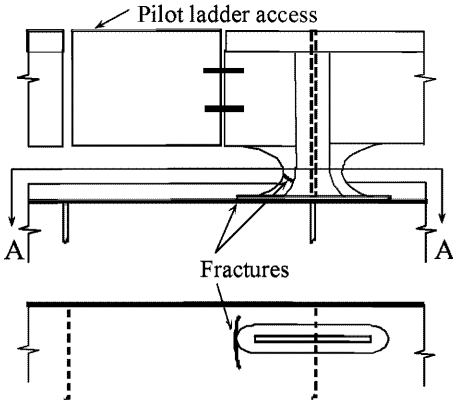
<b>BULK CARRIERS</b>		<b>Guidelines for Surveys, Assessment and Repair of Hull Structure</b>	
<b>Part 1</b>	<b>Cargo hold region</b>	<b>Example No. 12</b>	
<b>Area 1</b>	<b>Deck structure</b>		
<b>Detail of damage</b>		Fractures in deck plating at the pilot ladder access of bulwarks	
<p><b>Sketch of damage</b></p>

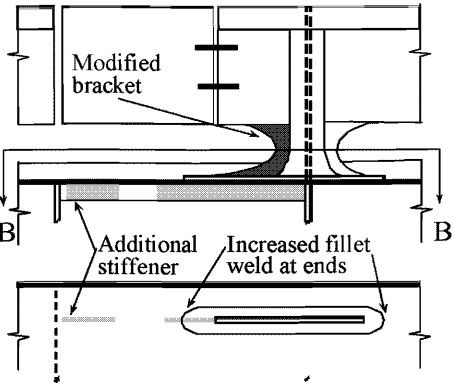
<p><b>View B-B</b></p>	
<p><b>Notes on possible cause of damage</b></p> <ol style="list-style-type: none"> <li>1. Stress concentration at the termination of bulwarks.</li> </ol>		<p><b>Notes on repairs</b></p> <ol style="list-style-type: none"> <li>1. Fractured deck plating should be cropped and part renewed.</li> <li>2. Reduction of stress concentration should be considered. In the above figure gusset plate was replaced with soft type for the fracture in gusset plate and pad plate was increased. Additional stiffeners were provided for the fracture in deck plating.</li> </ol>

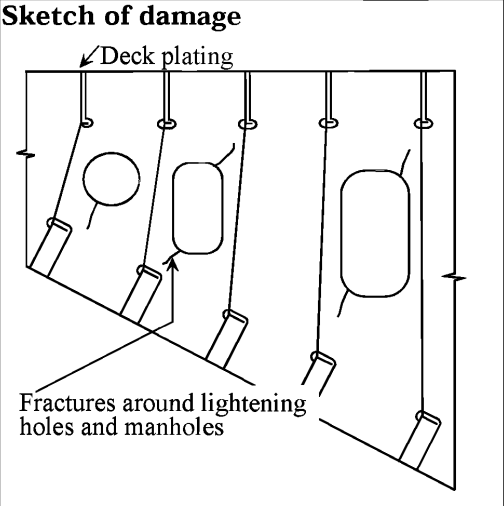
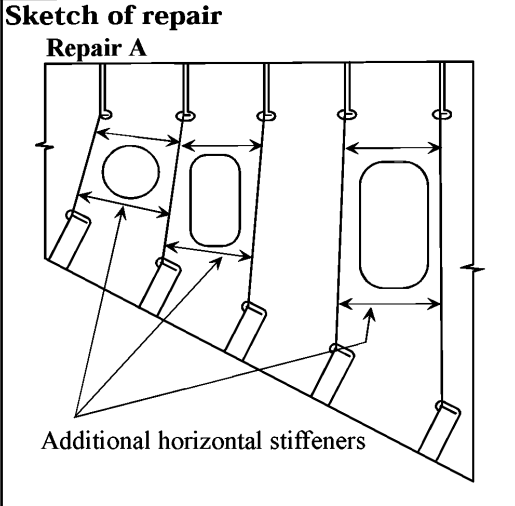
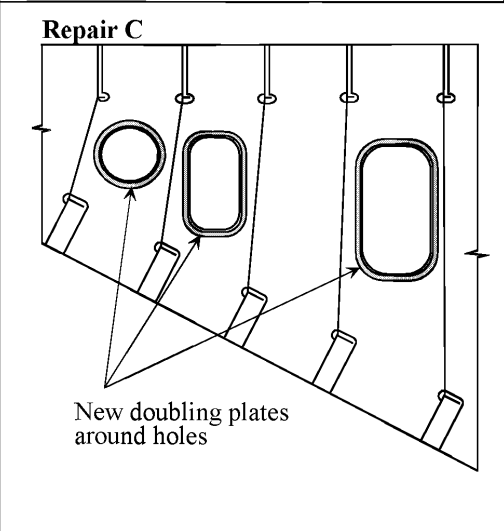
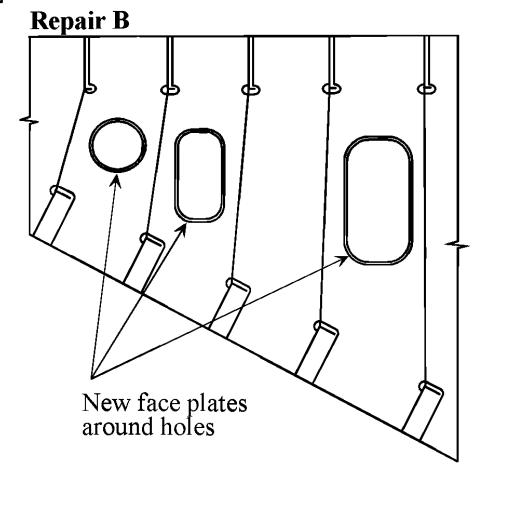
<b>BULK CARRIERS</b>		<b>Guidelines for Surveys, Assessment and Repair of Hull Structure</b>	
<b>Part 1</b>	<b>Cargo hold region</b>	<b>Example No.</b>	
<b>Area 2</b>	<b>Topside tank structure</b>	<b>1</b>	
<b>Detail of damage</b>		Fractures around unstiffened lightening holes and manholes in wash bulkhead	
<b>Sketch of damage</b>		<b>Sketch of repair</b>

<b>Repair C</b>		<b>Repair B</b>

<b>Notes on possible cause of damage</b>		<b>Notes on repairs</b>	
<ol style="list-style-type: none"> <li>General levels of corrosion and presence of stress concentration.</li> </ol>		<ol style="list-style-type: none"> <li>Corroded/fractured plate should be cropped and renewed with plating of enhanced thickness.</li> <li>Reinforcement should be considered.</li> </ol>

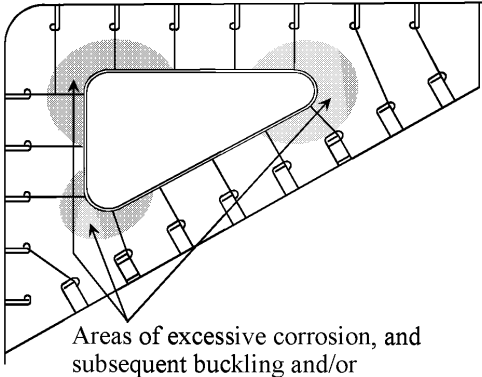
<b>BULK CARRIERS</b>		<b>Guidelines for Surveys, Assessment and Repair of Hull Structure</b>	
<b>Part 1</b>	<b>Cargo hold region</b>		<b>Example No.</b>
<b>Area 2</b>	<b>Topside tank structure</b>		<b>2-a</b>
<b>Detail of damage</b>		Thinning and subsequent buckling of web plating in the vicinity of the radii of the opening	
<b>Sketch of damage</b>		<b>Sketch of repair</b>

<p>Areas of excessive corrosion, and subsequent buckling and/or</p>

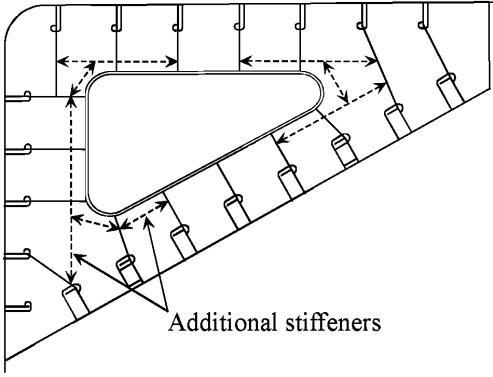
<p>Additional stiffeners</p>	
<b>Notes on possible cause of damage</b>		<b>Notes on repairs</b>	
<ol style="list-style-type: none"> <li>1. Insufficient buckling strength.</li> <li>2. Corrosion due to stress concentration at corners.</li> </ol>		<ol style="list-style-type: none"> <li>1. Buckled plating is to be cropped and parts renewed, if necessary.</li> <li>2. Additional stiffeners as shown above and/or renewal with plating of increased thickness should be considered.</li> </ol>

<p>Insert plate with increased thickness</p>	
<p><b>Notes on possible cause of damage</b></p> <p>1. Additional stresses at the free edge of transverse web. (In <b>Example 2-a - 2-c</b> face plate is provided for the reinforcement of the opening.)</p>		<p><b>Notes on repairs</b></p> <p>1. Corroded/buckled plating is to be cropped and part renewed with plating of increased thickness.</p>

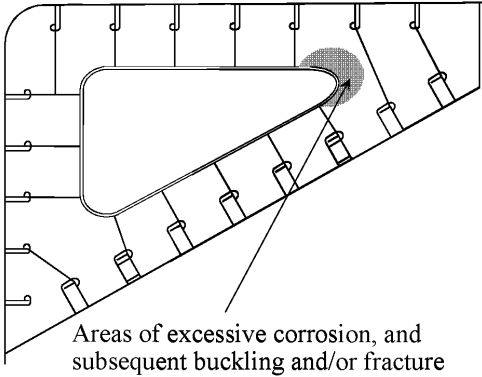
<b>BULK CARRIERS</b>		<b>Guidelines for Surveys, Assessment and Repair of Hull Structure</b>	
<b>Part 1</b>	<b>Cargo hold region</b>		<b>Example No.</b>
<b>Area 2</b>	<b>Topside tank structure</b>		<b>2-b</b>
<b>Detail of damage</b>		Thinning and subsequent buckling of web plating in the vicinity of the radii of the opening	
<b>Sketch of damage</b>		<b>Sketch of repair</b>

<p>Areas of excessive corrosion, and subsequent buckling and/or fracture</p>

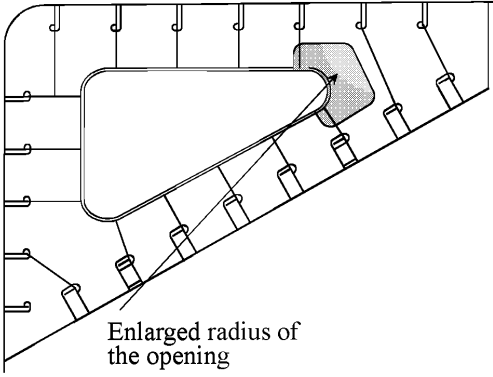
<p>Enlarged radius of the opening</p>	
<b>Notes on possible cause of damage</b>		<b>Notes on repairs</b>	
<ol style="list-style-type: none"> <li>1. Corrosion caused by stress concentration at the corner due to insufficient radius for the opening.</li> </ol>		<ol style="list-style-type: none"> <li>1. Corroded/buckled plating is to be cropped and parts renewed with plating of increased thickness and additional stiffeners are preferable to minimize deflection.</li> <li>2. An attempt should be made to improve the design of the radius if felt necessary.</li> </ol>

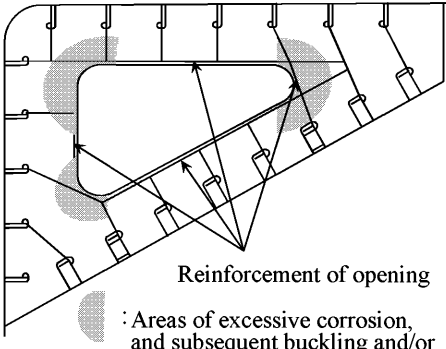
<b>BULK CARRIERS</b>		<b>Guidelines for Surveys, Assessment and Repair of Hull Structure</b>	
<b>Part 1</b>	<b>Cargo hold region</b>	<b>Example No.</b>	
<b>Area 2</b>	<b>Topside tank structure</b>	<b>2-c</b>	
<b>Detail of damage</b>	Thinning and subsequent buckling of web plating in the vicinity of the radii of the opening		
<p><b>Sketch of damage</b></p>

<p>Reinforcement of opening</p> <p>: Areas of excessive corrosion, and subsequent buckling and/or</p>		<p><b>Sketch of repair</b></p>

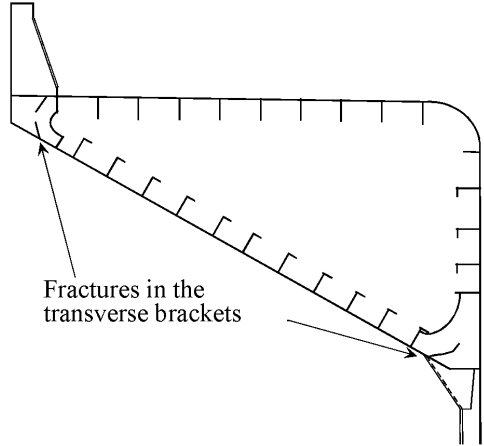
<b>BULK CARRIERS</b>		<b>Guidelines for Surveys, Assessment and Repair of Hull Structure</b>	
<b>Part 1</b>	<b>Cargo hold region</b>	<b>Example No.</b>	
<b>Area 2</b>	<b>Topside tank structure</b>	<b>7-a</b>	
<b>Detail of damage</b>		Fractures in transverse brackets	
<b>Sketch of damage</b>		<b>Sketch of repair</b>

<p>Fractures in the transverse brackets</p>

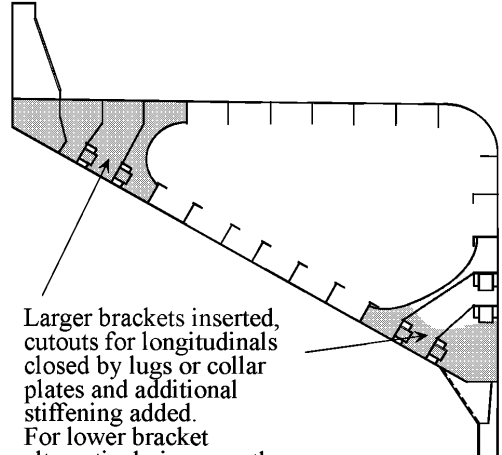
<p>Larger brackets inserted, cutouts for longitudinals closed by lugs or collar plates and additional stiffening added. For lower bracket alternatively increase the thickness</p>	
<b>Notes on possible cause of damage</b>		<b>Notes on repairs</b>	
<ol style="list-style-type: none"> <li>1. General levels of corrosion and presence of stress concentrations.</li> <li>2. Misalignment of the brackets with adjoining structure, e.g. side shell frame brackets and/or coaming brackets.</li> <li>3. High shear stresses due to insufficient bracket size.</li> <li>4. Inadvertent overloading.</li> </ol>		<ol style="list-style-type: none"> <li>1. If the damage is caused by misalignment with the side shell frame brackets or the hatch coaming brackets the misalignment is to be rectified and the replacement by larger brackets incorporated only if considered necessary.</li> </ol>

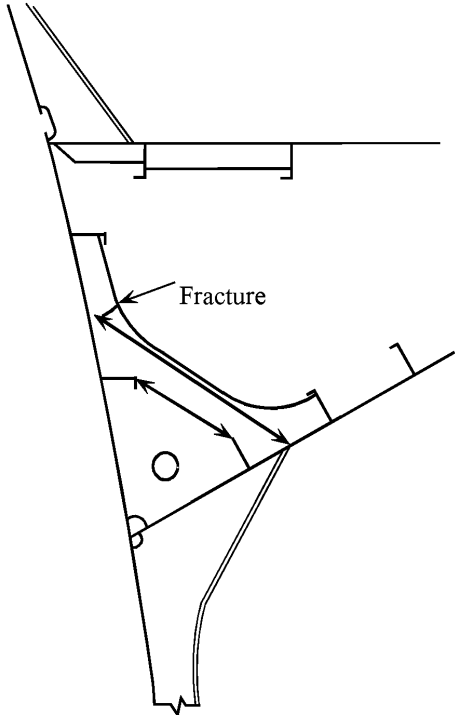
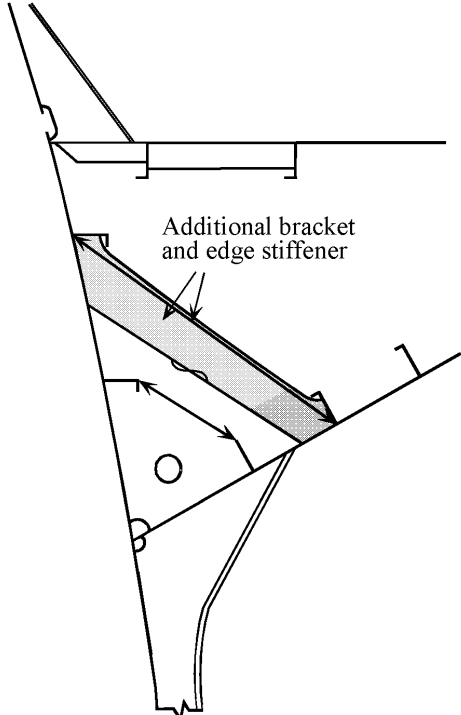
<b>BULK CARRIERS</b>		<b>Guidelines for Surveys, Assessment and Repair of Hull Structure</b>	
<b>Part 1</b>	<b>Cargo hold region</b>	<b>Example No.</b>	
<b>Area 2</b>	<b>Topside tank structure</b>	<b>7-b</b>	
<b>Detail of damage</b> Fractures in transverse bracket			
<b>Sketch of damage</b>		<b>Sketch of repair</b>

<b>Notes on possible cause of damage</b>		<b>Notes on repairs</b>	
<ol style="list-style-type: none"> <li>1. Insufficient strength.</li> <li>2. Corrosion.</li> </ol>		<ol style="list-style-type: none"> <li>1. Fractured part to be cropped and renewed.</li> <li>2. If the fractured part is free from corrosion, increased size and thickness should be considered. Partial renewal of the bracket may be accepted depending on the nature of the fracture.</li> </ol>

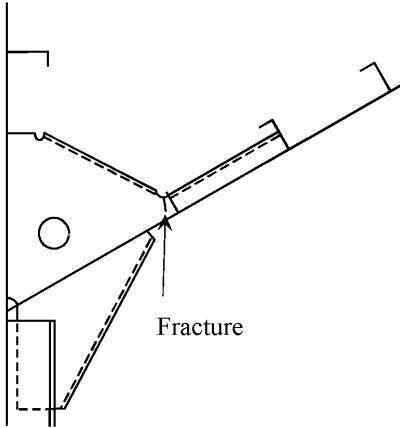
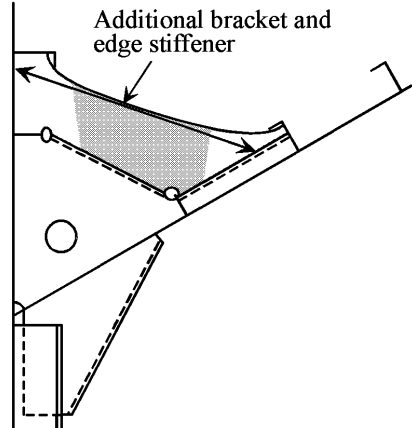
<b>BULK CARRIERS</b>		<b>Guidelines for Surveys, Assessment and Repair of Hull Structure</b>	
<b>Part 1</b>	<b>Cargo hold region</b>	<b>Example No.</b>	
<b>Area 2</b>	<b>Topside tank structure</b>	<b>7-c</b>	
<b>Detail of damage</b>		Fractures at toes of transverse bracket	
<b>Sketch of damage</b>		<b>Sketch of repair</b>

<b>Notes on possible cause of damage</b>		<b>Notes on repairs</b>	
<ol style="list-style-type: none"> <li>1. Stress concentration due to the shape of the bracket.</li> </ol>		<ol style="list-style-type: none"> <li>1. Cracked weld to be veed-out and rewelded.</li> </ol>

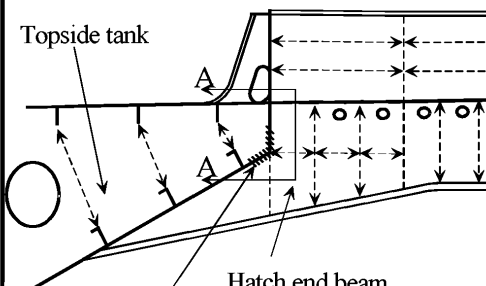
<b>BULK CARRIERS</b>		<b>Guidelines for Surveys, Assessment and Repair of Hull Structure</b>	
<b>Part 1</b>	<b>Cargo hold region</b>	<b>Example No. 8</b>	
<b>Area 2</b>	<b>Topside tank structure</b>		
<b>Detail of damage</b>		Fractures in sloping plating and vertical strake initiated from the connection of topside tank to hatch end beam	
<b>Sketch of damage</b>		<b>Sketch of repair</b>

<p>Topside tank</p> <p>Hatch end beam</p> <p>Fracture in sloping plating and vertical strake initiated from the connection of topside tank to hatch end beam</p> <p>Topside tank vertical strake</p> <p>Deck plating</p> <p>Fracture</p> <p>Hatch end beam</p> <p>Topside tank knuckle line</p> <p>Original bracket (See "Sketch of repair")</p> <p><b>View A-A</b></p>

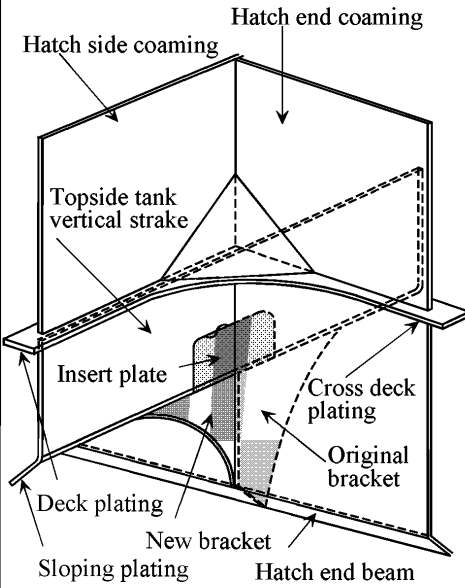
<p>Hatch side coaming</p> <p>Hatch end coaming</p> <p>Topside tank vertical strake</p> <p>Insert plate</p> <p>Deck plating</p> <p>Sloping plating</p> <p>Hatch end beam</p> <p>Cross deck plating</p> <p>Original bracket</p> <p>New bracket</p>

<b>Notes on possible cause of damage</b>		<b>Notes on repairs</b>	
<ol style="list-style-type: none"> <li>1. Stress concentration at the connection of hatch end beam to topside tank.</li> </ol>		<ol style="list-style-type: none"> <li>1. Fractured part to be cropped and renewed with increased thickness.</li> <li>2. Additional bracket should be considered for reinforcement.</li> </ol>

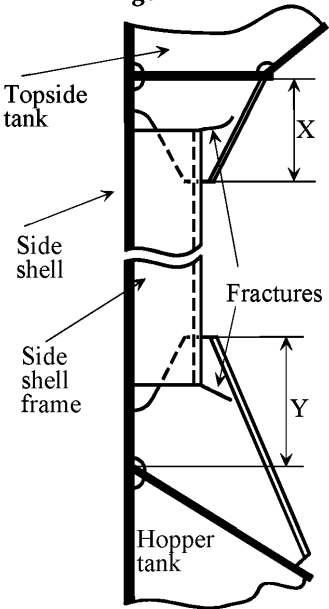
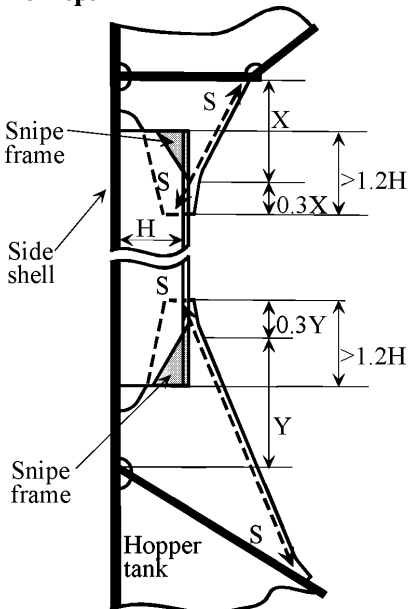
BULK CARRIERS		Guidelines for Surveys, Assessment and Repair of Hull Structure
Part 1	Cargo hold region	Example No.
Area 3	Cargo hold side structure	1-a
Detail of damage		Fractures in brackets at termination of frame
<b>Sketch of damage</b>

<p style="text-align: center;"><b>Separate bracket configuration</b></p>		<b>Sketch of repair</b>

<p style="text-align: center;">S=Snipped end</p>
<b>Notes on possible cause of damage</b> 1. This type of damage is caused due to stress concentration.		<b>Notes on repairs</b> 1. For small fractures, e. g. hairline fractures, the fracture can be veed-out, ground, examined by NDT for fractures, and rewelded. 2. For larger/significant fractures consideration is to be given to cropping and partly renewing/renewing the frame brackets. If renewing the brackets, end of frames can be sniped to soften them. 3. If felt prudent, soft toes are to be incorporated at the boundaries of the bracket to the hopper plating. 4. Attention to be given to the structure in wing tanks in way of the extended bracket arm. i.e. reinforcement provided in line with the bracket.

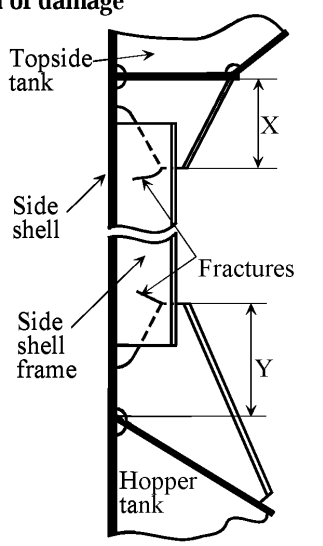
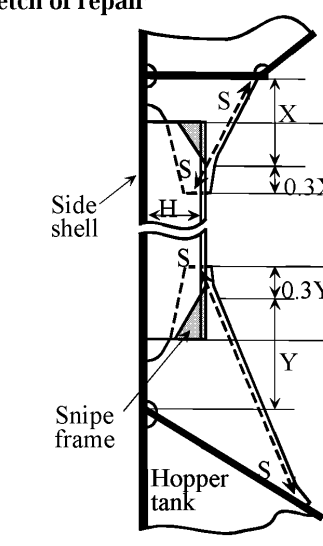
BULK CARRIERS		Guidelines for Surveys, Assessment and Repair of Hull Structure	
Part 1	Cargo hold region	Example No.	
Area 3	Cargo hold side structure	1-b	
Detail of damage		Fractures in side shell frame at bracket's toe	
<p>Sketch of damage</p>

<p>Separate bracket configuration</p>		<p>Sketch of repair</p>

<p>S=Snipped end</p>	
<p>Notes on possible cause of damage</p> <ol style="list-style-type: none"> <li>1. This type of damage is caused due to stress concentration.</li> </ol>		<p>Notes on repairs</p> <ol style="list-style-type: none"> <li>1. For small fractures, e. g. hairline fractures, the fracture can be veed-out, welded up, ground, examined by NDT for fractures, and rewelded.</li> <li>2. For larger/significant fractures consideration is to be given to cropping and partly renewing/ renewing the frame brackets. If renewing the brackets, end of frames can be snipped to soften them.</li> <li>3. If felt prudent, soft toes are to be incorporated at the boundaries of the bracket to the hopper plating.</li> <li>4. Attention to be given to the structure in wing tanks in way of the extended bracket arm. i.e. reinforcement provided in line with the bracket.</li> </ol>

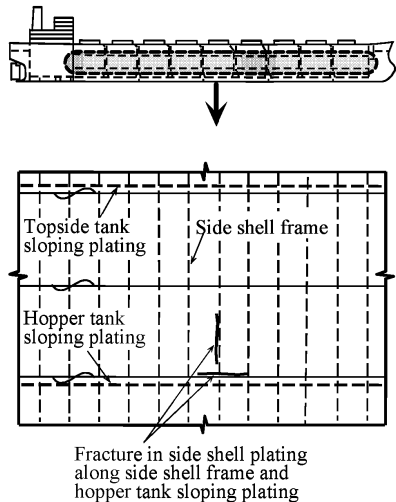
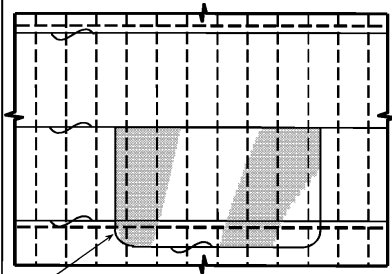
BULK CARRIERS		Guidelines for Surveys, Assessment and Repair of Hull Structure
Part 1	Cargo hold region	Example No.
Area 3	Cargo hold side structure	3
Detail of damage		Fractures in side shell frame/lower bracket and side shell plating near hopper
Sketch of damage		Sketch of repair

<p>Topside tank sloping plating</p> <p>Side shell frame</p> <p>Hopper tank sloping plating</p> <p>Fracture in side shell plating along side shell frame and hopper tank sloping plating</p>

<p>Part renewal including side shell frames and hopper sloping plating, as found necessary</p>
Notes on possible cause of damage		Notes on repairs
<p>1. Heavy corrosion (grooving). Refer to Figure 2 (c).</p>		<p>1. Sketch of repair applies when damage extends over several frames.</p> <p>2. Isolated fractures may be repaired by veeing-out and rewelding.</p> <p>3. Isolated cases of grooving may be repaired by build up of welding.</p>

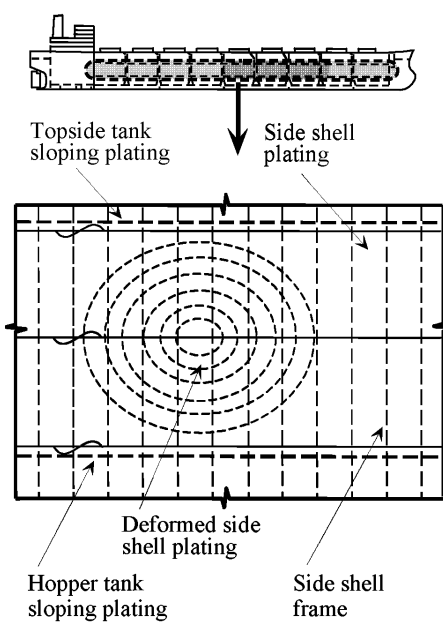
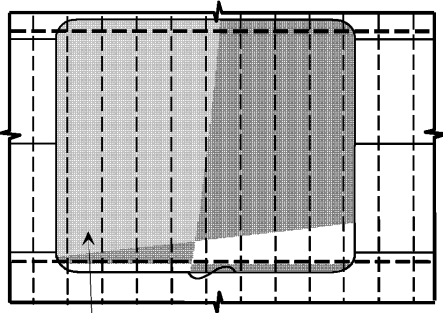
<b>BULK CARRIERS</b>		<b>Guidelines for Surveys, Assessment and Repair of Hull Structure</b>	
<b>Part 1</b>	<b>Cargo hold region</b>	<b>Example No.</b>	
<b>Area 3</b>	<b>Cargo hold side structure</b>	<b>4</b>	
<b>Detail of damage</b>		Deformation of side shell plating	
<p><b>Sketch of damage</b></p>

<p><b>Notes on possible cause of damage</b></p> <ol style="list-style-type: none"> <li>1. Insufficient stiffness of side shell frames due to buckling and/or detachment of side shell frames due to corrosion.</li> <li>2. Heavy weather.</li> </ol>		<p><b>Notes on repairs</b></p> <ol style="list-style-type: none"> <li>1. Deformed side shell plating including side shell frames should be cropped and renewed.</li> </ol>

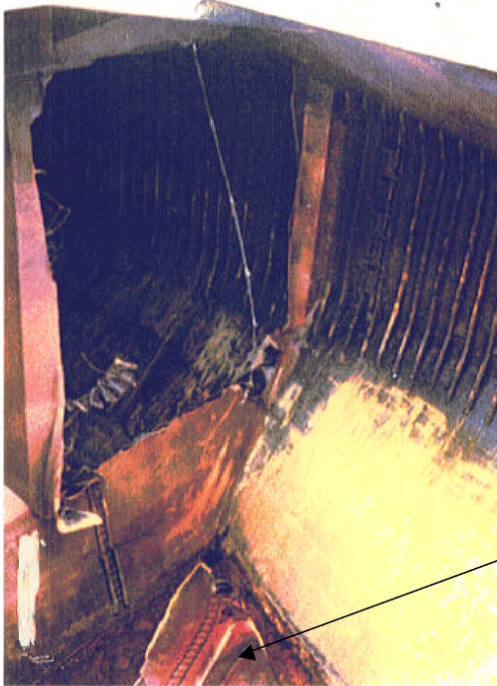
**Photograph 1**  
**Collapsed and detached transverse bulkhead**

Collapsed and detached transverse bulkhead on the tank top

- 1.4 Dry cargo holds, not designed as ballast holds, may sometimes be partially filled with water ballast in order to achieve a satisfactory air draught at the loading/discharging berths.  
The filling is restricted to a level that corresponds to the dry cargo hold scantlings, in particular the transverse bulkheads scantlings, and must only be carried out in port. In no case should these cargo holds be partially filled during voyage to save time at the berth. Such filling at sea may cause sloshing resulting in catastrophic failure such as indicated in **Photograph 1**.

- 1.5 Heavy corrosion may lead to collapse of the structure under extreme load, such as indicated in **Photograph 1** if it is not rectified properly.
- 1.6 A summary of potential problem areas is shown in **Figure 1**. It is emphasised that appropriate access arrangement as indicated in **Chapter 4 Survey planning, preparation and execution** of the guidelines, should be provided to enable a proper close-up inspection and thickness measurement as necessary.

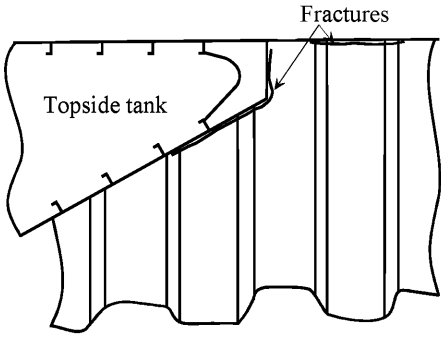
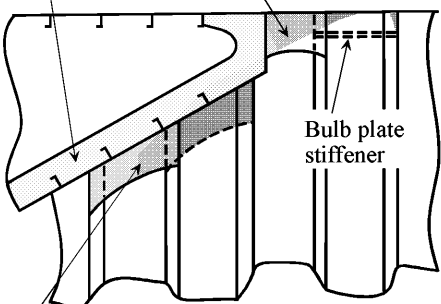
<p>Labels: Fractures, Topside tank</p>		<p>Continuous or intercostal reinforcement in line with flanges or gussets where not already fitted</p> <p>Adjacent to the topside tank either a gusset to a bulb plate stiffener may be</p>

<p>Labels: Bulb plate stiffener, Gusset (similar gusset on the opposite)</p>	
<b>Notes on possible cause of damage</b>		<b>Notes on repairs</b>	
<ol style="list-style-type: none"> <li>1. Damage due to poor design and/or defective welds.</li> </ol>		<ol style="list-style-type: none"> <li>1. Fractures may be veed-out and rewelded. If necessary corrugated plating cropped and renewed.</li> <li>2. It is recommended that reinforcement as shown above be incorporated, giving due consideration to the following criteria:                     <ol style="list-style-type: none"> <li>2.1 It is important to have the gusset plates well aligned with the transverse structure inside the tank. Gusset plates may be joggled to obtain this alignment.</li> <li>2.2 If there is no transverse web already existing inside the topside tank and in line with the flanges of corrugation or gusset plates, reinforcement as shown above to be fitted.</li> </ol> </li> </ol>

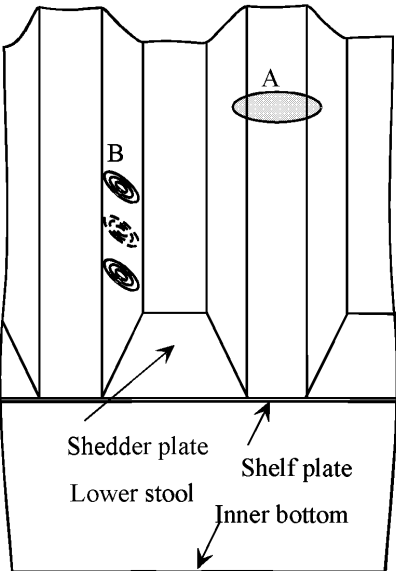
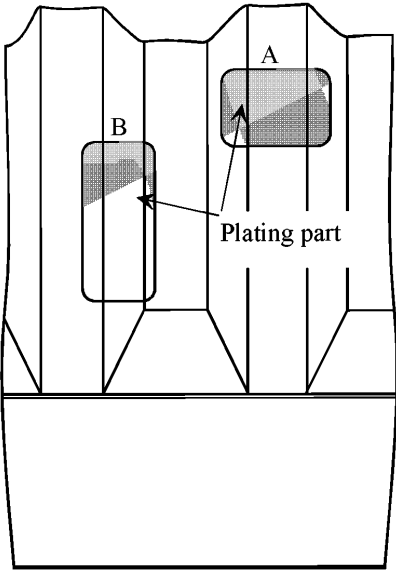
<b>Notes on possible cause of damage</b>		<b>Notes on repairs</b>	
<ol style="list-style-type: none"> <li>1. Damages by mechanical abuse during cargo handling e.g. grab damage.</li> <li>2. Damage resulting from thickness reduction by corrosion.</li> <li>3. Buckling caused by bending or shear, see locations A and B respectively above, with a minimum reduction in thickness could be caused by underdesign or overloading. If this cause is suspected, the Classification Society concerned shall be contacted before proceeding with repairs.</li> </ol>		<ol style="list-style-type: none"> <li>1. Damage by mechanical abuse If the indentation/buckling is local and of a minor nature, the plating can be faired in place. If the deformation is more pronounced and/or in association with a generalized reduction in thickness the plating is to be cropped and renewed, as shown at locations A and B above.</li> <li>2. Damage resulting from corrosion In this case thickness measurements are to be taken at mid-span and top and bottom of corrugations, and corrugations renewed or part renewed as necessary. Particular attention is to be given to the fit and alignment at corners of flanged corrugations when being partly renewed.</li> </ol>

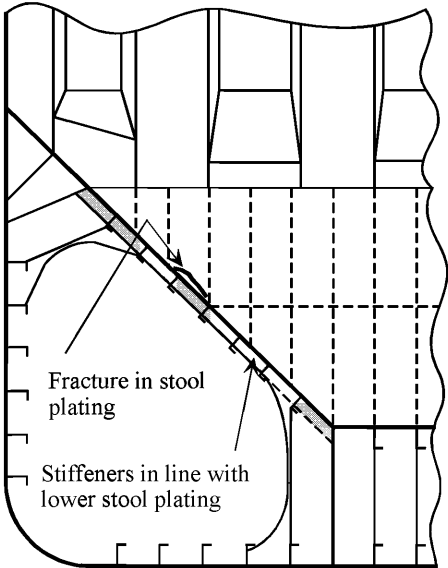
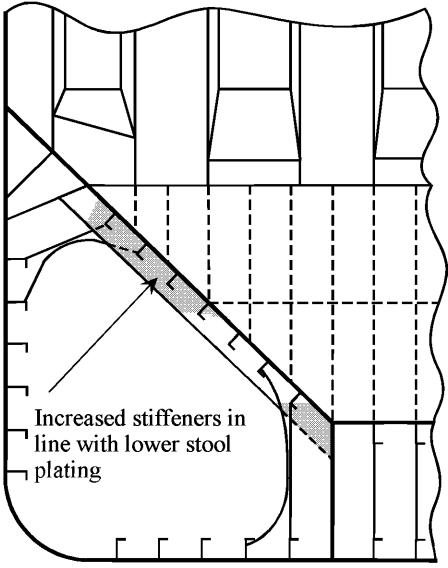
<p>Fracture in stool plating</p> <p>Stiffeners in line with lower stool plating</p>

<p>Increased stiffeners in line with lower stool plating</p>	
<b>Notes on possible cause of damage</b>		<b>Notes on repairs</b>	
<ol style="list-style-type: none"> <li>1. Insufficient strength of the connection</li> <li>2. Corrosion</li> </ol>		<ol style="list-style-type: none"> <li>1. Fractured stool plating should be partly cropped and renewed (thicker plate) if considered necessary.</li> <li>2. If the damage occurred due to insufficient strength, stiffeners in line with stool plating should be increased.</li> </ol>

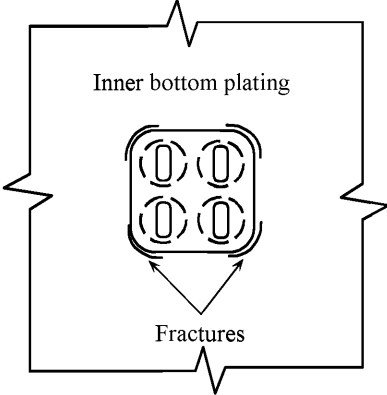
<b>BULK CARRIERS</b>	<b>Guidelines for Surveys, Assessment and Repair of Hull Structure</b>	
<b>Part 1</b>	<b>Cargo hold region</b>	<b>Example No.</b>
<b>Area 5</b>	<b>Double bottom structure including hopper</b>	<b>1</b>
<b>Detail of damage</b> Fractures in inner bottom plating around container bottom pocket		
<p><b>Sketch of damage</b></p>

<p>The sketch shows a rectangular container bottom pocket with four circular openings. The inner bottom plating is shown with jagged lines indicating fractures around the perimeter of the pocket. Labels include 'Inner bottom plating' and 'Fractures'.</p>	<p><b>Sketch of repair</b></p> <p><b>Most common repair</b></p>

<p><b>Notes on possible cause of damage</b></p> <ol style="list-style-type: none"> <li>1. Pocket is not supported correctly by floor, longitudinal and/or stiffener.</li> </ol>	<p><b>Notes on repairs</b></p> <ol style="list-style-type: none"> <li>1. Fractured plating should be cropped and part renewed.</li> <li>2. Adequate reinforcement should be considered.</li> </ol>

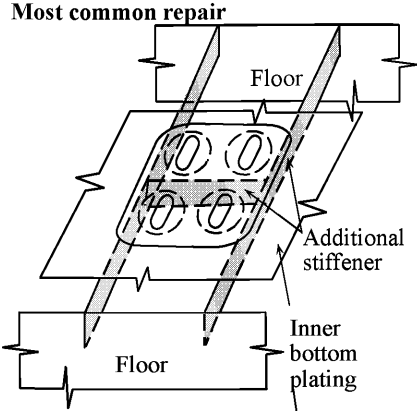
<p>This diagram shows the repair of the inner bottom plating. It features a 'Floor' above and below the damaged area. 'Additional stiffener' bars are added across the pocket, and the 'Inner bottom plating' is shown being replaced or reinforced. Labels include 'Floor', 'Additional stiffener', and 'Inner bottom plating'.</p> <p><b>Another possible repair</b></p>

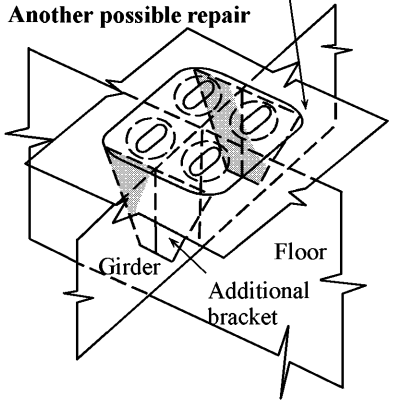
<p>This diagram shows an alternative repair method. A 'Girder' is added across the pocket, supported by an 'Additional bracket' on the side. The 'Floor' is also indicated. Labels include 'Girder', 'Additional bracket', and 'Floor'.</p>

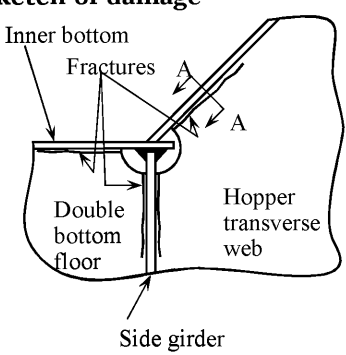
<b>BULK CARRIERS</b>		<b>Guidelines for Surveys, Assessment and Repair of Hull Structure</b>	
<b>Part 1</b>	<b>Cargo hold region</b>	<b>Example No.</b>	
<b>Area 5</b>	<b>Double bottom tank structure including hopper</b>	<b>4</b>	
<b>Detail of damage</b>		Fractures at weld connections of floors in way of hopper/inner bottom interface (welded knuckle)	
<p><b>Sketch of damage</b></p>

<p><b>View A - A</b> Transverse fractures in hopper web plating into possibly extending into the hopper sloping plating</p>
