**РОССИЙСКИЙ МОРСКОЙ РЕГИСТР СУДОХОДСТВА**  
**RUSSIAN MARITIME REGISTER OF SHIPPING**

**SUPPLEMENT TO RULES AND GUIDELINES  
OF RUSSIAN MARITIME REGISTER OF SHIPPING**

**IACS PROCEDURAL REQUIREMENTS,  
UNIFIED INTERPRETATIONS  
AND RECOMMENDATIONS**

НД № 2-020101-091-R-E

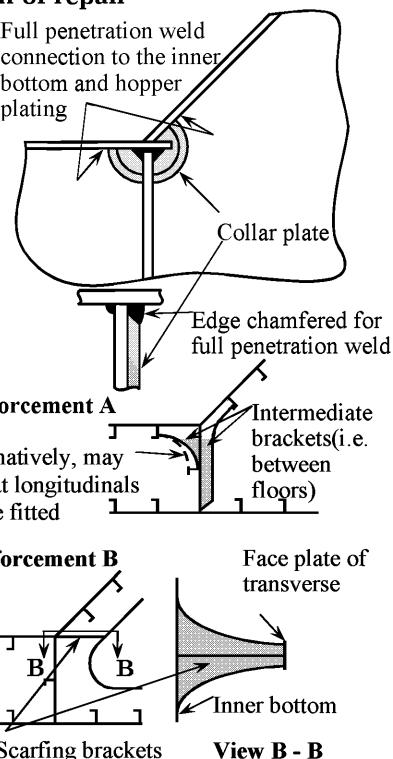
<p><b>Reinforcement A</b> Alternatively, may stop at longitudinals where fitted</p> <p><b>Reinforcement B</b></p> <p><b>View B - B</b></p>	
<b>Notes on possible cause of damage</b>		<b>Notes on repairs</b>	
<ol style="list-style-type: none"> <li>The damage is partly due to stress concentration at the edges of the weld created by the presence of the deflections in the inner bottom/hopper plating.</li> </ol>		<ol style="list-style-type: none"> <li>The fracture in the weld and/or plating is veed-out/cropped and renewed as appropriate.</li> <li>The cut-outs are eliminated by introducing suitable collar plates with emphasis on edge preparation and sequence of welding as shown above.</li> <li>Further reinforcements may be incorporated as shown above and depending on the judged cause of damage.</li> </ol>

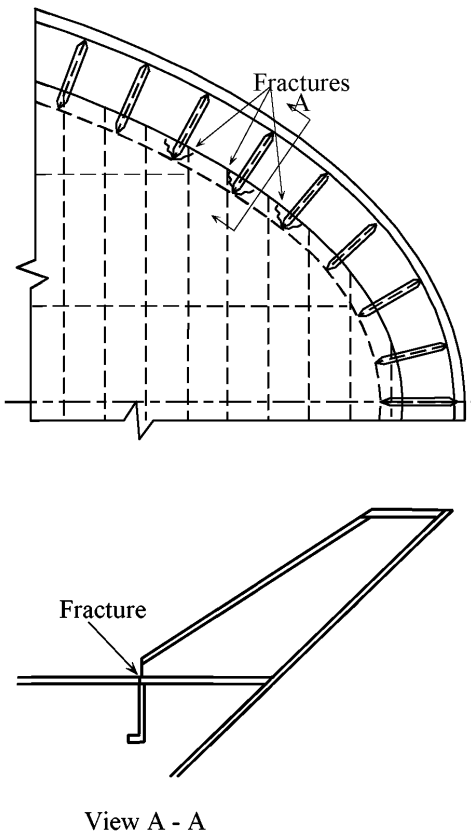
<b>BULK CARRIERS</b>		<b>Guidelines for Surveys, Assessment and Repair of Hull Structure</b>	
<b>Part 2</b>	<b>Fore and aft end regions</b>	<b>Example No.</b>	
<b>Area 1</b>	<b>Fore end structure</b>	<b>2</b>	
<b>Detail of damage</b>		Fractures in forecastle deck plating at bulwark	
<p><b>Sketch of damage</b></p>

<p><b>Notes on possible cause of damage</b></p> <ol style="list-style-type: none"> <li>1. Bow flare effect in heavy weather.</li> <li>2. Stress concentration due to poor design.</li> </ol>		<p><b>Notes on repairs</b></p> <ol style="list-style-type: none"> <li>1. Fractured deck plating should be cropped and renewed.</li> <li>2. Bracket in line with the bulwark stay to be fitted to reduce stress concentration.</li> </ol>

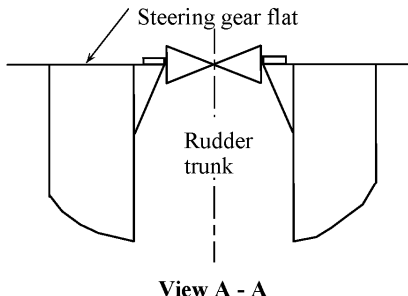
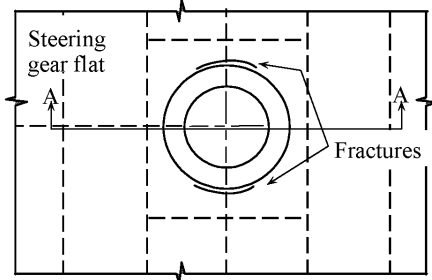
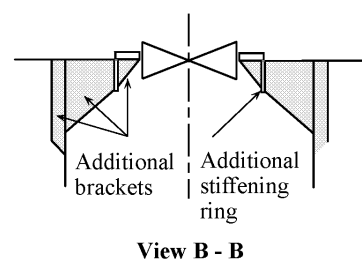
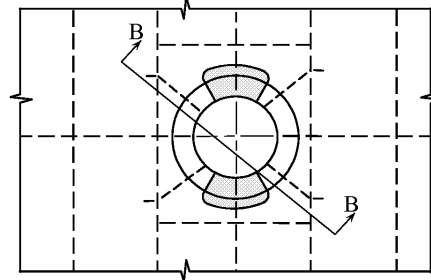
<b>BULK CARRIERS</b>		<b>Guidelines for Surveys, Assessment and Repair of Hull Structure</b>	
<b>Part 2</b>	<b>Fore and aft end regions</b>		<b>Example No.</b>
<b>Area 2</b>	<b>Aft end structure</b>		<b>3-a</b>
<b>Detail of damage</b>	Fractures in flat where rudder carrier is installed in steering gear room		
<b>Sketch of damage</b>		<b>Sketch of repair</b>

<p style="text-align: center;"><b>View A - A</b></p>

<p style="text-align: center;"><b>View B - B</b></p>

<b>Notes on possible cause of damage</b>		<b>Notes on repairs</b>	
<ol style="list-style-type: none"> <li>Inadequate design.</li> </ol>		<ol style="list-style-type: none"> <li>Fractured plating should be cropped and renewed.</li> <li>Additional brackets and stiffening ring should be fitted for reinforcement.</li> </ol>

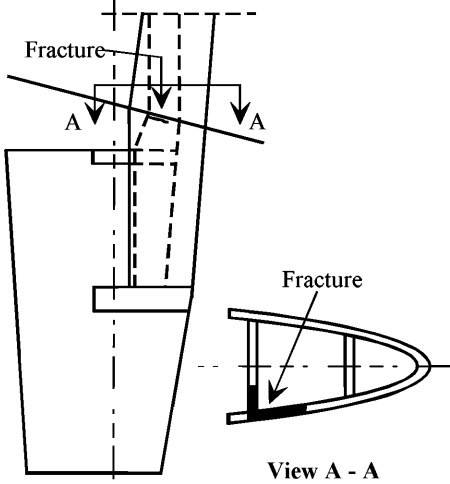
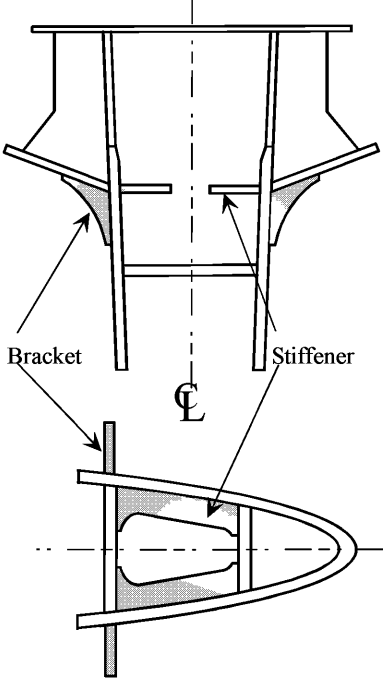
<b>BULK CARRIERS</b>	<b>Guidelines for Surveys, Assessment and Repair of Hull Structure</b>	
<b>Part 2</b>	<b>Fore and aft end regions</b>	<b>Example No.</b>
<b>Area 3</b>	<b>Stern frame, rudder arrangement and propeller shaft support</b>	<b>1</b>
<b>Detail of damage</b>	Fractures in rudder horn along bottom shell plating	
<b>Sketch of damage</b>	<b>Sketch of repair</b>

<p>Fracture</p> <p>View A - A</p>

<p>Bracket</p> <p>Stiffener</p>	
<b>Notes on possible cause of damage</b>	<b>Notes on repairs</b>	
1. Insufficient strength due to poor design.	<ol style="list-style-type: none"> <li>1. Fractured plating to be veed-out and rewelded.</li> <li>2. Fractured plating to be cropped and renewed if considered necessary.</li> <li>3. Reinforcement should be considered if considered necessary.</li> </ol>

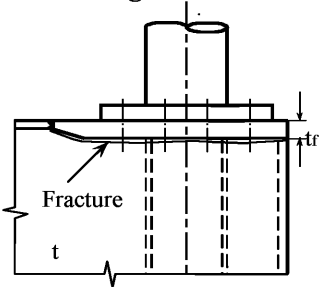
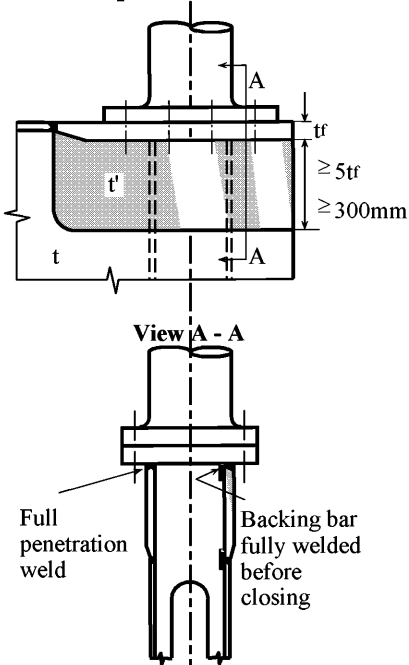
<b>BULK CARRIERS</b>		<b>Guidelines for Surveys, Assessment and Repair of Hull Structure</b>	
<b>Part 2</b>	<b>Fore and aft end regions</b>	<b>Example No. 3</b>	
<b>Area 3</b>	<b>Stern frame, rudder arrangement and propeller shaft support</b>		
<b>Detail of damage</b>		Fractures in connection of palm plate to rudder blade	
<b>Sketch of damage</b>		<b>Sketch of repair</b>

<p>View A - A</p> <p>Full penetration weld</p> <p>Backing bar fully welded before closing</p> <p><math>t</math> = plate thickness, mm  <math>tf</math> = actual flange thickness, mm  <math>t = \frac{tf}{3} + 5</math>, mm, where <math>tf \leq 50</math>mm  <math>t = 3\sqrt{tf}</math>, mm, where <math>tf \geq 50</math>mm</p>	
<b>Notes on possible cause of damage</b>		<b>Notes on repairs</b>	
<p>1. Inadequate connection between palm plate and rudder blade plating (insufficient plating thickness and/or insufficient fillet weld).</p>		<p>1. Modification of detail design of the connection by increasing the plate thickness and full penetration welding.</p>

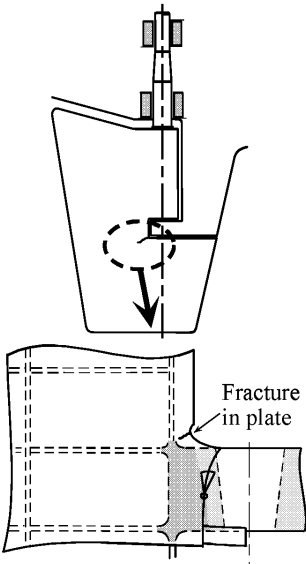
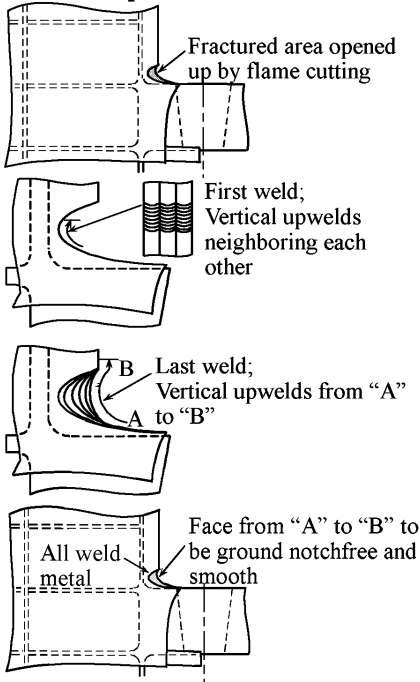
BULK CARRIERS		Guidelines for Surveys, Assessment and Repair of Hull Structure	
Part 2	Fore and aft end regions	Example No.	
Area 3	Stern frame, rudder arrangement and propeller shaft support	4	
Detail of damage		Fractures in rudder plating of semi-spade rudder (short fracture with end located forward of the vertical web)	
<p><b>Sketch of damage</b></p>

<p><b>Notes on possible cause of damage</b></p> <ol style="list-style-type: none"> <li>1. Stress concentration due to inadequate local design and/or fabrication notches in way of the butt weld between cast piece and plating.</li> </ol>		<p><b>Notes on repairs</b></p> <ol style="list-style-type: none"> <li>1. Grooving-out and welding of the fracture is not always adequate (metallurgical notch in way of a high stressed area).</li> <li>2. In the proposed repair procedure the metallurgical notches are shifted into a zone exposed to lower stresses.</li> <li>3. After welding a modification of the radius according to the proposal in <b>Example 5</b> is to be carried out.</li> <li>4. In case of very small crack it can be ground off by increasing the radius.</li> </ol>

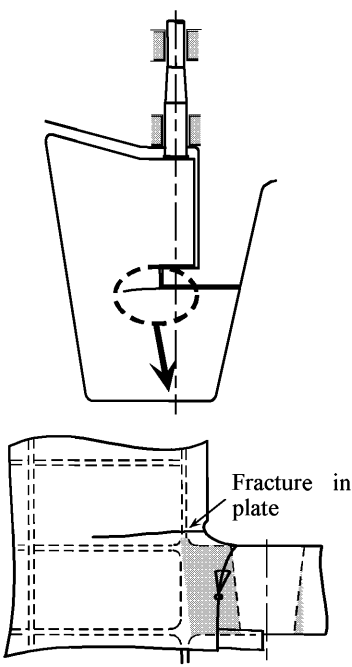
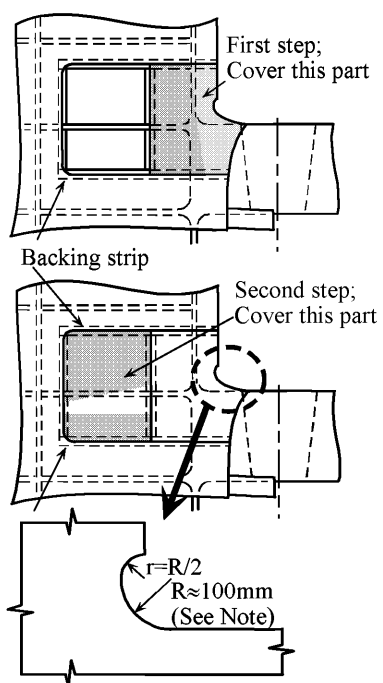
<b>GENERAL CARGO SHIPS</b>		<b>Guidelines for Surveys, Assessment and Repair of Hull Structure</b>
<b>Part 2</b>	<b>Fore and aft end regions</b>	<b>Example No.</b>
<b>Area 3</b>	<b>Stern frame, rudder arrangement and propeller shaft support</b>	<b>5</b>
<b>Detail of damage</b>	Fractures in rudder plating of semi-spade rudder extending beyond the vertical web	
<b>Sketch of damage</b>

<p>Note: R should be considered according to local detail</p>
<b>Notes on possible cause of damage</b> 1. Stress concentration due to inadequate local design and/or fabrication notches in way of the butt weld between cast piece and plating.		<b>Notes on repairs</b> 1. Fractured plating is to be cut-out. 2. Internal structures are to be checked. 3. Cut-out is to be closed by an insert plating according to the sketch (welding only from one side is demonstrated). 4. Modification of the radius. 5. In case of a new cast piece, connection with the plating is to be shifted outside the high stress area.

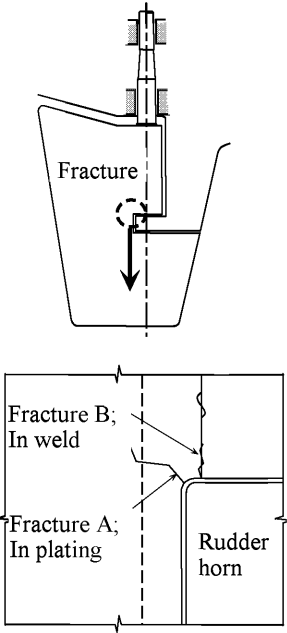
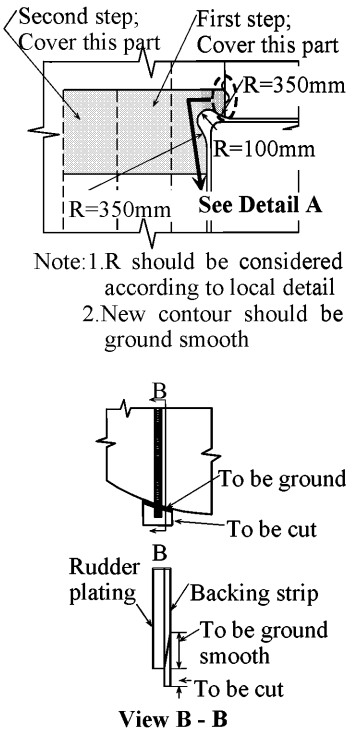
<b>BULK CARRIERS</b>		<b>Guidelines for Surveys, Assessment and Repair of Hull Structure</b>	
<b>Part 2</b>	<b>Fore and aft end regions</b>	<b>Example No.</b>	
<b>Area 3</b>	<b>Stern frame, rudder arrangement and propeller shaft support</b>	<b>6</b>	
<b>Detail of damage</b>	Fractures in rudder plating of semi-spade rudder in way of pintle cutout		
<p><b>Sketch of damage</b></p>

<p>The sketch shows a semi-spade rudder with a fracture in the plating. A detail view below shows 'Fracture B; In weld' and 'Fracture A; In plating' near the 'Rudder horn'.</p>		<p><b>Sketch of repair</b></p>

<p>The repair sketch shows a cross-section of the rudder with a repair area. It indicates 'Second step; Cover this part' and 'First step; Cover this part'. Radii are specified as <math>R=350\text{mm}</math> and <math>R=100\text{mm}</math>. A detail view shows 'Rudder plating', 'Backing strip', and areas 'To be ground' and 'To be cut'. The view is labeled 'View B - B'.</p> <p>Note: 1.R should be considered according to local detail 2.New contour should be ground smooth</p>

<p><b>Notes on possible cause of damage</b></p> <ol style="list-style-type: none"> <li>1. Inadequate design for stress concentration in way of pintle bearing (<b>Fracture A</b>).</li> <li>2. Imperfection in welding seam (<b>Fracture B</b>).</li> </ol>		<p><b>Notes on repairs</b></p> <ol style="list-style-type: none"> <li>1. Fractured part to be cropped off.</li> <li>2. Repair by two insert plates of modified, stress releasing contour. For the vertical seam no backing strip is used 100mm off contour, welding from both sides, to be ground after welding.</li> <li>3. Variant (See <b>Detail A</b>): Repair as mentioned under 2 with the use of backing strip for the complete vertical seam. After welding backing strip partly removed by grinding.</li> </ol>

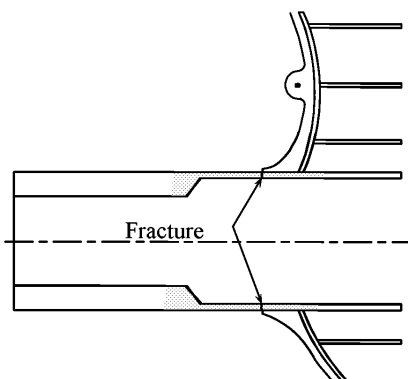
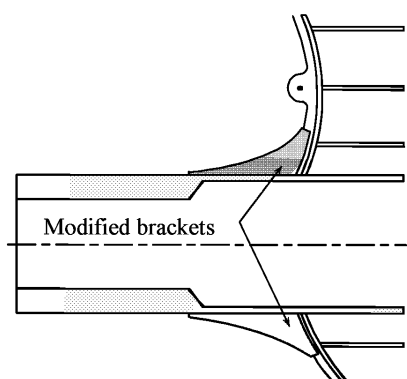
<b>BULK CARRIERS</b>		<b>Guidelines for Surveys, Assessment and Repair of Hull Structure</b>	
<b>Part 2</b>	<b>Fore and aft end regions</b>	<b>Example No.</b>	
<b>Area 3</b>	<b>Stern frame, rudder arrangement and propeller shaft support</b>	<b>8</b>	
<b>Detail of damage</b>		Fractures in stern tube at the connection to stern frame	
<b>Sketch of damage</b>		<b>Sketch of repair</b>

<b>Notes on possible cause of damage</b>		<b>Notes on repairs</b>	
<ol style="list-style-type: none"> <li>1. Fatigue fracture due to vibration.</li> </ol>		<ol style="list-style-type: none"> <li>1. Fractured tube is to be veed-out and welded from both sides.</li> <li>2. Brackets are to be replaced by modified brackets with soft transition.</li> </ol>

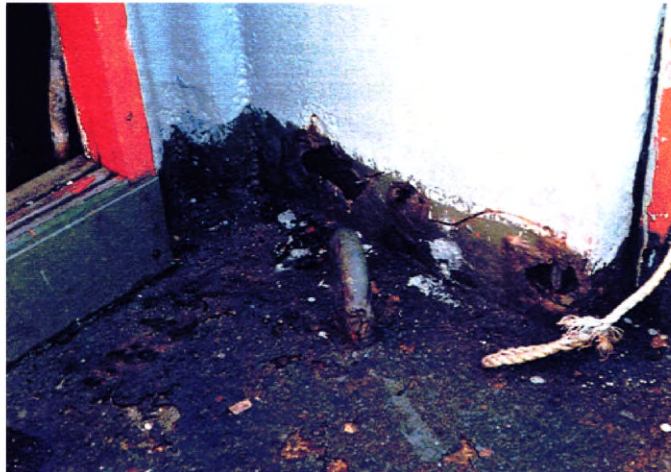
**Photograph 1** Corroded accommodation house side structure

Severe corrosion may be found in exposed deck plating and deck house side structure adjacent to the deck plating where water is liable to accumulate (See **Photograph 1**). Corrosion may also be found in accommodation bulkheads around cutout for fittings, such as doors, side scuttles, ventilators, etc., where proper maintenance of the area is relatively difficult. Deterioration of the bulkheads including fittings may impair the integrity of weathertightness.

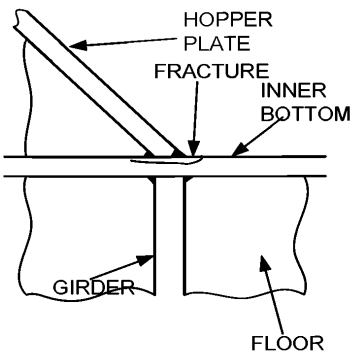
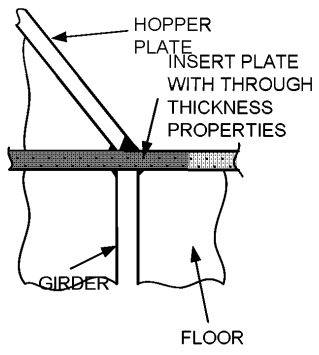
OIL Tankers		Guidelines for Surveys, Assessment and Repair of Hull Structure	
Group 1	Cargo area	Example No.	
	Hopper and double bottom ballast tank	2	
<b>Detail of damage</b>		Fracture at connection of bilge hopper plate and inner bottom	
<p><b>Sketch of damage</b></p>

<p><b>Notes:</b> Plate midlines intersect</p>	
<p><b>Factors which may have caused damage</b></p> <p>1. Stress concentration at the knuckle.</p>		<p><b>Notes on repairs</b></p> <p>See Sketch.</p>

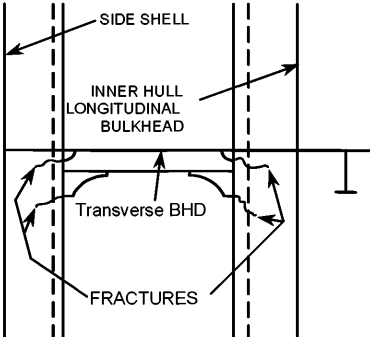
OIL Tankers		Guidelines for Surveys, Assessment and Repair of Hull Structure	
Group 2	Cargo area	Example No.	
	<b>Wing ballast tank</b>	<b>1</b>	
Detail of damage	Crack in way of connection of longitudinals to transverse bulkhead		
<p><b>Sketch of damage</b></p>

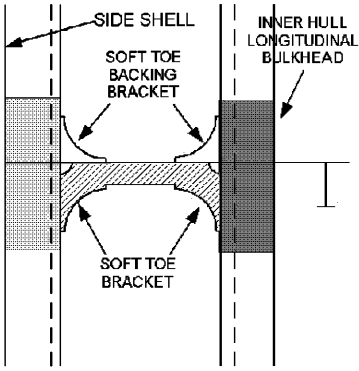
<p><b>Sketch of repair</b></p>

<p><b>Factors which may have caused damage</b></p> <ol style="list-style-type: none"> <li>1. Asymmetrical connection of bracket without backing bracket.</li> <li>2. Relative deflection of adjoining transverse web against transverse bulkhead.</li> <li>3. Additional biaxial bending stresses due to asymmetry of the angle bar longitudinal instead of symmetric T section.</li> <li>4. Dynamic load in the vicinity of the water line.</li> <li>5. Large upstand at bracket toe.</li> </ol>	<p><b>Notes on repairs</b></p> <p>See Sketch.</p>

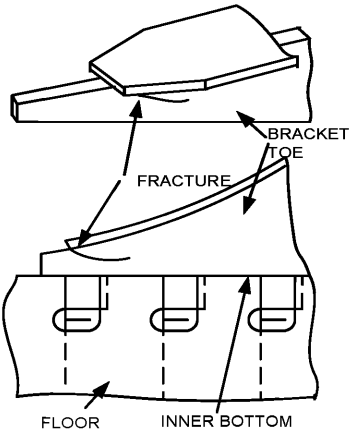
OIL Tankers		Guidelines for Surveys, Assessment and Repair of Hull Structure
<b>Group 4</b>	<b>Cargo area</b>	<b>Example No.</b>
	<b>Web Frame in cargo tank</b>	<b>1</b>
<b>Detail of damage</b>		Fracture at toe of web frame bracket connection to inner bottom.
<p><b>Sketch of damage</b></p>

<p>The sketch shows a perspective view of a bracket with a fracture at its toe. Below it is a plan view of the inner bottom structure with three brackets. Labels include 'FLOOR', 'INNER BOTTOM', and 'BRACKET TOE'. An arrow points to the 'FRACTURE' location on the bracket's toe.</p>		<p><b>Sketch of repair</b>                      Modify Face Taper                      1. Breadth taper 20 degrees.                      2. Breadth at toe as small as practical.                      3. Thickness taper 1 in 3 to 10mm.</p>

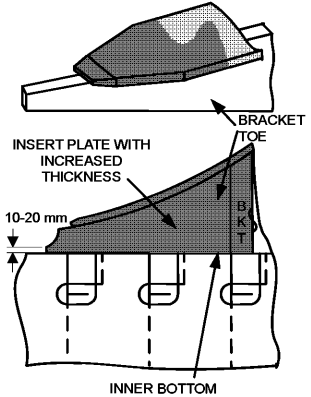
<p>The repair sketch shows a bracket with a tapered toe. An 'INSERT PLATE WITH INCREASED THICKNESS' is shown being applied to the toe. A dimension of '10-20 mm' is indicated for the thickness of the insert. Labels include 'BRACKET TOE', 'INSERT PLATE WITH INCREASED THICKNESS', '10-20 mm', and 'INNER BOTTOM'.</p>

<p><b>Factors which may have caused damage</b></p> <ol style="list-style-type: none"> <li>1. Inadequate tapering the toe end.</li> <li>2. Insufficient tapering of flange.</li> <li>3. Lateral flexing of the bracket.</li> </ol>		<p><b>Notes on repairs</b>                      See Sketch.</p>

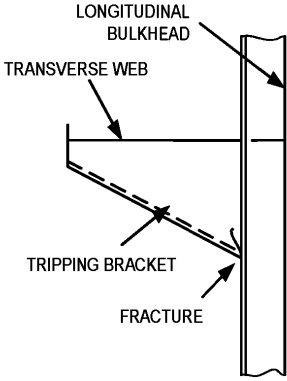
OIL Tankers		Guidelines for Surveys, Assessment and Repair of Hull Structure	
Group 4	Cargo area	Example No.	
	Web Frame in cargo tank	5	
<b>Detail of damage</b>	Fracture in way of connection of transverse web tripping brackets to longitudinal		
<p><b>Sketch of damage</b></p>

<p>A technical sketch showing a longitudinal bulkhead on the right and a transverse web on the left. A tripping bracket connects the transverse web to the bulkhead. A dashed line indicates a fracture at the heel of the bracket where it meets the bulkhead.</p>		<p><b>Sketch of repair</b></p>

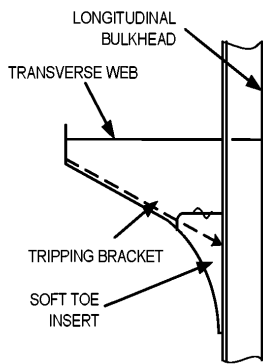
<p>A technical sketch similar to the damage sketch, but with a curved 'soft toe insert' added to the heel of the tripping bracket to prevent further fracture.</p>	
<p><b>Factors which may have caused damage</b></p> <ol style="list-style-type: none"> <li>1. Hard spot at the toe of bracket.</li> <li>2. Vibration.</li> </ol>		<p><b>Notes on repairs</b></p> <p>See Sketch.</p> <ol style="list-style-type: none"> <li>1. Soft bracket may be added on upper side of web, to avoid fracture at the heel.</li> </ol>

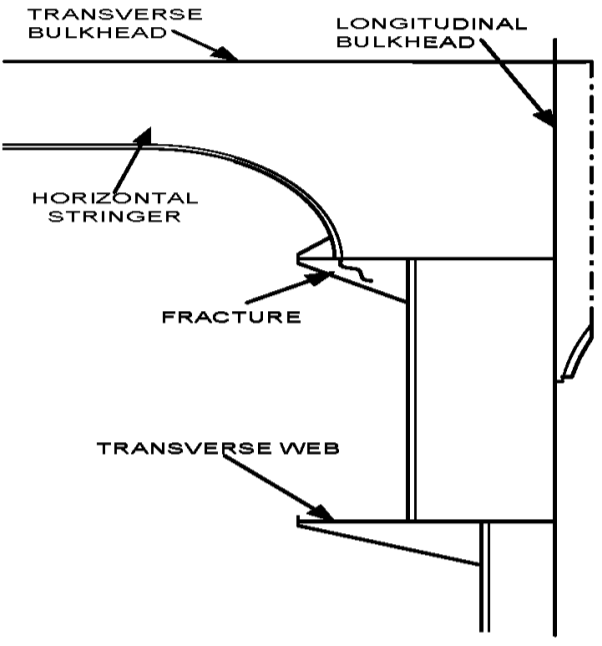
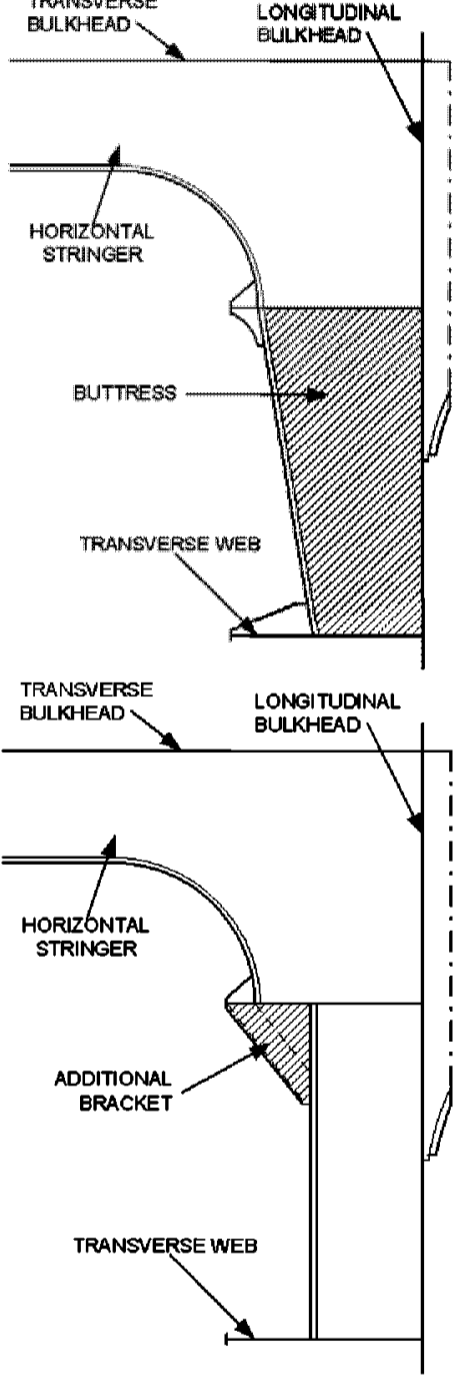
<b>OIL Tankers</b>		<b>Guidelines for Surveys, Assessment and Repair of Hull Structure</b>	
<b>Group 5</b>	<b>Cargo area</b>	<b>Example No.</b>	
	<b>Transverse Bulkhead in cargo tank</b>	<b>1</b>	
<b>Detail of damage</b>	Fracture in way of connection of transverse bulkhead stringer to transverse web frames and longitudinal bulkhead stringer		
<b>Sketch of damage</b>	<b>Sketch of repair</b>

<b>Factors which may have caused damage</b>	<b>Notes on repairs</b>		
<ol style="list-style-type: none"> <li>1. Stress concentration due to discontinuous structure.</li> <li>2. High shear stress in the horizontal stringer.</li> </ol>	<p>See Sketch.</p>

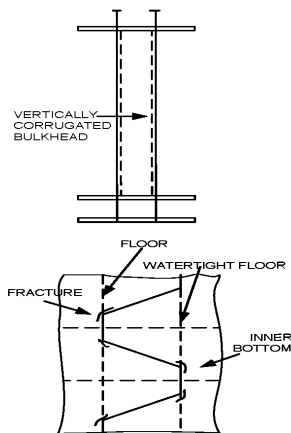
OIL Tankers		Guidelines for Surveys, Assessment and Repair of Hull Structure	
Group 5	Cargo area	Example No.	
Transverse Bulkhead in cargo tank		6	
Detail of damage	Vertically corrugated bulkhead without stool, connection to deck and inner bottom		
Sketch of damage	Sketch of repair

<p>The sketch shows a vertical section of a bulkhead. The top part is labeled 'VERTICALLY CORRUGATED BULKHEAD'. Below it, a horizontal line is labeled 'FLOOR'. A dashed line represents the 'WATERTIGHT FLOOR'. A fracture is indicated by a jagged line on the bulkhead. The bottom part is labeled 'INNER BOTTOM'.</p>

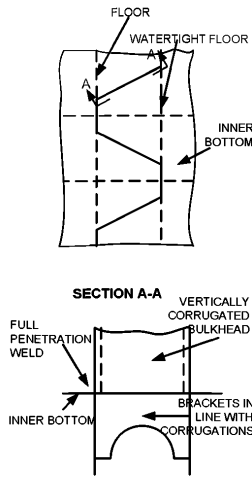
<p>The sketch shows a section A-A of the bulkhead. The top part is labeled 'FLOOR'. Below it, a horizontal line is labeled 'WATERTIGHT FLOOR'. A dashed line represents the 'INNER BOTTOM'. A 'FULL PENETRATION WELD' is shown connecting the bulkhead to the floor. 'BRACKETS IN LINE WITH CORRUGATIONS' are shown on the inner bottom. The bulkhead is labeled 'VERTICALLY CORRUGATED BULKHEAD'.</p>

<p><b>Factors which may have caused damage</b></p> <ol style="list-style-type: none"> <li>1. Stress concentration due to unsupported corrugation web.</li> <li>2. High through thickness stress, lamellar tearing.</li> <li>3. Weld details and dimensions.</li> <li>4. Misalignment between face of corrugation and floor underneath.</li> <li>5. Cut-outs and scallops or air holes increasing the stress in the floor.</li> <li>6. Insufficient through thickness properties of inner bottom plate.</li> </ol>	<p><b>Notes on repairs</b></p> <p>See Sketch.</p>

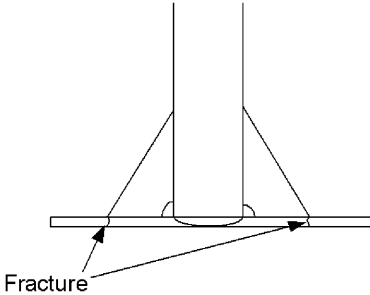
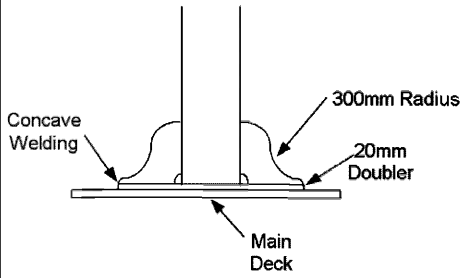
OIL Tankers		Guidelines for Surveys, Assessment and Repair of Hull Structure	
Group 6	Deck Structure		Example No.
			<b>5</b>
<b>Detail of damage</b>		Fractured deck plating in way of deck pipe support stanchions (midships)	
<b>Sketch of damage</b>		<b>Sketch of repair</b>

<b>Factors which may have caused damage</b>		<b>Notes on repairs</b>	
<p>1. Stanchions experience more severe relative displacements from hull girder bending.</p>		<p>See Sketch.</p>

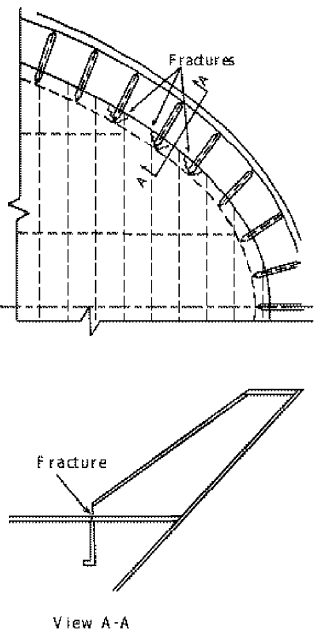
<b>OIL Tankers</b>		<b>Guidelines for Surveys, Assessment and Repair of Hull Structure</b>
<b>Group 7</b>	Fore region	<b>Example No.</b>
<b>Area 1</b>	Forecastle	<b>1</b>
<b>Detail of damage</b>		Fracture in forecastle deck plating at bulwark
<p><b>Sketch of damage</b></p>

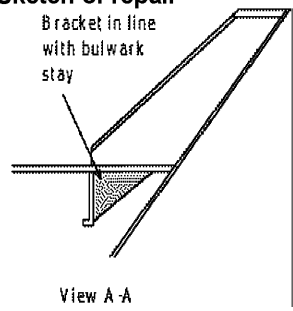
<p><b>Sketch of repair</b></p>

<p><b>Factors which may have caused damage</b></p> <ol style="list-style-type: none"> <li>1. Bow Flare effect in heavy weather.</li> <li>2. Stress concentration due to poor design.</li> </ol>		<p><b>Notes on repairs</b></p> <ol style="list-style-type: none"> <li>1. Fractured deck plating should be cropped and renewed.</li> <li>2. Bracket in line with the bulwark stay to be fitted to reduce stress concentration.</li> </ol>

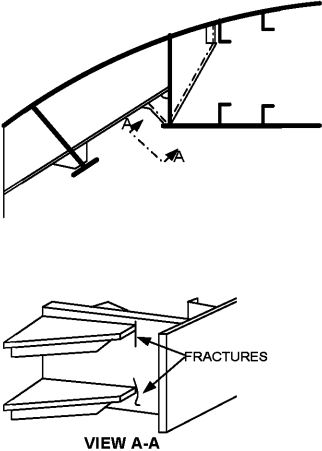
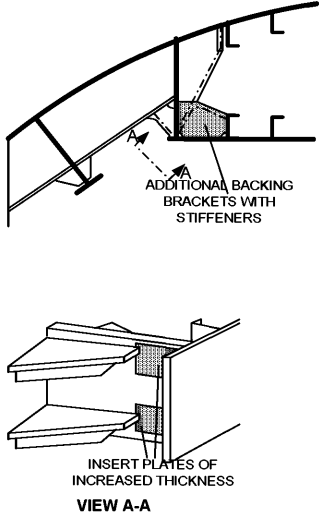
OIL Tankers		Guidelines for Surveys, Assessment and Repair of Hull Structure
Group 7	Fore region	Example No.
Area 1	Forepeak ballast tank	4
Detail of damage	Fractured vertical web at the longitudinal stiffener ending in way of the parabolic bow structure.	
Sketch of damage	Sketch of repair

<b>Factors which may have caused damage</b> <ol style="list-style-type: none"> <li>1. Stress concentrations at bracket ending due to inadequate support at bracket toes in way of connection to web frame members.</li> <li>2. Localised thinning in way of coating failure at bracket endings due to flexing of the structure.</li> <li>3. Dynamic seaway loadings at bow causing flexing at bracket endings.</li> </ol>	<b>Notes on repairs</b> See Sketch.

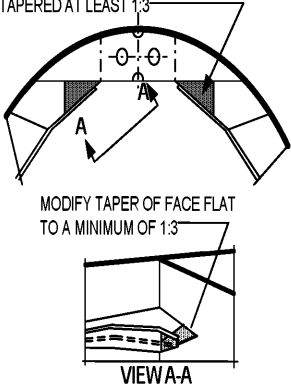
<p><b>Sketch of repair</b></p> <p>LARGER INSERTS OF INCREASED THICKNESS WITH FACE PLATES TAPERED AT LEAST 1:3</p>

<p>MODIFY TAPER OF FACE FLAT TO A MINIMUM OF 1:3</p> <p>VIEW A-A</p>	
<p><b>Factors which may have caused damage</b></p> <ol style="list-style-type: none"> <li>1. Inadequate brackets forming the longitudinal endings at bow structure.</li> <li>2. Localised thinning in way of coating failure at longitudinal endings due to flexing of the structure.</li> <li>3. Dynamic seaway loadings at bow causing flexing at longitudinal endings.</li> </ol>		<p><b>Notes on repairs</b></p> <p>See Sketch.</p>

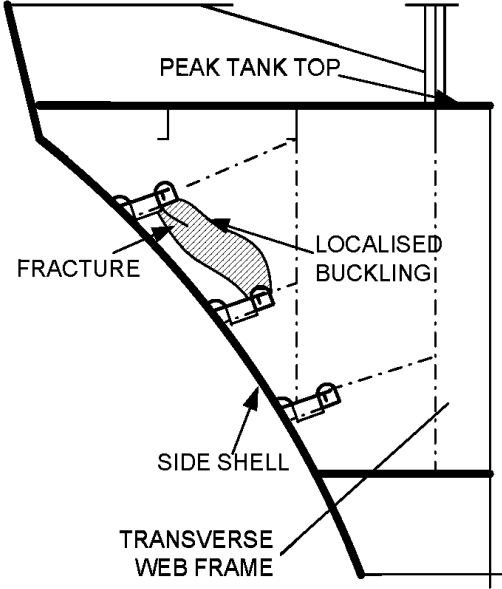
OIL Tankers		Guidelines for Surveys, Assessment and Repair of Hull Structure	
Group 7	Fore region	Example No.	
Area 1	Forepeak ballast tank	7	
Detail of damage		Fracture and buckle of bow transverse web frame in way of longitudinal cut-outs.	
Sketch of damage		Sketch of repair

<p>The sketch shows a cross-section of the forepeak ballast tank. Labels include: PEAK TANK TOP, FRACTURE (pointing to a break in the transverse web frame), LOCALISED BUCKLING (pointing to a distorted area of the web frame), SIDE SHELL, and TRANSVERSE WEB FRAME.</p>

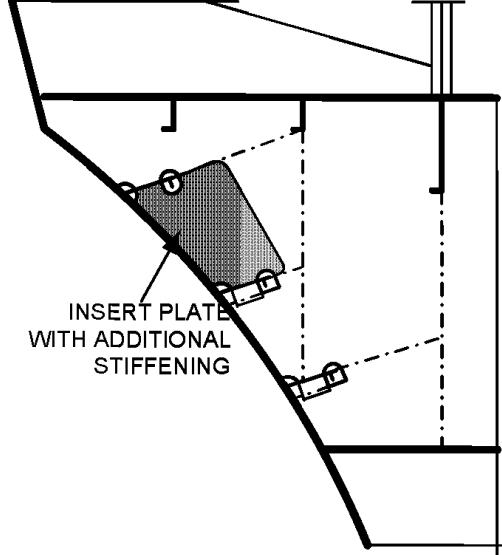
<p>The sketch shows the same cross-section as the damage sketch, but with a shaded rectangular area labeled 'INSERT PLATE WITH ADDITIONAL STIFFENING' applied to the damaged portion of the transverse web frame.</p>	
<p><b>Factors which may have caused damage</b></p> <ol style="list-style-type: none"> <li>1. Localised thinning in way of coating failure at cut-outs and sharp edges due to working of the structure.</li> <li>2. Dynamic seaway loadings in way of bow flare.</li> </ol>		<p><b>Notes on repairs</b></p> <p>See Sketch.</p>

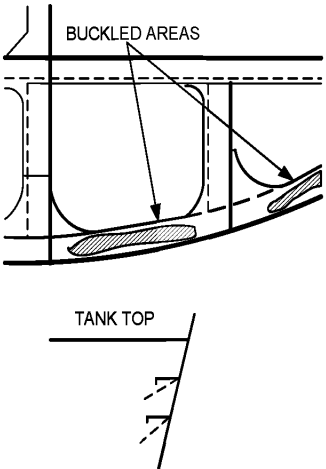
<b>OIL Tankers</b>		<b>Guidelines for Surveys, Assessment and Repair of Hull Structure</b>	
<b>Group 7</b>	<b>Fore region</b>	<b>Example No.</b>	
<b>Area 1</b>	<b>Fore peak ballast tank</b>	<b>8</b>	
<b>Detail of damage</b>		<b>Buckled and tripped breathhooks</b>	
<b>Sketch of damage</b>		<b>Sketch of repair</b>

<p>The sketch shows a cross-section of a fore peak ballast tank. The top structure is labeled 'BUCKLED AREAS' with arrows pointing to distorted regions. Below the tank, a section labeled 'TANK TOP' shows a sloped surface with several small rectangular protrusions.</p>

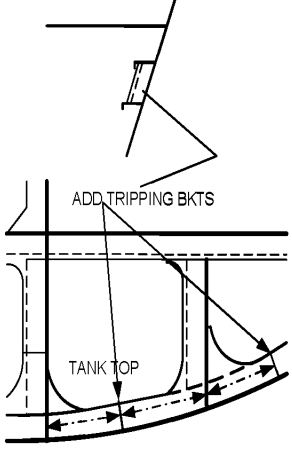
<p>The repair sketch shows the same tank structure. A detail at the top shows a bent being added to a sloped surface. The main sketch is labeled 'ADD. TRIPPING BKTS' with arrows pointing to new rectangular protrusions on the tank top. The 'TANK TOP' label is also present.</p>	
<b>Factors which may have caused damage</b>		<b>Notes on repairs</b>

<ol style="list-style-type: none"> <li>1. Bow impact load.</li> <li>2. Low buckling resistance.</li> </ol>		<p>See Sketch.</p>

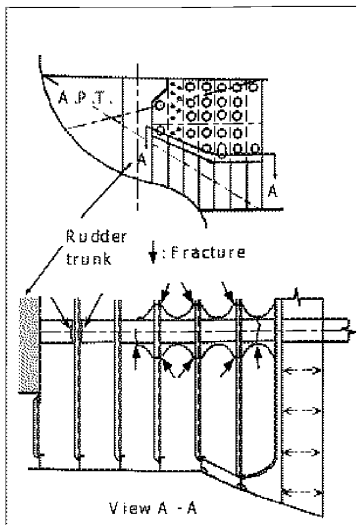
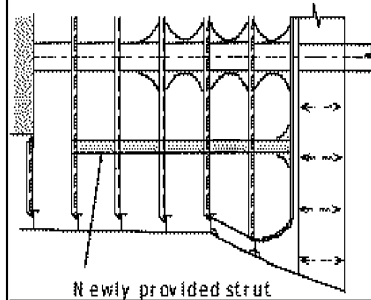
<b>Factors which may have caused damage</b>		<b>Notes on repairs</b>	
<ol style="list-style-type: none"> <li>1. Vibration.</li> </ol>		<ol style="list-style-type: none"> <li>1. The fractured plating should be cropped and renewed.</li> <li>2. Natural frequency of the panel should be changed, e.g. reinforcement by additional strut.</li> </ol>

**3.3.2** In order to prevent recurrence of damages suspected to be caused by main engine or propeller excited vibration, the cause of the vibration should be ascertained and additional reinforcements provided as found necessary (See Examples 9 and 10).

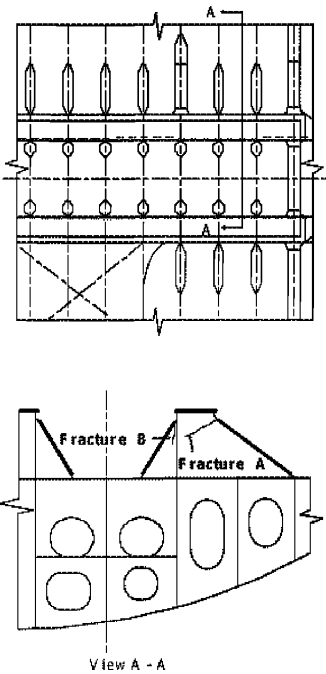
OIL Tankers		Guidelines for Surveys, Assessment and Repair of Hull Structure	
Group 8	Machinery and accommodation spaces	Example No.	
Area 1	Engine room	1	
Detail of damage		Fractures in brackets at main engine foundation	
<p><b>Sketch of damage</b></p>

<p><b>Factors which may have caused damage</b></p> <ol style="list-style-type: none"> <li>1. Vibration of main engine.</li> <li>2. Insufficient strength of brackets at main engine foundation.</li> <li>3. Insufficient pre-load of the bolts.</li> </ol>		<p><b>Notes on repairs</b></p> <ol style="list-style-type: none"> <li>1. Fractures may be veed-out and rewelded.</li> <li>2. New modified brackets at main engine foundation.</li> <li>3. Or insert pieces and additional flanges to increase section modulus of the brackets.</li> </ol>

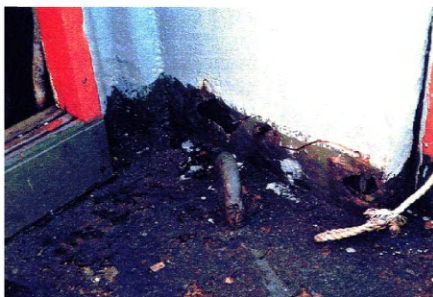
**Photograph 1 Corroded accommodation house side structure**

Severe corrosion may be found in exposed deck plating and deck house side structure adjacent to the deck plating where water is liable to accumulate (See **Photograph 1**). Corrosion may also be found in accommodation bulkheads around cut-out for fittings, such as doors, side scuttles, ventilators, etc., where proper maintenance of the area is relatively difficult. Deterioration of the bulkheads including fittings may impair the integrity of weathertightness.

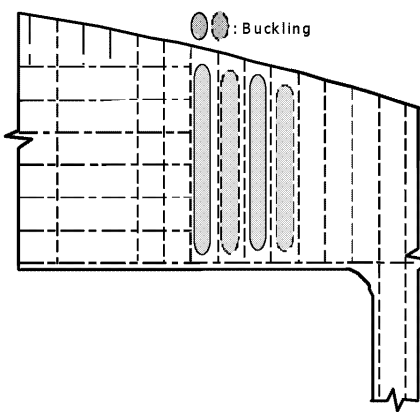
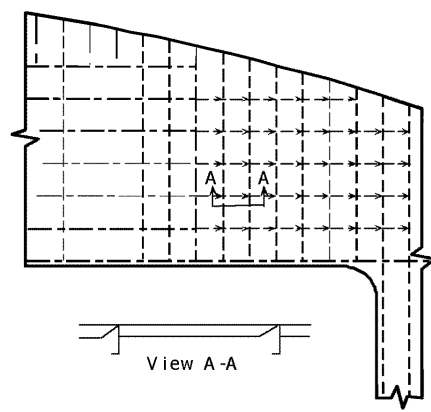
GENERAL CARGO SHIPS		Guidelines for Surveys, Assessment and Repair of Hull Structure
Part 1	Cargo hold region	Example No.
Area 1	Upper deck structure	1
Detail of damage	Buckling of deck plating of transverse framing system	
Sketch of damage	Sketch of repair

<p><b>Notes on possible cause of damage</b></p> <ol style="list-style-type: none"> <li>1. Excessive compressive stress due to slamming or bow flare effect.</li> <li>2. Insufficient longitudinal stiffening of deck plating.</li> </ol>	<p><b>Notes on repairs</b></p> <ol style="list-style-type: none"> <li>1. Buckled plating should be cropped and renewed. Longitudinal internal stiffeners should be provided. (Instead of longitudinal stiffeners, renewal by thicker deck plating can be accepted.)</li> <li>2. Stress concentration may occur at the end of sniped stiffener resulting in fatigue fracture. For locations where high cyclic stress may occur, appropriate connection such as lug-connection should be considered.</li> </ol>

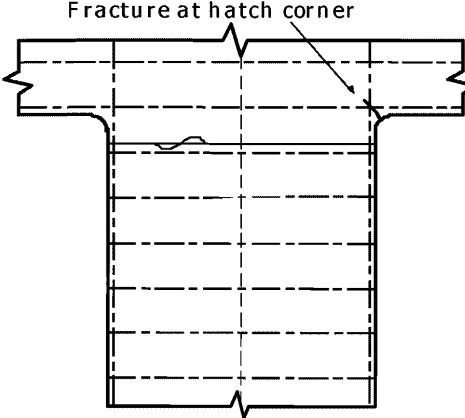
GENERAL CARGO SHIPS		Guidelines for Surveys, Assessment and Repair of Hull Structure
Part 1	Cargo hold region	Example No.
Area 1	Upper deck structure	2
Detail of damage		Fractures at main cargo hatch corner
<b>Sketch of damage</b>

<p>Fracture at hatch corner</p>		<b>Sketch of repair</b> Insert plate of enhanced steel grade and increased thickness

<b>Notes on possible cause of damage</b> <ol style="list-style-type: none"> <li>1. Stress concentration at hatch corners, i.e. radius of corner.</li> <li>2. Welded attachment of shedder plate close to edge of hatch corner.</li> <li>3. Wire rope groove.</li> </ol>		<b>Notes on repairs</b> <ol style="list-style-type: none"> <li>1. The corner plating in way of the fracture is to be cropped and renewed. If stress concentration is primary cause, insert plate should be of increased thickness, enhanced steel grade and/or improved geometry. Insert plate should be continued beyond the longitudinal and transverse extent of the hatch corner radius ellipse or parabola, and the butt welds to the adjacent deck plating should be located well clear of the butts in the hatch coaming. It is recommended that the edges of the insert plate and the butt welds connecting the insert plates to the surrounding deck plating be made smooth by grinding. In this respect caution should be taken to ensure that the micro grooves of the grinding are parallel to the plate edge.</li> <li>2. If the cause of fracture is welded attachment of shedder plate, the deck connection should be left unwelded.</li> <li>3. If the cause of the fracture is wire rope groove, replacement to the original design can be accepted.</li> </ol>

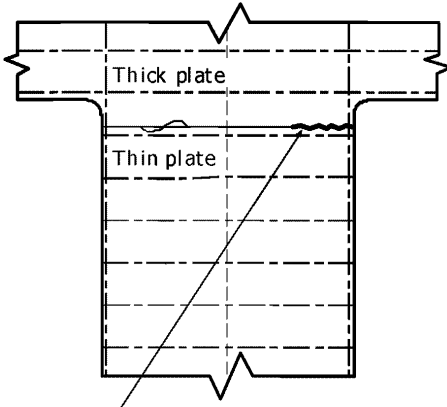
GENERAL CARGO SHIPS		Guidelines for Surveys, Assessment and Repair of Hull Structure	
Part 1	Cargo hold region	Example No.	
Area 1	Upper deck structure	3-a	
<b>Detail of damage</b>		Fracture of welded seam between thick plate and thin plate at cross deck	
<b>Sketch of damage</b>

<p>Thick plate</p> <p>Thin plate</p> <p>Fracture at welded seam</p>		<b>Sketch of repair</b>

<p>Insert plate of suitable intermediate thickness</p>	
<b>Notes on possible cause of damage</b> <ol style="list-style-type: none"> <li>1. Stress concentration created by abrupt change in deck plating thickness.</li> <li>2. In-plane bending in cross deck strip due to torsional (longitudinal) movements of ship sides.</li> <li>3. Welded seam not clear of tangent point of hatch corner.</li> </ol>		<b>Notes on repairs</b> <ol style="list-style-type: none"> <li>1. Insert plate of intermediate thickness is recommended.</li> <li>2. Smooth transition between plates (beveling) should be considered.</li> </ol>

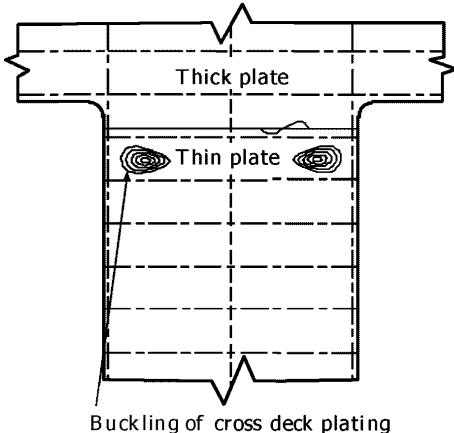
<p>Thick plate</p> <p>Thin plate</p> <p>Buckling of cross deck plating</p>

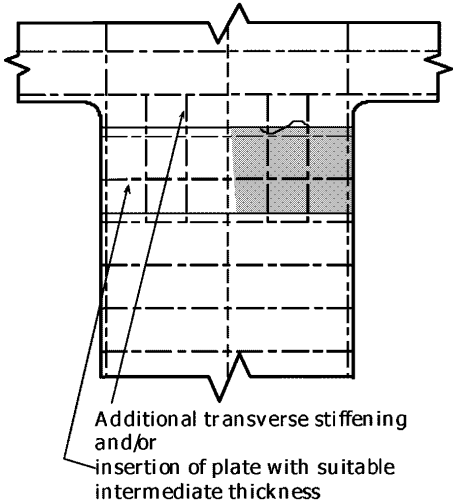
<p>Additional transverse stiffening and/or insertion of plate with suitable intermediate thickness</p>	
<b>Notes on possible cause of damage</b>		<b>Notes on repairs</b>	
<ol style="list-style-type: none"> <li>In-plane bending of cross deck strip due to torsional (longitudinal) movement of ship sides, often in combination with</li> <li>corrosion.</li> </ol> <p>Insufficient transverse stiffening.</p>		<ol style="list-style-type: none"> <li>Transverse stiffeners extending from hatch sides towards centerline at least 10% of breadth of hatch, and/or increased plate thickness in the same area.</li> </ol>

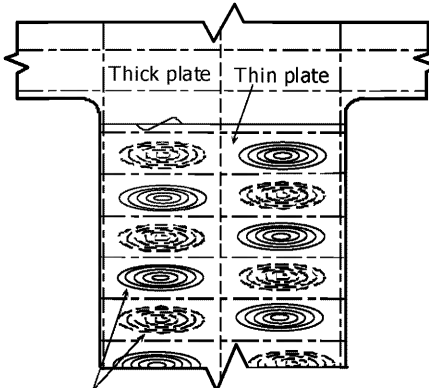
GENERAL CARGO SHIPS		Guidelines for Surveys, Assessment and Repair of Hull Structure	
Part 1	Cargo hold region	Example No.	
Area 1	Upper deck structure	3-c	
Detail of damage		Overall buckling of cross deck plating	
Sketch of damage		Sketch of repair

<p>Buckling of cross deck plating</p>

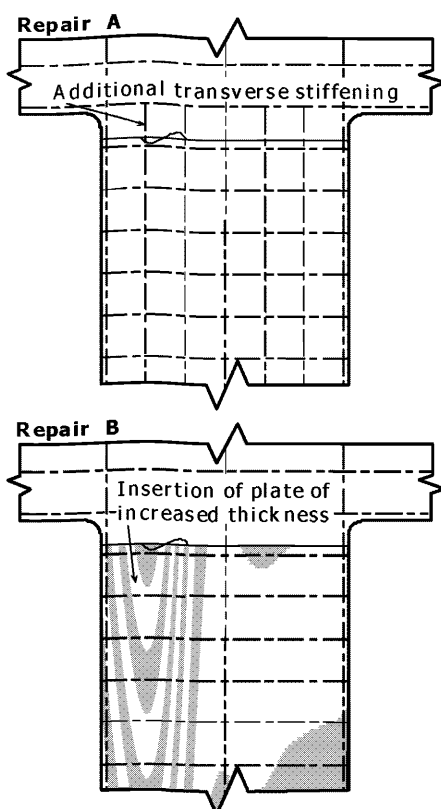
<p>Repair A Additional transverse stiffening</p> <p>Repair B Insertion of plate of increased thickness</p>	
Notes on possible cause of damage		Notes on repairs	
<ol style="list-style-type: none"> <li>1. Transverse compression of deck due to sea load.</li> <li>2. Insufficient transverse stiffening.</li> </ol>		<ol style="list-style-type: none"> <li>1. <b>Repair A</b> Plating of original thickness in combination with additional transverse stiffening.</li> <li>2. <b>Repair B</b> Insertion of plating of increased thickness.</li> </ol>

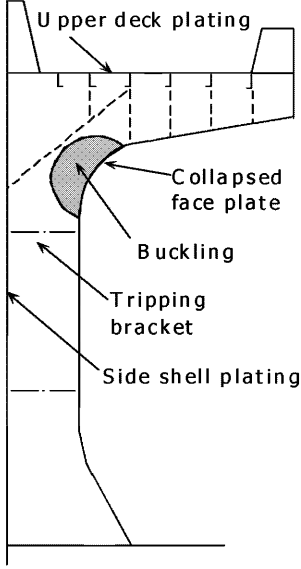
GENERAL CARGO SHIPS		Guidelines for Surveys, Assessment and Repair of Hull Structure	
Part 1	Cargo hold region	Example No.	
Area 1	Upper deck structure	4	
Detail of damage		Buckling of web beam	
<p><b>Sketch of damage</b></p>

<p><b>Notes on possible cause of damage</b></p> <ol style="list-style-type: none"> <li>1. Overloading by green sea on deck or by excessive deck cargo.</li> <li>2. Excessive corrosion.</li> <li>3. Insufficient/improper web stiffening.</li> </ol>		<p><b>Notes on repairs</b></p> <ol style="list-style-type: none"> <li>1. Buckled part is to be cropped and renewed.</li> <li>2. If corrosion is not the cause, renewal by thicker plate (web and/or face) and/or reinforcement by stiffener and tripping bracket should be considered.</li> </ol>

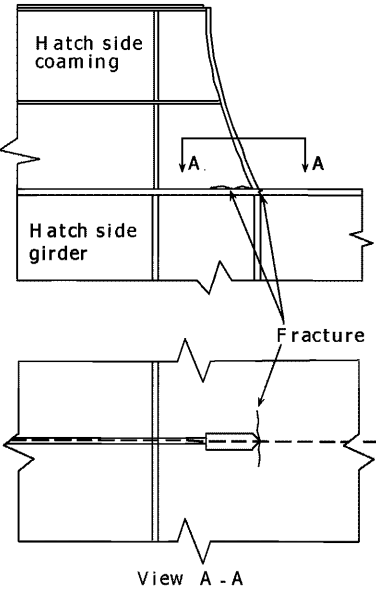
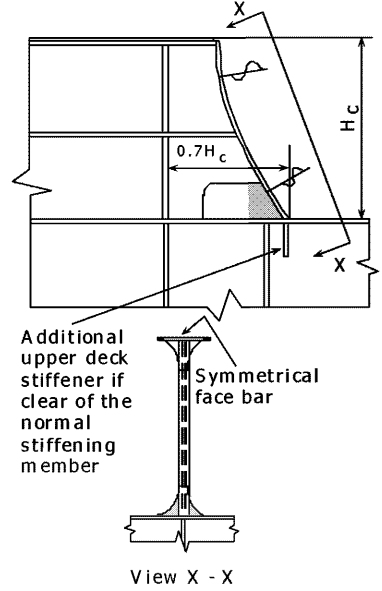
Notes on possible cause of damage		Notes on repairs	
<p>1. This damage is caused by stress concentrations attributed to the design of the bracket.</p>		<p>1. The design of the bracket can be altered as shown above, however, it is to be ensured that an additional under deck stiffener is provided at the toe of the termination bracket, where the toe is clear of the normal stiffening member.</p> <p>2. Full penetration weld for a distance of <math>0.15 H_c</math> from toe of side coaming termination bracket and for connection of athwartship gusset bracket to deck.</p> <p>3. The fracture in deck plating to be veed-out and rewelded or deck plating cropped and part renewed as appropriate, using low hydrogen electrodes for welding.</p>

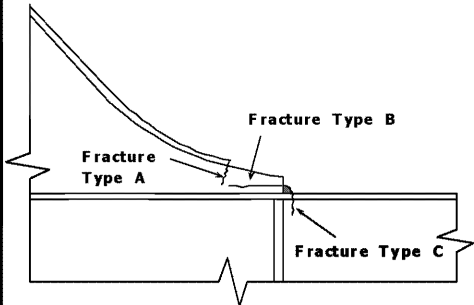
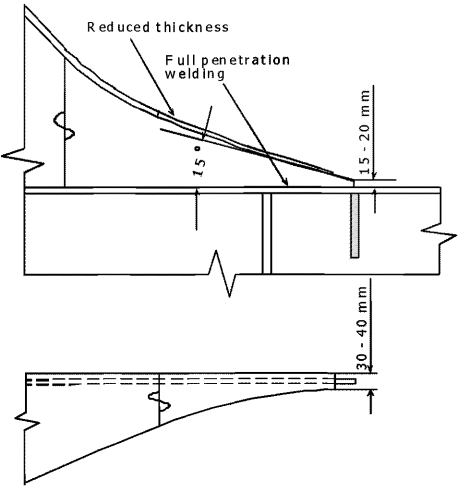
GENERAL CARGO SHIPS		Guidelines for Surveys, Assessment and Repair of Hull Structure	
Part 1	Cargo hold region	Example No.	
Area 1	Upper deck structure	5-b	
Detail of damage	Fractures in continuous longitudinal hatch coaming extension bracket		
Sketch of damage	Sketch of repair

<b>Notes on possible cause of damage</b> <ol style="list-style-type: none"> <li>1. Flange force at the end of the flange too high due to insufficient tapering (<b>Fracture Type A</b>, propagating in the web).</li> <li>2. Shear force in the web plate too high due to insufficient reduction of the web height at the end (<b>Fracture Type B</b>, propagating in the web at the undercut or HAZ of the fillet weld).</li> <li>3. HAZ of the fillet weld). Insufficient support of the extension bracket below the deck (<b>Fracture Type C</b>, starting from undercut or HAZ of the fillet weld and propagating in the deck plating).</li> </ol>	<b>Notes on repairs</b> <ol style="list-style-type: none"> <li>1. Extend the extension bracket as long as possible to arrange a gradual transition.</li> <li>2. Reduce the web height at the end of the bracket; in case of high stress areas grind smooth the transition to the deck plating welding.</li> <li>3. Reduce the cross sectional area of the flange at the end as far as possible.</li> <li>4. Provide longitudinal structure in way of the web of the extension bracket to the next transverse structure or provide a new transverse structure.</li> </ol>

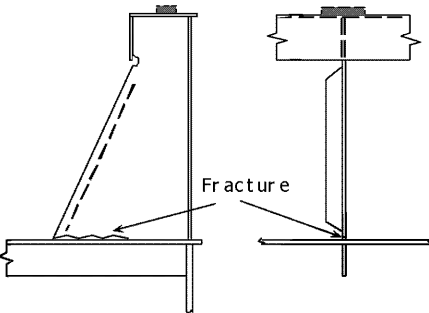
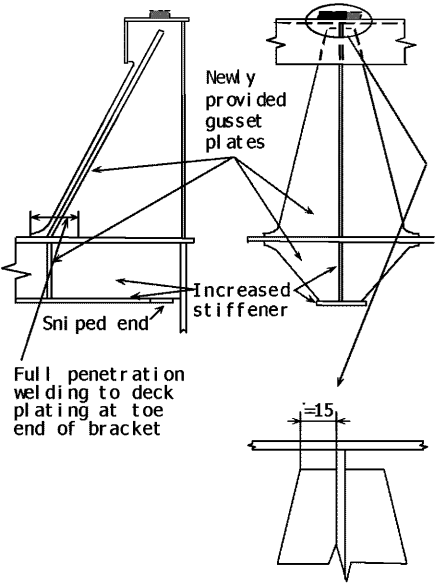
GENERAL CARGO SHIPS		Guidelines for Surveys, Assessment and Repair of Hull Structure
Part 1	Cargo hold region	Example No.
Area 1	Upper deck structure	6
Detail of damage	Fractures in web of transverse hatch coaming stay	
Sketch of damage	Sketch of repair

<p>Fracture</p>

<p>Newly provided gusset plates</p> <p>Increased stiffener</p> <p>Sni ped end</p> <p>Full penetration welding to deck plating at toe end of bracket</p> <p>=15</p>	
Notes on possible cause of damage	Notes on repairs	
<p>1. Insufficient consideration of the horizontal friction forces in way of the resting pads for hatch cover.</p>	<p>1. Modification of the design of the hatch coaming stay.</p> <p>2. Full penetration welding between gusset plates and deck plating.</p> <p>3. Strengthening and continuation of the structure below the deck.</p> <p>4. Use pads with smaller coefficient of friction.</p>

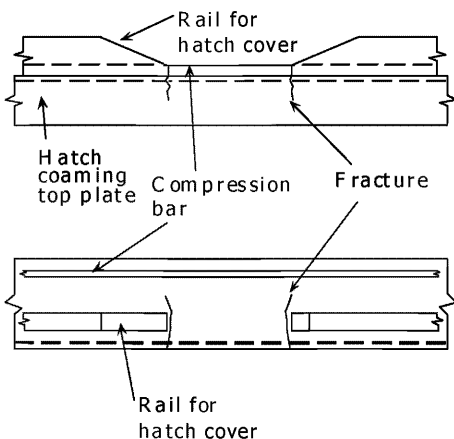
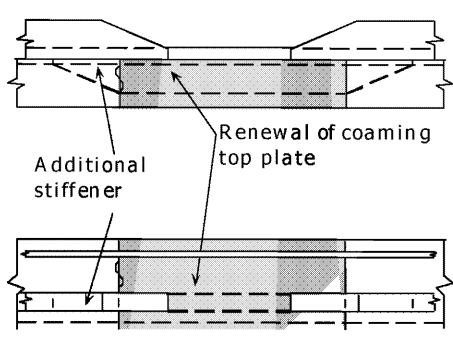
GENERAL CARGO SHIPS		Guidelines for Surveys, Assessment and Repair of Hull Structure	
Part 1	Cargo hold region	Example No.	
Area 1	Upper deck structure	7-a	
<b>Detail of damage</b>		Fractures in hatch coaming top plate at the termination of rail for hatch cover	
<b>Sketch of damage</b>

<b>Sketch of repair</b>

<b>Notes on possible cause of damage</b> <ol style="list-style-type: none"> <li>1. Stress concentration at the termination of the rail for hatch cover.</li> </ol>		<b>Notes on repairs</b> <ol style="list-style-type: none"> <li>1. Fractured plate is to be cropped and part renewed.</li> <li>2. Thicker insert plate and/or reinforcement by additional stiffener under the top plate should be considered. Also refer to <b>Example 7-b</b>.</li> </ol>

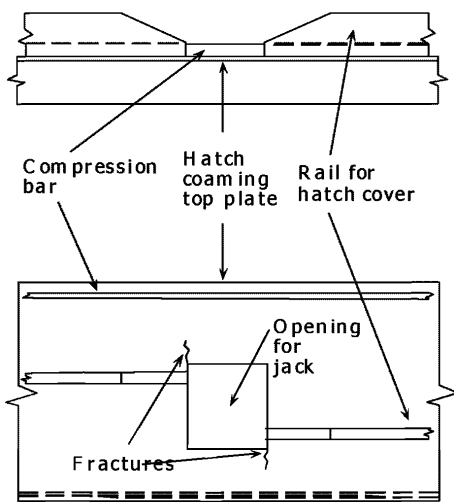
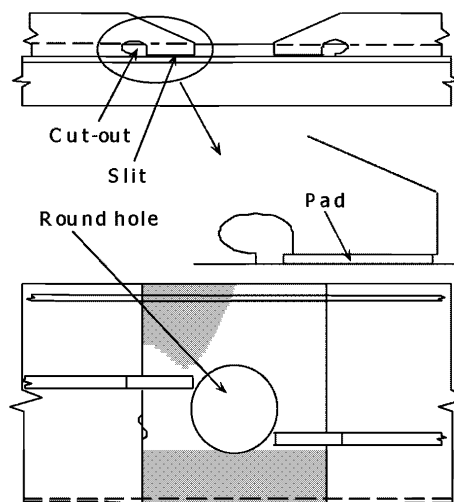
GENERAL CARGO SHIPS		Guidelines for Surveys, Assessment and Repair of Hull Structure	
Part 1	Cargo hold region	Example No.	
Area 1	Upper deck structure	7-b	
<b>Detail of damage</b>		Fractures in hatch coaming top plate at the termination of rail for hatch cover	
<b>Sketch of damage</b>

<p>Labels: Compression bar, Hatch coaming top plate, Rail for hatch cover, Fractures, Opening for jack.</p>		<b>Sketch of repair</b>

<p>Labels: Cut-out, Slit, Round hole, Pad.</p>	
<b>Notes on possible cause of damage</b> 1. Stress concentration at the termination of the rail for hatch cover.		<b>Notes on repairs</b> 1. Fractured plate is to be cropped and part renewed. 2. Thicker insert plate and/or reduction of stress concentration adopting large radius should be considered. Or cut-out in the rail and detachment of the welds as shown in the above drawing should be considered in order to reduce the stress of the corner of the opening.
