**РОССИЙСКИЙ МОРСКОЙ РЕГИСТР СУДОХОДСТВА**  
**RUSSIAN MARITIME REGISTER OF SHIPPING**

**SUPPLEMENT TO RULES AND GUIDELINES  
OF RUSSIAN MARITIME REGISTER OF SHIPPING**

**IACS PROCEDURAL REQUIREMENTS,  
UNIFIED INTERPRETATIONS  
AND RECOMMENDATIONS**

НД № 2-020101-091-R-E

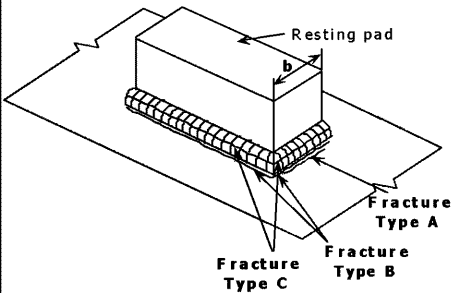
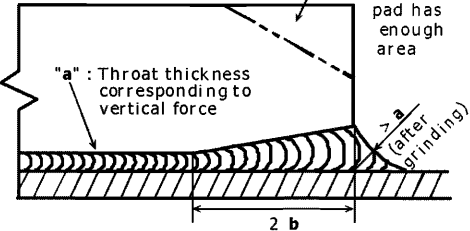
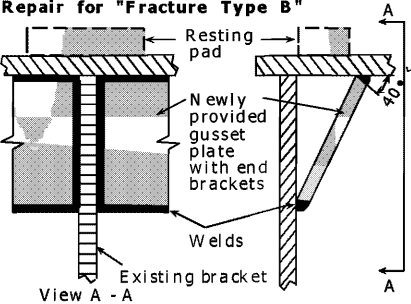
GENERAL CARGO SHIPS		Guidelines for Surveys, Assessment and Repair of Hull Structure
Part 1	Cargo hold region	Example No.
Area 1	Upper deck structure	8
Detail of damage		Fractures in hatch coaming top plate around resting pad
<p><b>Sketch of damage</b></p>

<p><b>Fracture Type A:</b> Starting in way of the undercut or HAZ of the transverse fillet weld and propagating in the top plating.</p> <p><b>Fracture Type B:</b> Starting in way of the undercut or HAZ of the longitudinal fillet weld and propagating in the top plating.</p> <p><b>Fracture Type C:</b> Starting and propagating in fillet weld</p>		<p><b>Sketch of repair</b></p> <p><b>Repair for "Fracture Type A"</b> Note: Cut, if the pad has enough area</p>

<p><b>Repair for "Fracture Type B"</b></p>

<p><b>Notes on possible cause of damage</b></p> <ol style="list-style-type: none"> <li><b>Fracture Type A:</b> Inappropriate transition from the hatch coaming top plating to the resting pad in respect to longitudinal stresses.</li> <li><b>Fracture Type B:</b> Insufficient support of the resting pad below the top plating.</li> <li><b>Fracture Type C:</b> Insufficient throat thickness of the fillet weld in relation to the vertical forces.</li> </ol> <p><b>Notes on repairs</b></p> <ol style="list-style-type: none"> <li><b>Fracture Type A:</b> Modification of the transverse fillet weld according to the sketch; in some cases smoothing of the transition by grinding is acceptable.</li> <li><b>Fracture Type B:</b> Strengthening of the structures below the top plating according to the sketch.</li> <li><b>Fracture Type C:</b> Increasing the throat thickness corresponding to the acting vertical forces.</li> </ol>

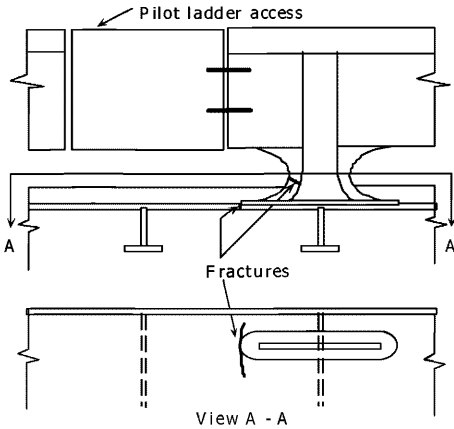
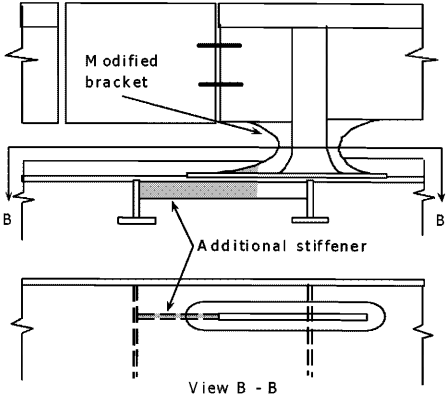
GENERAL CARGO SHIPS		Guidelines for Surveys, Assessment and Repair of Hull Structure	
Part 1	Cargo hold region	Example No.	
Area 1	Upper deck structure	9	
Detail of damage		Fracture in deck plating at the pilot ladder access of bulwarks	
<p><b>Sketch of damage</b></p>

<p><b>Sketch of repair</b></p>

<p><b>Notes on possible cause of damage</b></p> <ol style="list-style-type: none"> <li>1. Stress concentration at the termination of bulwarks.</li> </ol>		<p><b>Notes on repairs</b></p> <ol style="list-style-type: none"> <li>1. Fractured deck plating should be cropped and part renewed.</li> <li>2. Reduction of stress concentration should be considered. In the above figure gusset plate was replaced with soft type for the fracture in gusset plate and pad plate was increased. Additional stiffeners were provided for the fracture in deck plating.</li> </ol>

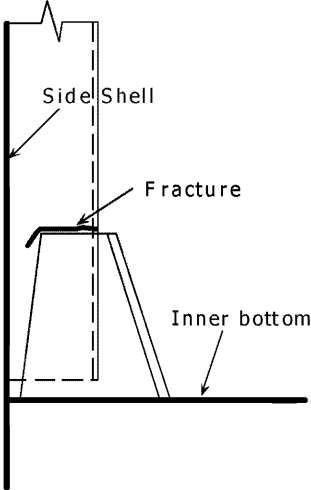
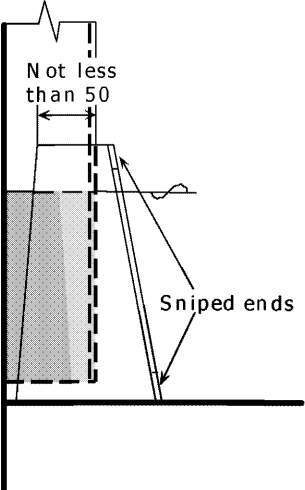
GENERAL CARGO SHIPS		Guidelines for Surveys, Assessment and Repair of Hull Structure	
Part 1	Cargo hold region	Example No.	
Area 2	Side structure	1	
Detail of damage		Fracture in side shell frame at lower bracket	
<p><b>Sketch of damage</b></p>

<p><b>Sketch of repair</b></p>

<p><b>Notes on possible cause of damage</b></p> <p>1. This type of damage is caused due to stress concentration.</p>		<p><b>Notes on repairs</b></p> <p>1. For small fractures, e. g. hairline fractures, the fracture can be veed-out, welded up, ground, examined by NDT for fractures, and rewelded.</p> <p>2. For larger/significant fractures consideration is to be given to cropping and partly renewing/ renewing the frame brackets. If renewing the brackets, end of frames can be sniped to soften them.</p> <p>3. If felt prudent, soft toes are to be incorporated at the boundaries of the bracket to the inner bottom plating.</p>

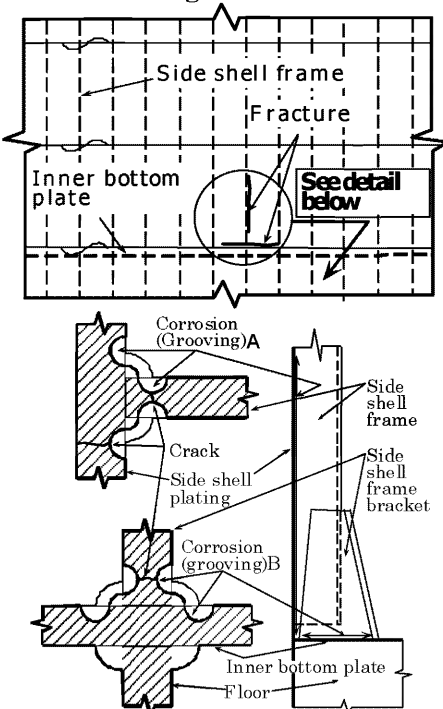
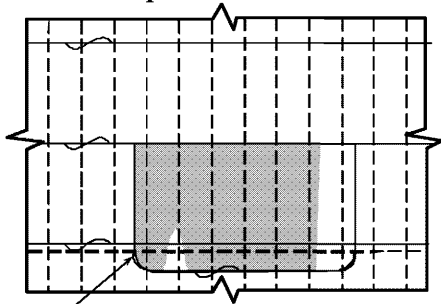
GENERAL CARGO SHIPS		Guidelines for Surveys, Assessment and Repair of Hull Structure	
Part 1	Cargo hold region	Example No.	
Area 2	Side structure	2	
Detail of damage		Fractures in side shell frame/lower bracket and side shell plating near tank top	
Sketch of damage		Sketch of repair

<p>The sketch of damage consists of two parts. The top part is a plan view of the side shell structure showing a fracture in the side shell frame and inner bottom plating. Labels include 'Side shell frame', 'Fracture', and 'Inner bottom plate'. A circular callout points to a detail view. The bottom part is a cross-sectional detail view showing 'Corrosion (Grooving) A' on the side shell frame, a 'Crack' in the side shell plating, and 'Corrosion (grooving) B' on the inner bottom plate. Other labels include 'Side shell frame', 'Side shell frame bracket', and 'Floor'.</p>

<p>The sketch of repair shows a plan view of the side shell structure with a shaded area indicating the part renewal. The label below the sketch reads: 'Part renewal including side shell frames and inner bottom plating, as found necessary'.</p>

<b>Notes on possible cause of damage</b> <ol style="list-style-type: none"> <li>1. Fracture in side shell plating along side shell frame: Heavy corrosion (grooving) along side shell frame (See A).</li> <li>2. Fracture in side shell plating along tank top: Heavy corrosion (grooving) along tank top (See B) resulting detachment of side shell frame bracket from inner bottom plating.</li> </ol>		<b>Notes on repairs</b> <ol style="list-style-type: none"> <li>1. Sketch of repair applies when damage extends over several frames.</li> <li>2. Isolated fractures may be repaired by veeing-out and rewelding.</li> <li>3. Isolated cases of grooving may be repaired by build up of welding.</li> </ol>

<p>Note: Regarding "View A-A", refer to <b>Example 2</b> of <b>Area 2</b> of this part</p>		<p><b>Sketch of repair</b></p>

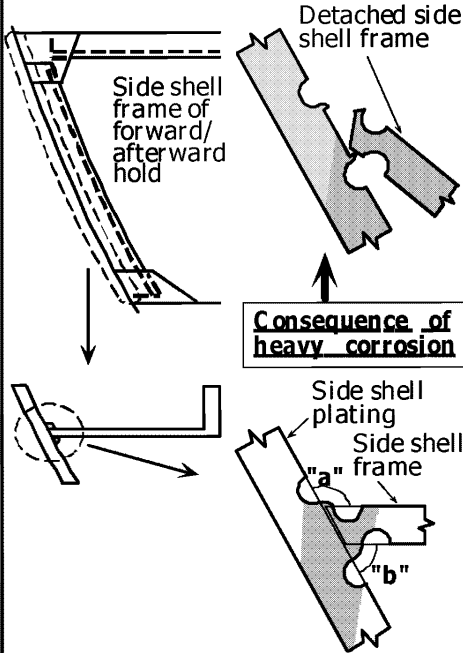
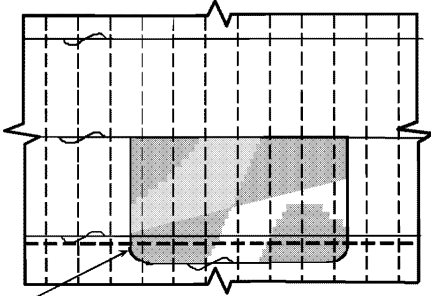
GENERAL CARGO SHIPS		Guidelines for Surveys, Assessment and Repair of Hull Structure
Part 1	Cargo hold region	Example No.
Area 2	Side structure	3
Detail of damage		Adverse effect of corrosion on the frame of forward/afterward hold
<p><b>Sketch of damage</b></p>

<p>Detached side shell frame</p> <p>Side shell frame of forward/afterward hold</p> <p><b>Consequence of heavy corrosion</b></p> <p>Side shell plating</p> <p>Side shell frame</p> <p>"a"</p> <p>"b"</p>		<p><b>Sketch of repair</b></p>

<ol style="list-style-type: none"> <li>1. Part renewal including side shell frames and inner bottom plating, as found necessary</li> <li>2. Deep penetration welding at the connections of side shell frames to side shell plating</li> </ol>
<p><b>Notes on possible cause of damage</b></p> <ol style="list-style-type: none"> <li>1. Heavy corrosion (grooving) of side shell frame along side shell plating and difference of throat thickness "a" from "b". (Since original throat thickness of "a" is usually smaller than that of "b", if same welding procedure is applied, the same corrosion has a more severe effect on "a", and may cause collapse and/or detachment of side shell frame.)</li> </ol>		<p><b>Notes on repairs</b></p> <ol style="list-style-type: none"> <li>1. Sketch of repair applies when damage extends over several frames.</li> <li>2. Isolated fractures may be repaired by veeing-out and rewelding.</li> <li>3. Isolated cases of grooving may be repaired by build up of welding.</li> </ol>

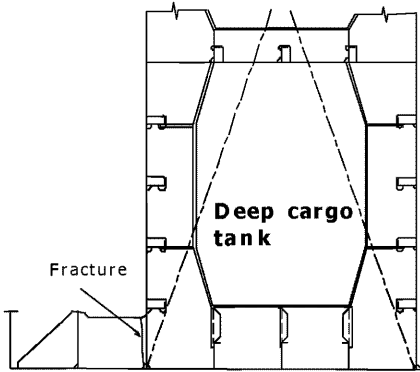
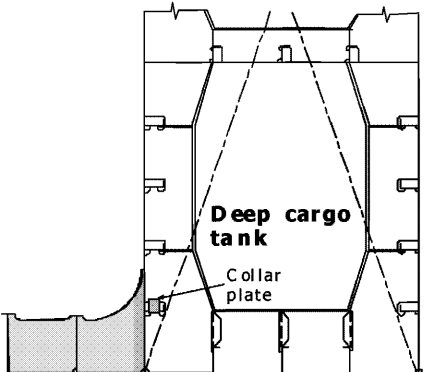
<b>Notes on possible cause of damage</b>		<b>Notes on repairs</b>	
<p>1. Damage caused by stress concentration leading to fatigue fracture on side shell. This will be exacerbated because of the greater flexibility of the ordinary hold structure in relation to the deep cargo tank structure.</p>		<p>1. The fractured shell plate is to be cropped and part renewed as necessary.</p> <p>2. Brackets should be modified.</p>

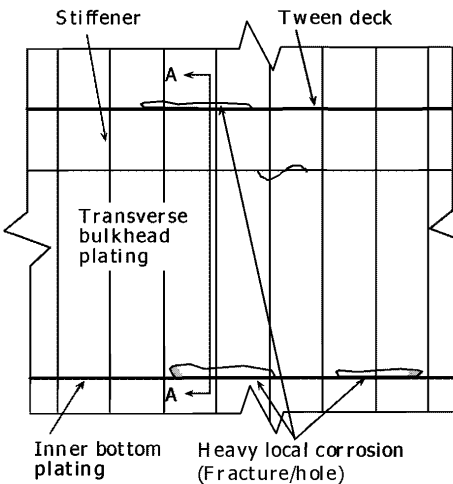
GENERAL CARGO SHIPS		Guidelines for Surveys, Assessment and Repair of Hull Structure	
Part 1	Cargo hold region	Example No.	
Area 3	Transverse bulkhead structure	1	
Detail of Corrosion along inner bottom or tween deck plating damage			
<p><b>Sketch of damage</b></p>

<p><b>Notes on possible cause of damage</b></p> <ol style="list-style-type: none"> <li>1. Heavy corrosion including grooving along inner bottom plating or tween deck due to poor drainage.</li> </ol>		<p><b>Notes on repairs</b></p> <ol style="list-style-type: none"> <li>1. The extent of the renewal should be determined carefully. If the renewal plate (original thickness) is welded to thin plate (corroded plate), it may cause stress concentration and cause fracture.</li> <li>2. Protective coating should be applied.</li> </ol>

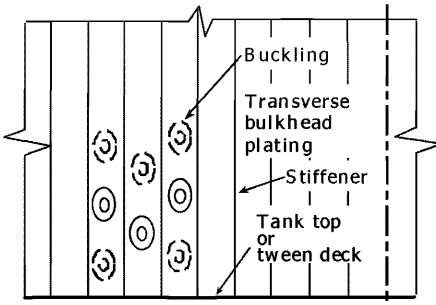
GENERAL CARGO SHIPS		Guidelines for Surveys, Assessment and Repair of Hull Structure
Part 1	Cargo hold region	Example No.
Area 3	Transverse bulkhead structure	2
Detail of damage		Buckling in transverse bulkhead
<p><b>Sketch of damage</b></p>

<p><b>Notes on possible cause of damage</b></p> <ol style="list-style-type: none"> <li>1. Heavy general corrosion.</li> </ol>		<p><b>Notes on repairs</b></p> <ol style="list-style-type: none"> <li>1. The extent of the renewal should be determined carefully. If the renewal plating (original thickness) is welded to thin plating (corroded plating), it may cause stress concentration and fracture.</li> <li>2. Protective coating should be applied.</li> </ol>

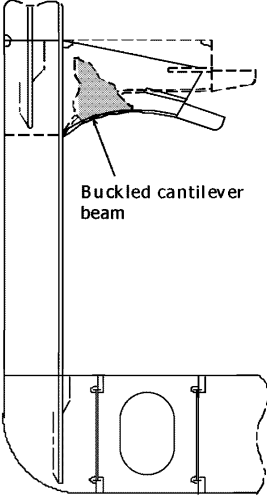
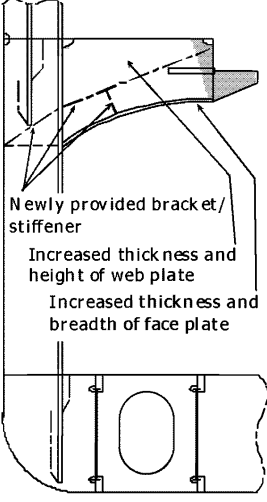
<p>Buckled cantilever beam</p>

GENERAL CARGO SHIPS		Guidelines for Surveys, Assessment and Repair of Hull Structure	
Part 1	Cargo hold region	Example No.	
Area 4	Tween deck structure	1	
Detail of damage		Sagging of deck panel/buckling of cantilever beam	
Sketch of damage		Sketch of repair

<p><b>Repair B</b></p> <p>Renewed beam</p> <p>Newly provided pillar</p> <p>View A-A</p> <p>Closed access hole</p>	
<b>Notes on possible cause of damage</b> 1. Poor design, overloading and/or excessive inertia force caused in heavy weather.		<b>Notes on repairs</b> 1. The affected structures are to be cropped and renewed. 2. <b>Repair A:</b> Reinforcement should be considered by increased scantlings of beam and/or additional stiffeners. 3. <b>Repair B:</b> Pillars may be provided for reinforcement subject to the approval of the owner. In such a case, reinforcement of the floor under the pillar should be considered. (In the above example, access hole was closed.)

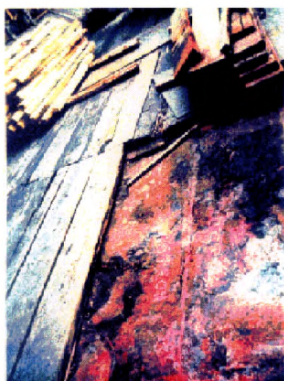
**Photograph 1**  
**Fractured inner bottom plating due to heavy corrosion on both sides**

- 2.1.2 When the tank top plating has been covered with dunnage or ceiling the plating may have suffered heavy corrosion, due to high humidity, and lack of proper maintenance (See **Photograph 1**).

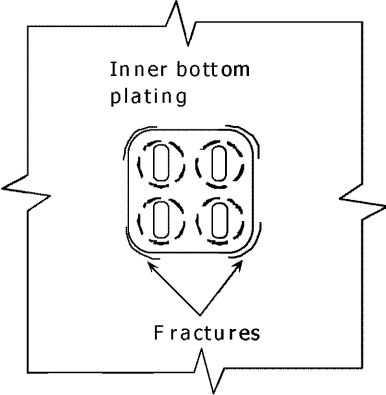
GENERAL CARGO SHIPS		Guidelines for Surveys, Assessment and Repair of Hull Structure	
Part 1	Cargo hold region	Example No.	
Area 5	Double bottom structure	1	
Detail of damage		Fractures in inner bottom plating around container bottom pocket	
<p><b>Sketch of damage</b></p>

<p><b>Notes on possible cause of damage</b></p> <ol style="list-style-type: none"> <li>1. Pocket is not supported correctly by floor, longitudinal and/or stiffener.</li> </ol>		<p><b>Notes on repairs</b></p> <ol style="list-style-type: none"> <li>1. Fractured plating should be cropped and part renewed.</li> <li>2. Adequate reinforcement should be considered.</li> </ol>

- 2.3.1** Fractures will normally be found by close-up inspection paying particular attention to the boundary connections of the tank top and to penetrations through the tank top (See **Example 1**).
- 2.3.2** Fractures that extend through the thickness of the plating or through the boundary welds may be observed during pressure testing of the double bottom tanks.

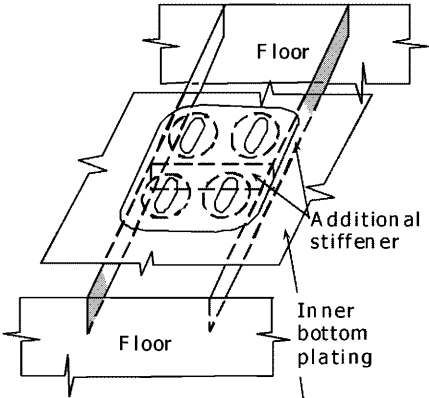
<p><b>Sketch of repair</b></p> <p><b>Most common repair</b></p>

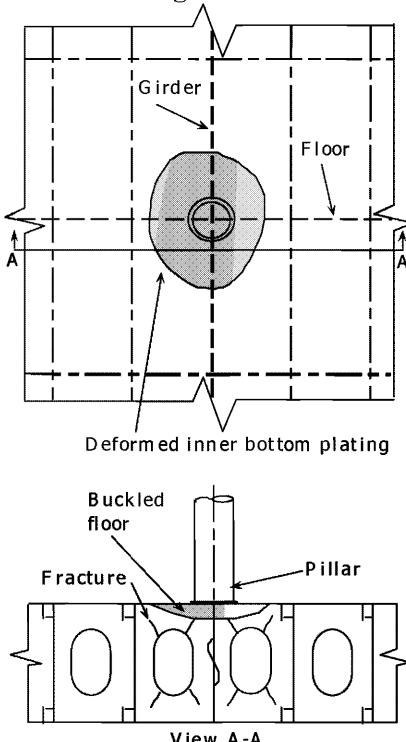
GENERAL CARGO SHIPS		Guidelines for Surveys, Assessment and Repair of Hull Structure	
Part 1	Cargo hold region	Example No.	
Area 5	Double bottom structure	2	
Detail of damage		Dented inner bottom plating and buckled/fractured floor under pillar	
<p><b>Sketch of damage</b></p>

<p><b>Notes on possible cause of damage</b></p> <ol style="list-style-type: none"> <li>1. Inadequate arrangement and/or reinforcement of access holes.</li> <li>2. Excessive deck-loading on tween deck.</li> </ol>		<p><b>Notes on repairs</b></p> <ol style="list-style-type: none"> <li>1. Dented inner bottom plating is to be cropped and part renewed.</li> <li>2. The fractured floor is to be cropped and part renewed.</li> <li>3. Access holes should be closed by insert plates.</li> <li>4. Stiffener on floor/girder and/or brackets should be considered. (Fitting of brackets in the hold is subject to the agreement of the owner.)</li> </ol>

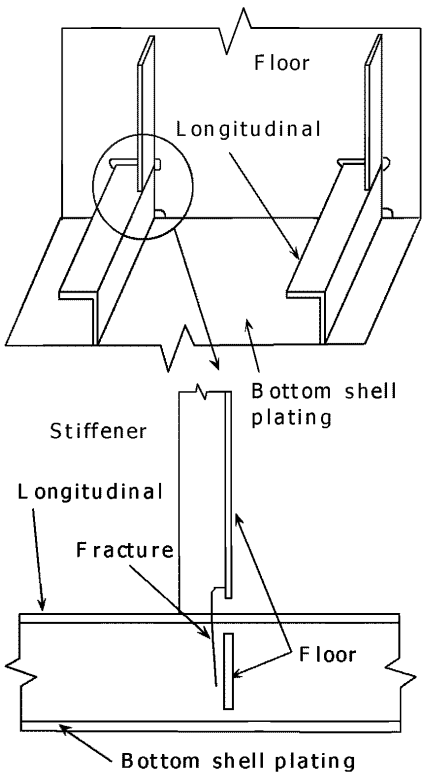
GENERAL CARGO SHIPS		Guidelines for Surveys, Assessment and Repair of Hull Structure	
Part 1	Cargo hold region	Example No.	
Area 5	Double bottom structure	3-a	
Detail of damage		Fractures at the connection of bottom/inner bottom longitudinal to floor stiffener	
<p><b>Sketch of damage</b></p>

<p>Note: same damage may occur at similar connection to inner bottom plating</p>		<p><b>Sketch of repair</b></p>

<p><b>Notes on possible cause of damage</b></p> <ol style="list-style-type: none"> <li>1. Damage can be caused by stress concentrations leading to accelerated fatigue in this region.</li> </ol>		<p><b>Notes on repairs</b></p> <ol style="list-style-type: none"> <li>1. If fracture extends to over one third of the depth of the longitudinal, then crop and part renew. Otherwise the fracture can be veed-out and welded.</li> </ol>

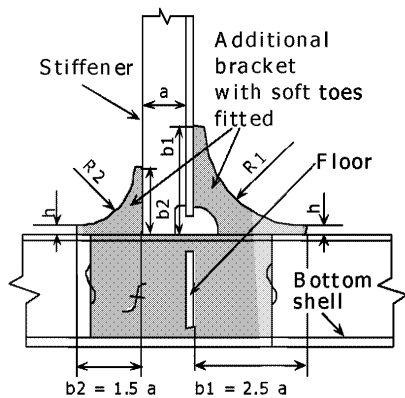
<p><math>f</math>: Where required, the longitudinal to be cropped and part renewed</p> <ol style="list-style-type: none"> <li>1. For a slope at toes max. 1 : 3, <math>R1 = (b1-h) \times 1.6</math> and <math>R2 = (b2-h) \times 1.6</math></li> <li>2. Soft toe bracket to be welded first to longitudinal</li> <li>3. Scallop in bracket to be as small as possible, recommended max. 35 mm</li> <li>4. If toes of brackets are ground smooth, full penetration welds in way to be provided</li> <li>5. Maximum length to thickness ratio = 50 : 1 for unstiffened bracket edge</li> <li>6. Toe height, <math>h</math>, to be as small as possible (10- 15 mm)</li> </ol>

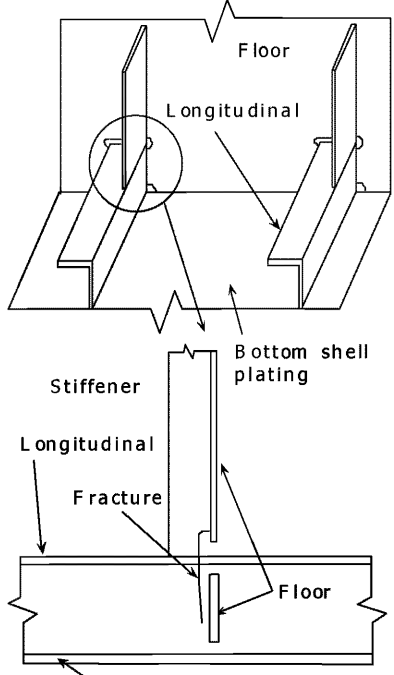
GENERAL CARGO SHIPS		Guidelines for Surveys, Assessment and Repair of Hull Structure	
Part 1	Cargo hold region	Example No.	
Area 5	Double bottom structure	3-b	
Detail of damage		Fractures at the connection of bottom/inner bottom longitudinal to floor stiffener	
<p><b>Sketch of damage</b></p>

<p>The sketch shows a 3D perspective of a floor stiffener connection. Labels include 'Floor', 'Longitudinal', 'Stiffener', 'Bottom shell plating', and 'Fracture'. A note states: 'Note: same damage may occur at similar connection to inner bottom plating'.</p>		<p><b>Sketch of repair</b></p>

<p><b>Notes on possible cause of damage</b></p> <ol style="list-style-type: none"> <li>1. Damage can be caused by stress concentrations leading to accelerated fatigue in this region.</li> </ol>		<p><b>Notes on repairs</b></p> <ol style="list-style-type: none"> <li>1. If fracture extends to over one third of the depth of the longitudinal, then crop and part renew. Otherwise the fracture can be veed-out and welded.</li> </ol>

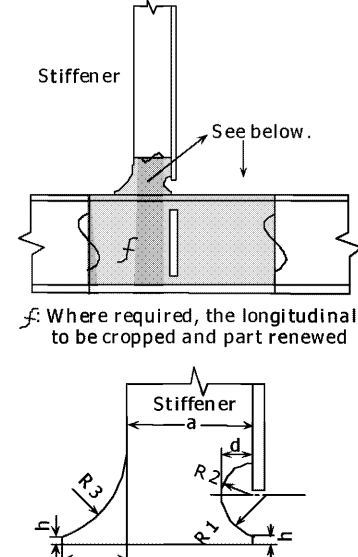
<p>The repair sketch shows a cross-section of a stiffener with a key hole notch. Labels include 'Stiffener', 'See below.', and 'f:'. A note states: 'f: Where required, the longitudinal to be cropped and part renewed'. A detail of the notch geometry shows radii R1, R2, R3, and dimensions 'a', 'd', and 'h'.</p> <p>Various cut-out shapes have been developed. The following is one example.</p> <ol style="list-style-type: none"> <li>1. Toe height as small as possible (h = 10 - 15 mm)</li> <li>2. Depth "d" of key hole notch as small a possible, max. 30 mm</li> <li>3. For a slope at toe max. 1 : 3</li> <li>4. R1 = 1.5d, R2 = d and R3 = 1.5c</li> </ol>

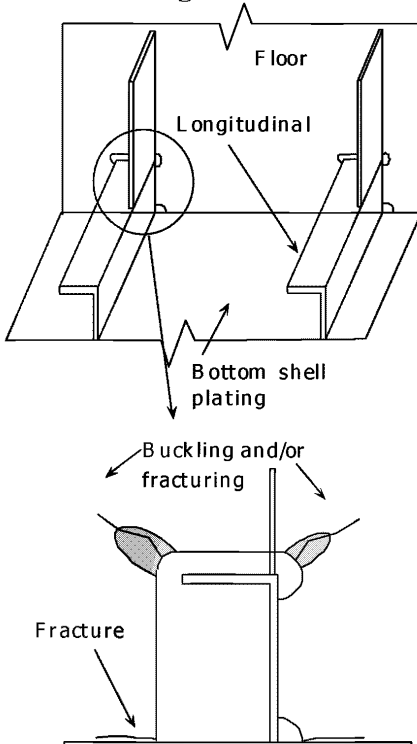
GENERAL CARGO SHIPS		Guidelines for Surveys, Assessment and Repair of Hull Structure	
Part 1	Cargo hold region	Example No.	
Area 5	Double bottom structure	4	
<b>Detail of damage</b>		Fractures and buckling in way of a cut-out for the passage of a longitudinal through a transverse primary member	
<b>Sketch of damage</b>

<p>Note: same type of damage may occur at similar connections to inner bottom</p>		<b>Sketch of repair</b> <p><b>Repair A</b></p>

<b>Notes on possible cause of damage</b> <ol style="list-style-type: none"> <li>Damage can be caused by general levels of corrosion and presence of stress concentration associated with the presence of a cut-out.</li> </ol>		<b>Notes on repairs</b> <ol style="list-style-type: none"> <li>If fractures are significant then crop and part renew the floor plating otherwise the fracture can be veed-out and welded provided the plating is not generally corroded.</li> <li><b>Repair B</b> is to be incorporated if the lug proves to be ineffective.</li> </ol>

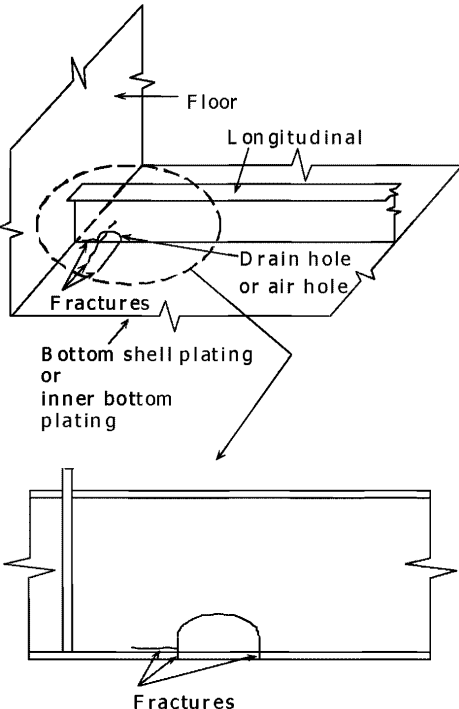
GENERAL CARGO SHIPS		Guidelines for Surveys, Assessment and Repair of Hull Structure	
Part 1	Cargo hold region	Example No.	
Area 5	Double bottom structure	5	
Detail of damage	Fractures in bottom shell plating/inner bottom plating at the corner drain hole/air hole in longitudinal		
Sketch of damage		Sketch of repair

<p>The sketch shows a longitudinal section of the hull structure. A horizontal line represents the 'Floor'. Below it, a 'Longitudinal' section of the 'Bottom shell plating or inner bottom plating' is shown. A 'Drain hole or air hole' is located in this plating. 'Fractures' are indicated by jagged lines at the corner of the hole. A second sketch below shows a similar section with 'Fractures' at the bottom of the plating.</p>

<b>Notes on possible cause of damage</b> <ol style="list-style-type: none"> <li>1. Stress concentration and/or corrosion due to stress concentration at the corner of drain hole/air hole.</li> </ol>		<b>Notes on repairs</b> <ol style="list-style-type: none"> <li>1. Fractured plating should be cropped and part renewed.</li> <li>2. If fatigue life is to be improved, change of drain hole/air hole shape is to be considered.</li> </ol>

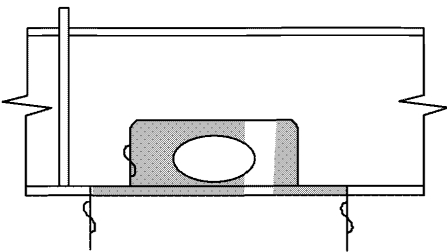
<p>The sketch shows the same longitudinal section as the damage sketch, but the fractured plating has been removed and replaced with a new section, indicated by a shaded area. The drain hole is now a smooth, rounded shape.</p>

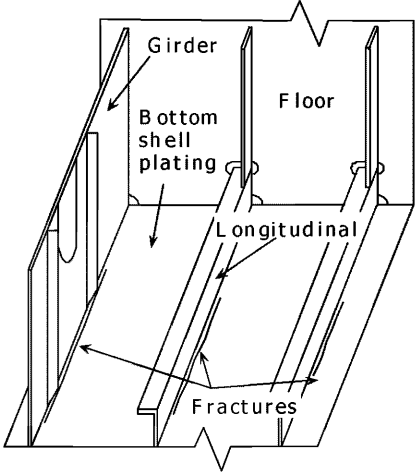
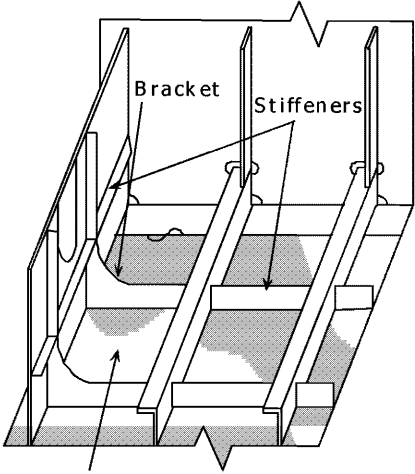
<b>GENERAL CARGO SHIPS</b>		<b>Guidelines for Surveys, Assessment and Repair of Hull Structure</b>	
<b>Part 1</b>	<b>Cargo hold region</b>	<b>Example No.</b>	
<b>Area 5</b>	<b>Double bottom structure</b>	<b>6</b>	
<b>Detail of damage</b>	Fracture in bottom shell plating along side girder and/or bottom longitudinal		
<b>Sketch of damage</b>		<b>Sketch of repair</b>

<b>Notes on possible cause of damage</b>		<b>Notes on repairs</b>	
1. Vibration.		<ol style="list-style-type: none"> <li>1. Fractured bottom shell plating should be cropped and renewed.</li> <li>2. Natural frequency of the panel should be changed, e.g. reinforcement by additional stiffener/bracket.</li> </ol>

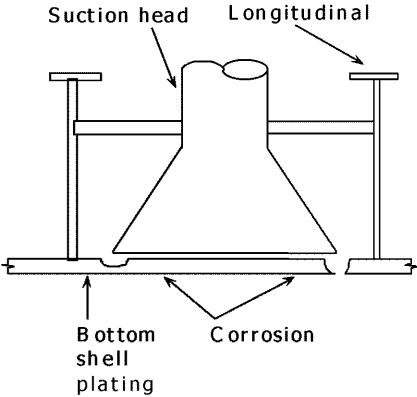
GENERAL CARGO SHIPS		Guidelines for Surveys, Assessment and Repair of Hull Structure	
Part 1	Cargo hold region	Example No.	
Area 5	Double bottom structure	7	
Detail of damage		Corrosion in bottom plating below suction head	
<p><b>Sketch of damage</b></p>

<ol style="list-style-type: none"> <li>1. Insert to have round corners</li> <li>2. Non-destructive examination to be applied after welding based on the Society's rules</li> </ol>	
<p><b>Notes on possible cause of damage</b></p> <ol style="list-style-type: none"> <li>1. High flow rate associated with insufficient corrosion prevention system.</li> <li>2. Galvanic action between dissimilar metals</li> </ol>		<p><b>Notes on repairs</b></p> <ol style="list-style-type: none"> <li>1. Affected plating should be cropped and part renewed. Thicker plate and suitable beveling should be considered.</li> <li>2. If the corrosion is limited to a small area, i.e. pitting corrosion, repair by welding is acceptable.</li> </ol>

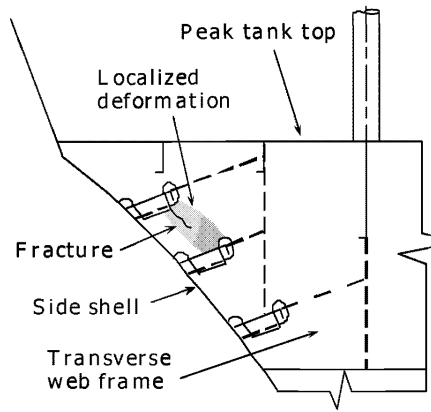
<b>GENERAL CARGO SHIPS</b>		<b>Guidelines for Surveys, Assessment and Repair of Hull Structure</b>
<b>Part 2</b>	<b>Fore and aft end regions</b>	<b>Example No.</b>
<b>Area 1</b>	<b>Fore end structure</b>	<b>1</b>
<b>Detail of damage</b>	<b>Fracture and deformation of bow transverse web in way of cut-outs for side longitudinals</b>	
<p><b>Sketch of damage</b></p>

<p><b>Notes on possible cause of damage</b></p> <ol style="list-style-type: none"> <li>1. Localized material wastage in way of coating failure at cut-outs and sharp edges due to working of the structure.</li> <li>2. Dynamic seaway loading in way of bow flare.</li> </ol>	<p><b>Notes on repairs</b></p> <ol style="list-style-type: none"> <li>1. Sufficient panel strength to be provided to absorb the dynamic loads enhanced by bow flare shape.</li> </ol>

**3.3.1** In the case of fractures caused by sea-loads the structure should be cropped and renewed. Increased thickness of plating and/or design modification to reduce stress concentrations should be considered (See **Examples 1, 2 and 6**).

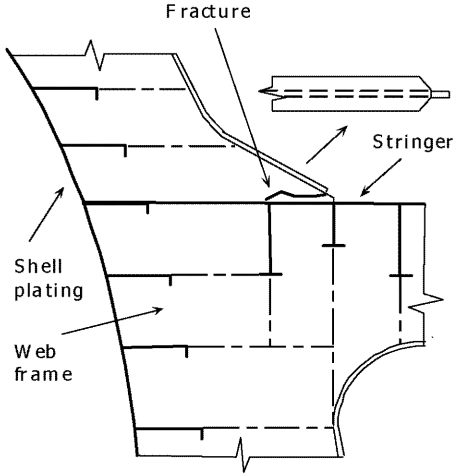
GENERAL CARGO SHIPS		Guidelines for Surveys, Assessment and Repair of Hull Structure	
Part 2	Fore and aft end regions		Example No.
Area 1	Fore end structure		2
Detail of damage	Fracture at toe of web frame bracket connection to stringer platform		
<p><b>Sketch of damage</b></p>

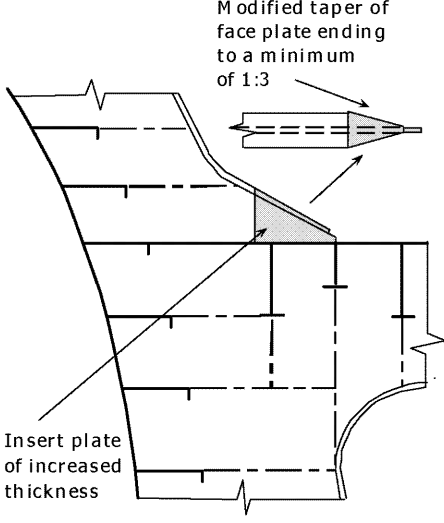
<p><b>Sketch of repair</b></p>

<p><b>Notes on possible cause of damage</b></p> <ol style="list-style-type: none"> <li>1. Inadequate bracket forming the web frame connection to the stringer.</li> <li>2. Localized material wastage in way of coating failure at bracket due to flexing of the structure.</li> <li>3. Dynamic seaway loading in way of bow flare.</li> </ol>		<p><b>Notes on repairs</b></p> <ol style="list-style-type: none"> <li>1. Adequate soft nose bracket endings with a face plate taper of at least 1 : 3 to be provided.</li> </ol>

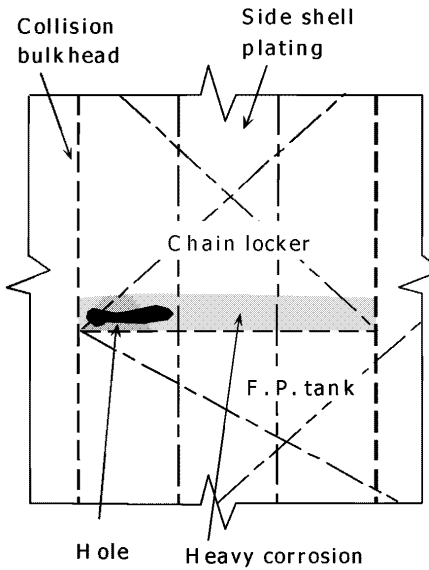
GENERAL CARGO SHIPS		Guidelines for Surveys, Assessment and Repair of Hull Structure	
Part 2	Fore and aft end regions	Example No.	
Area 1	Fore end structure	3	
Detail of damage		Fracture in side shell plating in way of chain locker	
<p><b>Sketch of damage</b></p>

<p>Collision bulkhead</p> <p>Side shell plating</p> <p>Chain locker</p> <p>F.P. tank</p> <p>Hole</p> <p>Heavy corrosion</p>		<p><b>Sketch of repair</b></p>

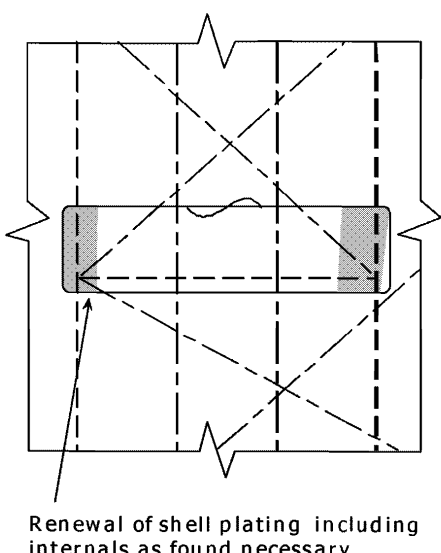
<p>Renewal of shell plating including internals as found necessary</p>	
<p><b>Notes on possible cause of damage</b></p> <ol style="list-style-type: none"> <li>1. Heavy corrosion in region where mud is accumulated.</li> </ol>		<p><b>Notes on repairs</b></p> <ol style="list-style-type: none"> <li>1. Corroded plating should be cropped and renewed.</li> <li>2. Protective coating should be applied.</li> </ol>

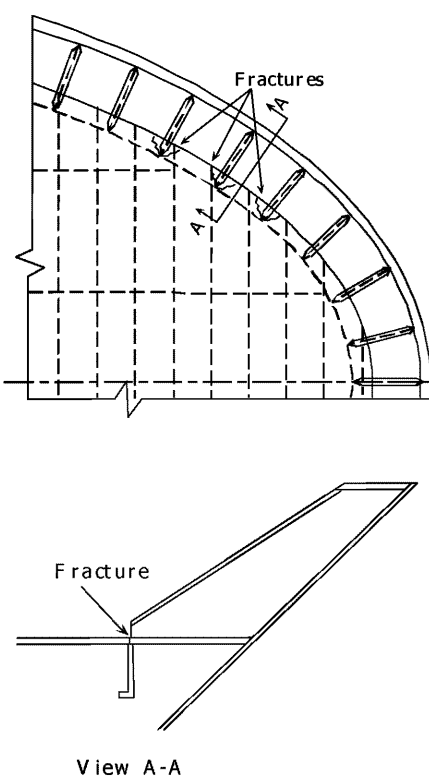
GENERAL CARGO SHIPS		Guidelines for Surveys, Assessment and Repair of Hull Structure	
Part 2	Fore and aft end regions		Example No.
Area 1	Fore end structure		6
Detail of damage	Fracture in forecastle deck plating at bulwark		
Sketch of damage	Sketch of repair

<p>Fractures</p> <p>Fracture</p> <p>View A-A</p>

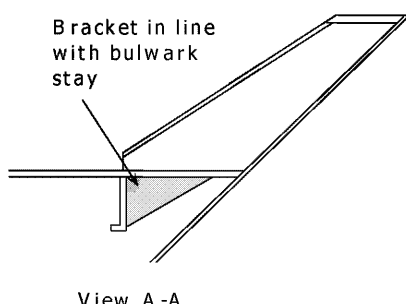
<p>Bracket in line with bulwark stay</p> <p>View A-A</p>	
<b>Notes on possible cause of damage</b> <ol style="list-style-type: none"> <li>1. Bow flare effect in heavy weather.</li> <li>2. Stress concentration due to poor design.</li> </ol>		<b>Notes on repairs</b> <ol style="list-style-type: none"> <li>1. Fractured deck plating should be cropped and renewed.</li> <li>2. Bracket in line with the bulwark stay to be fitted to reduce stress concentration.</li> </ol>

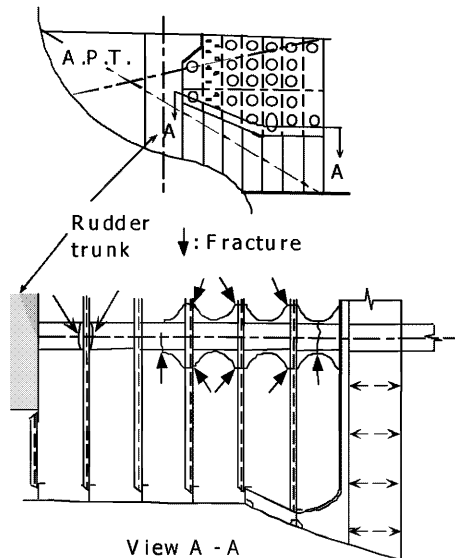
GENERAL CARGO SHIPS		Guidelines for Surveys, Assessment and Repair of Hull Structure	
Part 2	Fore and aft end regions	Example No.	
Area 2	Aft end structure	2	
Detail of damage		Fractures at the connection of floors and girders/side brackets	
Sketch of damage		Sketch of repair

<p>View A - A</p>

3.3.1 Repairs of main engines and propeller excited vibration damage should be made by returning the structure to its original condition. In order to prevent recurrence of the damage the cause of the vibration should be ascertained and additional reinforcements provided as found necessary (See **Examples 1** and **2**).

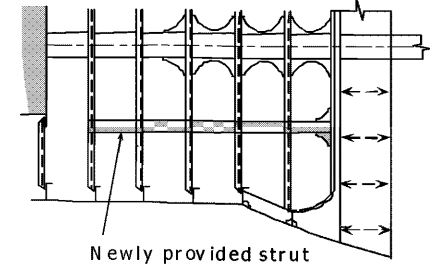
<p>Newly provided strut</p>	
<b>Notes on possible cause of damage</b> 1. Vibration.		<b>Notes on repairs</b> 1. The fractured plating should be cropped and renewed. 2. Natural frequency of the panel should be changed, e.g. reinforcement by additional strut.

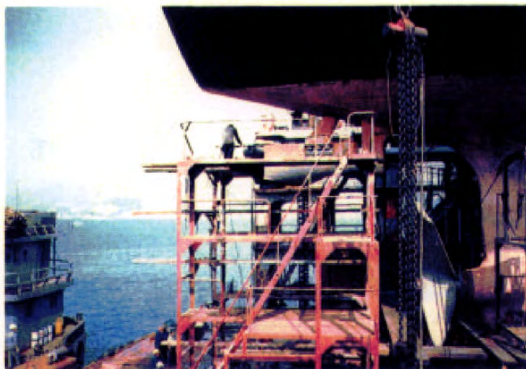
**Photograph 1**  
**Fractured rudder due to corrosion in rudder plating**

Corrosion/erosion (such as deep pitting corrosion) should be looked for in rudder/rudder horn, especially in welds. In extreme cases the corrosion/erosion may cause a large fracture as shown in **Photograph 1**.

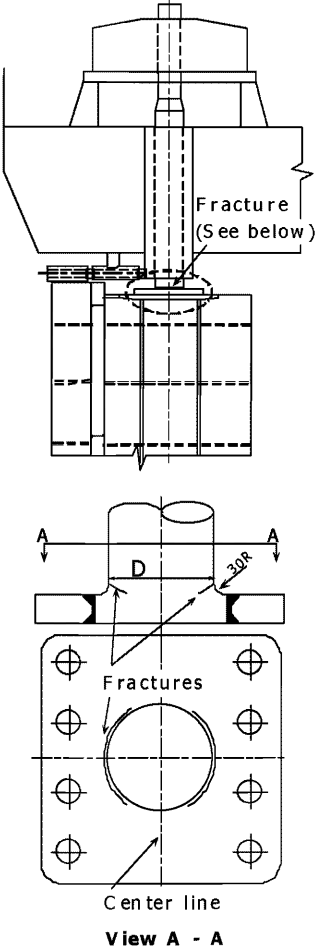
GENERAL CARGO SHIPS		Guidelines for Surveys, Assessment and Repair of Hull Structure	
Part 2	Fore and aft end regions	Example No.	
Area 3	Stern frame, rudder arrangement and propeller shaft support	1	
Detail of damage		Fracture in rudder stock	
Sketch of damage		Sketch of repair

<p>Fracture (See below)</p> <p>Fractures</p> <p>Center line</p> <p>View A - A</p>

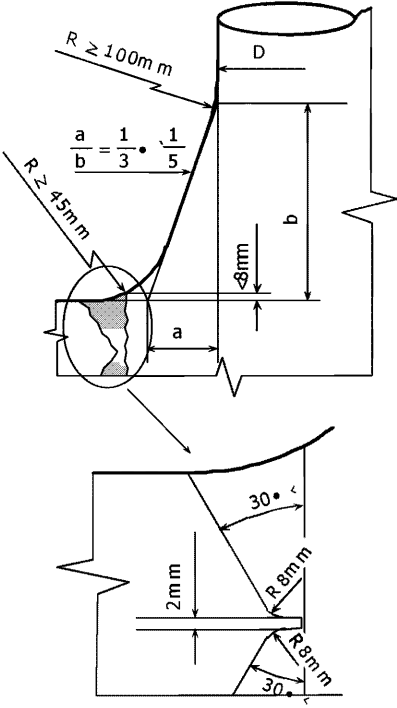
<p><math>R \geq 100\text{mm}</math></p> <p><math>\frac{a}{b} = \frac{1}{3} \cdot \frac{1}{5}</math></p> <p><math>R \geq 45\text{mm}</math></p> <p><math>&lt;8\text{mm}</math></p> <p><math>30^\circ</math></p> <p><math>R 8\text{mm}</math></p> <p><math>2\text{mm}</math></p> <p><math>30^\circ</math></p>	
Notes on possible cause of damage		Notes on repairs	
1. Inadequate design for stress concentration in rudder stock.		1. Modification of detail design of rudder stock to reduce the stress concentration.

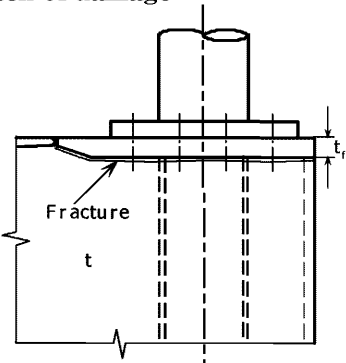
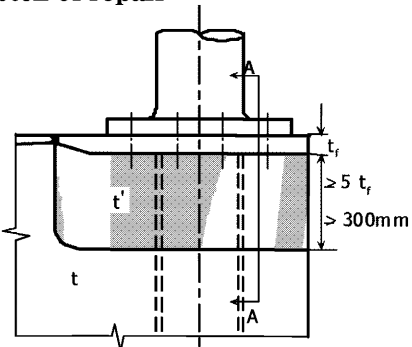
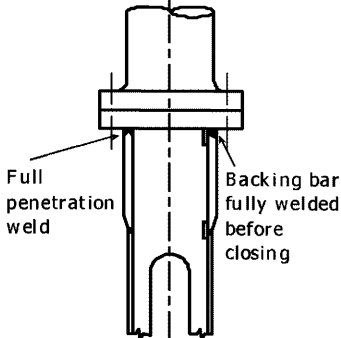
GENERAL CARGO SHIPS		Guidelines for Surveys, Assessment and Repair of Hull Structure
Part 2	Fore and aft end regions	Example No.
Area 3	Stern frame, rudder arrangement and propeller shaft support	2
Detail of damage	Fracture in connection of palm plate to rudder blade	
Sketch of damage	Sketch of repair

<p>View A - A</p>

<p>Full penetration weld</p> <p>Backing bar fully welded before closing</p> <p><math>t</math> = plate thickness, mm  <math>t_r</math> = actual flange thickness, mm  <math>t' = \frac{t_r}{3} + 5</math>, mm, where <math>t_r &lt; 50</math>mm  <math>t' = 3 \sqrt{t_r}</math>, mm, where <math>t_r \geq 50</math>mm</p>	
Notes on possible cause of damage	Notes on repairs

1. Inadequate connection between palm plate and rudder blade plating (insufficient plating thickness and/or insufficient fillet weld).	1. Modification of detail design of the connection by increasing the plate thickness and full penetration welding.

- 2.2.4 Fractures should be looked for at the transition radius between rudder stock and horizontal coupling (palm) plate, and the connection between horizontal coupling plate and rudder blade in case of horizontal coupling. Typical fractures are shown in **Examples 1 and 2**. Fatigue fractures should be looked for at the palm plate itself in case of loosened or lost coupling bolts.

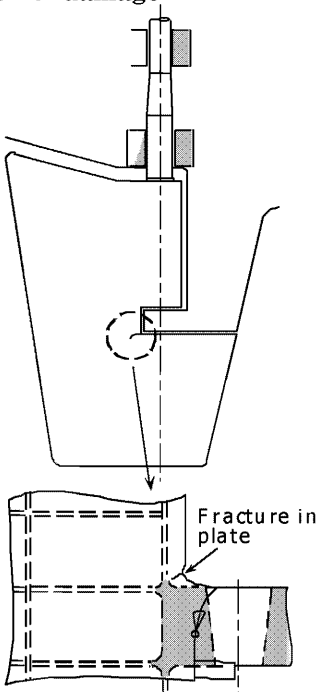
GENERAL CARGO SHIPS		Guidelines for Surveys, Assessment and Repair of Hull Structure
Part 2	Fore and aft end regions	Example No.
Area 3	Stern frame, rudder arrangement and propeller shaft support	3
Detail of damage	Fracture in rudder plating of semi-spade rudder (short fracture with end located forward of the vertical web)	
Sketch of damage	Sketch of repair

<p>Fracture in plate</p>

- 2.2.2 Fractures should be looked for at weld connection between rudder horn, propeller boss and propeller shaft brackets, and stern frame.
- 2.2.3 Fractures should be looked for at the upper and lower corners in way of the pintle recess in case of semi-spade rudders. Typical fractures are shown in **Examples 3 to 5**.

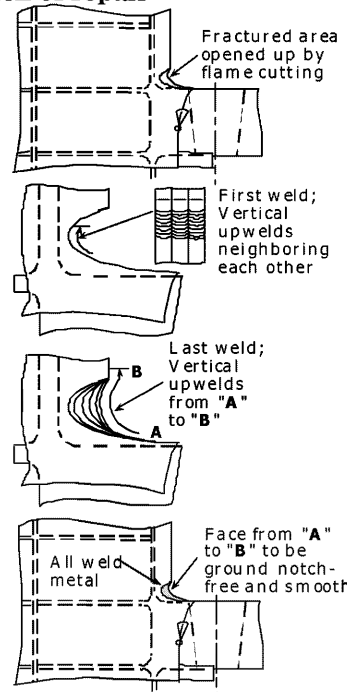
<p>Fractured area opened up by flame cutting</p> <p>First weld; Vertical upwelds neighboring each other</p> <p>Last weld; Vertical upwelds from "A" to "B"</p> <p>All weld metal</p> <p>Face from "A" to "B" to be ground notch-free and smooth</p>	
<b>Notes on possible cause of damage</b> <ol style="list-style-type: none"> <li>1. Stress concentration due to inadequate local design and/or fabrication notches in way of the butt weld between cast piece and plating.</li> </ol>	<b>Notes on repairs</b> <ol style="list-style-type: none"> <li>1. Grooving-out and welding of the fracture is not always adequate (metallurgical notch in way of a high stressed area).</li> <li>2. In the proposed repair procedure the metallurgical notches are shifted into a zone exposed to lower stresses.</li> <li>3. After welding a modification of the radius according to the proposal in <b>Example 5</b> is to be carried out.</li> <li>4. In case of very small crack it can be ground off by increasing the radius.</li> </ol>

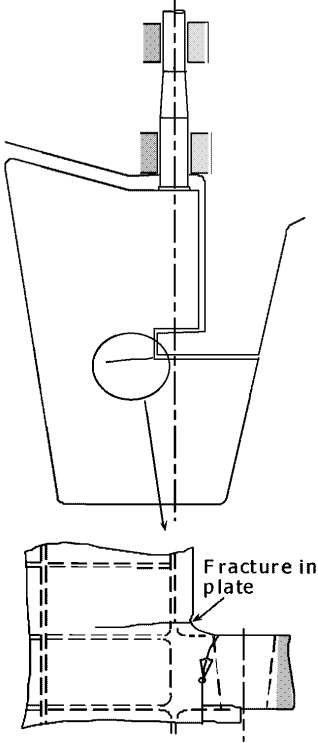
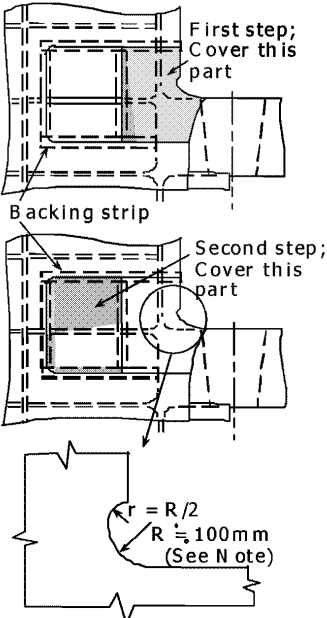
GENERAL CARGO SHIPS		Guidelines for Surveys, Assessment and Repair of Hull Structure	
Part 2	Fore and aft end regions	Example No.	
Area 3	Stern frame, rudder arrangement and propeller shaft support	4	
Detail of damage	Fracture in rudder plating of semi-spade rudder extending beyond the vertical web		
Sketch of damage		Sketch of repair

<p>Note: R should be considered according to local detail</p>	
<b>Notes on possible cause of damage</b> <ol style="list-style-type: none"> <li>1. Stress concentration due to inadequate local design and/or fabrication notches in way of the butt weld between cast piece and plating.</li> </ol>		<b>Notes on repairs</b> <ol style="list-style-type: none"> <li>1. Fractured plating is to be cut-out.</li> <li>2. Internal structures are to be checked.</li> <li>3. Cut-out is to be closed by an insert plating according to the sketch (welding only from one side is demonstrated).</li> <li>4. Modification of the radius.</li> <li>5. In case of a new cast piece, connection with the plating is to be shifted outside the high stress area.</li> </ol>

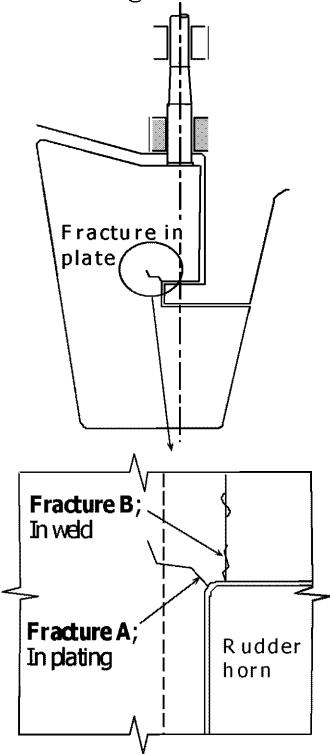
GENERAL CARGO SHIPS		Guidelines for Surveys, Assessment and Repair of Hull Structure
Part 2	Fore and aft end regions	Example No.
Area 3	Stern frame, rudder arrangement and propeller shaft support	5
Detail of damage	Fracture in rudder plating of semi-spade rudder in way of pintle cutout	
<b>Sketch of damage</b>

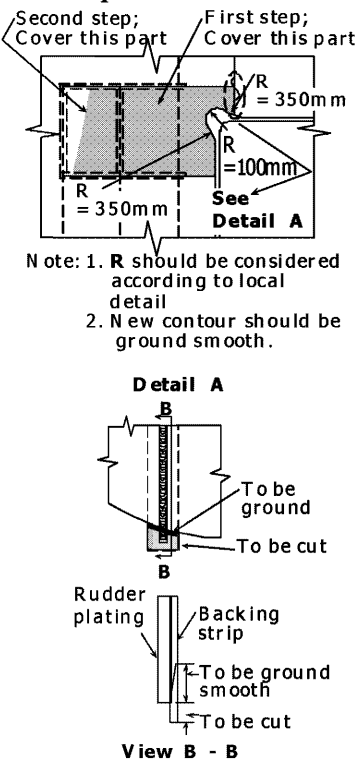
<b>Sketch of repair</b>

<p>Note: 1. <b>R</b> should be considered according to local detail 2. New contour should be ground smooth.</p> <p><b>Detail A</b></p> <p>Rudder plating Backing strip To be ground To be cut <b>View B - B</b></p>
<b>Notes on possible cause of damage</b> 1. Inadequate design for stress concentration in way of pintle bearing 2. ( <b>Fracture A</b> ). Imperfection in welding seam ( <b>Fracture B</b> ).		<b>Notes on repairs</b> 1. Fractured part to be cropped off. 2. Repair by two insert plates of modified, stress releasing contour. For the vertical seam no backing strip is used 100mm off contour, welding from both sides, to be ground after welding. 3. Variant (See <b>Detail A</b> ): Repair as mentioned under 2 with the use of backing strip for the complete vertical seam. After welding backing strip partly removed by grinding.

The area of the pintle recess corners has to be ground smooth after the repair. In many cases a modification of the radius, an increased thickness of plating and an enhanced steel quality may be necessary.

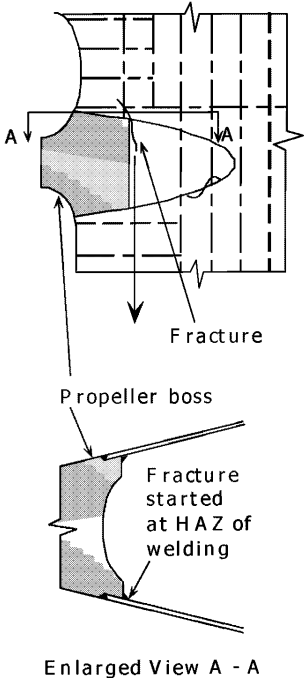
GENERAL CARGO SHIPS		Guidelines for Surveys, Assessment and Repair of Hull Structure
Part 2	Fore and aft end regions	Example No.
Area 3	Stern frame, rudder arrangement and propeller shaft support	6
Detail of damage	Fracture in side shell plating at the connection to propeller boss	
Sketch of damage		Sketch of repair

<p>Fracture</p> <p>Propeller boss</p> <p>Fracture started at HAZ of welding</p> <p>Enlarged View A - A</p>

Repair examples for propeller boss and stern tube are shown in **Examples 6** and **7**. Regarding the welding reference is made to **3.1.2**, **3.2.4** and **3.2.5**.

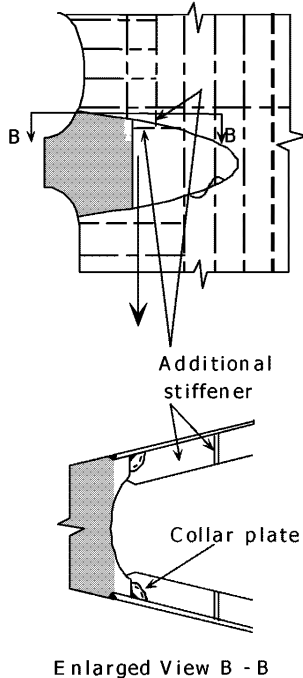
<p>Additional stiffener</p> <p>Collar plate</p> <p>Enlarged View B - B</p>
<b>Notes on possible cause of damage</b> 1. Fatigue fracture due to vibration.		<b>Notes on repairs</b> 1. Fractured side shell plating is to be cropped and part renewed. 2. Additional stiffeners are to be provided. 3. Collar plate is to be provided.

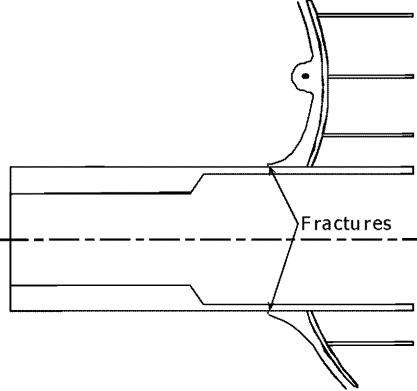
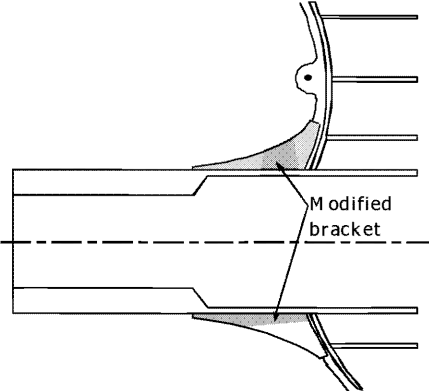
GENERAL CARGO SHIPS		Guidelines for Surveys, Assessment and Repair of Hull Structure	
Part 2	Fore and aft end regions	Example No.	
Area 3	Stern frame, rudder arrangement and propeller shaft support	7	
Detail of damage	Fracture in stern tube at the connection to stern frame		
Sketch of damage		Sketch of repair

<b>Notes on possible cause of damage</b> 1. Fatigue fracture due to vibration.		<b>Notes on repairs</b> 1. Fractured tube is to be welded from both sides. 2. Brackets are to be replaced by modified brackets with soft transition.

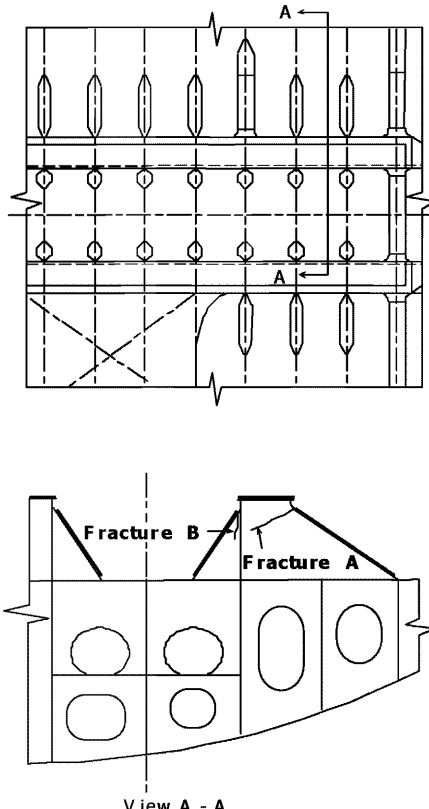
GENERAL CARGO SHIPS		Guidelines for Surveys, Assessment and Repair of Hull Structure	
Part 3	Machinery and accommodation spaces	Example No.	
Area 1	Engine room structure	1	
<b>Detail of damage</b>		<b>Fractures in brackets at main engine foundation</b>	
<p><b>Sketch of damage</b></p>

<p>View A - A</p>		<p><b>Sketch of repair</b></p>

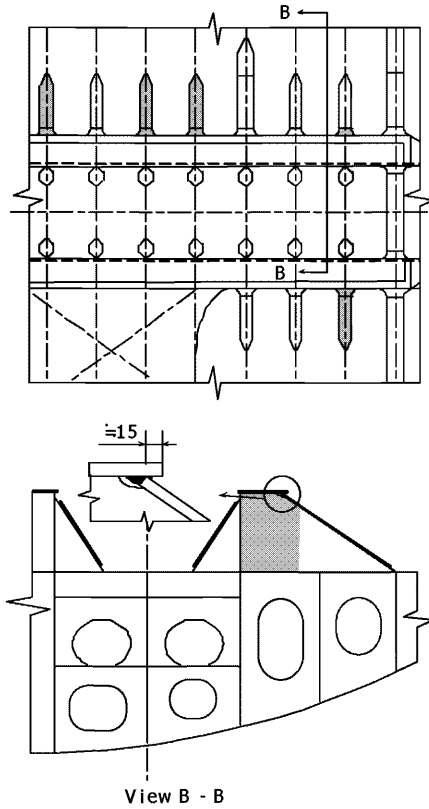
<p>View B - B</p>	
<p><b>Notes on possible cause of damage</b></p> <ol style="list-style-type: none"> <li>1. Vibration of main engine.</li> <li>2. Insufficient strength of brackets at main engine foundation.</li> <li>3. Insufficient pre-load of the bolts.</li> </ol>		<p><b>Notes on repairs</b></p> <ol style="list-style-type: none"> <li>1. Fractures may be veed-out and</li> <li>2. rewelded. New modified brackets at main engine foundation. Or insert pieces and additional flanges to increase section modulus of the brackets.</li> </ol>

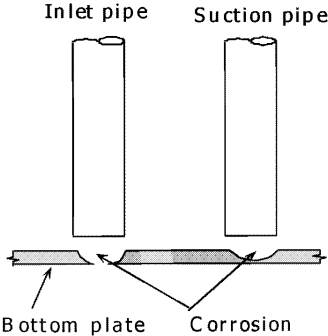
<b>GENERAL CARGO SHIPS</b>		<b>Guidelines for Surveys, Assessment and Repair of Hull Structure</b>	
<b>Part 3</b>	<b>Machinery and accommodation spaces</b>	<b>Example No.</b>	
<b>Area 1</b>	<b>Engine room structure</b>	<b>3</b>	
<b>Detail of damage</b>	Corrosion in bottom plating under inlet/suction/pipe in way of bilge tank in engine room		
<b>Sketch of damage</b>		<b>Sketch of repair</b>

<b>Notes on possible cause of damage</b>		<b>Notes on repairs</b>	
<p>1. Heavy corrosion of bottom plating under the inlet/suction pipe.</p>		<p>1. Corrode bottom plate is to be cropped and part renewed. Thicker plate is preferable.  2. Replacement of pipe end by enlarged conical opening (similar to suction head in ballast tank) is preferable.</p>

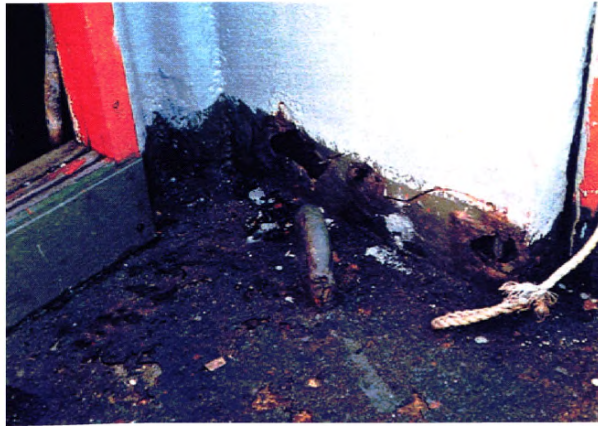
**Photograph 1** Corroded accommodation house structure

The main damage is corrosion which may cause serious problems since the structure is relatively thin. Serious corrosion may be found in exposed deck plating and its adjoining accommodation house structure where water is liable to collect (See **Photograph 1**). Corrosion is also found in accommodation bulkheads where fittings such as doors, side scuttles, ventilators, etc. are fitted and proper maintenance of the area is relatively difficult. Deterioration of the bulkheads including fittings may impair the integrity of weathertightness.
