**РОССИЙСКИЙ МОРСКОЙ РЕГИСТР СУДОХОДСТВА**  
**RUSSIAN MARITIME REGISTER OF SHIPPING**

**SUPPLEMENT TO RULES AND GUIDELINES**  
**OF RUSSIAN MARITIME REGISTER OF SHIPPING**

**IACS PROCEDURAL REQUIREMENTS,**  
**UNIFIED INTERPRETATIONS**  
**AND RECOMMENDATIONS**

## **GENERAL DRY CARGO SHIPS**

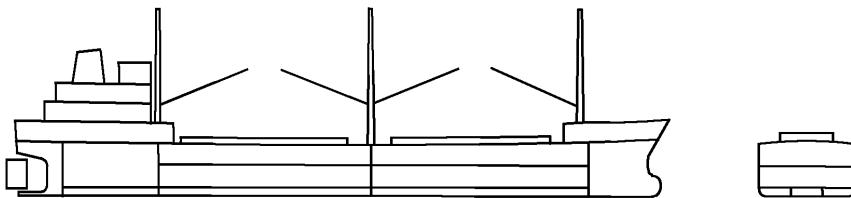
**Figure 1** General view of a typical general dry cargo ship

**Figure 1** shows a typical general arrangement of a general dry cargo ship with single tween deck.

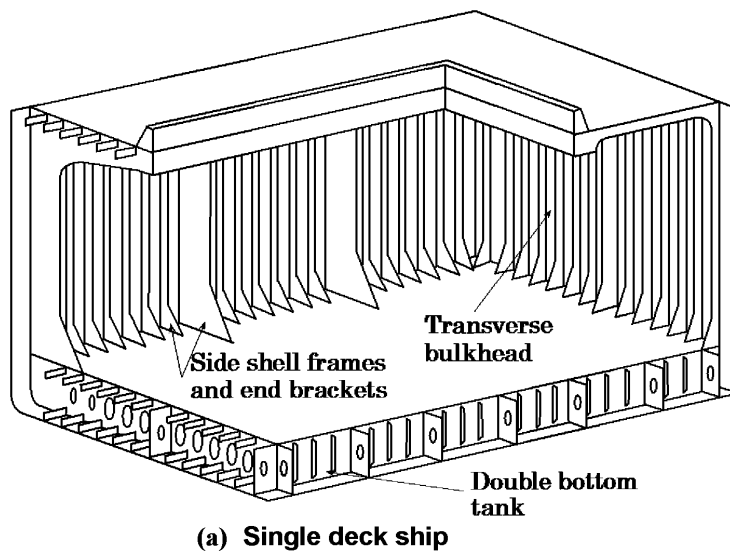
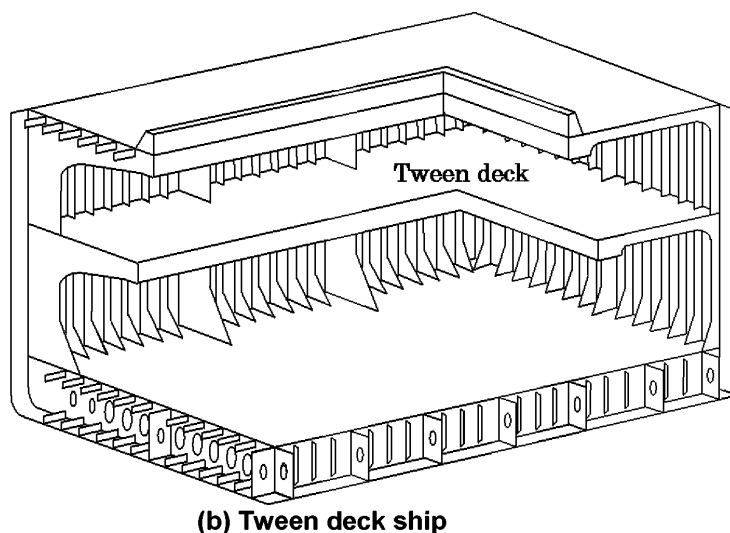
Figure 2 Cargo hold structural configurations for general dry cargo ships

**Figures 2 (a) and (b)** show cargo hold structural configurations for general dry cargo ships. As

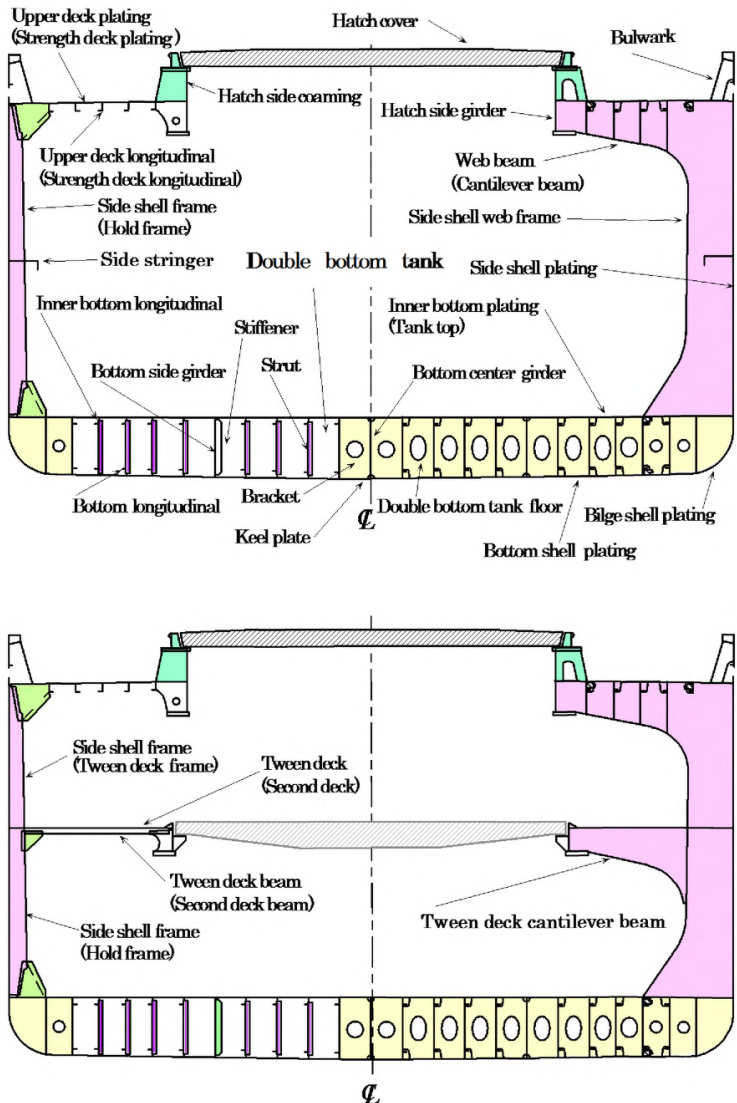
Figure 3 (a) Nomenclature for typical transverse section in way of cargo hold

- 3.2.1 For clarity of definition and reporting of survey data, it is recommended that standard nomenclature for structural elements be adopted. Typical sections in way of cargo holds are illustrated in **Figures 3 (a) and (b)**. These figures show the generally accepted nomenclature.

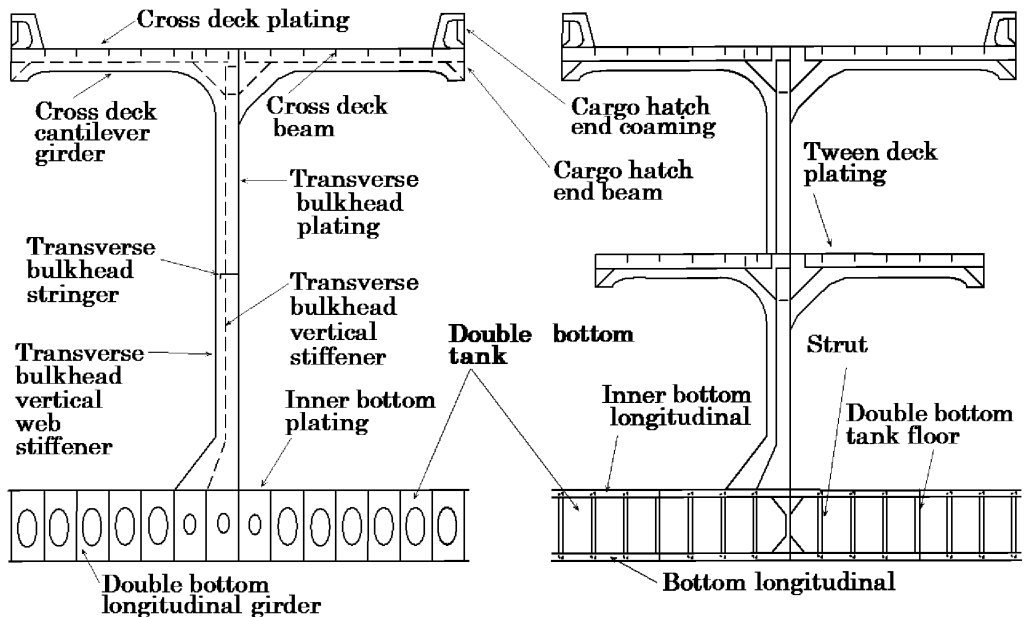
Figure 3 (b) Nomenclature for typical watertight bulkhead

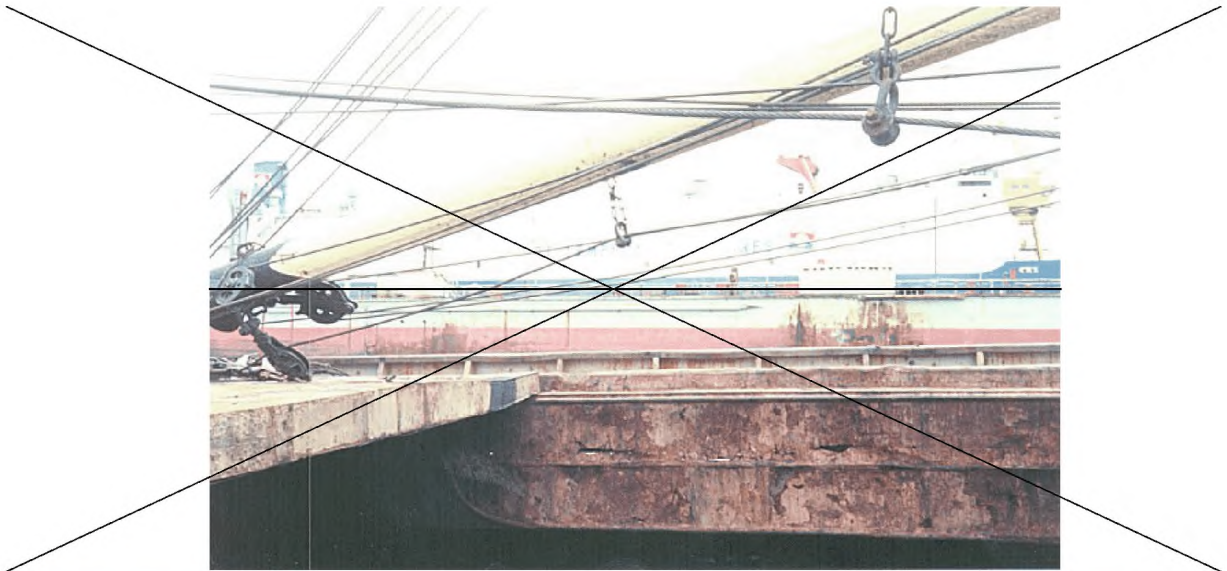
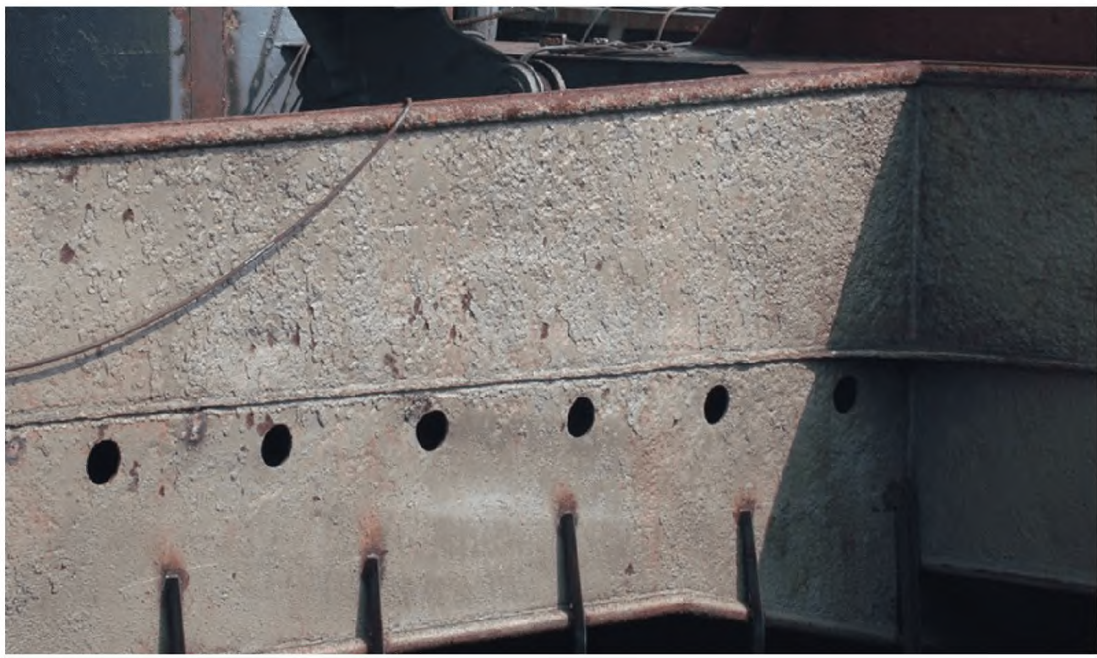
**Photograph 1 Heavy corrosion of hatch coaming**

**3.1.2** Severe corrosion of the hatch coaming from inside and of under deck girders may occur due to difficult access for maintenance of the protective coating. This may in turn lead to fractures (See **Photograph 1**).

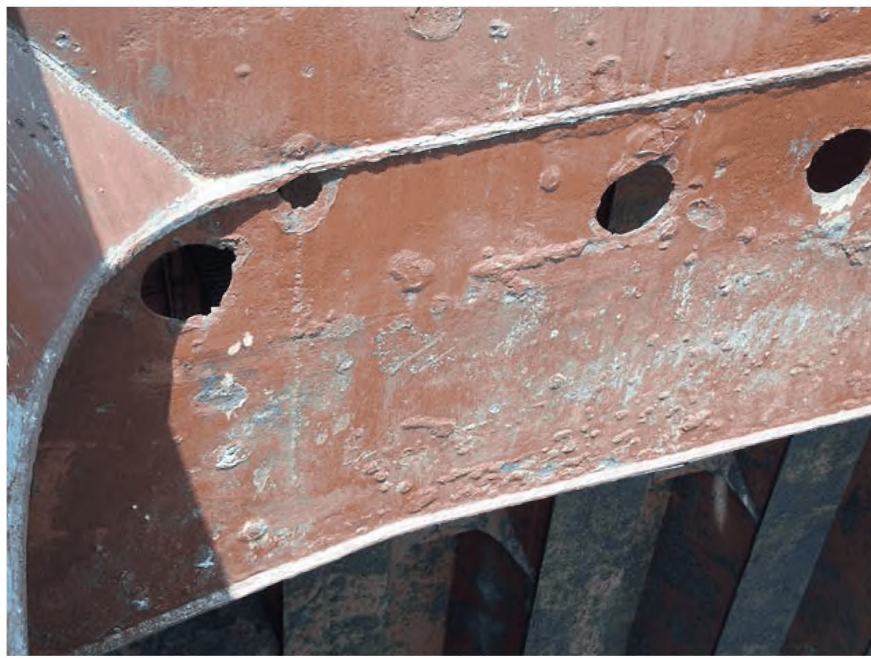
**Photograph 2 Heavy corrosion of hatch coaming**

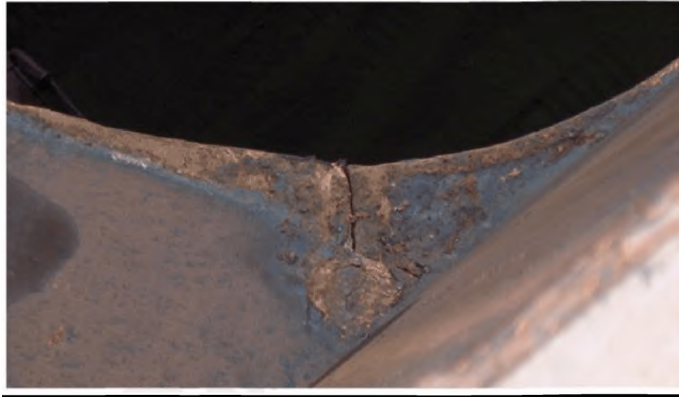
**Photograph 3 Fractures at the hatch corner**

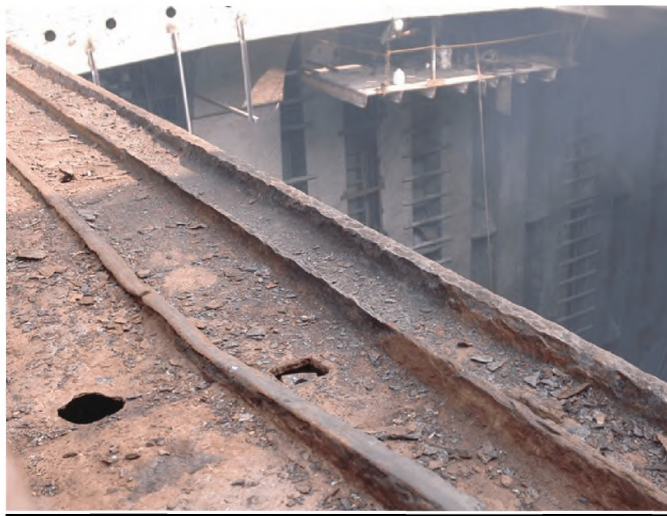
**Photograph 4 Corrosion at the top of the hatch coaming**

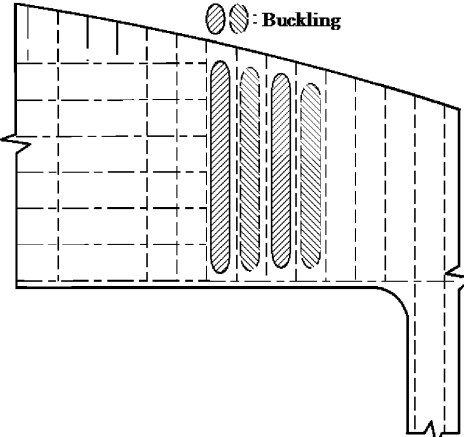
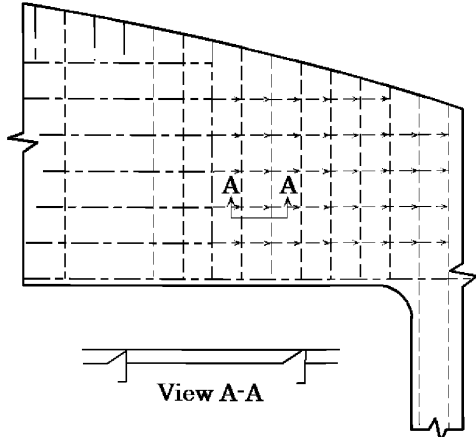
GENERAL DRY CARGO SHIPS		Guidelines for Surveys, Assessment and Repair of Hull Structure
Part 1	Cargo hold region	Example No.
Area 1	Upper deck structure	1
Detail of damage	Buckling of deck plating of transverse framing system	
Sketch of damage	Sketch of repair

<b>Notes on possible cause of damage</b> <ol style="list-style-type: none"> <li>Excessive compressive stress due to slamming or bow flare effect.</li> <li>Insufficient longitudinal stiffening of deck plating.</li> </ol>	<b>Notes on repairs</b> <ol style="list-style-type: none"> <li>Buckled plating should be cropped and renewed. Longitudinal internal stiffeners should be provided. (Instead of longitudinal stiffeners, renewal by thicker deck plating can be accepted.)</li> <li>Stress concentration may occur at the end of sniped stiffener resulting in fatigue fracture. For locations where high cyclic stress may occur, appropriate connection such as lug-connection should be considered.</li> </ol>

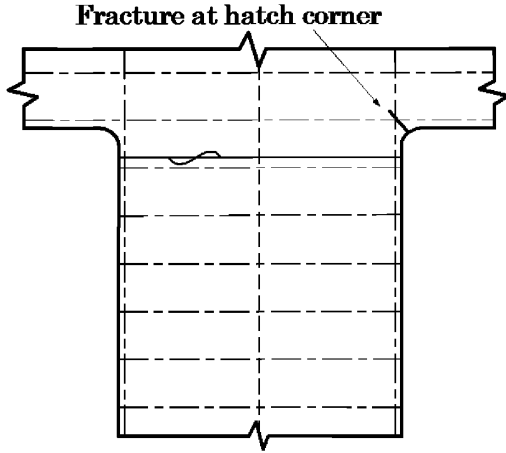
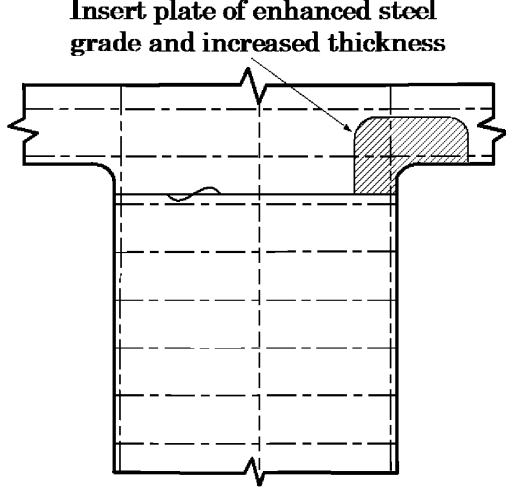
<b>GENERAL DRY CARGO SHIPS</b>		<b>Guidelines for Surveys, Assessment and Repair of Hull Structure</b>	
<b>Part 1</b>	<b>Cargo hold region</b>	<b>Example No.</b>	
<b>Area 1</b>	<b>Upper deck structure</b>	<b>2</b>	
<b>Detail of damage</b>		Fractures at main cargo hatch corner	
<b>Sketch of damage</b>

<p style="text-align: center;"><b>Fracture at hatch corner</b></p>		<b>Sketch of repair</b> <b>Insert plate of enhanced steel grade and increased thickness</b>

<b>Notes on possible cause of damage</b> <ol style="list-style-type: none"> <li>1. Stress concentration at hatch corners, i.e. radius of corner.</li> <li>2. Welded attachment of shedder plate close to edge of hatch corner.</li> <li>3. Wire rope groove.</li> </ol>		<b>Notes on repairs</b> <ol style="list-style-type: none"> <li>1. The corner plating in way of the fracture is to be cropped and renewed. If stress concentration is primary cause, insert plate should be of increased thickness, enhanced steel grade and/or improved geometry. Insert plate should be continued beyond the longitudinal and transverse extent of the hatch corner radius ellipse or parabola, and the butt welds to the adjacent deck plating should be located well clear of the butts in the hatch coaming. It is recommended that the edges of the insert plate and the butt welds connecting the insert plates to the surrounding deck plating be made smooth by grinding. In this respect caution should be taken to ensure that the micro grooves of the grinding are parallel to the plate edge.</li> <li>2. If the cause of fracture is welded attachment of shedder plate, the deck connection should be left unwelded.</li> <li>3. If the cause of the fracture is wire rope groove, replacement to the original design can be accepted.</li> </ol>

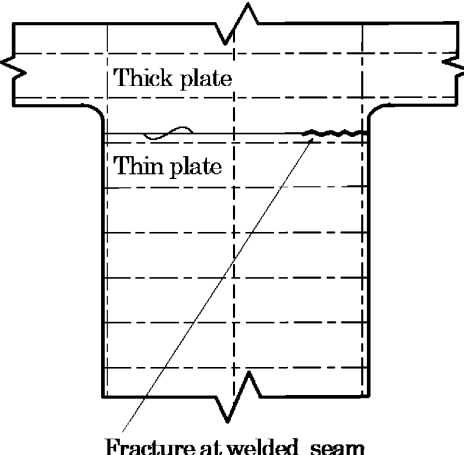
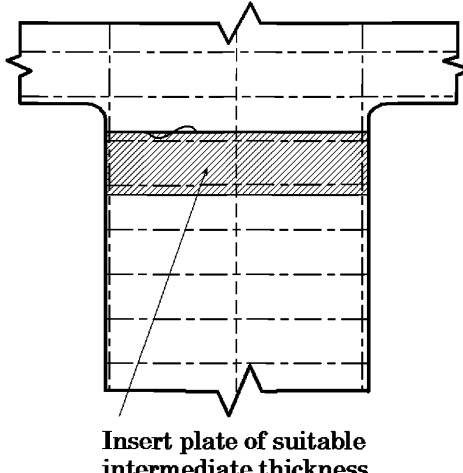
<b>GENERAL DRY CARGO SHIPS</b>		<b>Guidelines for Surveys, Assessment and Repair of Hull Structure</b>
<b>Part 1</b>	<b>Cargo hold region</b>	<b>Example No.</b>
<b>Area 1</b>	<b>Upper deck structure</b>	<b>3-a</b>
<b>Detail of damage</b>	Fracture of welded seam between thick plate and thin plate at cross deck	
<b>Sketch of damage</b>		<b>Sketch of repair</b>

<p>Thick plate</p> <p>Thin plate</p> <p>Fracture at welded seam</p>

<p>Insert plate of suitable intermediate thickness</p>
<b>Notes on possible cause of damage</b>		<b>Notes on repairs</b>
<ol style="list-style-type: none"> <li>1. Stress concentration created by abrupt change in deck plating thickness.</li> <li>2. In-plane bending in cross deck strip due to torsional (longitudinal) movements of ship sides.</li> <li>3. Welded seam not clear of tangent point of hatch corner.</li> </ol>		<ol style="list-style-type: none"> <li>1. Insert plate of intermediate thickness is recommended.</li> <li>2. Smooth transition between plates (beveling) should be considered.</li> </ol>

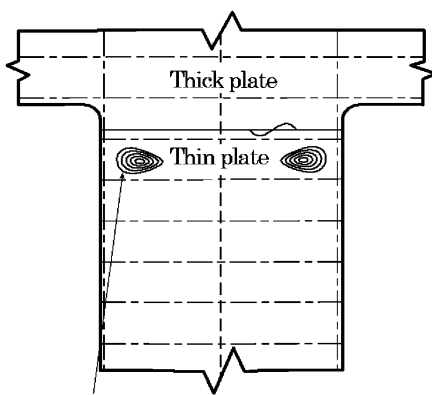
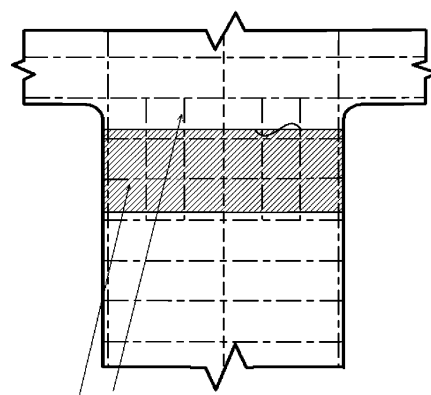
<b>GENERAL DRY CARGO SHIPS</b>		<b>Guidelines for Surveys, Assessment and Repair of Hull Structure</b>
<b>Part 1</b>	<b>Cargo hold region</b>	<b>Example No.</b>
<b>Area 1</b>	<b>Upper deck structure</b>	<b>3-b</b>
<b>Detail of damage</b>	Plate buckling in thin plate near thick plate at cross deck	
<b>Sketch of damage</b>	<b>Sketch of repair</b>

<p><b>Buckling of cross deck plating</b></p>

<p><b>Additional transverse stiffening and/or insertion of plate with suitable intermediate thickness</b></p>	
<b>Notes on possible cause of damage</b>	<b>Notes on repairs</b>	
<ol style="list-style-type: none"> <li>1. In-plane bending of cross deck strip due to torsional (longitudinal) movement of ship sides, often in combination with corrosion.</li> <li>2. Insufficient transverse stiffening.</li> </ol>	<ol style="list-style-type: none"> <li>1. Transverse stiffeners extending from hatch sides towards centerline at least 10% of breadth of hatch, and/or increased plate thickness in the same area.</li> </ol>

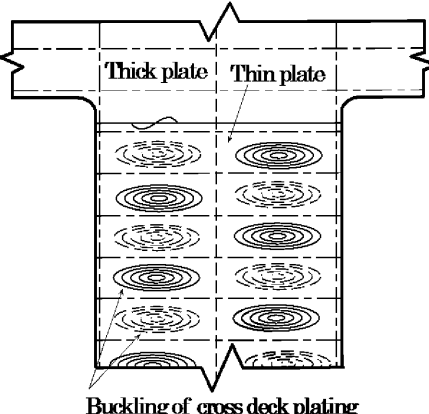
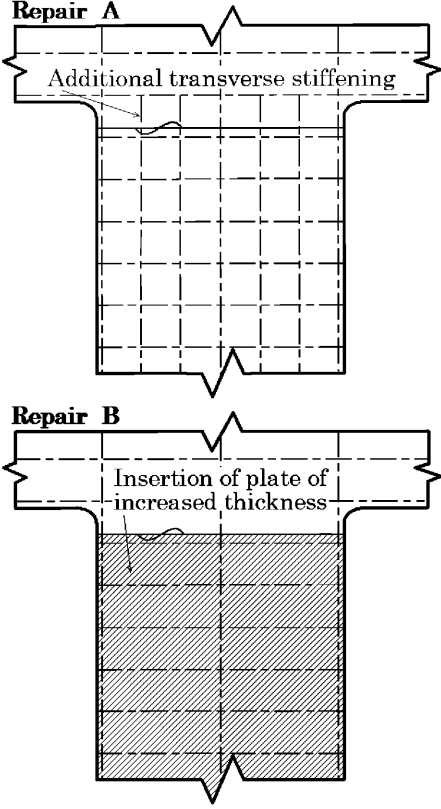
GENERAL DRY CARGO SHIPS		Guidelines for Surveys, Assessment and Repair of Hull Structure
Part 1	Cargo hold region	Example No.
Area 1	Upper deck structure	3-c
Detail of damage		Overall buckling of cross deck plating
Sketch of damage		Sketch of repair

<p>Buckling of cross deck plating</p>

<p>Repair A Additional transverse stiffening</p> <p>Repair B Insertion of plate of increased thickness</p>
Notes on possible cause of damage		Notes on repairs
<ol style="list-style-type: none"> <li>1. Transverse compression of deck due to sea load.</li> <li>2. Insufficient transverse stiffening.</li> </ol>		<ol style="list-style-type: none"> <li>1. <b>Repair A</b> Plating of original thickness in combination with additional transverse stiffening.</li> <li>2. <b>Repair B</b> Insertion of plating of increased thickness.</li> </ol>

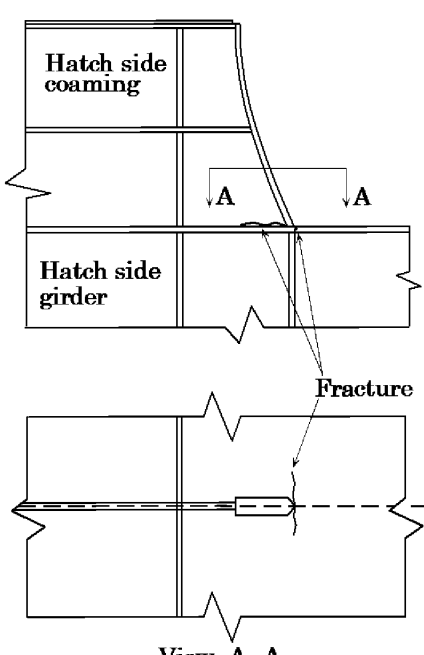
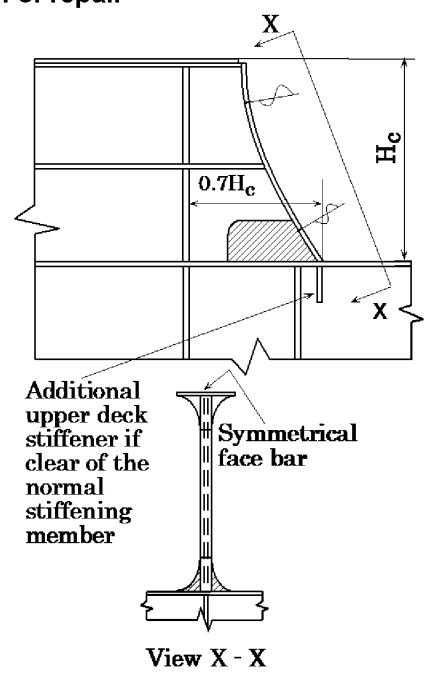
GENERAL DRY CARGO SHIPS		Guidelines for Surveys, Assessment and Repair of Hull Structure
Part 1	Cargo hold region	Example No.
Area 1	Upper deck structure	5-a
Detail of damage		Fractures in the web or in the deck at the toes of the longitudinal hatch coaming termination bracket (discontinuous longitudinal hatch coaming)
<b>Sketch of damage</b>

<b>Notes on possible cause of damage</b> 1. This damage is caused by stress concentrations attributed to the design of the bracket.		<b>Notes on repairs</b> 1. The design of the bracket can be altered as shown above, however, it is to be ensured that an additional under deck stiffener is provided at the toe of the termination bracket, where the toe is clear of the normal stiffening member. Full penetration weld for a distance of $0.15 H_c$ 2. from toe of side coaming termination bracket and for connection of athwartship gusset bracket to deck. The fracture in deck plating to be veed-out and 3. rewelded or deck plating cropped and part renewed as appropriate, using low hydrogen electrodes for welding.

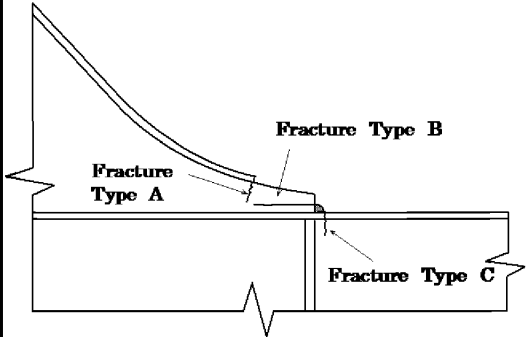
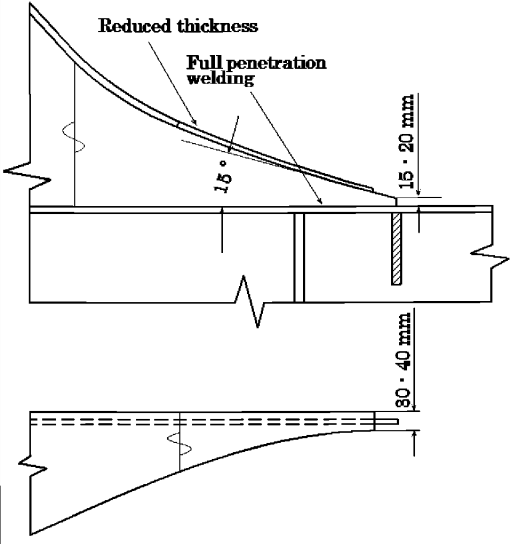
GENERAL DRY CARGO SHIPS		Guidelines for Surveys, Assessment and Repair of Hull Structure
Part 1	Cargo hold region	Example No.
Area 1	Upper deck structure	5-b
Detail of damage		Fractures in continuous longitudinal hatch coaming extension bracket
<b>Sketch of damage</b>

<b>Notes on possible cause of damage</b> <ol style="list-style-type: none"> <li>1. Flange force at the end of the flange too high due to insufficient tapering (<b>Fracture Type A</b>, propagating in the web).</li> <li>2. Shear force in the web plate too high due to insufficient reduction of the web height at the end (<b>Fracture Type B</b>, propagating in the web at the undercut or HAZ of the fillet weld). Insufficient support of the extension bracket below the deck (<b>Fracture Type C</b>, starting from undercut or HAZ of the fillet weld and propagating in the deck plating).</li> </ol>		<b>Notes on repairs</b> <ol style="list-style-type: none"> <li>1. Extend the extension bracket as long as possible to arrange a gradual transition.</li> <li>2. Reduce the web height at the end of the bracket; in case of high stress areas grind smooth the transition to the deck plating welding.</li> <li>3. Reduce the cross sectional area of the flange at the end as far as possible.</li> <li>4. Provide longitudinal structure in way of the web of the extension bracket to the next transverse structure or provide a new transverse structure.</li> </ol>

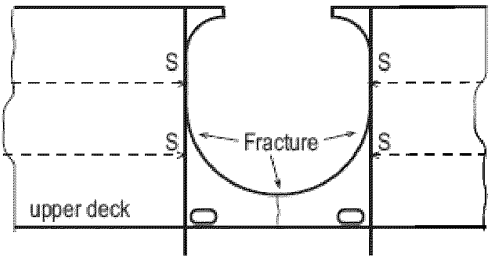
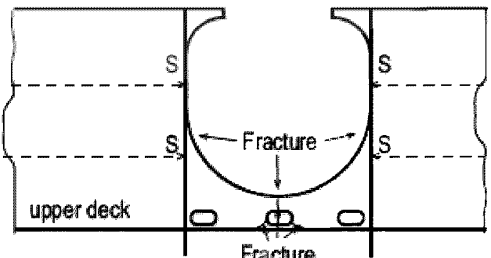
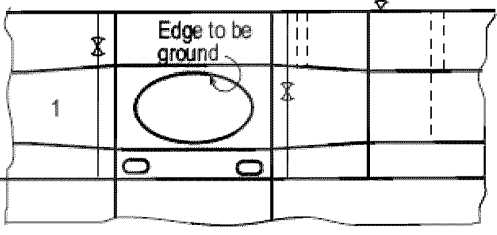
<b>GENERAL DRY CARGO SHIPS</b>		<b>Guidelines for Surveys, Assessment and Repair of Hull Structure</b>
<b>Part 1</b>	<b>Cargo hold region</b>	<b>Example No.</b>
<b>Area 1</b>	<b>Upper deck structure</b>	<b>5-c</b>
<b>Detail of damage</b>		<b>Fracture in access hole of longitudinal hatch coaming</b>
<b>Sketch of damage</b>

<b>Notes on possible cause of damage</b> <u>1. Coincidence of maximum increased stress due to the reduction of the hatch coaming with the metallurgical notches due to the welding seams in web and flat bar located at the same position. Insufficient transverse stiffening.</u>		<b>Notes on repairs</b> <u>1. Hatch coaming to be continuous.</u> <u>2. Access opening to be provided.</u> <u>3. Drain holes to be elliptical and located above fillet weld to deck.</u> <u>4. Hatch coaming stiffeners of same material as coaming.</u>

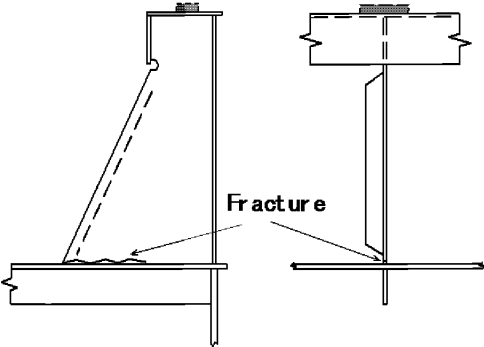
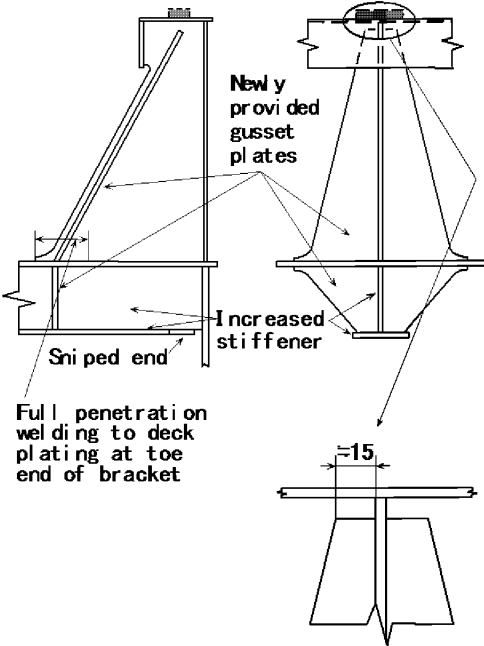
GENERAL DRY CARGO SHIPS		Guidelines for Surveys, Assessment and Repair of Hull Structure
Part 1	Cargo hold region	Example No.
Area 1	Upper deck structure	6
Detail of damage		Fractures in web of transverse hatch coaming stay
<b>Sketch of damage</b>

<b>Notes on possible cause of damage</b> 1. Insufficient consideration of the horizontal friction forces in way of the resting pads for hatch cover.		<b>Notes on repairs</b> 1. Modification of the design of the hatch coaming stay. 2. Full penetration welding between gusset plates and deck plating. 3. Strengthening and continuation of the structure below the deck. 4. Use pads with smaller coefficient of friction.

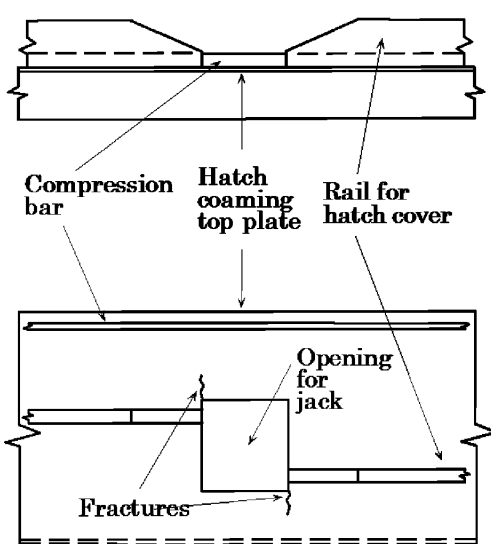
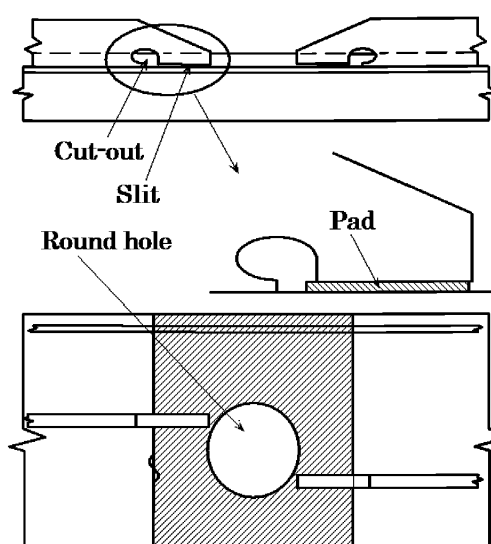
GENERAL DRY CARGO SHIPS		Guidelines for Surveys, Assessment and Repair of Hull Structure
Part 1	Cargo hold region	Example No.
Area 1	Upper deck structure	7-b
Detail of damage	Fractures in hatch coaming top plate at the termination of rail for hatch cover	
Sketch of damage	Sketch of repair

<p>Compression bar</p> <p>Hatch coaming top plate</p> <p>Rail for hatch cover</p> <p>Opening for jack</p> <p>Fractures</p>

<p>Cut-out</p> <p>Slit</p> <p>Round hole</p> <p>Pad</p>	
Notes on possible cause of damage	Notes on repairs	
<ol style="list-style-type: none"> <li>1. Stress concentration at the termination of the rail for hatch cover.</li> </ol>	<ol style="list-style-type: none"> <li>1. Fractured plate is to be cropped and part renewed.</li> <li>2. Thicker insert plate and/or reduction of stress concentration adopting large radius should be considered. Or cut-out in the rail and detachment of the welds as shown in the above drawing should be considered in order to reduce the stress of the corner of the opening.</li> </ol>

<b>GENERAL DRY CARGO SHIPS</b>		<b>Guidelines for Surveys, Assessment and Repair of Hull Structure</b>
<b>Part 1</b>	<b>Cargo hold region</b>	<b>Example No.</b>
<b>Area 1</b>	<b>Upper deck structure</b>	<b>7-a</b>
<b>Detail of damage</b>	Fractures in hatch coaming top plate at the termination of rail for hatch cover	
<p><b>Sketch of damage</b></p>		<p><b>Sketch of repair</b></p>
<p><b>Notes on possible cause of damage</b></p> <ol style="list-style-type: none"> <li>1. Stress concentration at the termination of the rail for hatch cover.</li> </ol>		<p><b>Notes on repairs</b></p> <ol style="list-style-type: none"> <li>1. Fractured plate is to be cropped and part renewed.</li> <li>2. Thicker insert plate and/or reinforcement by additional stiffener under the top plate should be considered. Also refer to <b>Example 7-b</b>.</li> </ol>

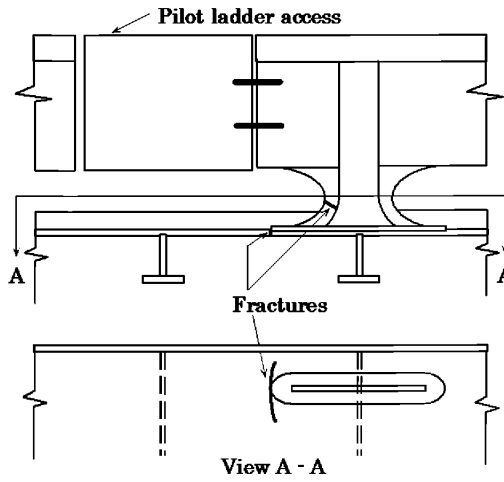
<b>GENERAL DRY CARGO SHIPS</b>		<b>Guidelines for Surveys, Assessment and Repair of Hull Structure</b>
<b>Part 1</b>	<b>Cargo hold region</b>	<b>Example No.</b>
<b>Area 1</b>	<b>Upper deck structure</b>	<b>9</b>
<b>Detail of damage</b>	Fracture in deck plating at the pilot ladder access of bulwarks	
<b>Sketch of damage</b>	<b>Sketch of repair</b>

<p>Pilot ladder access</p> <p>Fractures</p> <p>View A - A</p>

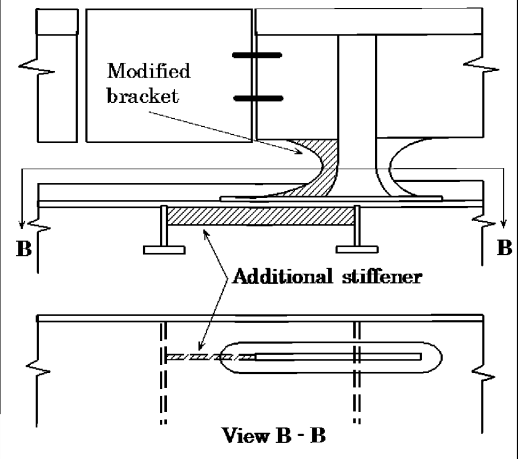
<p>Modified bracket</p> <p>Additional stiffener</p> <p>View B - B</p>	
<b>Notes on possible cause of damage</b>	<b>Notes on repairs</b>	
<ol style="list-style-type: none"> <li>1. Stress concentration at the termination of bulwarks.</li> </ol>	<ol style="list-style-type: none"> <li>1. Fractured deck plating should be cropped and part renewed.</li> <li>2. Reduction of stress concentration should be considered. In the above figure gusset plate was replaced with soft type for the fracture in gusset plate and pad plate was increased. Additional stiffeners were provided for the fracture in deck plating.</li> </ol>

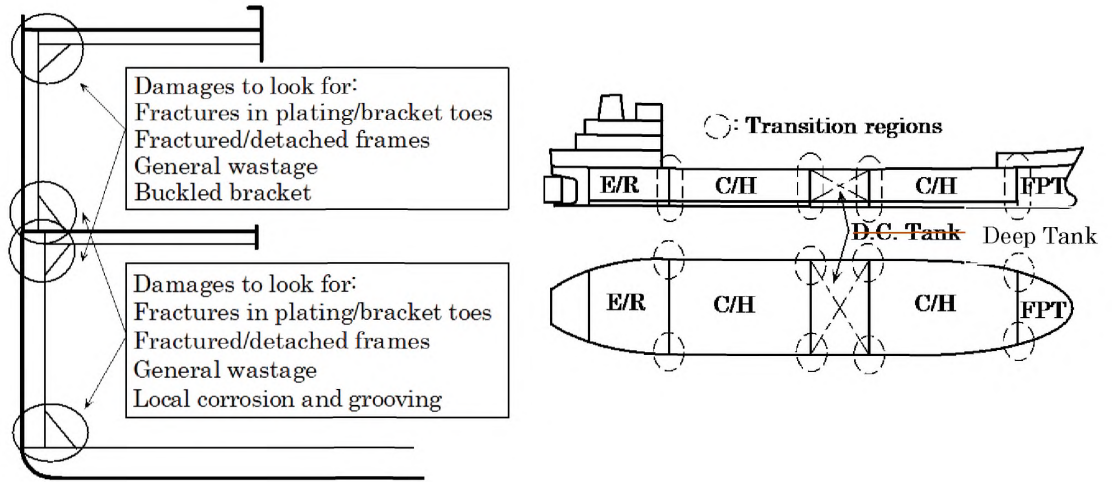
(a) Side shell frames (b) Transition regions  
 Figure 1 Potential problem problems areas

- 1.6 A summary of potential problem areas is shown in **Figures 1 (a) and (b)**. Serious consequences of damaged ship sides are illustrated in **Photographs 1 and 2**.

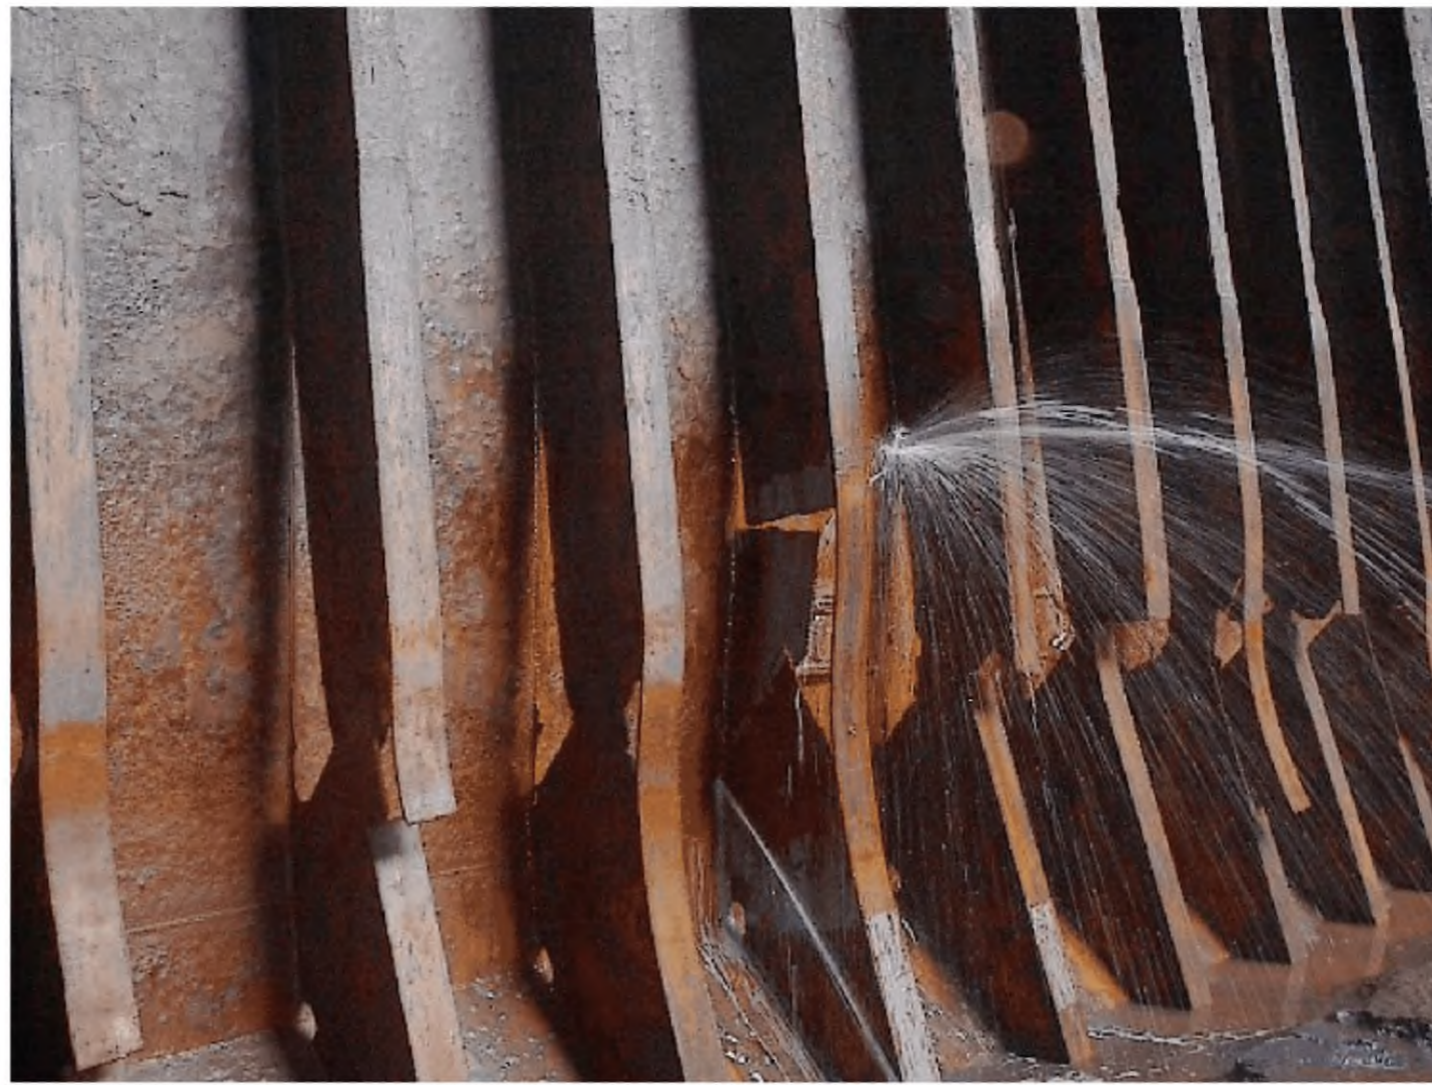
**Photograph 1** Leakage from side shell plating due to heavy corrosion

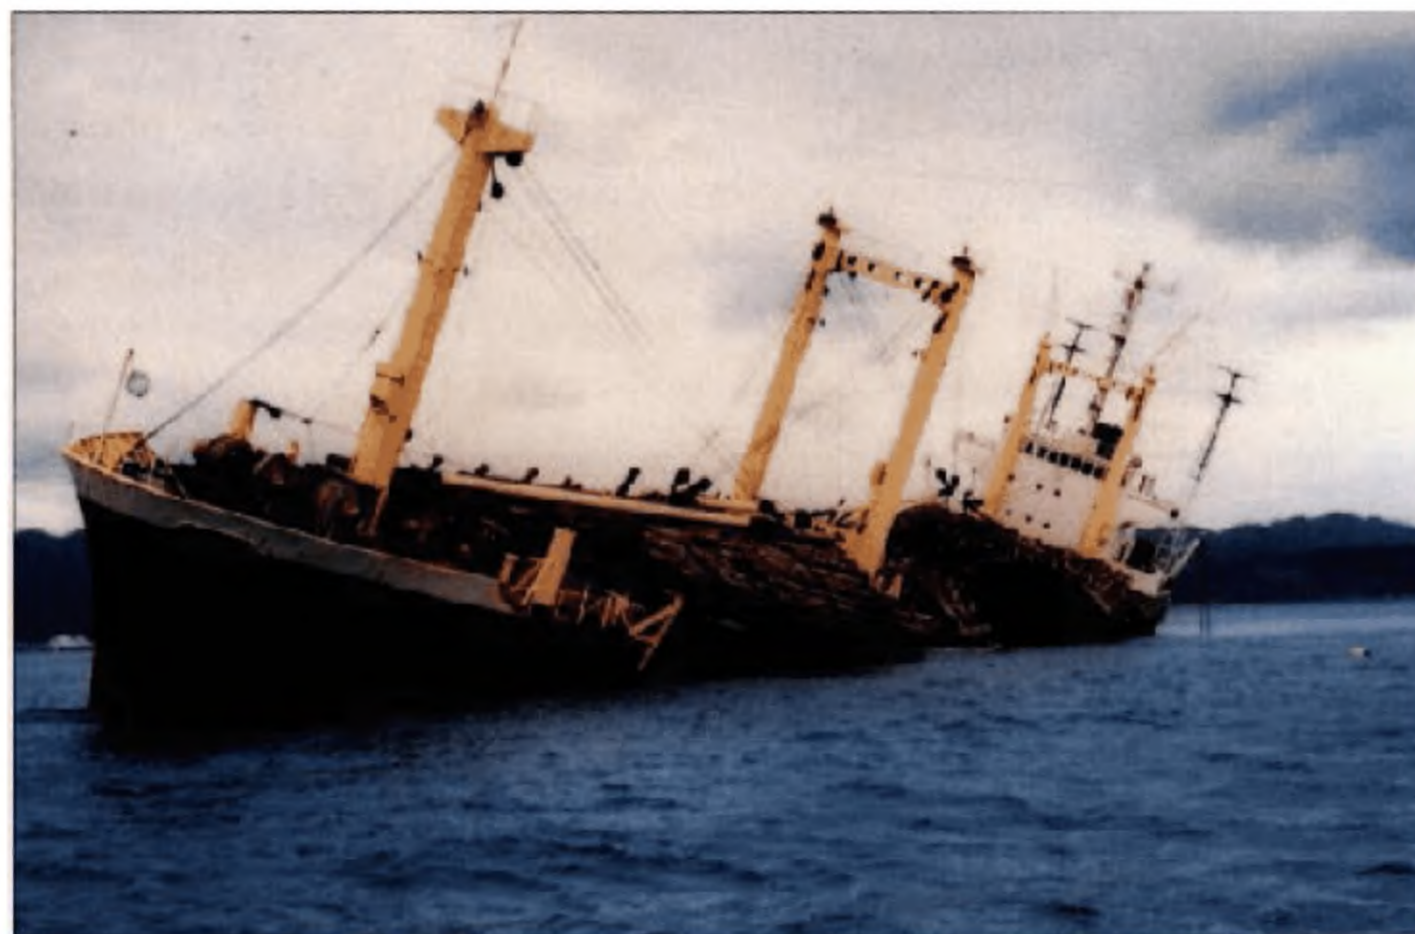
**Photograph 2** Timber carrier listing due to ingress of water

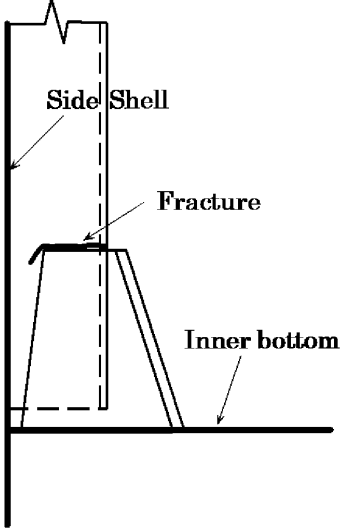
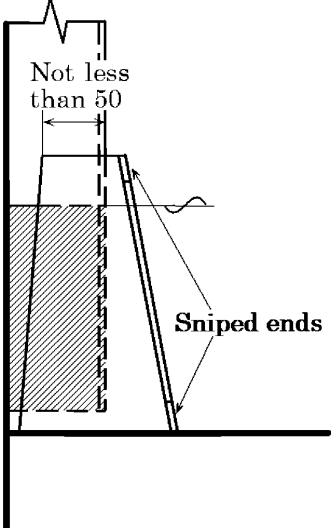
<b>GENERAL DRY CARGO SHIPS</b>		<b>Guidelines for Surveys, Assessment and Repair of Hull Structure</b>	
<b>Part 1</b>	<b>Cargo hold region</b>	<b>Example No.</b>	
<b>Area 2</b>	<b>Side structure</b>	<b>1</b>	
<b>Detail of damage</b>		Fracture in side shell frame at lower bracket	
<b>Sketch of damage</b>		<b>Sketch of repair</b>

<b>Notes on possible cause of damage</b>		<b>Notes on repairs</b>	
<p>1. This type of damage is caused due to stress concentration.</p>		<p>1. For small fractures, e. g. hairline fractures, the fracture can be veed-out, welded up, ground, examined by NDT for fractures, and rewelded. For larger/significant fractures consideration is</p> <p>2. to be given to cropping and partly renewing/renewing the frame brackets. If renewing the brackets, end of frames can be sniped to soften them.</p> <p>If felt prudent, soft toes are to be incorporated</p> <p>3. at the boundaries of the bracket to the inner bottom plating.</p>

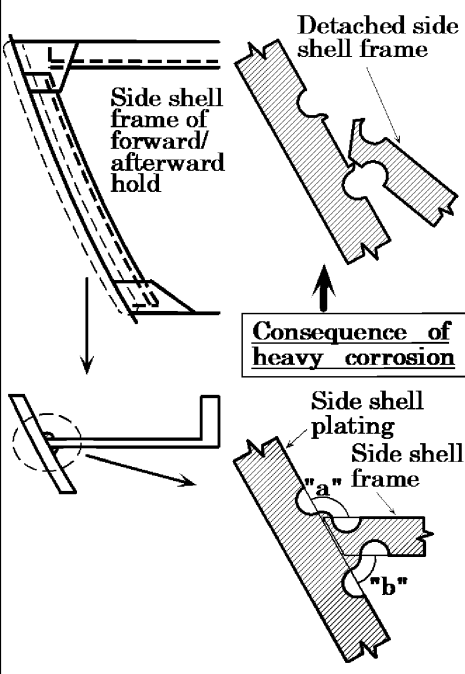
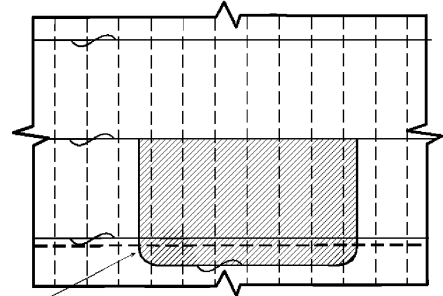
GENERAL DRY CARGO SHIPS		Guidelines for Surveys, Assessment and Repair of Hull Structure
Part 1	Cargo hold region	Example No.
Area 2	Side structure	3
Detail of damage	Adverse effect of corrosion on the frame of forward/afterward hold	
Sketch of damage		Sketch of repair

<ol style="list-style-type: none"> <li>1. Part renewal including side shell frames and inner bottom plating, as found necessary</li> <li>2. Deep penetration welding at the connections of side shell frames to side shell plating</li> </ol>
<b>Notes on possible cause of damage</b> <ol style="list-style-type: none"> <li>1. Heavy corrosion (grooving) of side shell frame along side shell plating and difference of throat thickness "a" from "b". (Since original throat thickness of "a" is usually smaller than that of "b", if same welding procedure is applied, the same corrosion has a more severe effect on "a", and may cause collapse and/or detachment of side shell frame.)</li> </ol>		<b>Notes on repairs</b> <ol style="list-style-type: none"> <li>1. Sketch of repair applies when damage extends over several frames.</li> <li>2. Isolated fractures may be repaired by veeing-out and rewelding.</li> <li>3. Isolated cases of grooving may be repaired by build up of welding.</li> </ol>

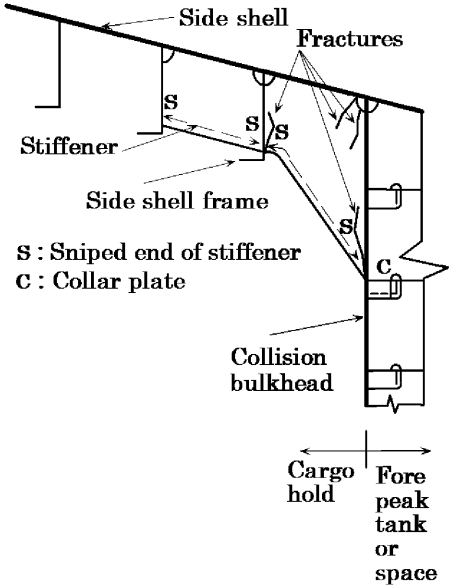
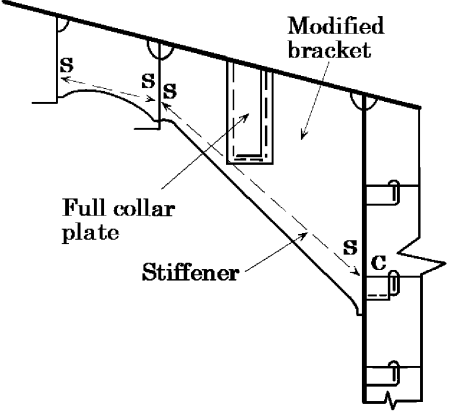
GENERAL DRY CARGO SHIPS		Guidelines for Surveys, Assessment and Repair of Hull Structure	
Part 1	Cargo hold region	Example No.	
Area 2	Side structure	4	
<b>Detail of damage</b>		Fractures at the supporting brackets in way of the collision bulkhead, (with no side shell panting stringers fitted in hold)	
<b>Sketch of damage</b>		<b>Sketch of repair</b>

<p><b>S</b> : Sniped end of stiffener <b>C</b> : Collar plate</p>

<b>Notes on possible cause of damage</b>		<b>Notes on repairs</b>	
<ol style="list-style-type: none"> <li>Insufficient bracket size resulting in high stress due to load cantilevered from side frame.</li> <li>Stress concentration at toe of bracket and misalignment between bracket and stringer in fore peak tank or space.</li> </ol>		<ol style="list-style-type: none"> <li>The extended bracket arm connection to the collision bulkhead is to have a soft toe, and any cut-outs for stiffeners in the fore peak tank or space are to be collared when situated in the vicinity of the bracket toe. When fractures have extended into the side shell or bulkhead plating, the plating is to be cropped and part renewed.</li> <li>When fractures have extended into the side shell or bulkhead plating, the plating is to be cropped and part renewed.</li> </ol>

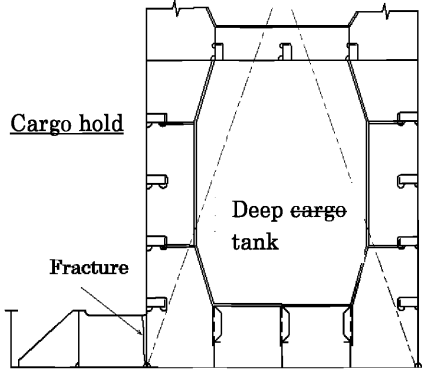
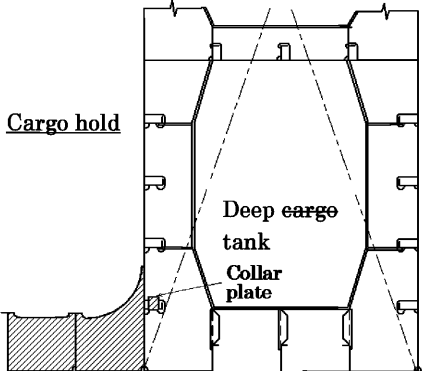
GENERAL DRY CARGO SHIPS		Guidelines for Surveys, Assessment and Repair of Hull Structure	
Part 1	Cargo hold region		Example No.
Area 2	Side structure		6
Detail of damage		Fractures in way of continuation/extension brackets at the end of deep cargo tank	
<p><b>Sketch of damage</b></p>

<p><b>Side shell</b></p>		<p><b>Sketch of repair</b></p>

<p><b>Side shell</b></p>	
<p><b>Notes on possible cause of damage</b></p> <p>1. Damage caused by stress concentration leading to fatigue fracture on side shell. This will be exacerbated because of the greater flexibility of the ordinary hold structure in relation to the deep cargo tank structure.</p>		<p><b>Notes on repairs</b></p> <p>1. The fractured shell plate is to be cropped and part renewed as necessary. 2. Brackets should be modified.</p>

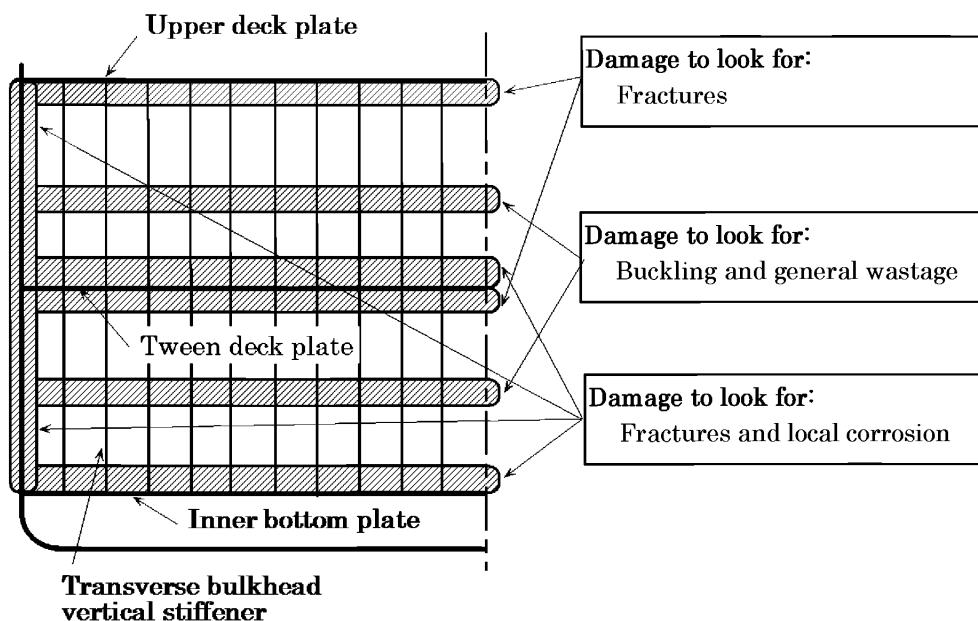
Figure 1 Transverse bulkhead - potential problem areas

- The structure may sometimes appear to be in good condition when it is in fact excessively corroded. In view of this, appropriate access arrangements as indicated in **Chapter 4 Survey planning, preparation and execution** of the Guidelines guidelines, should be provided to enable a proper close-up inspection and thickness measurement (See **Figure 1**).

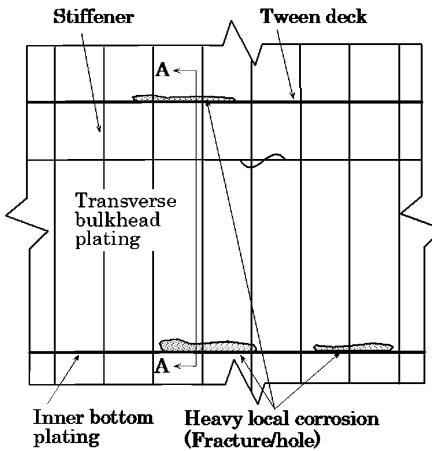
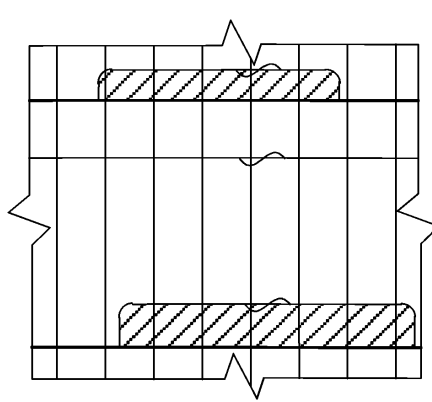
GENERAL DRY CARGO SHIPS		Guidelines for Surveys, Assessment and Repair of Hull Structure	
Part 1	Cargo hold region	Example No.	
Area 3	Transverse bulkhead structure	1	
Detail of damage		Corrosion along inner bottom or tween deck plating	
<p><b>Sketch of damage</b></p>

<p>Note: Regarding "View A-A", refer to Example 2 of Area 2 of this part</p>		<p><b>Sketch of repair</b></p>

<p><b>Notes on possible cause of damage</b></p> <ol style="list-style-type: none"> <li>1. Heavy corrosion including grooving along inner bottom plating or tween deck due to poor drainage.</li> </ol>		<p><b>Notes on repairs</b></p> <ol style="list-style-type: none"> <li>1. The extent of the renewal should be determined carefully. If the renewal plate (original thickness) is welded to thin plate (corroded plate), it may cause stress concentration and cause fracture.</li> <li>2. Protective coating should be applied.</li> </ol>

- 2.1.1 Heavy wastage along the boundaries at ship's sides and at transverse bulkheads may occur as a result of seawater accumulated from wet cargo due to poor drainage. Such damages are related to those suffered at the lower end of side structures and transverse bulkhead structures (See **Area 2, Example 2** and **Area 3, Example 1**).

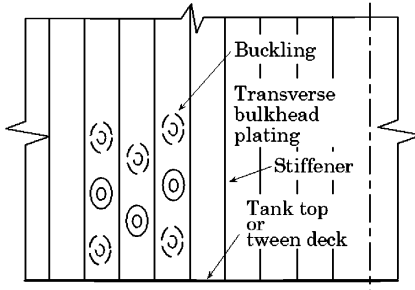
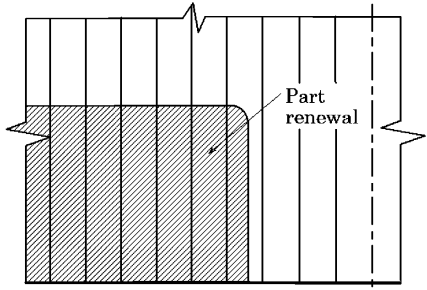
GENERAL DRY CARGO SHIPS		Guidelines for Surveys, Assessment and Repair of Hull Structure	
Part 1	Cargo hold region	Example No.	
Area 3	Transverse bulkhead structure	2	
Detail of damage		Shear & buckling in transverse bulkhead	
<p><b>Sketch of damage</b></p>

<p><b>Sketch of repair</b></p>

<p><b>Notes on possible cause of damage</b></p> <p>1. Heavy general corrosion.</p>		<p><b>Notes on repairs</b></p> <p>1. The extent of the renewal should be determined carefully. If the renewal plating (original thickness) is welded to thin plating (corroded plating), it may cause stress concentration and fracture.</p> <p>2. Protective coating should be applied.</p>
