**РОССИЙСКИЙ МОРСКОЙ РЕГИСТР СУДОХОДСТВА**  
**RUSSIAN MARITIME REGISTER OF SHIPPING**

**SUPPLEMENT TO RULES AND GUIDELINES**  
**OF RUSSIAN MARITIME REGISTER OF SHIPPING**

**IACS PROCEDURAL REQUIREMENTS,**  
**UNIFIED INTERPRETATIONS**  
**AND RECOMMENDATIONS**

## **GENERAL DRY CARGO SHIPS**

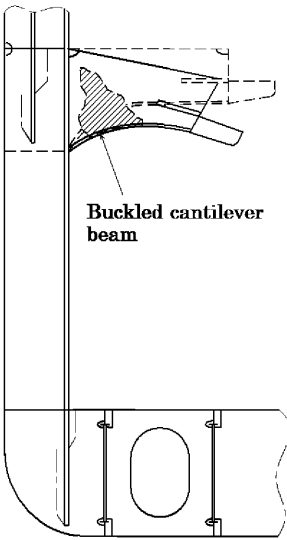
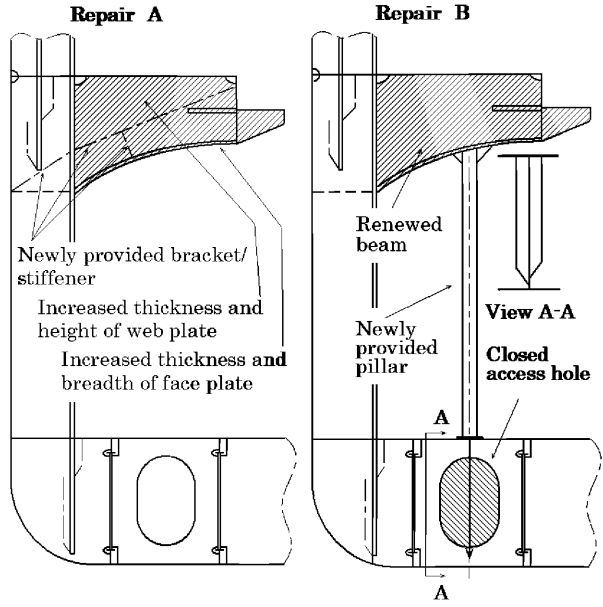
GENERAL DRY CARGO SHIPS		Guidelines for Surveys, Assessment and Repair of Hull Structure	
Part 1	Cargo hold region	Example No.	
Area 4	Tween deck structure	1	
Detail of damage		Sagging of deck panel/buckling of cantilever beam	
Sketch of damage		Sketch of repair

<p>Buckled cantilever beam</p>

<p>Repair A</p> <p>Repair B</p> <p>Newly provided bracket/stiffener</p> <p>Increased thickness and height of web plate</p> <p>Increased thickness and breadth of face plate</p> <p>Renewed beam</p> <p>Newly provided pillar</p> <p>View A-A</p> <p>Closed access hole</p> <p>A</p>	
Notes on possible cause of damage		Notes on repairs	
<ol style="list-style-type: none"> <li>Poor design, overloading and/or excessive inertia force caused in heavy weather.</li> </ol>		<ol style="list-style-type: none"> <li>The affected structures are to be cropped and renewed.</li> <li><b>Repair A:</b> Reinforcement should be considered by increased scantlings of beam and/or additional stiffeners.</li> <li><b>Repair B:</b> Pillars may be provided for reinforcement subject to the approval of the owner. In such a case, reinforcement of the floor under the pillar should be considered. (In the above example, access hole was closed.)</li> </ol>

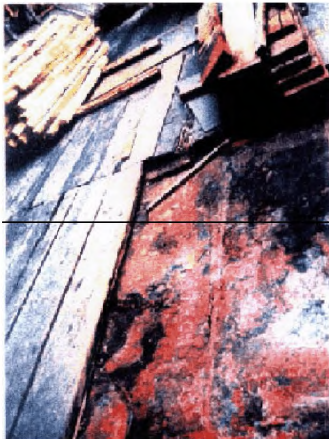
**Photograph 1**  
**Fractured inner bottom plating due to heavy corrosion on both sides**

- 2.1.2 When the tank top plating has been covered with dunnage or ceiling the plating may have suffered heavy corrosion, due to high humidity, and lack of proper maintenance (See **Photograph 1**).

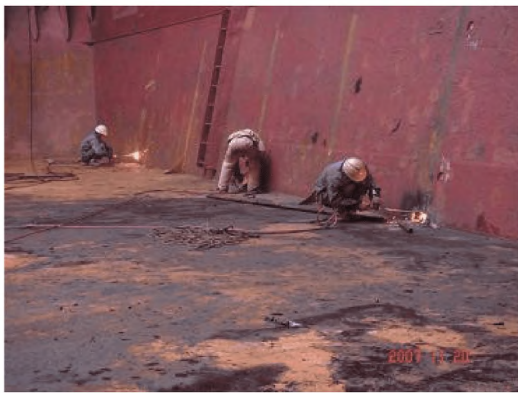
**Photograph 1** Heavy corrosion affecting inner bottom plating

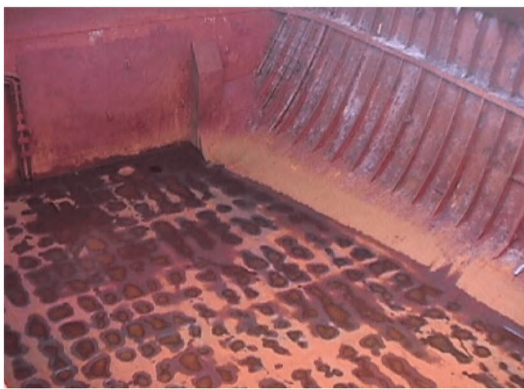
**Photograph 2** Damaged inner bottom plating

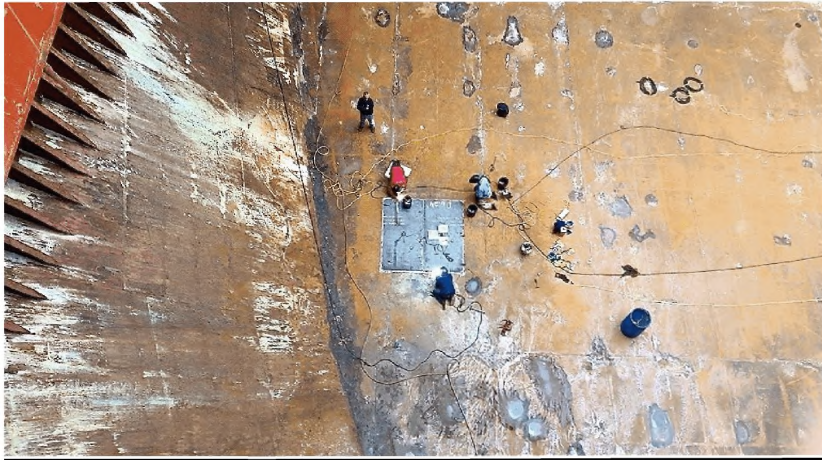
**Photograph 3 Repairs of damaged inner bottom plating**

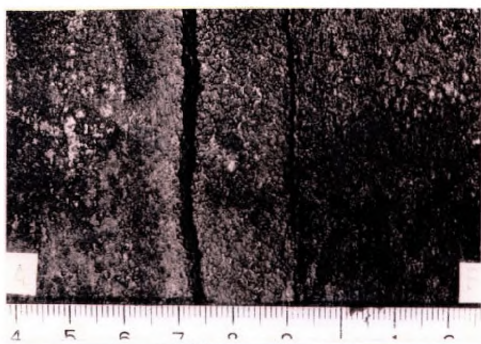
**Photograph 24**  
Grooving corrosion of welding of bottom plating

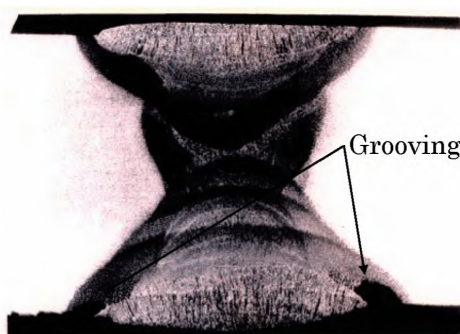
**Photograph 35**  
Section of the grooving shown in Photograph 24

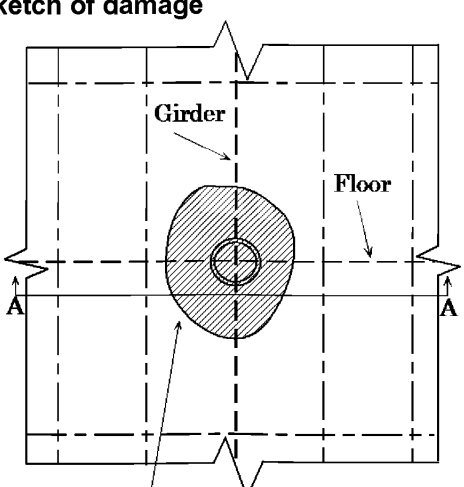
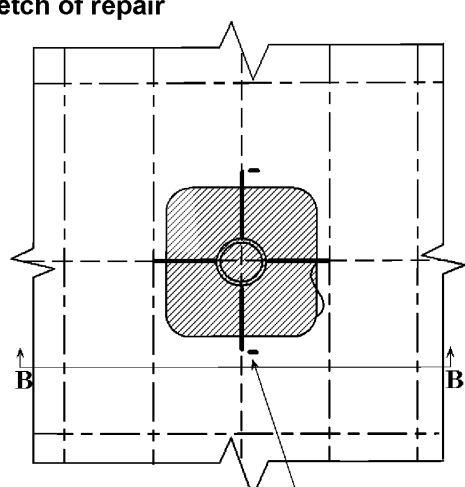
GENERAL DRY CARGO SHIPS		Guidelines for Surveys, Assessment and Repair of Hull Structure
Part 1	Cargo hold region	Example No.
Area 5	Double bottom structure	2
Detail of damage	Dented inner bottom plating and buckled/fractured floor under pillar	
<p><b>Sketch of damage</b></p>

<p><b>View A-A</b></p>	<p><b>Sketch of repair</b></p>

<p><b>View B-B</b></p>	
<p><b>Notes on possible cause of damage</b></p> <ol style="list-style-type: none"> <li>1. Inadequate arrangement and/or reinforcement of access holes.</li> <li>2. Excessive deck-loading on tween deck.</li> </ol>	<p><b>Notes on repairs</b></p> <ol style="list-style-type: none"> <li>1. Dented inner bottom plating is to be cropped and part renewed.</li> <li>2. The fractured floor is to be cropped and part renewed.</li> <li>3. Access holes should be closed by insert plates.</li> <li>4. Stiffener on floor/girder and/or brackets should be considered. (Fitting of brackets in the hold is subject to the agreement of the owner.)</li> </ol>

- 2.2.1 Deformed structure may be observed near hatch openings where cargo and/ or hatch cover pontoons may have bumped into the structure during lift on or lift off operations.
- 2.2.2 Sagging of plate panels may be caused by lateral overloading as a consequence of excessive cargo loads, improper distribution /support of cargo loads, excessive inertia forces imposed by the cargo in extreme weather conditions, or a combination of these causes. It is essential that an under-deck inspection also be carried out to assess the extent of such damage (See **Example 1**). If the tween deck is supported by pillars, excessive loads could be transmitted to the double bottom structure (inner bottom plating, floors, girders) which could be damaged. Therefore inspection of double bottom tanks may be necessary (See **Area 5, Example 2**).

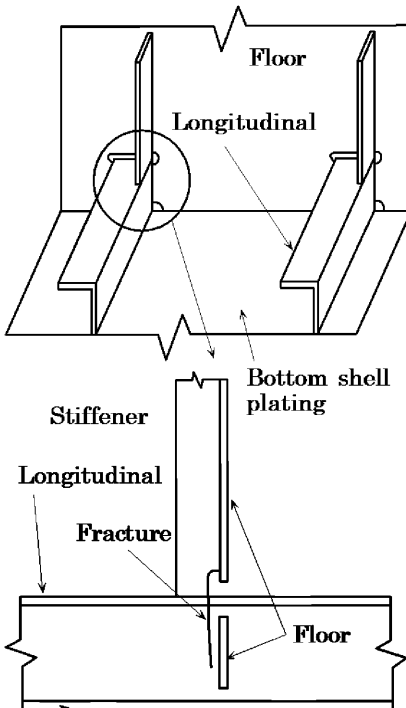
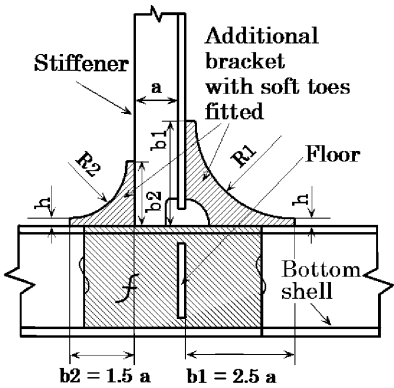
GENERAL DRY CARGO SHIPS		Guidelines for Surveys, Assessment and Repair of Hull Structure	
Part 1	Cargo hold region	Example No.	
Area 5	Double bottom structure	3-a	
Detail of damage		Fractures at the connection of bottom/inner bottom longitudinal to floor stiffener	
Sketch of damage		Sketch of repair

<p>Note: same damage may occur at similar connection to inner bottom plating</p>

<p><math>f</math>: Where required, the longitudinal to be cropped and part renewed</p> <ol style="list-style-type: none"> <li>1. For a slope at toes max. 1 : 3, <math>R1 = (b1-h) \times 1.6</math> and <math>R2 = (b2-h) \times 1.6</math></li> <li>2. Soft toe bracket to be welded first to longitudinal</li> <li>3. Scallop in bracket to be as small as possible, recommended max. 35 mm</li> <li>4. If toes of brackets are ground smooth, full penetration welds in way to be provided</li> <li>5. Maximum length to thickness ratio = 50 : 1 for unstiffened bracket edge</li> <li>6. Toe height, <math>h</math>, to be as small as possible (10- 15 mm)</li> </ol>

Notes on possible cause of damage		Notes on repairs	
<ol style="list-style-type: none"> <li>1. Damage can be caused by stress concentrations leading to accelerated fatigue in this region.</li> </ol>		<ol style="list-style-type: none"> <li>1. If fracture extends to over one third of the depth of the longitudinal, then crop and part renew. Otherwise the fracture can be veed-out and welded.</li> </ol>

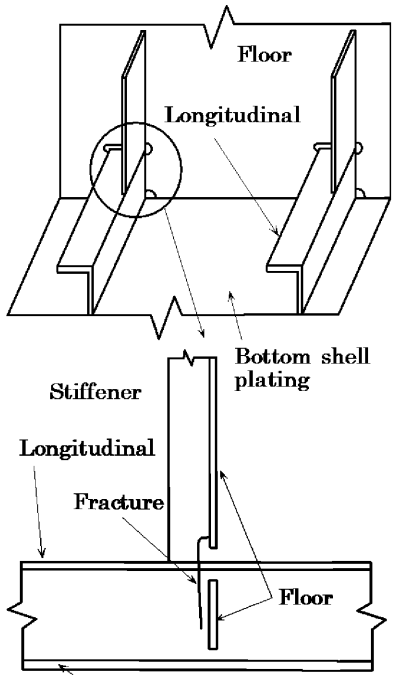
GENERAL DRY CARGO SHIPS		Guidelines for Surveys, Assessment and Repair of Hull Structure
Part 1	Cargo hold region	Example No.
Area 5	Double bottom structure	3-b
Detail of damage	Fractures at the connection of bottom/inner bottom longitudinal to floor stiffener	
<p><b>Sketch of damage</b></p>

<p>Note: same damage may occur at similar connection to inner bottom plating</p>		<p><b>Sketch of repair</b></p>

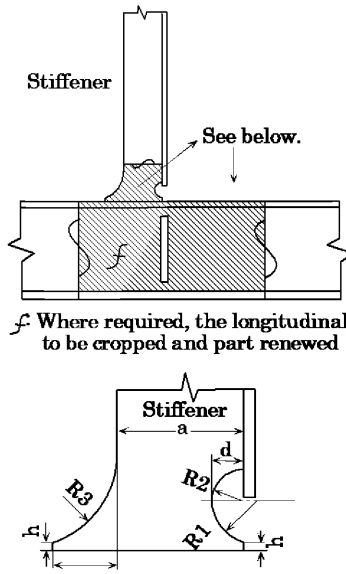
<p>Where required, the longitudinal to be cropped and part renewed</p> <p>Various cut-out shapes have been developed. The following is one example.</p> <ol style="list-style-type: none"> <li>1. Toe height as small as possible (<math>h = 10 - 15 \text{ mm}</math>)</li> <li>2. Depth "d" of key hole notch as small as possible, max. 30 mm</li> <li>3. For a slope at toe max. 1 : 3</li> <li>4. <math>R1 = 1.5d</math>, <math>R2 = d</math> and <math>R3 = 1.5c</math></li> </ol>
<p><b>Notes on possible cause of damage</b></p> <ol style="list-style-type: none"> <li>1. Damage can be caused by stress concentrations leading to accelerated fatigue in this region.</li> </ol>		<p><b>Notes on repairs</b></p> <ol style="list-style-type: none"> <li>1. If fracture extends to over one third of the depth of the longitudinal, then crop and part renew. Otherwise the fracture can be veed-out and welded.</li> </ol>

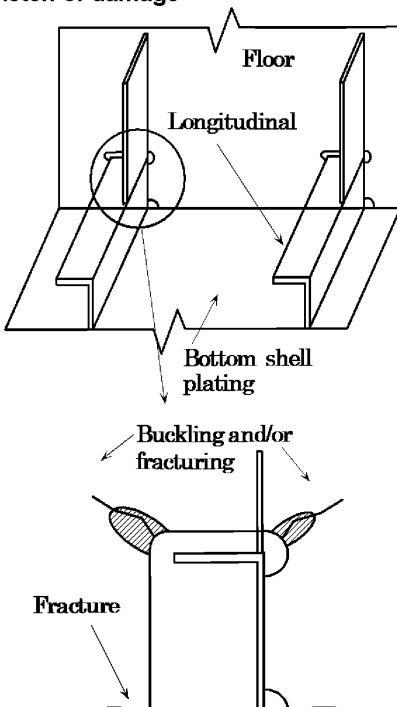
<b>GENERAL DRY CARGO SHIPS</b>		<b>Guidelines for Surveys, Assessment and Repair of Hull Structure</b>
<b>Part 1</b>	<b>Cargo hold region</b>	<b>Example No.</b>
<b>Area 5</b>	<b>Double bottom structure</b>	<b>4</b>
<b>Detail of damage</b>	Fractures and buckling in way of a cut-out for the passage of a longitudinal through a transverse primary member	
<b>Sketch of damage</b>

<p><b>Note:</b> same type of damage may occur at similar connections to inner bottom</p>	
<b>Sketch of repair</b>	<p><b>Repair A</b></p>

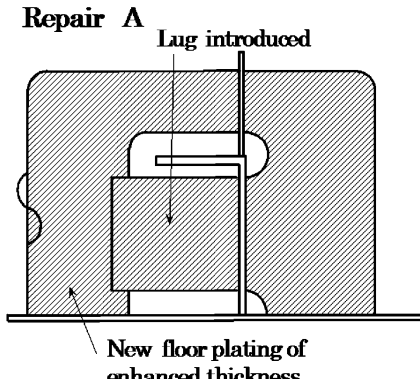
<b>Notes on possible cause of damage</b>	<p>1. Damage can be caused by general levels of corrosion and presence of stress concentration associated with the presence of a cut-out.</p>	
<b>Notes on repairs</b>	<p>1. If fractures are significant then crop and part renew the floor plating otherwise the fracture can be veed-out and welded provided the plating is not generally corroded.</p> <p><b>Repair B</b> is to be incorporated if the lug proves to be ineffective.</p> <p>2.</p>

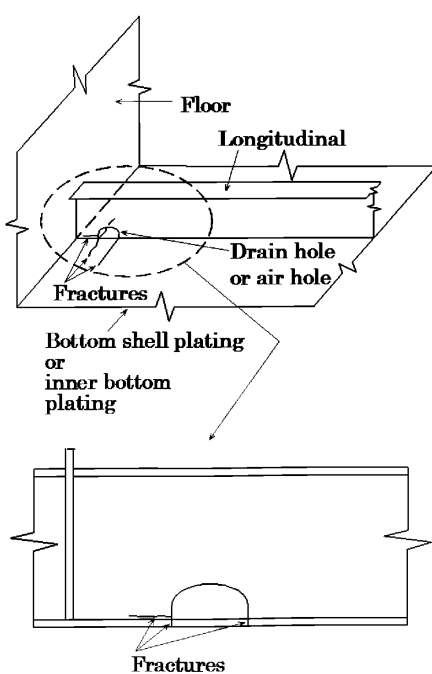
GENERAL DRY CARGO SHIPS		Guidelines for Surveys, Assessment and Repair of Hull Structure	
Part 1	Cargo hold region	Example No.	
Area 5	Double bottom structure	5	
<b>Detail of damage</b>		Fractures in bottom shell plating/inner bottom plating at the corner drain hole/air hole in longitudinal	
<b>Sketch of damage</b>		<b>Sketch of repair</b>

<p>The sketch shows a perspective view of a double bottom structure. A longitudinal beam is shown above the bottom shell plating. A drain hole or air hole is located at the corner of the bottom shell plating. Fractures are indicated by jagged lines at the corner of the drain hole. Labels include: Floor, Longitudinal, Drain hole or air hole, Fractures, and Bottom shell plating or inner bottom plating. Below this is a cross-sectional view showing the fractures at the corner of the drain hole.</p>

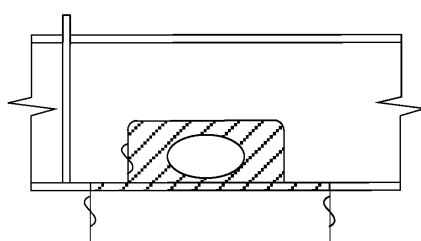
<p>The sketch shows the same double bottom structure after repair. The fractured plating at the corner of the drain hole has been cropped and replaced with new plating, indicated by hatching. Labels include: Floor, Longitudinal, Drain hole or air hole, and Fractures.</p>

<b>Notes on possible cause of damage</b>		<b>Notes on repairs</b>	
<ol style="list-style-type: none"> <li>1. Stress concentration and/or corrosion due to stress concentration at the corner of drain hole/air hole.</li> </ol>		<ol style="list-style-type: none"> <li>1. Fractured plating should be cropped and part renewed.</li> <li>2. If fatigue life is to be improved, change of drain hole/air hole shape is to be considered.</li> </ol>

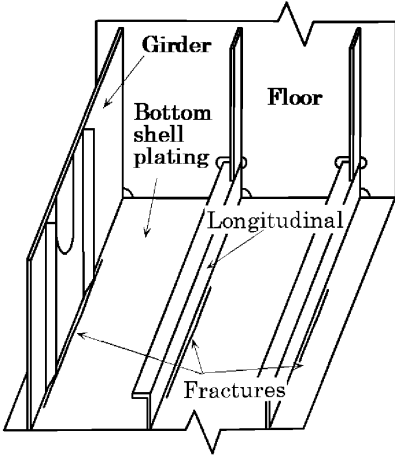
<b>GENERAL DRY CARGO SHIPS</b>		<b>Guidelines for Surveys, Assessment and Repair of Hull Structure</b>
<b>Part 1</b>	<b>Cargo hold region</b>	<b>Example No.</b>
<b>Area 5</b>	<b>Double bottom structure</b>	<b>6</b>
<b>Detail of damage</b>	Fracture in bottom shell plating along side girder and/or bottom longitudinal	
<b>Sketch of damage</b>

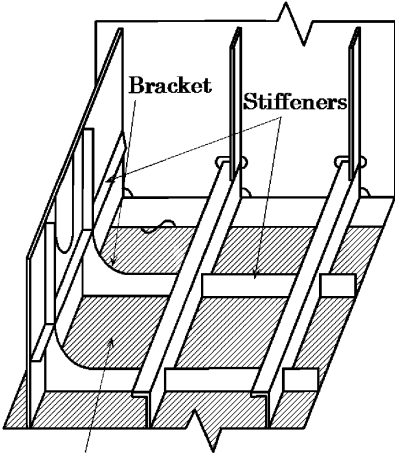
<b>Sketch of repair</b>

<b>Notes on possible cause of damage</b>	<b>Notes on repairs</b>	
1. Vibration.	<ol style="list-style-type: none"> <li>1. Fractured bottom shell plating should be cropped and renewed.</li> <li>2. Natural frequency of the panel should be changed, e.g. reinforcement by additional stiffener/bracket.</li> </ol>

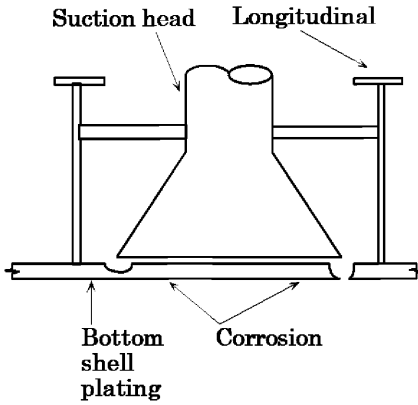
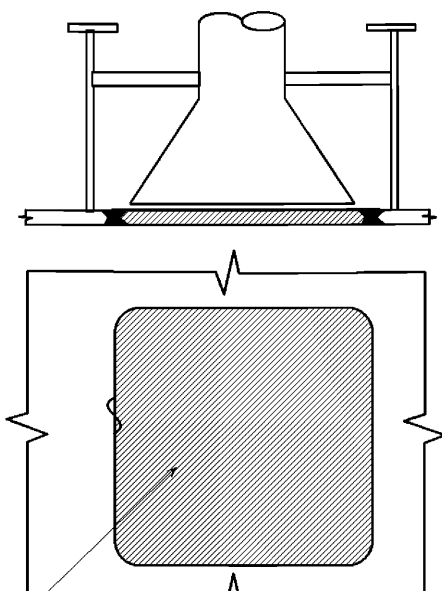
GENERAL DRY CARGO SHIPS		Guidelines for Surveys, Assessment and Repair of Hull Structure
Part 1	Cargo hold region	Example No.
Area 5	Double bottom structure	7
Detail of damage		Corrosion in bottom plating below suction head
Sketch of damage		Sketch of repair

<b>Notes on possible cause of damage</b> <ol style="list-style-type: none"> <li>1. High flow rate associated with insufficient corrosion prevention system.</li> <li>2. Galvanic action between dissimilar metals</li> </ol>		<b>Notes on repairs</b> <ol style="list-style-type: none"> <li>1. Affected plating should be cropped and part renewed. Thicker plate and suitable beveling should be considered.</li> <li>2. If the corrosion is limited to a small area, i.e. pitting corrosion, repair by welding is acceptable.</li> </ol>

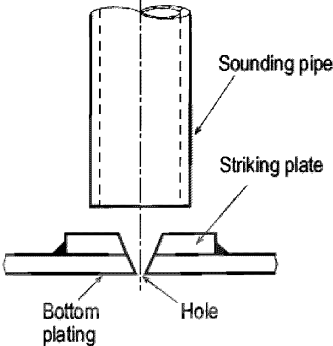
GENERAL DRY CARGO SHIPS		Guidelines for Surveys, Assessment and Repair of Hull Structure	
Part 1	Cargo hold region	Example No.	
Area 5	Double bottom structure	9	
Detail of damage		Corrosion in bottom plating below sounding pipe	
<p><b>Sketch of damage</b></p>

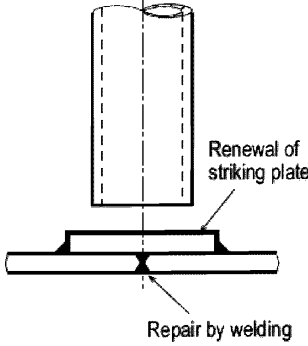
<p><b>Sketch of repair</b></p> <p><b>Repair A</b></p>

<p><b>Notes on possible cause of damage</b></p> <ol style="list-style-type: none"> <li>1. Accelerated corrosion of striking plate by the striking of the weight of the sounding tape.</li> </ol>		<p><b>Notes on repairs</b></p> <ol style="list-style-type: none"> <li>1. Corroded bottom plating should be welded or partly cropped and renewed if considered necessary.</li> <li>2. Corroded striking plate should be renewed.</li> </ol>

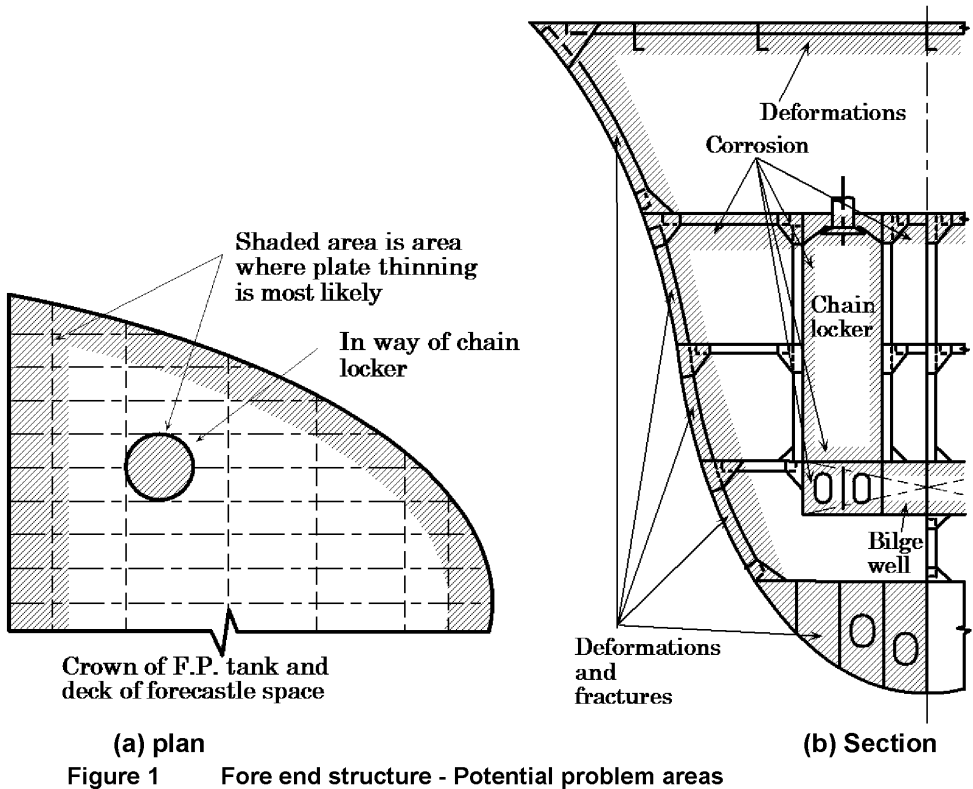
- 2.3.1 Fractures in the fore peak tank are normally found by close-up inspection of the internal structure.
- 2.3.2 Fractures that extend through the thickness of the plating or through the boundary welds may be observed during pressure testing of the double bottom tanks.

- 2.1.1 Wastage (and possible subsequent fractures) is more likely to show initially in locations as indicated in **Figure 1**. A close-up inspection should be carried out. In addition, a representative selection of thickness measurements should be taken with particular attention being given to locations such as chain lockers.
- 2.1.2 Structure in chain lockers is liable to have heavy corrosion because of mechanical damage to the protective coating by anchor chains. In some ships, e.g. relatively small ships, side shell plating may form boundaries of the chain lockers. Consequently, heavy corrosion may result in a hole in the side shell plating.

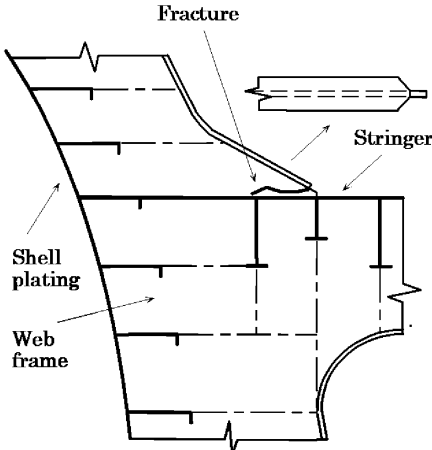
GENERAL DRY CARGO SHIPS		Guidelines for Surveys, Assessment and Repair of Hull Structure	
Part 2	Fore and aft end regions	Example No.	
Area 1	Fore end structure	2	
<b>Detail of damage</b>		Fracture at toe of web frame bracket connection to stringer platform bracket	
<b>Sketch of damage</b>

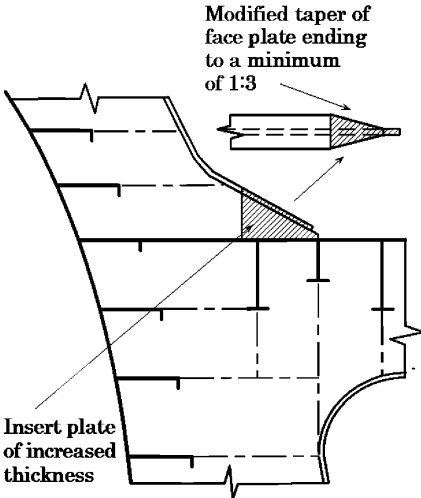
<b>Sketch of repair</b>

<b>Notes on possible cause of damage</b> <ol style="list-style-type: none"> <li>1. Inadequate bracket forming the web frame connection to the stringer.</li> <li>2. Localized material wastage in way of coating failure at bracket due to flexing of the structure.</li> <li>3. Dynamic seaway loading in way of bow flare.</li> </ol>		<b>Notes on repairs</b> <ol style="list-style-type: none"> <li>1. Adequate soft nose bracket endings with a face plate taper of at least 1 : 3 to be provided.</li> </ol>

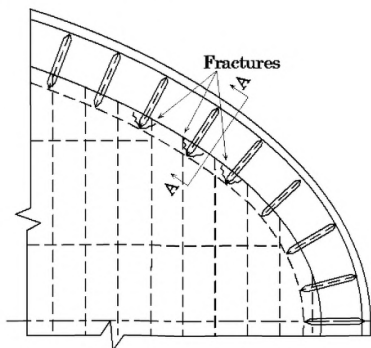
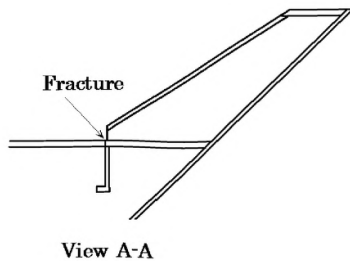
**Sketch of damage**

<b>Detail of damage</b>	Fracture in forecastle deck plating at bulwark
-------------------------	--

3.3.1 In the case of fractures caused by sea-loads the structure should be cropped and renewed. Increased thickness of plating and/or design modification to reduce stress concentrations should be considered (See **Examples 1, 2 and 6**).

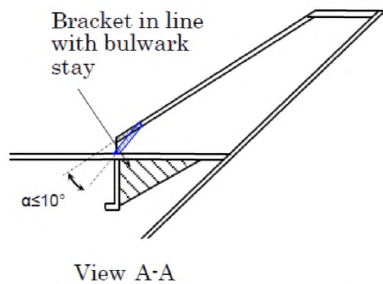
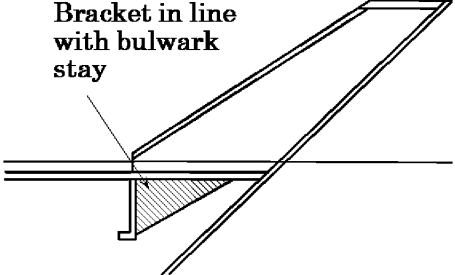
**Sketch of repair**

<p><b>Bracket in line with bulwark stay</b></p>

<p><b>View A-A</b></p>
<p><b>Notes on possible cause of damage</b></p> <ol style="list-style-type: none"> <li>1. Bow flare effect in heavy weather.</li> <li>2. Stress concentration due to poor design.</li> </ol>	<p><b>Notes on repairs</b></p> <ol style="list-style-type: none"> <li>1. Fractured deck plating should be cropped and renewed.</li> <li>2. Bracket in line with the bulwark stay to be fitted to reduce stress concentration.</li> <li>3. <u>The lower end of the bulwark bracket flange to be reshaped in order to avoid the sniper end.</u></li> </ol>

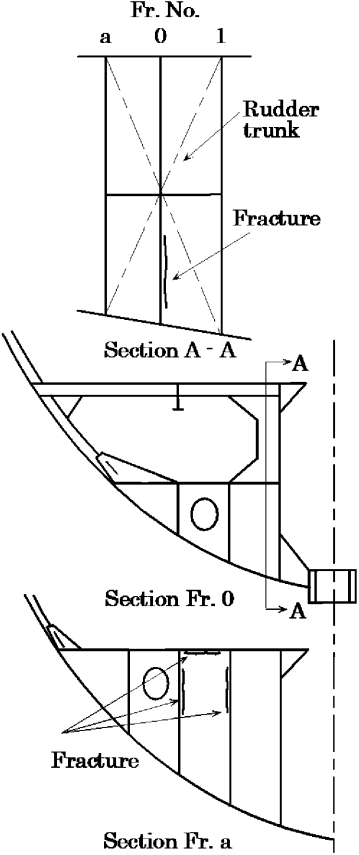
GENERAL DRY CARGO SHIPS		Guidelines for Surveys, Assessment and Repair of Hull Structure	
Part 2	Fore and aft end regions		Example No.
Area 2	Aft end structure		1
Detail of damage		Fractures in longitudinal bulkhead in way of rudder trunk	
Sketch of damage		Sketch of repair	
<p>Fr. No. 0 1</p>

<p>Rudder trunk</p> <p>Fracture</p> <p>Section A - A</p> <p>Section Fr. 0</p> <p>Section Fr. a</p>		<p>Fr. No. 0 1</p>

3.3.1 Repairs of main engines and propeller excited vibration damage should be made by returning the structure to its original condition. In order to prevent recurrence of the damage the cause of the vibration should be ascertained and additional reinforcements provided as found necessary (See **Examples 1 and 2**).

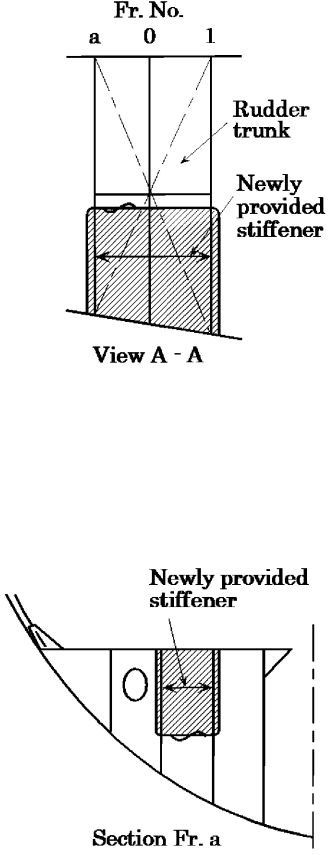
<p>Rudder trunk</p> <p>Newly provided stiffener</p> <p>View A - A</p> <p>Section Fr. a</p>	
Notes on possible cause of damage		Notes on repairs	
1. Vibration.		1. The fractured plating should be cropped and renewed. 2. Natural frequency of the plate between stiffeners should be changed, e.g. reinforcement by additional stiffeners.

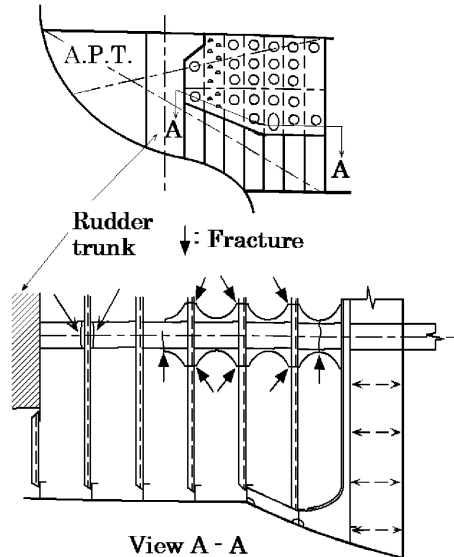
<b>GENERAL DRY CARGO SHIPS</b>		<b>Guidelines for Surveys, Assessment and Repair of Hull Structure</b>	
<b>Part 2</b>	<b>Fore and aft end regions</b>	<b>Example No.</b>	
<b>Area 2</b>	<b>Aft end structure</b>	<b>2</b>	
<b>Detail of damage</b>		Fractures at the connection of floors and girders/side brackets	
<p><b>Sketch of damage</b></p>

<p>Rudder trunk</p> <p>↓ Fracture</p> <p>View A - A</p>		<p><b>Sketch of repair</b></p>

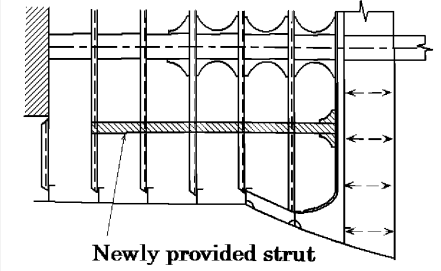
<p>Newly provided strut</p>	
<p><b>Notes on possible cause of damage</b></p> <ol style="list-style-type: none"> <li>1. Vibration.</li> </ol>		<p><b>Notes on repairs</b></p> <ol style="list-style-type: none"> <li>1. The fractured plating should be cropped and renewed.</li> <li>2. Natural frequency of the panel should be changed, e.g. reinforcement by additional strut.</li> </ol>

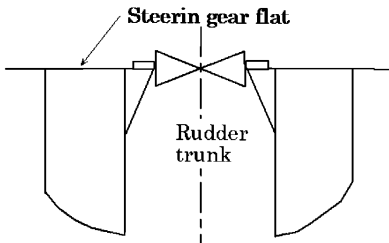
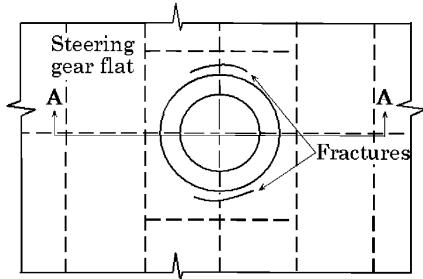
**Sketch of damage**

<b>Detail of damage</b>	Fractures in flat where rudder carrier is installed in steering gear room
-------------------------	---

View A - A

3.3.2 Fractured structure which supports the rudder carrier is to be cropped and renewed, and may have to be reinforced (See **Example 3**).

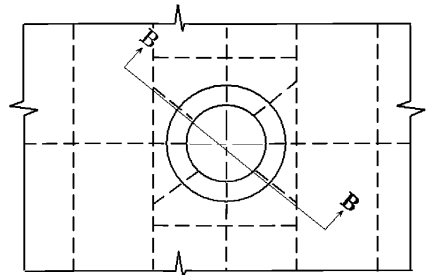
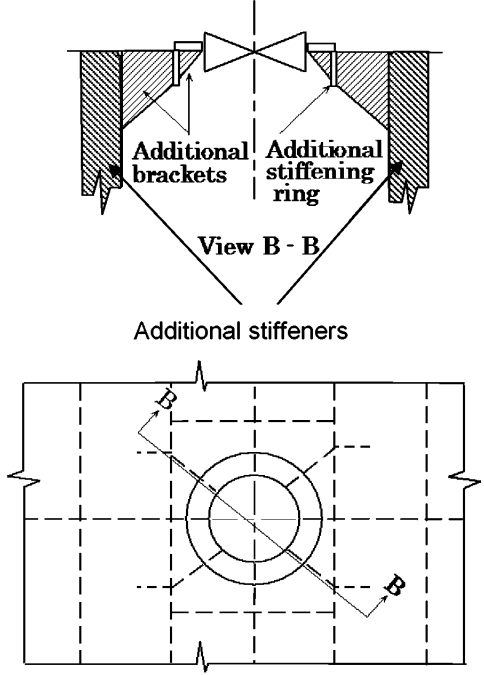
**Sketch of repair**

View B - B

<p style="text-align: center;">View B - B</p> <p style="text-align: center;">Additional stiffeners</p>
<p><b>Notes on possible cause of damage</b></p> <ol style="list-style-type: none"> <li>1. Inadequate design.</li> </ol>	<p><b>Notes on repairs</b></p> <ol style="list-style-type: none"> <li>1. Fractured plating should be cropped and renewed.</li> <li>2. Additional brackets, <u>stiffeners</u> and stiffening ring should be fitted for reinforcement.</li> </ol>

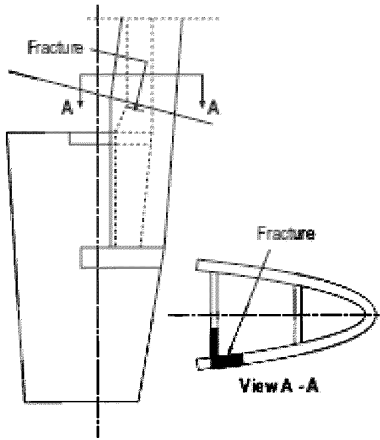
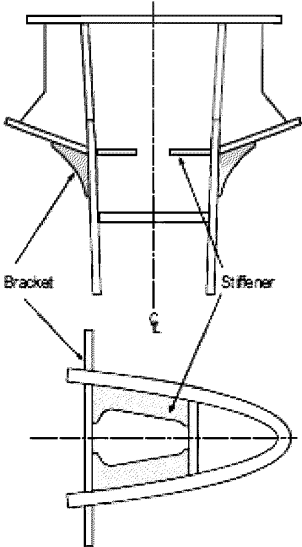
GENERAL DRY CARGO SHIPS		Guidelines for Surveys, Assessment and Repair of Hull Structure	
Part 2	Fore and aft end regions		Example No.
Area 2	Aft end structure		3-c
<b>Detail of damage</b> Stern frame, rudder arrangement and propeller shaft support			
<b>Sketch of damage</b>		<b>Sketch of repair</b>

<b>Notes on possible cause of damage</b>		<b>Notes on repairs</b>	
<ol style="list-style-type: none"> <li>1. Insufficient strength due to poor design.</li> </ol>		<ol style="list-style-type: none"> <li>1. Fractured plating to be veed-out and re-welded.</li> <li>2. Fractured plating to be cropped and renewed if considered necessary.</li> <li>3. Reinforcement should be considered if deemed necessary.</li> </ol>

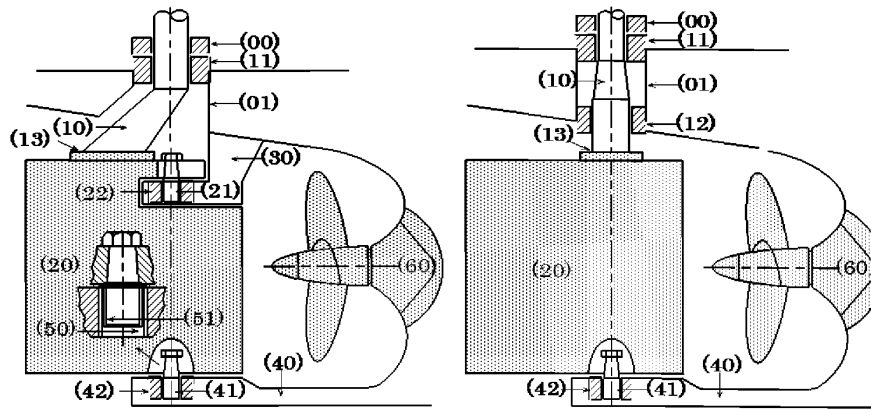
(a) Rudders supported by sole piece

- (00) Rudder carrier
- (01) Rudder trunk
- (10) Rudder stock
- (11) Carrier bearing
- (12) Neck bearing
- (13) Horizontal coupling (Flange coupling)
- (14) Cone coupling
- (20) Rudder blade
- (21) Upper pintle
- (22) Upper pintle bearing
- (30) Rudder horn
- (31) Horn pintle
- (32) Horn pintle bearing
- (40) Sole piece
- (41) Bottom pintle
- (42) Bottom pintle bearing
- (50) Bush
- (51) Sleeve (Liner)
- (60) Propeller boss (Stern tube casting)
- (70) Propeller shaft bracket (Tail shaft strut)

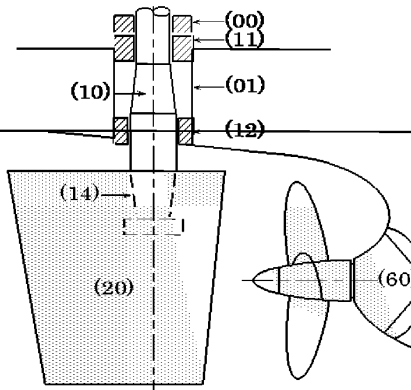
(c) Spade rudder

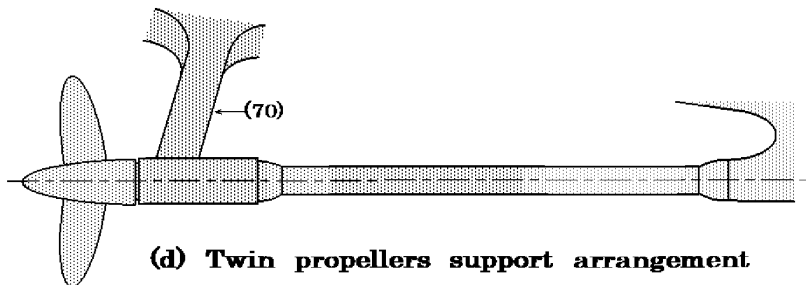
(d) Twin propellers support arrangement

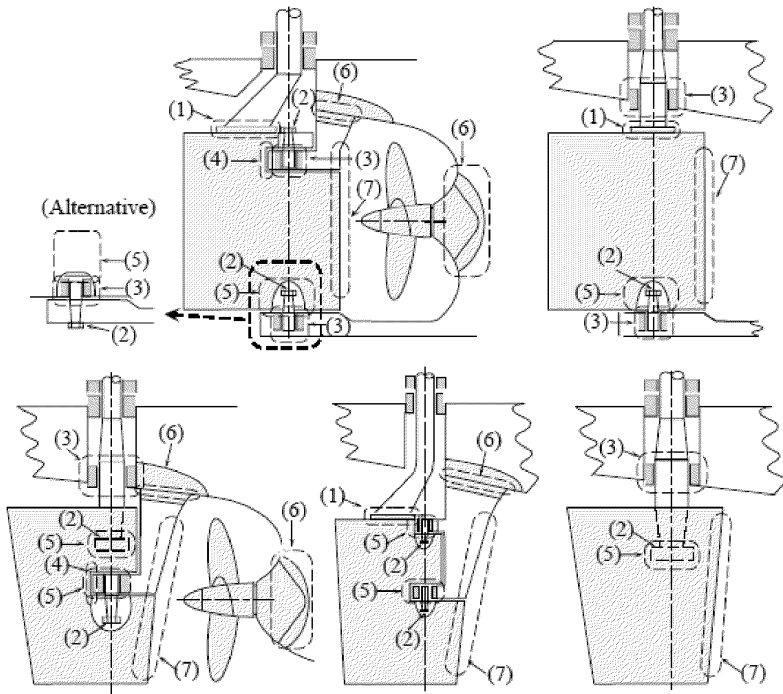
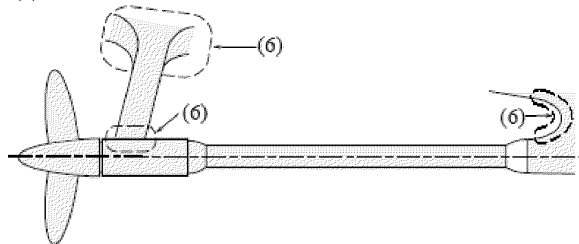
**Figure 2 Potential problem areas**

**Damage to look for:**

- (1) Fractures and loose coupling bolts
- (2) Loose nut
- (3) Wear (excessive bearing clearance)
- (4) Fractures in way of pintle cutout
- (5) Fractures in way of removable access plate
- (6) Fractures
- (7) Erosion

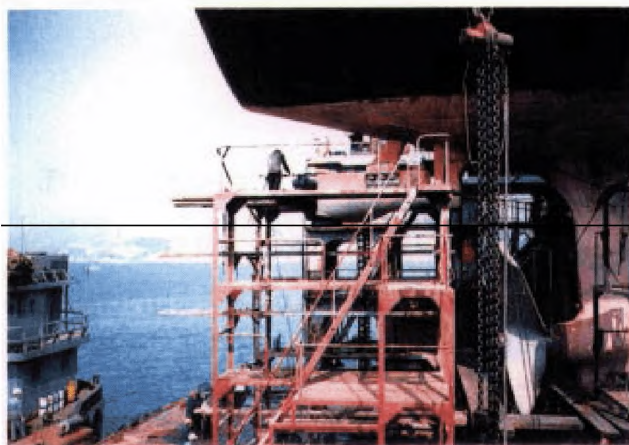
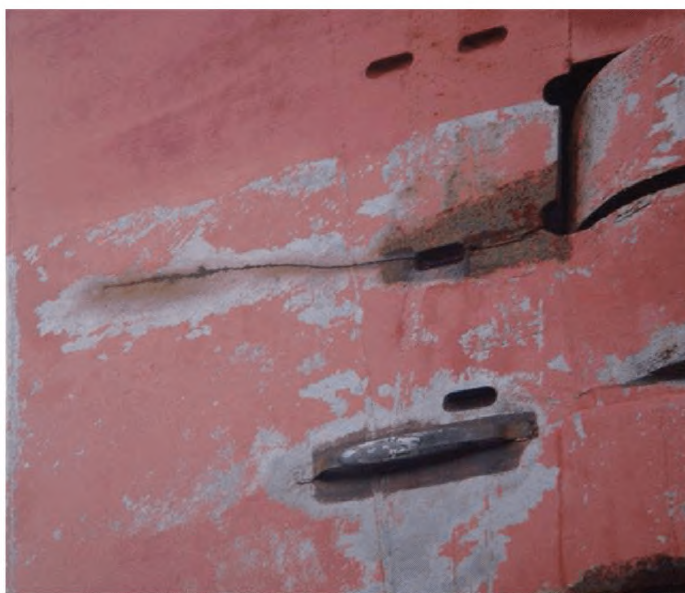
**Photograph 1**  
**Fractured rudder due to corrosion in rudder plating**

**Photograph 1 Fractured rudder due to corrosion in rudder plating**

Corrosion/erosion (such as deep pitting corrosion) should be looked for in rudder/rudder horn, especially in welds. In extreme cases the corrosion /erosion may cause a large fracture as shown in **Photograph 1**.

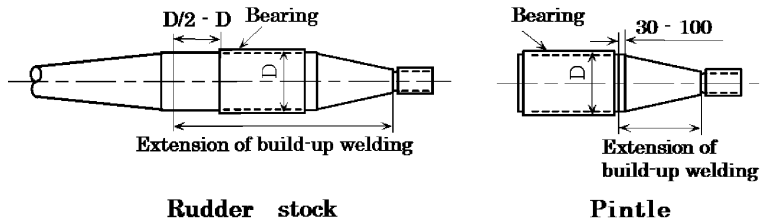
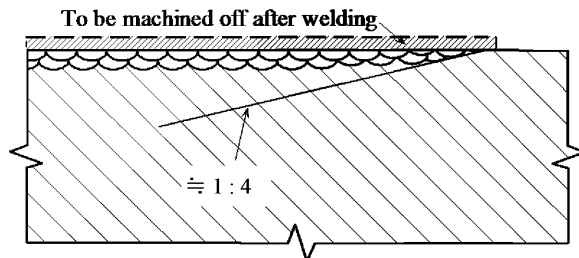
**Figure 3 Rudder stock repair by welding**

### Replacing wasted material by similar ordinary weld material

- Removal of the wasted area by machining and/or grinding, non-destructive examination for fractures (magnetic particle inspection preferred)
- Build-up welding by automatic spiral welding (turning device) according to an approved welding procedure (weld process, preheating, welding consumables, etc.)
- Extension of build-up welding over the area of **large bending moments (shafts)** according to the sketch

- Sufficient number of weld layers to compensate removed material, at least one layer in excess (heat treatment of the remaining layer)
- Transition at the end of the build-up welding according to the following sketch

- Post weld heat treatment if required in special cases (never for stainless steel cladding on ordinary steel)
- Final machining, at least two layers of welding material have to remain on the rudder stock (See the above sketch)
- Non-destructive fracture examination

Rudder stocks and/or pintles may be repaired by welding replacing wasted material by similar weld material. After removal of the wasted area (corrosion, scratches, etc.) by machining and/or grinding the build-up welding has to be carried out by an automatic spiral welding according to an approved welding procedure. The welding has to be extended over the area of large bending moments (rudder stocks). In special cases post weld heat treatment has to be carried out according to the requirements of the Classification Society. After final machining, a sufficient number of layers of welding material have to remain on the rudder stock/pintle. A summary of the most important steps and conditions of this repair is shown in the **Figure 3**.

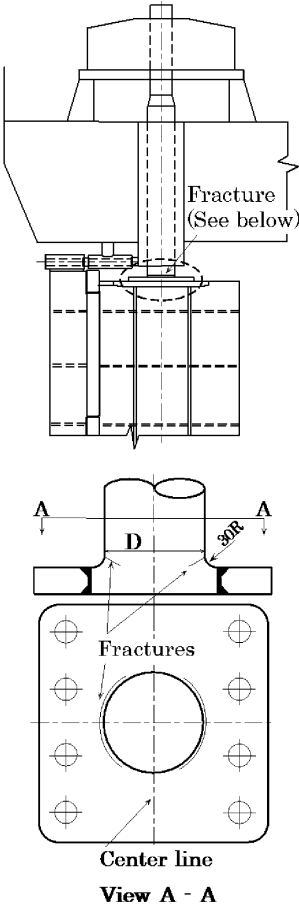
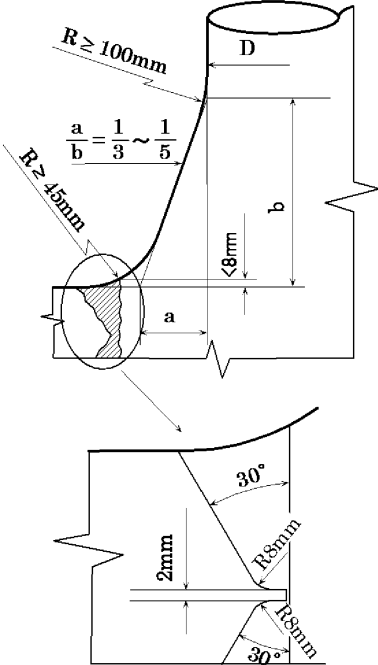
<b>GENERAL DRY CARGO SHIPS</b>		<b>Guidelines for Surveys, Assessment and Repair of Hull Structure</b>
<b>Part 2</b>	<b>Fore and aft end regions</b>	<b>Example No.</b>
<b>Area 3</b>	<b>Stern frame, rudder arrangement and propeller shaft support</b>	<b>1</b>
<b>Detail of damage</b>   Fracture in rudder stock		
<b>Sketch of damage</b>

<p>Fracture (See below)</p> <p>Center line View A - A</p>		<b>Sketch of repair</b>

<p><math>R \geq 100\text{mm}</math></p> <p><math>\frac{a}{b} = \frac{1}{3} \sim \frac{1}{5}</math></p> <p><math>R \geq 45\text{mm}</math></p> <p><math>D</math></p> <p><math>b</math></p> <p><math>&lt;8\text{mm}</math></p> <p><math>a</math></p> <p><math>30^\circ</math></p> <p><math>2\text{mm}</math></p> <p><math>R8\text{mm}</math></p> <p><math>R8\text{mm}</math></p> <p><math>30^\circ</math></p>
<b>Notes on possible cause of damage</b> 1. Inadequate design for stress concentration in rudder stock.		<b>Notes on repairs</b> 1. Modification of detail design of rudder stock to reduce the stress concentration.

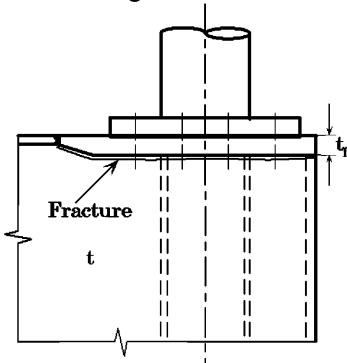
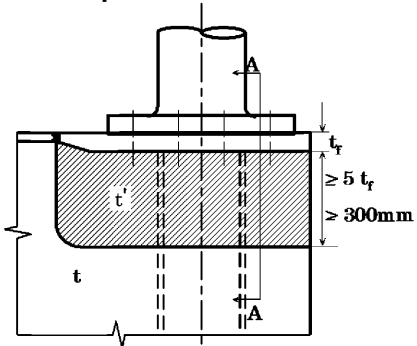
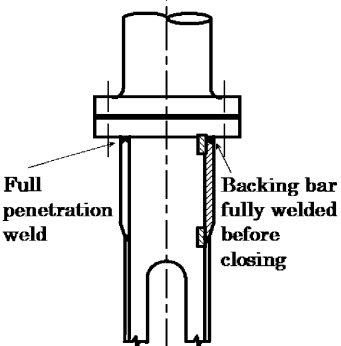
GENERAL DRY CARGO SHIPS		Guidelines for Surveys, Assessment and Repair of Hull Structure
Part 2	Fore and aft end regions	Example No.
Area 3	Stern frame, rudder arrangement and propeller shaft support	2
Detail of damage		Fracture in connection of palm plate to rudder blade
Sketch of damage		Sketch of repair

<p style="text-align: center;">View A - A</p>

<p>Full penetration weld</p> <p>Backing bar fully welded before closing</p> <p><math>t</math> = plate thickness, mm  <math>t_r</math> = actual flange thickness, mm  <math>t' = \frac{t_r}{3} + 5</math>, mm, where <math>t_r &lt; 50</math>mm  <math>t' = 3 \sqrt{t_r}</math>, mm, where <math>t_r \geq 50</math>mm</p>
Notes on possible cause of damage		Notes on repairs

1. Inadequate connection between palm plate and rudder blade plating (insufficient plating thickness and/or insufficient fillet weld).		1. Modification of detail design of the connection by increasing the plate thickness and full penetration welding.

- 2.2.4 Fractures should be looked for at the transition radius between rudder stock and horizontal coupling (palm) plate, and the connection between horizontal coupling plate and rudder blade in case of horizontal coupling. Typical fractures are shown in **Examples 1 and 2**. Fatigue fractures should be looked for at the palm plate itself in case of loosened or lost coupling bolts.

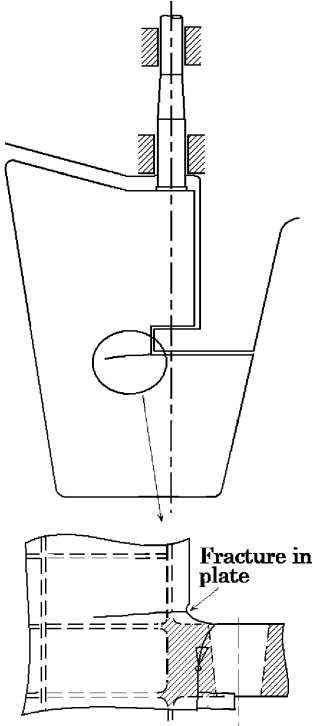
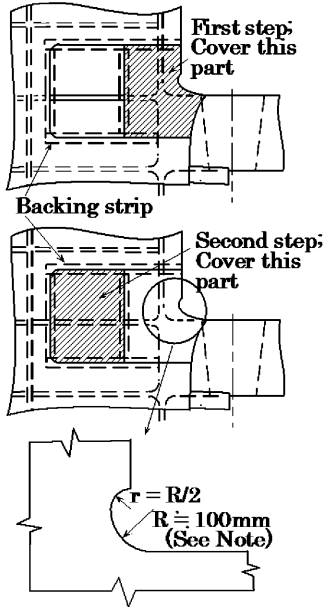
GENERAL DRY CARGO SHIPS		Guidelines for Surveys, Assessment and Repair of Hull Structure
Part 2	Fore and aft end regions	Example No.
Area 3	Stern frame, rudder arrangement and propeller shaft support	4
Detail of damage	Fracture in rudder plating of semi-spade rudder extending beyond the vertical web	
<b>Sketch of damage</b>

<b>Sketch of repair</b>

<p><b>Note:</b> R should be considered according to local detail</p>
<b>Notes on possible cause of damage</b> <ol style="list-style-type: none"> <li>1. Stress concentration due to inadequate local design and/or fabrication notches in way of the butt weld between cast piece and plating.</li> </ol>		<b>Notes on repairs</b> <ol style="list-style-type: none"> <li>1. Fractured plating is to be cut-out.</li> <li>2. Internal structures are to be checked.</li> <li>3. Cut-out is to be closed by an insert plating according to the sketch (welding only from one side is demonstrated).</li> <li>4. Modification of the radius.</li> <li>5. In case of a new cast piece, connection with the plating is to be shifted outside the high stress area.</li> </ol>

In case of longer fatigue fractures starting in the lower and/or upper corners of the pintle recess of semi-spade rudders that propagate over a longer distance into the plating, thorough check of the internal structures has to be carried out. The fractured parts of the plating and internal structures, if necessary, have to be replaced by insert plates. A proper welding connection between the insert plate and the internal stiffening structure is very important (See **Examples 4 and 5**).

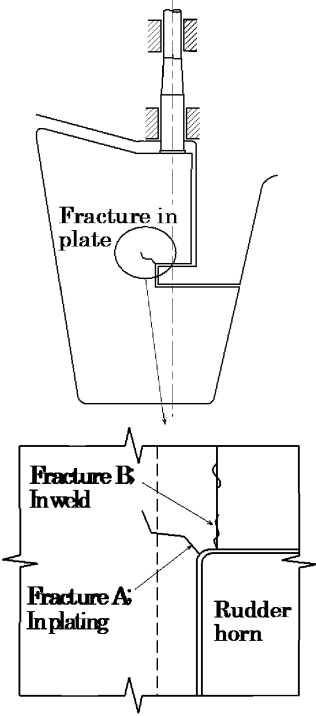
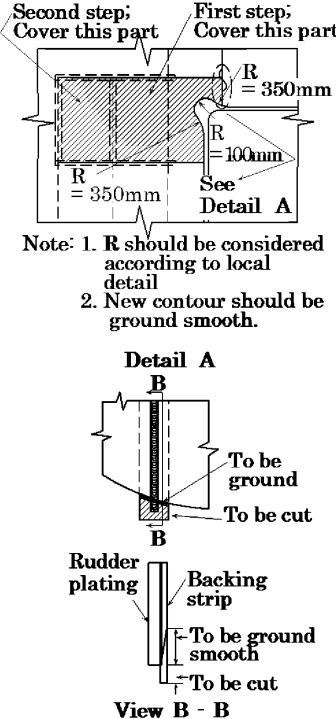
GENERAL DRY CARGO SHIPS		Guidelines for Surveys, Assessment and Repair of Hull Structure
Part 2	Fore and aft end regions	Example No.
Area 3	Stern frame, rudder arrangement and propeller shaft support	5
Detail of damage		Fracture in rudder plating of semi-spade rudder in way of pintle cutout
Sketch of damage		Sketch of repair

<p>Fracture in plate</p> <p>Fracture B In weld</p> <p>Fracture A In plating</p> <p>Rudder horn</p>

<p>Second step; Cover this part</p> <p>First step; Cover this part</p> <p><math>R = 350\text{mm}</math></p> <p><math>R = 100\text{mm}</math></p> <p>See Detail A</p> <p>Note: 1. <math>R</math> should be considered according to local detail 2. New contour should be ground smooth.</p> <p>Detail A</p> <p>To be ground</p> <p>To be cut</p> <p>Rudder plating</p> <p>Backing strip</p> <p>To be ground smooth</p> <p>To be cut</p> <p>View B - B</p>
Notes on possible cause of damage		Notes on repairs

<ol style="list-style-type: none"> <li>Inadequate design for stress concentration in way of pintle bearing (Fracture A).</li> <li>Imperfection in welding seam (Fracture B).</li> </ol>		<ol style="list-style-type: none"> <li>Fractured part to be cropped off.</li> <li>Repair by two insert plates of modified, stress releasing contour. For the vertical seam no backing strip is used 100mm off contour, welding from both sides, to be ground after welding.</li> <li>Variant (See Detail A): Repair as mentioned under 2 with the use of backing strip for the <del>complete</del> <u>complete</u> vertical seam. After welding backing strip partly removed by grinding.</li> </ol>

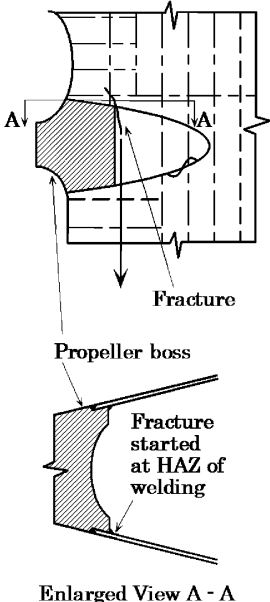
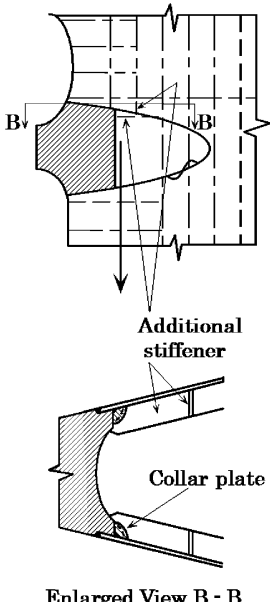
<b>GENERAL DRY CARGO SHIPS</b>		<b>Guidelines for Surveys, Assessment and Repair of Hull Structure</b>
<b>Part 2</b>	<b>Fore and aft end regions</b>	<b>Example No.</b>
<b>Area 3</b>	<b>Stern frame, rudder arrangement and propeller shaft support</b>	<b>6</b>
<b>Detail of damage</b>   Fracture in side shell plating at the connection to propeller boss		
<b>Sketch of damage</b>		<b>Sketch of repair</b>

<p>Fracture</p> <p>Propeller boss</p> <p>Fracture started at HAZ of welding</p> <p>Enlarged View A - A</p>

<p>Additional stiffener</p> <p>Collar plate</p> <p>Enlarged View B - B</p>
<b>Notes on possible cause of damage</b>		<b>Notes on repairs</b>
<ol style="list-style-type: none"> <li>1. Fatigue fracture due to vibration.</li> </ol>		<ol style="list-style-type: none"> <li>1. Fractured side shell plating is to be cropped and part renewed.</li> <li>2. Additional stiffeners are to be provided.</li> <li>3. Collar plate is to be provided.</li> </ol>

Repair examples for propeller boss and stern tube are shown in **Examples 6** and **7**. Regarding the welding reference is made to **3.1.2**, **3.2.4** and **3.2.5**.

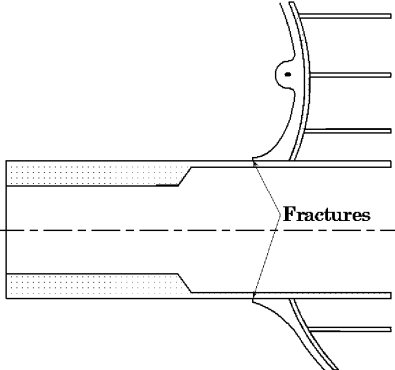
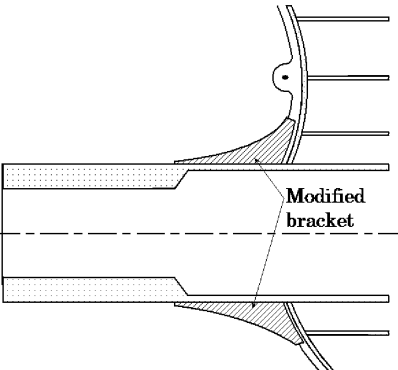
GENERAL DRY CARGO SHIPS		Guidelines for Surveys, Assessment and Repair of Hull Structure	
Part 2	Fore and aft end regions	Example No.	
Area 3	Stern frame, rudder arrangement and propeller shaft support	7	
<b>Detail of damage</b>		Fracture in stern tube at the connection to stern frame	
<b>Sketch of damage</b>		<b>Sketch of repair</b>

<b>Notes on possible cause of damage</b>		<b>Notes on repairs</b>	
<ol style="list-style-type: none"> <li>1. Fatigue fracture due to vibration.</li> </ol>		<ol style="list-style-type: none"> <li>1. Fractured tube is to be welded from both sides.</li> <li>2. Brackets are to be replaced by modified brackets with soft transition.</li> </ol>

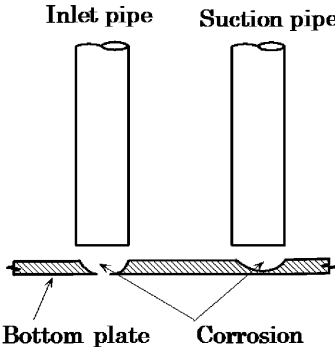
GENERAL DRY CARGO SHIPS		Guidelines for Surveys, Assessment and Repair of Hull Structure	
Part 3	Machinery and accommodation spaces	Example No.	
Area 1	Engine room structure	3	
Detail of damage	Corrosion in bottom plating under inlet/suction/pipe in way of bilge storage tank in engine room		
Sketch of damage	Sketch of repair

<b>Notes on possible cause of damage</b> 1. Heavy corrosion of bottom plating under the inlet/suction pipe.	<b>Notes on repairs</b> 1. Corroded bottom plate is to be cropped and part renewed. Thicker plate is preferable. 2. Replacement of pipe end by enlarged conical opening (similar to suction head in ballast tank) is preferable.

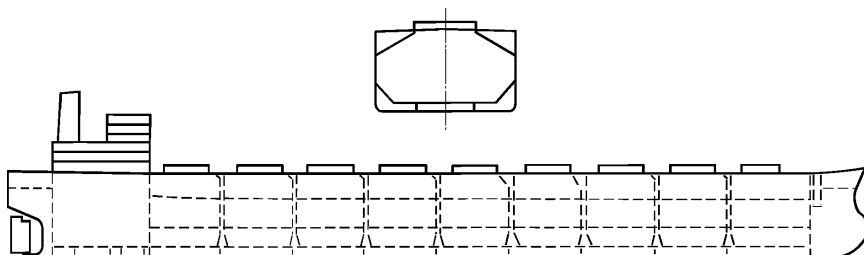
**Figure 1** General view of a typical single skin bulk carrier

This manual gives guidelines for a bulk carrier type ship which is constructed with a single deck, single skin, double bottom, hopper side tanks and topside tanks in cargo spaces, and is intended primarily to carry dry cargo, including ore, in bulk. **Figure 1** shows the general view of a typical single skin bulk carrier with 9 cargo holds.
