**РОССИЙСКИЙ МОРСКОЙ РЕГИСТР СУДОХОДСТВА**  
**RUSSIAN MARITIME REGISTER OF SHIPPING**

**SUPPLEMENT TO RULES AND GUIDELINES**  
**OF RUSSIAN MARITIME REGISTER OF SHIPPING**

**IACS PROCEDURAL REQUIREMENTS,**  
**UNIFIED INTERPRETATIONS**  
**AND RECOMMENDATIONS**

## **GENERAL DRY CARGO SHIPS**

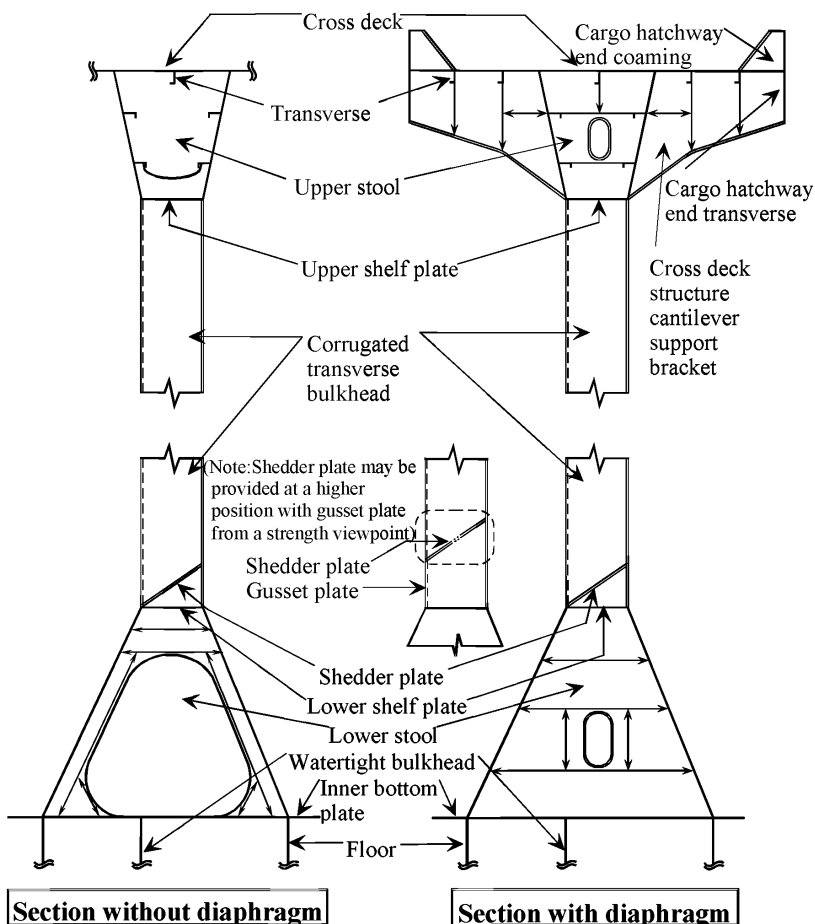
**Figure 3 (b) Nomenclature for typical watertight bulkhead**

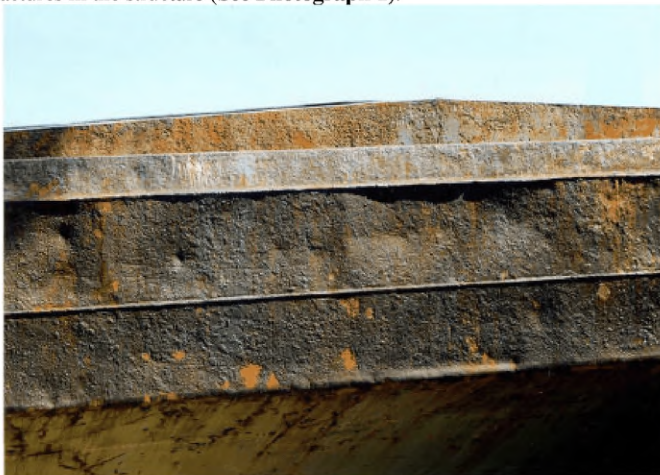
**Photograph 1** Heavy corrosion of hatch coaming and topside tank plating vertical strake

- 3.1.1** The level of wastage of under-deck stiffeners/structure in cross deck may have to be established by means of thickness measurements. The combined effect of the marine environment and the high humidity atmosphere within cargo holds will give rise to a high corrosion rate.
- 3.1.2** Severe corrosion of the hatch coaming plating inside cargo hold and topside tank plating vertical strake may occur due to difficult access for the maintenance of the protective coating. This may lead to fractures in the structure (See **Photograph 1**).

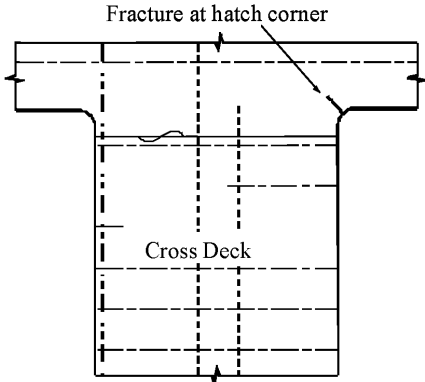
<b>BULK CARRIERS</b>		<b>Guidelines for Surveys, Assessment and Repair of Hull Structure</b>	
<b>Part 1</b>	<b>Cargo hold region</b>	<b>Example No.</b>	
<b>Area 1</b>	<b>Deck structure</b>	<b>1</b>	
<b>Detail of damage</b>		Fractures at main cargo hatch corner	
<b>Sketch of damage</b>

<b>Notes on possible cause of damage</b> <ol style="list-style-type: none"> <li>1. Stress concentration at hatch corners, i.e. radius of corner.</li> <li>2. Welded attachment of shedder plate close to edge of hatch corner.</li> <li>3. Wire rope groove.</li> </ol>		<b>Notes on repairs</b> <ol style="list-style-type: none"> <li>1. The corner plating in way of the fracture is to be cropped and renewed. If stress concentration is primary cause, insert plate should be increased thickness, enhanced steel grade and/or improved geometry. Insert plate should be continued beyond the longitudinal and transverse extent of the hatch corner radius ellipse or parabola, and the butt welds to the adjacent deck plating should be located well clear of the butts in the hatch coaming. It is recommended that the edges of the insert plate and the butt welds connecting the insert plates to the surrounding deck plating be made smooth by grinding. In this respect caution should be taken to ensure that the micro grooves of the grinding are parallel to the plate edge.</li> <li>2. If the cause of fracture is welded attachment of shedder plate, the deck connection should be left unwelded.</li> <li>3. If the cause of the fracture is wire rope groove, replacement to the original design can be accepted.</li> </ol>

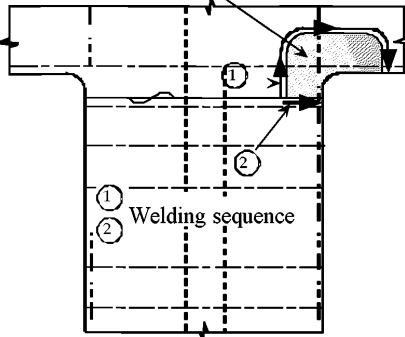
<b>Sketch of repair</b> Insert plate of enhanced steel grade and increased thickness

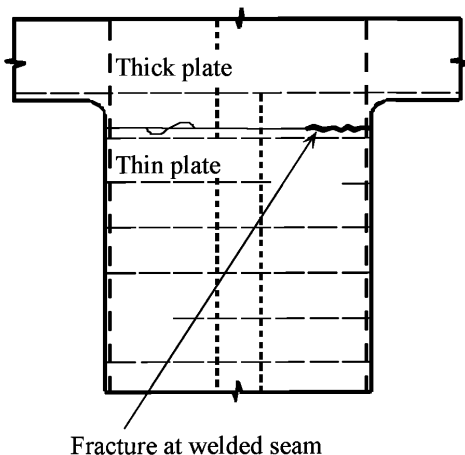
<b>BULK CARRIERS</b>		<b>Guidelines for Surveys, Assessment and Repair of Hull Structure</b>	
<b>Part 1</b>	<b>Cargo hold region</b>	<b>Example No.</b>	
<b>Area 1</b>	<b>Deck structure</b>	<b>2-a</b>	
<b>Detail of damage</b>		Fractures of welded seam between thick plate and thin plate at cross deck	
<p><b>Sketch of damage</b></p>

<p><b>Notes on possible cause of damage</b></p> <ol style="list-style-type: none"> <li>1. Stress concentration created by abrupt change in deck plating thickness.</li> <li>2. In-plane bending in cross deck strip due to torsional (longitudinal) movements of ship sides.</li> <li>3. Welded seam not clear of tangent point of hatch corner.</li> </ol>		<p><b>Notes on repairs</b></p> <ol style="list-style-type: none"> <li>1. Insert plate of intermediate thickness is recommended.</li> <li>2. Smooth transition between plates (beveling) should be considered.</li> </ol>

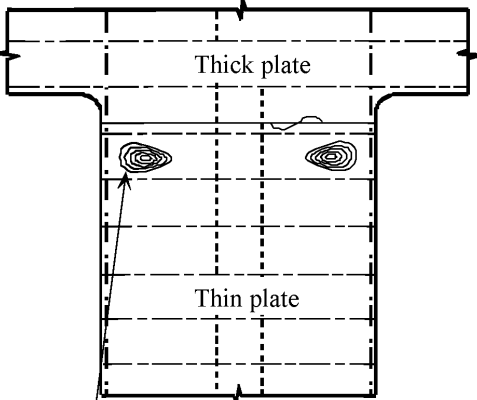
<b>BULK CARRIERS</b>		<b>Guidelines for Surveys, Assessment and Repair of Hull Structure</b>	
<b>Part 1</b>	<b>Cargo hold region</b>	<b>Example No.</b>	
<b>Area 1</b>	<b>Deck structure</b>	<b>2-b</b>	
<b>Detail of damage</b>		Plate buckling in thin plate near thick plate at cross deck	
<b>Sketch of damage</b>		<b>Sketch of repair</b>

<p>Buckling of cross deck plating (Buckling of hatch end structure should be examined. Refer to <b>Example 7-a.</b>)</p>

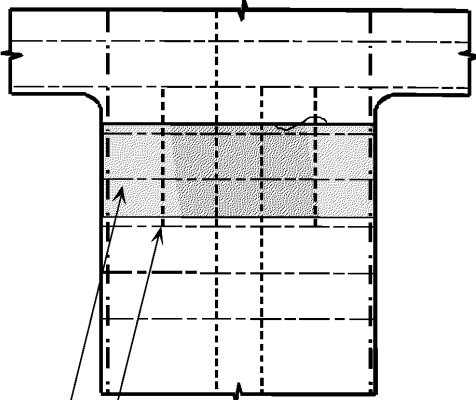
<p>Additional transverse stiffening and/or insertion of plate with suitable intermediate thickness</p>	
<b>Notes on possible cause of damage</b>		<b>Notes on repairs</b>	
<ol style="list-style-type: none"> <li>1. In-plane bending of cross deck strip due to torsional (longitudinal) movement of ship sides, often in combination with corrosion.</li> <li>2. Insufficient plate thickness and/or transverse stiffening.</li> </ol>		<ol style="list-style-type: none"> <li>1. Transverse stiffeners extending from hatch sides towards centerline at least 10% of breadth of hatch, and/or increased plate thickness in the same area.</li> </ol>

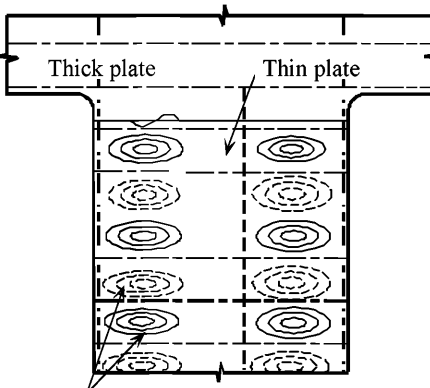
BULK CARRIERS		Guidelines for Surveys, Assessment and Repair of Hull Structure	
Part 1	Cargo hold region	Example No.	
Area 1	Deck structure	2-c	
<b>Detail of damage</b>		Overall buckling of cross deck plating	
<p><b>Sketch of damage</b></p>

<p>Buckling of cross deck plating (Buckling of hatch end structure should be examined. Refer to Example 7-a.)</p>		<p><b>Sketch of repair</b></p> <p><b>Repair A</b></p>

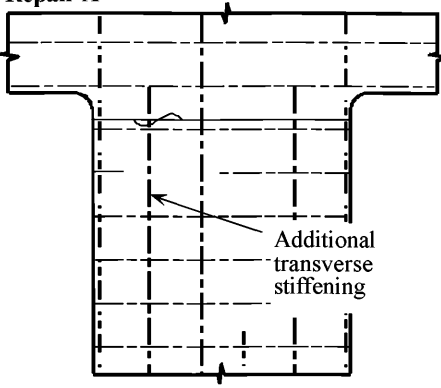
<p>Additional transverse stiffening</p> <p><b>Repair B</b></p>

<p>Insertion of plate with increased thickness</p>	
<p><b>Notes on possible cause of damage</b></p> <ol style="list-style-type: none"> <li>1. Transverse compression of deck due to sea load.</li> <li>2. Transverse compression of deck due to excessive loading in two adjacent holds.</li> <li>3. Insufficient plate thickness and/or transverse stiffening.</li> </ol>		<p><b>Notes on repairs</b></p> <ol style="list-style-type: none"> <li>1. <b>Repair A</b> Plating of original thickness in combination with additional transverse stiffening.</li> <li>2. <b>Repair B</b> Insertion of plating of increased thickness.</li> </ol>

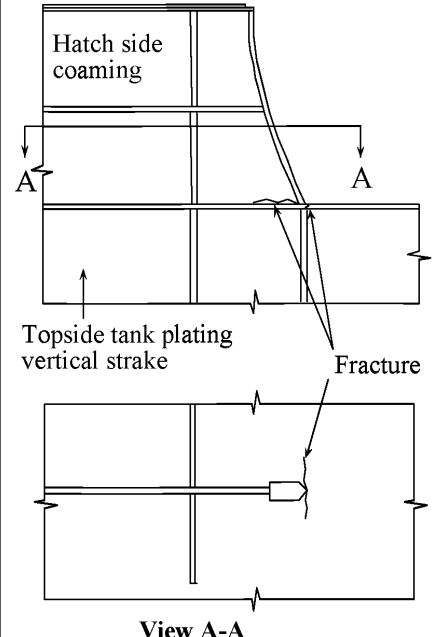
<b>BULK CARRIERS</b>		<b>Guidelines for Surveys, Assessment and Repair of Hull Structure</b>	
<b>Part 1</b>	<b>Cargo hold region</b>	<b>Example No.</b>	
<b>Area 1</b>	<b>Deck structure</b>	<b>3-a</b>	
<b>Detail of damage</b>		Fractures in the web or in the deck at the toes of the longitudinal hatch coaming termination bracket	
<p><b>Sketch of damage</b></p>

<p><b>View X-X</b></p>	
<p><b>Notes on possible cause of damage</b></p> <ol style="list-style-type: none"> <li>1. This damage is caused by stress concentrations attributed to the design of the bracket.</li> </ol>		<p><b>Notes on repairs</b></p> <ol style="list-style-type: none"> <li>1. The design of the bracket can be altered as shown above, however, it is to be ensured that an additional under deck stiffener is provided at the toe of the termination bracket, where the toe is clear of the normal stiffening member.</li> <li>2. Full penetration weld for a distance of <math>0.15 H_C</math> from toe of side coaming termination bracket and for connection of athwartship gusset bracket to deck.</li> <li>3. The fracture in deck plating to be veed-out and rewelded or deck plating cropped and part renewed as appropriate, using low hydrogen electrodes for welding.</li> </ol>

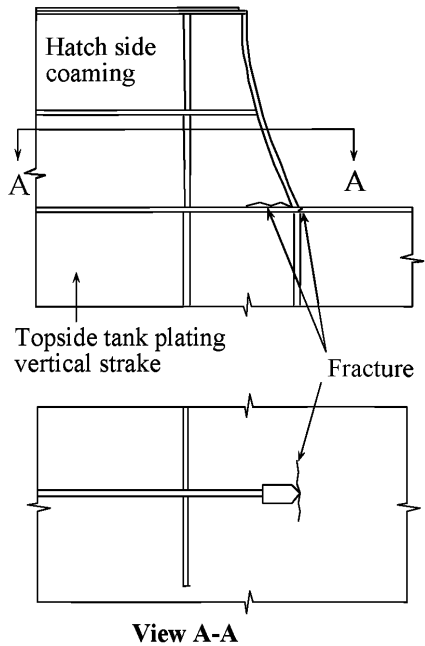
<b>BULK CARRIERS</b>		<b>Guidelines for Surveys, Assessment and Repair of Hull Structure</b>	
<b>Part 1</b>	<b>Cargo hold region</b>	<b>Example No.</b>	
<b>Area 1</b>	<b>Deck structure</b>	<b>3-b</b>	
<b>Detail of damage</b>		Fractures in the web or in the deck at the toes of the longitudinal hatch coaming termination bracket	
<p><b>Sketch of damage</b></p>

<p>Hatch side coaming</p> <p>Topside tank plating vertical strake</p> <p>Fracture</p> <p>View A-A</p>		<p><b>Sketch of repair</b></p>

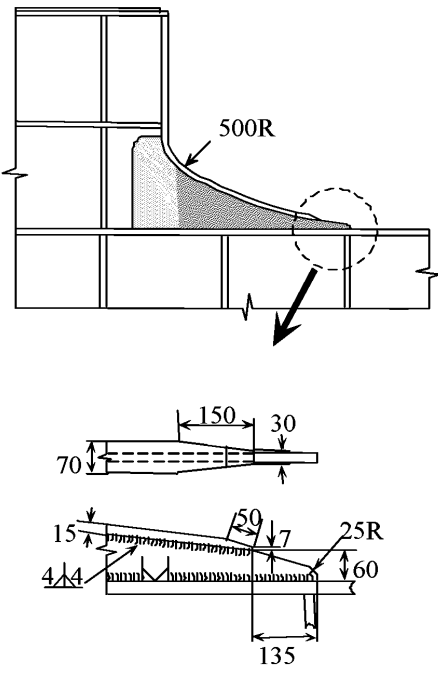
<p>500R</p> <p>150 30</p> <p>70</p> <p>15 50 7 25R 60</p> <p>135</p> <p>4/4</p>	
<p><b>Notes on possible cause of damage</b></p> <ol style="list-style-type: none"> <li>1. This damage is caused by stress concentrations attributed to the design of the bracket.</li> </ol>		<p><b>Notes on repairs</b></p> <ol style="list-style-type: none"> <li>1. The design of the bracket can be altered as shown above, however, it is to be ensured that an additional under deck stiffener is provided at the toe of the termination bracket, where the toe is clear of the normal stiffening member.</li> <li>2. The fracture in deck plating to be veed-out and rewelded or deck plating cropped and part renewed as appropriate, using low hydrogen electrodes for welding.</li> </ol>

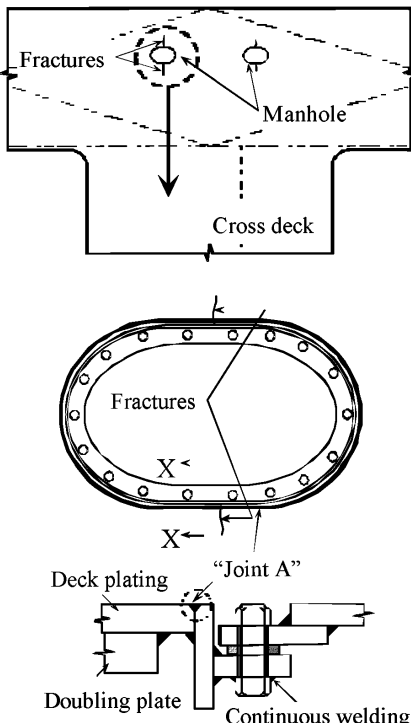
<b>BULK CARRIERS</b>		<b>Guidelines for Surveys, Assessment and Repair of Hull Structure</b>	
<b>Part 1</b>	<b>Cargo hold region</b>		<b>Example No.</b>
<b>Area 1</b>	<b>Deck structure</b>		<b>4</b>
<b>Detail of damage</b>		Fractures in deck plating initiated from weld of access manhole	
<b>Sketch of damage</b>		<b>Sketch of repair</b>

<p>The sketch of damage includes a plan view of a manhole on a deck with dashed lines indicating fractures in the deck plating around its perimeter. A vertical arrow points to a cross-section labeled 'X-X'. This cross-section shows the deck plating, a doubling plate, and a joint labeled 'Joint A' with continuous welding. Fractures are shown in the deck plating near the joint.</p>

<b>Notes on possible cause of damage</b>		<b>Notes on repairs</b>	
<ol style="list-style-type: none"> <li>1. Heavy weather.</li> <li>2. Improper welding of joint "A".</li> </ol>		<ol style="list-style-type: none"> <li>1. The fracture in deck plating to be veed-out and rewelded, or deck plating cropped and part renewed if considered necessary.</li> <li>2. Full penetration of joint "A" should be considered.</li> </ol>

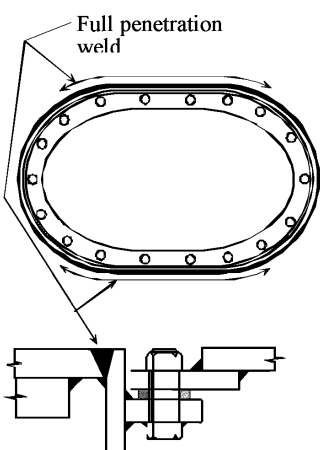
<p>The sketch of repair shows a plan view of the manhole with a thickened rim labeled 'Full penetration weld'. Below it is a cross-section of the joint showing the repair work, including the full penetration weld and the joint 'A'.</p>

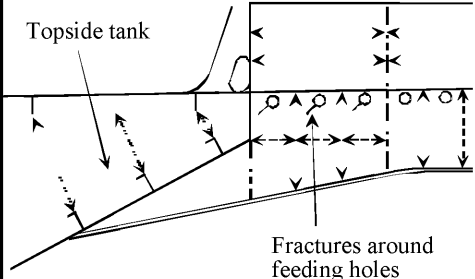
<b>BULK CARRIERS</b>		<b>Guidelines for Surveys, Assessment and Repair of Hull Structure</b>	
<b>Part 1</b>	<b>Cargo hold region</b>	<b>Example No.</b>	
<b>Area 1</b>	<b>Deck structure</b>	<b>9</b>	
<b>Detail of damage</b>		Fractures in hatch end beam around feeding holes	
<p><b>Sketch of damage</b></p>

<p>Topside tank</p> <p>Fractures around feeding holes</p>		<p><b>Sketch of repair</b></p>

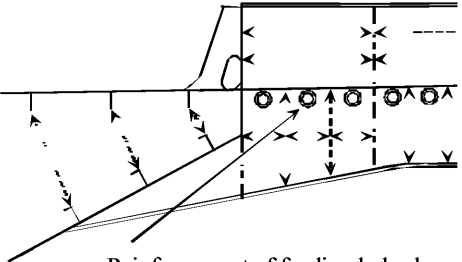
<p>Reinforcement of feeding holes by doubling plate or insert of pipe. See “Detail” below.</p>	
<p><b>Notes on possible cause of damage</b></p> <ol style="list-style-type: none"> <li>1. Inadequate reinforcement around feeding hole.</li> <li>2. Corrosion.</li> </ol>		<p><b>Notes on repairs</b></p> <ol style="list-style-type: none"> <li>1. Fractured part to be veed-out or cropped and renewed.</li> <li>2. If the fractured part is free from corrosion, reinforcement should be considered.</li> </ol>

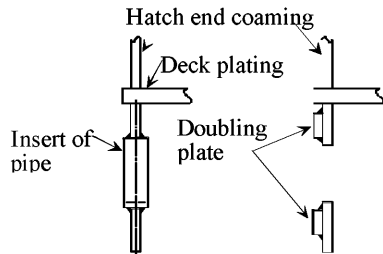
<p>Hatch end coaming</p> <p>Deck plating</p> <p>Insert of pipe</p> <p>Doubling plate</p> <p><b>Detail</b></p>

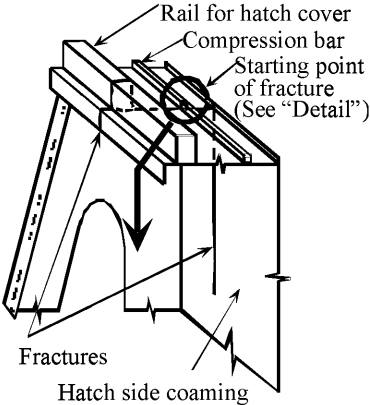
BULK CARRIERS		Guidelines for Surveys, Assessment and Repair of Hull Structure	
Part 1	Cargo hold region	Example No.	
Area 1	Deck structure	11	
<b>Detail of damage</b>		Fractures in hatch coaming top plate initiated from butt weld of compression bar	
<p><b>Sketch of damage</b></p>

<p><b>Notes on possible cause of damage</b></p> <ol style="list-style-type: none"> <li>1. Heavy weather</li> <li>2. Insufficient preparation of weld of compression bar and/or rail (Although the compression bar and rail are not longitudinal strength members, they subject same longitudinal stress as longitudinal members)</li> <li>3. Crack may initiate from insufficient penetration of weld of rail for hatch cover.</li> </ol>		<p><b>Notes on repairs</b></p> <ol style="list-style-type: none"> <li>1. Loading condition of the ship and proper welding procedure should be carefully considered.</li> <li>2. Fractured structure is to be cropped and renewed if considered necessary. (Small fracture may be vee-d-out and rewelded.)</li> <li>3. Full penetration welding should be applied to the butt weld of compression bar and rail.</li> </ol>

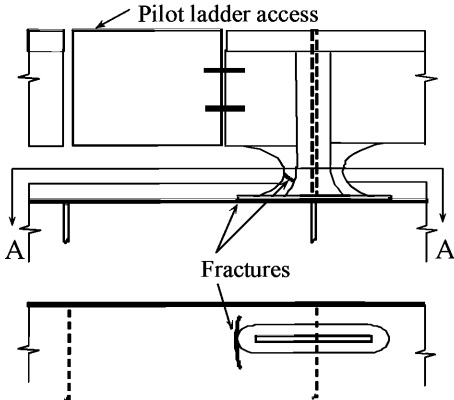
<b>BULK CARRIERS</b>		<b>Guidelines for Surveys, Assessment and Repair of Hull Structure</b>	
<b>Part 1</b>	<b>Cargo hold region</b>	<b>Example No. 12</b>	
<b>Area 1</b>	<b>Deck structure</b>		
<b>Detail of damage</b>		Fractures in deck plating at the pilot ladder access of bulwarks	
<b>Sketch of damage</b>

<p style="text-align: center;"><b>View A-A</b></p>		<b>Sketch of repair</b>

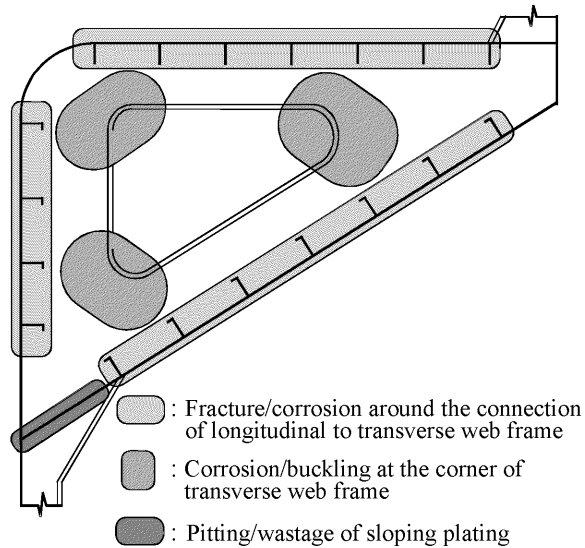
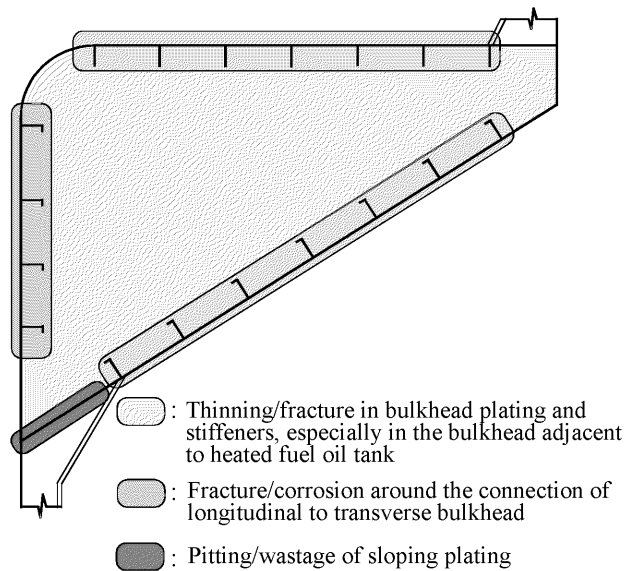
**(a) Transverse web frame section**

**(b) Transverse bulkhead section**

**Figure 1 Topside tank - Potential problem areas**

**2.1.2** Rate and extent of corrosion depends on the environmental conditions, and protective measures employed, such as coatings and sacrificial anodes. The following structures are generally susceptible to corrosion (See **Figure 1**).

- (a) Structure in corrosive environment
  - Deck plating and deck longitudinal
  - Transverse bulkhead adjacent to heated fuel oil tank
  - Lowest part of sloping plating
- (b) Structure subject to high stress
  - Face plates and web plates of transverse at corners
  - Connection of side longitudinal to transverse
- (c) Areas susceptible to coating breakdown
  - Back side of face plate of longitudinal
  - Welded joint
  - Edge of access opening
- (d) Areas subjected to poor drainage
  - Web of side and sloping longitudinals

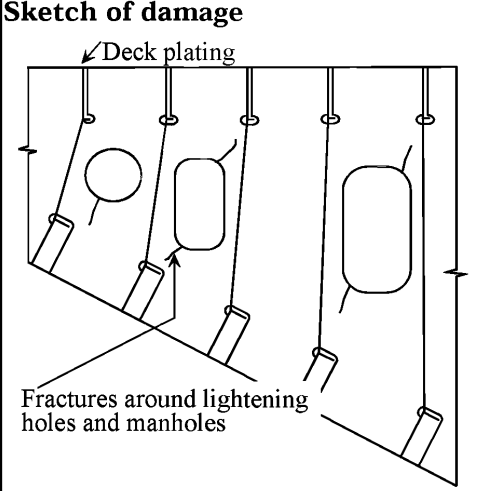
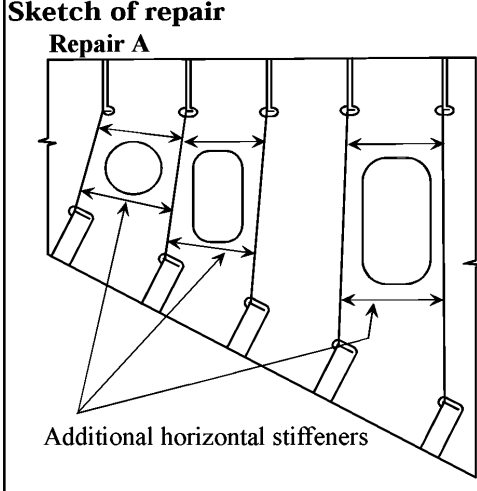
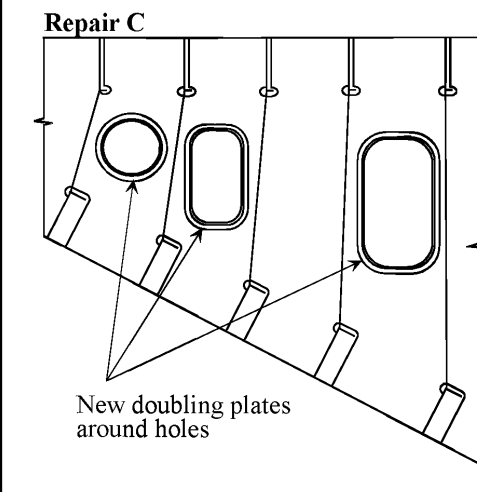
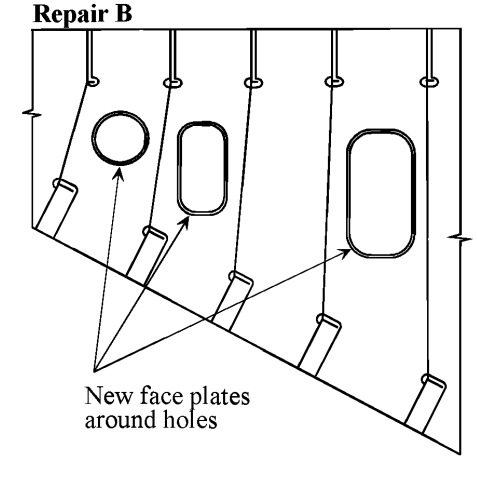
<b>BULK CARRIERS</b>		<b>Guidelines for Surveys, Assessment and Repair of Hull Structure</b>	
<b>Part 1</b>	<b>Cargo hold region</b>	<b>Example No.</b>	
<b>Area 2</b>	<b>Topside tank structure</b>	<b>1</b>	
<b>Detail of damage</b>		Fractures around unstiffened lightening holes and manholes in wash bulkhead	
<b>Sketch of damage</b>		<b>Sketch of repair</b>

<b>Repair C</b>		<b>Repair B</b>

<b>Notes on possible cause of damage</b>		<b>Notes on repairs</b>	
<ol style="list-style-type: none"> <li>General levels of corrosion and presence of stress concentration.</li> </ol>		<ol style="list-style-type: none"> <li>Corroded/fractured plate should be cropped and renewed with plating of enhanced thickness.</li> <li>Reinforcement should be considered.</li> </ol>

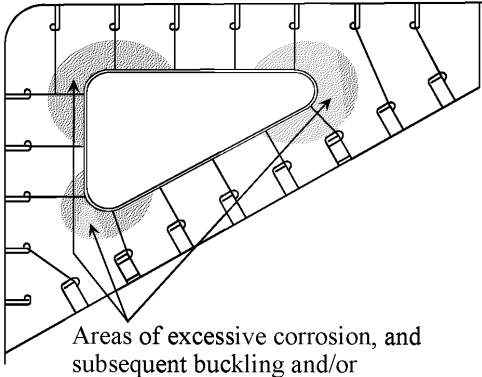
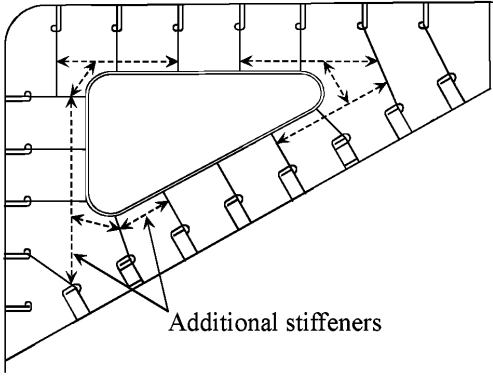
<p>Areas of excessive corrosion, and subsequent buckling and/or</p>

<p>Additional stiffeners</p>	
<b>Notes on possible cause of damage</b>		<b>Notes on repairs</b>	
<ol style="list-style-type: none"> <li>1. Insufficient buckling strength.</li> <li>2. Corrosion due to stress concentration at corners.</li> </ol>		<ol style="list-style-type: none"> <li>1. Buckled plating is to be cropped and parts renewed, if necessary.</li> <li>2. Additional stiffeners as shown above and/or renewal with plating of increased thickness should be considered.</li> </ol>

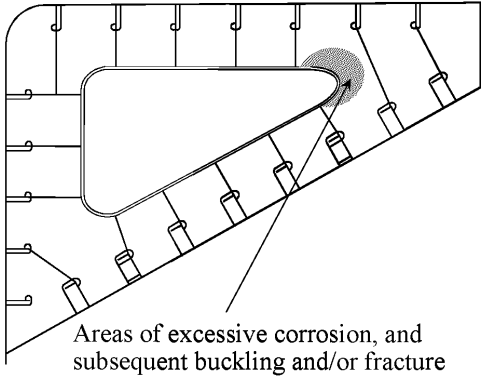
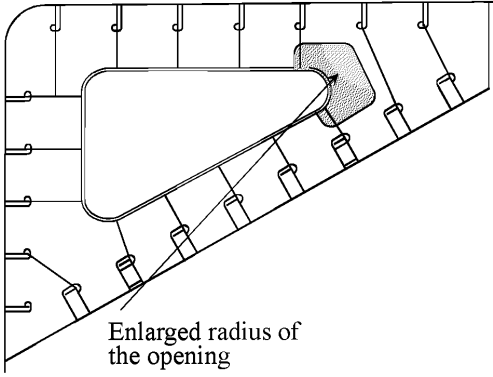
<p>Areas of excessive corrosion, and subsequent buckling and/or fracture</p>

<p>Enlarged radius of the opening</p>	
<b>Notes on possible cause of damage</b>		<b>Notes on repairs</b>	
<ol style="list-style-type: none"> <li>1. Corrosion caused by stress concentration at the corner due to insufficient radius for the opening.</li> </ol>		<ol style="list-style-type: none"> <li>1. Corroded/buckled plating is to be cropped and parts renewed with plating of increased thickness and additional stiffeners are preferable to minimize deflection.</li> <li>2. An attempt should be made to improve the design of the radius if felt necessary.</li> </ol>

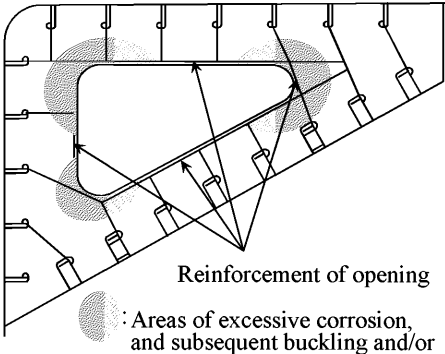
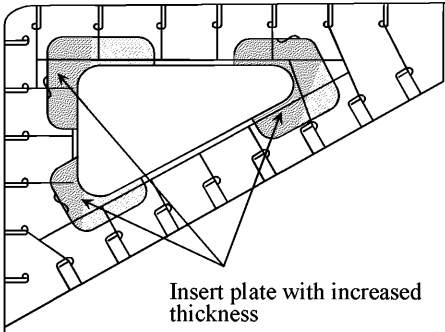
<p>Reinforcement of opening</p> <p>: Areas of excessive corrosion, and subsequent buckling and/or</p>

<p>Insert plate with increased thickness</p>	
<b>Notes on possible cause of damage</b>		<b>Notes on repairs</b>	
<p>1. Additional stresses at the free edge of transverse web. (In <b>Example 2-a - 2-c</b> face plate is provided for the reinforcement of the opening.)</p>		<p>1. Corroded/buckled plating is to be cropped and part renewed with plating of increased thickness.</p>

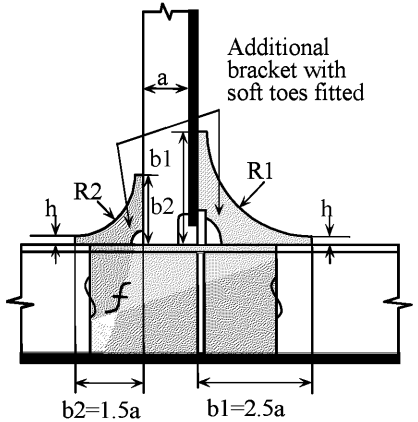
<b>BULK CARRIERS</b>		<b>Guidelines for Surveys, Assessment and Repair of Hull Structure</b>	
<b>Part 1</b>	<b>Cargo hold region</b>	<b>Example No.</b>	
<b>Area 2</b>	<b>Topside tank structure</b>	<b>5</b>	
<b>Detail of damage</b>		Fractures in longitudinal at transverse web frame or bulkhead	
<b>Sketch of damage</b>		<b>Sketch of repair</b>	
<p><b>Notes on possible cause of damage</b></p> <p>1. Damage can be caused by stress concentrations leading to accelerated fatigue in this region.</p>		<p><b>Notes on repairs</b></p> <p>1. If fracture extends to over one third of the depth of the longitudinal, then crop and part renew. Otherwise the fracture can be veed-out and welded.</p>

- $f$ : Where required, the longitudinal to be cropped and part renewed
1. For a slope at toes max. 1:3,  $R1=(b1-h) \times 1.6$  and  $R2=(b2-h) \times 1.6$
  2. Soft toe bracket to be welded first to longitudinal
  3. Scallop in bracket to be as small as possible, recommended max. 35mm
  4. If toes of brackets are ground smooth, full penetration welds in way to be provided
  5. Maximum length to thickness ratio =50:1 for unstiffened bracket edge
  6. Toe height,  $h$ , to be as small as possible (10-15mm)

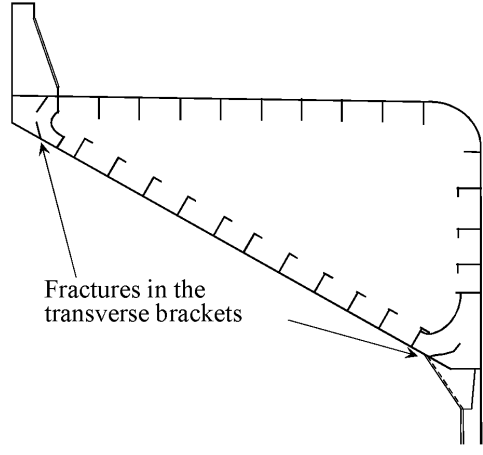
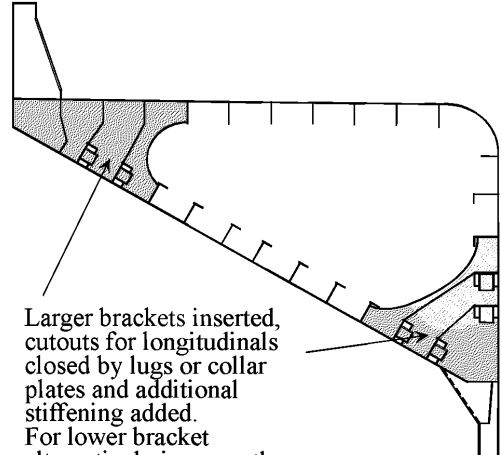
<p>Fractures in the transverse brackets</p>

<p>Larger brackets inserted, cutouts for longitudinals closed by lugs or collar plates and additional stiffening added. For lower bracket alternatively increase the thickness</p>	
<b>Notes on possible cause of damage</b>		<b>Notes on repairs</b>	
<ol style="list-style-type: none"> <li>1. General levels of corrosion and presence of stress concentrations.</li> <li>2. Misalignment of the brackets with adjoining structure, e.g. side shell frame brackets and/or coaming brackets.</li> <li>3. High shear stresses due to insufficient bracket size.</li> <li>4. Inadvertent overloading.</li> </ol>		<ol style="list-style-type: none"> <li>1. If the damage is caused by misalignment with the side shell frame brackets or the hatch coaming brackets the misalignment is to be rectified and the replacement by larger brackets incorporated only if considered necessary.</li> </ol>

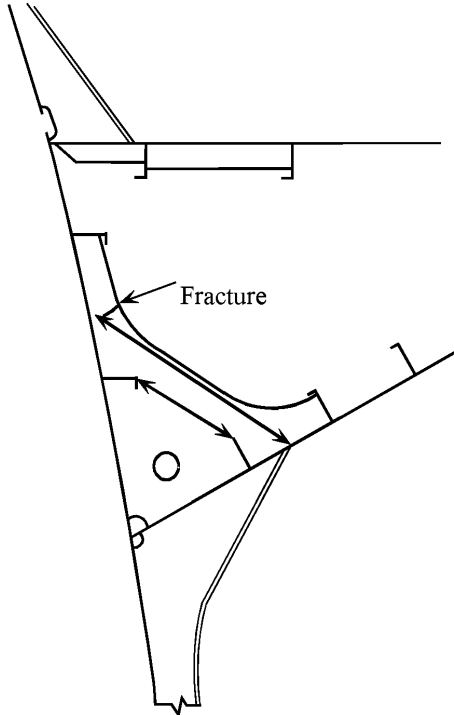
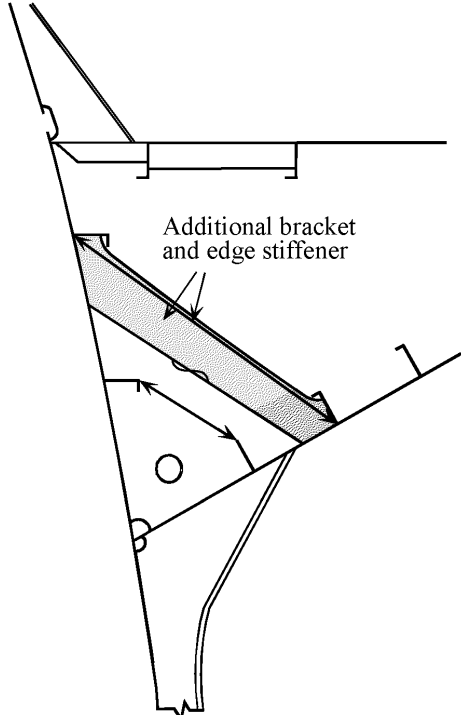
<b>Notes on possible cause of damage</b>		<b>Notes on repairs</b>	
<ol style="list-style-type: none"> <li>1. Insufficient strength.</li> <li>2. Corrosion.</li> </ol>		<ol style="list-style-type: none"> <li>1. Fractured part to be cropped and renewed.</li> <li>2. If the fractured part is free from corrosion, increased size and thickness should be considered. Partial renewal of the bracket may be accepted depending on the nature of the fracture.</li> </ol>

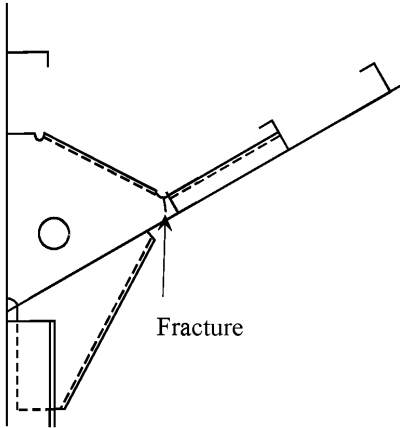
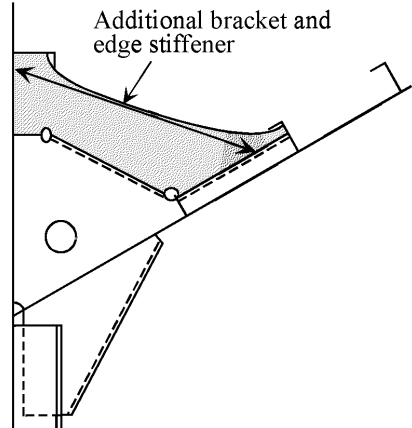
<p>Fracture</p>

<p>Additional bracket and edge stiffener</p>	
<b>Notes on possible cause of damage</b>		<b>Notes on repairs</b>	
<ol style="list-style-type: none"> <li>1. Stress concentration due to the shape of the bracket.</li> </ol>		<ol style="list-style-type: none"> <li>1. Cracked weld to be veed-out and rewelded.</li> </ol>

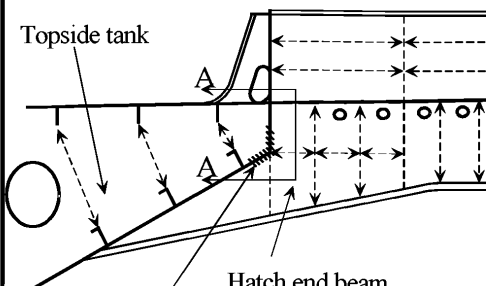
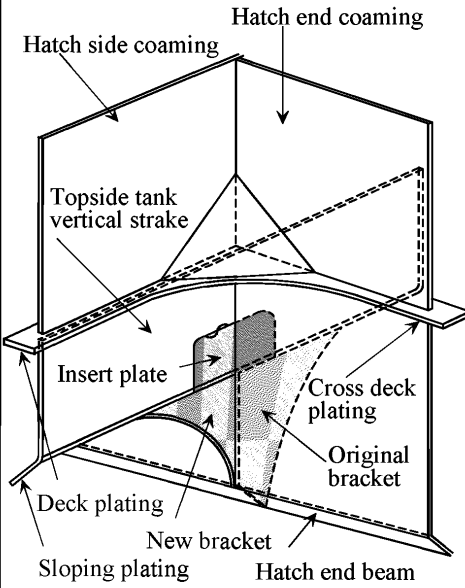
<p>Topside tank</p> <p>Hatch end beam</p> <p>Fracture in sloping plating and vertical strake initiated from the connection of topside tank to hatch end beam</p> <p>Topside tank vertical strake</p> <p>Deck plating</p> <p>Fracture</p> <p>Hatch end beam</p> <p>Topside tank knuckle line</p> <p>Original bracket (See "Sketch of repair")</p> <p><b>View A-A</b></p>

<p>Hatch end coaming</p> <p>Hatch side coaming</p> <p>Topside tank vertical strake</p> <p>Insert plate</p> <p>Cross deck plating</p> <p>Original bracket</p> <p>Deck plating</p> <p>Sloping plating</p> <p>New bracket</p> <p>Hatch end beam</p>

<b>Notes on possible cause of damage</b>		<b>Notes on repairs</b>	
<ol style="list-style-type: none"> <li>1. Stress concentration at the connection of hatch end beam to topside tank.</li> </ol>		<ol style="list-style-type: none"> <li>1. Fractured part to be cropped and renewed with increased thickness.</li> <li>2. Additional bracket should be considered for reinforcement.</li> </ol>

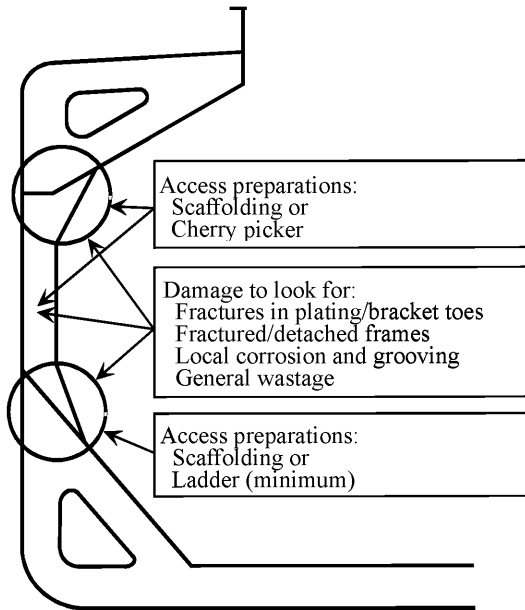
**Figure 1**  
Side shell frame - Potential problem areas

- 1.6** A summary of potential problem areas is shown in **Figures 1 - 4**. Examples of failure and damaged ship side structure are illustrated in **Photographs 1- 2**.

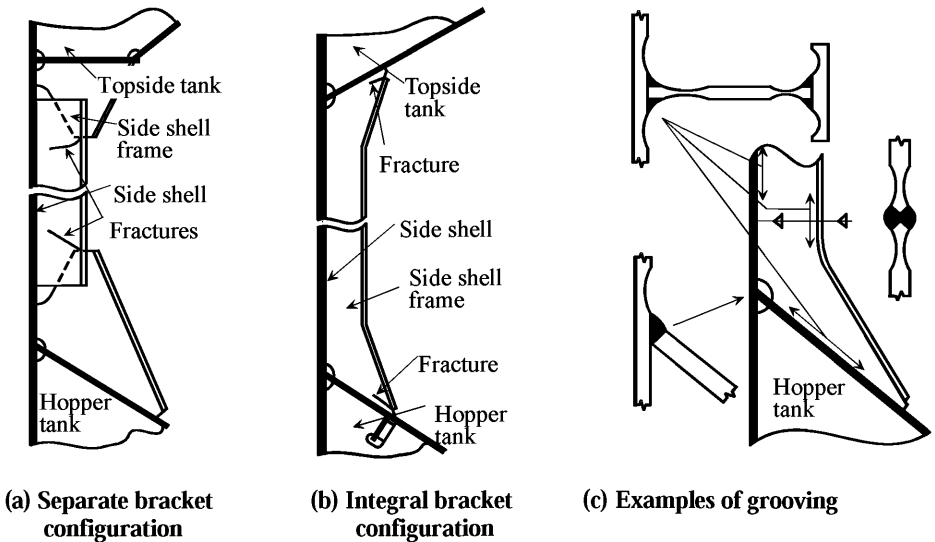
**Figure 2** Damages to side shell frame - Potential problem areas

(Note) The type of bracket configuration used will, to a large extent, dictate the location and extent of fracture. Where separate brackets are employed, the fracture location is normally at the bracket toe position on the frames, whereas with integral brackets the location is at the toe position on the hopper and topside tank.

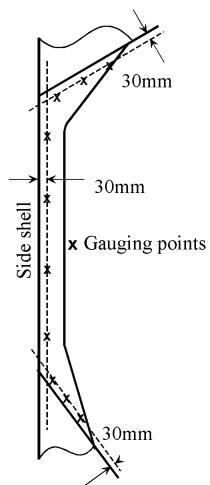
**Figure 3**  
**Representative gauging locations on the side shell frame - Potential problem areas**

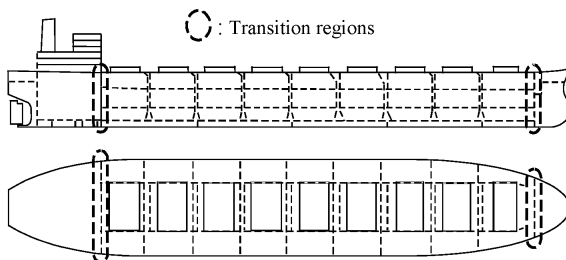
**Figure 4**    **Transition regions - Potential problem area**

- 1.5** The structure at the transition regions at the fore and aft ends of the ship are subject to stress concentrations due to structural discontinuities. The side shell plating at the transition regions is also subject to panting. The lack of continuity of the longitudinal structure, and the increased slenderness and flexibility of the side structure, makes the structure at the transition regions more prone to fracture damages.

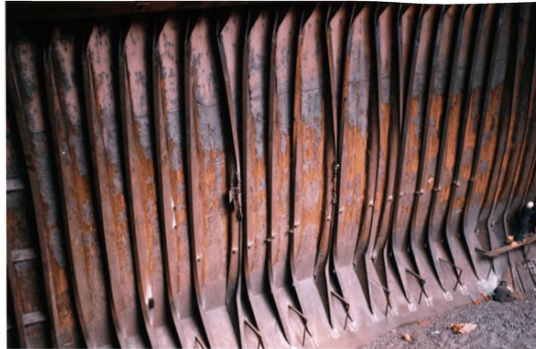
**Photograph 1** Collapsed side shell frames (See Example 4)

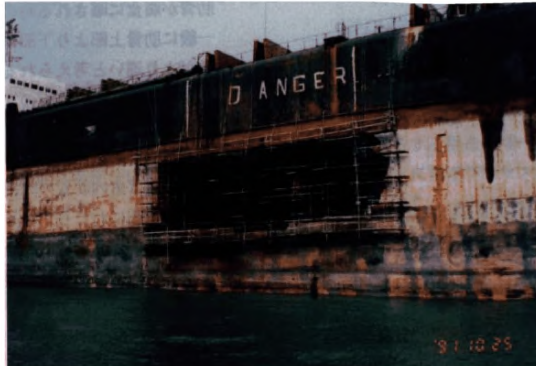
**Photograph 2** Missing side shell structure (See Examples 4 and 5)

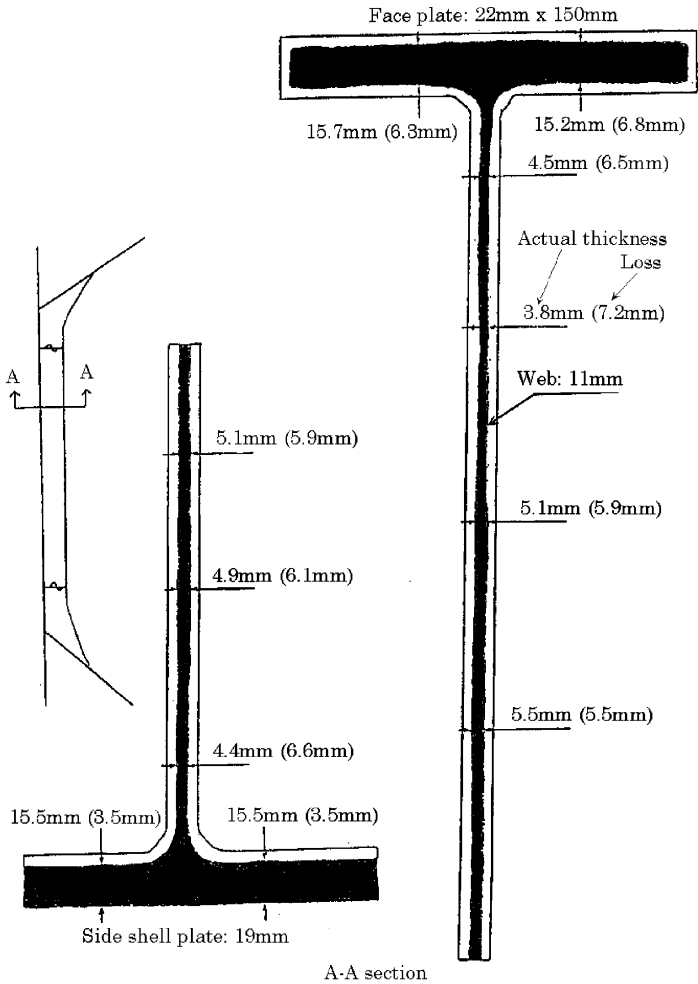
**Figure 5 Uniform corrosion of side shell frame**

- 2.1.1 Attention is drawn to the fact that side shell frames may be significantly weakened by loss of thickness although diminution and deformations may not be apparent. Inspection should be made after the removal of any scale or rust deposit. Thickness measurements may be necessary, particularly if the corrosion is smooth and uniform, to determine the condition of the structure (See **Figure 5**).

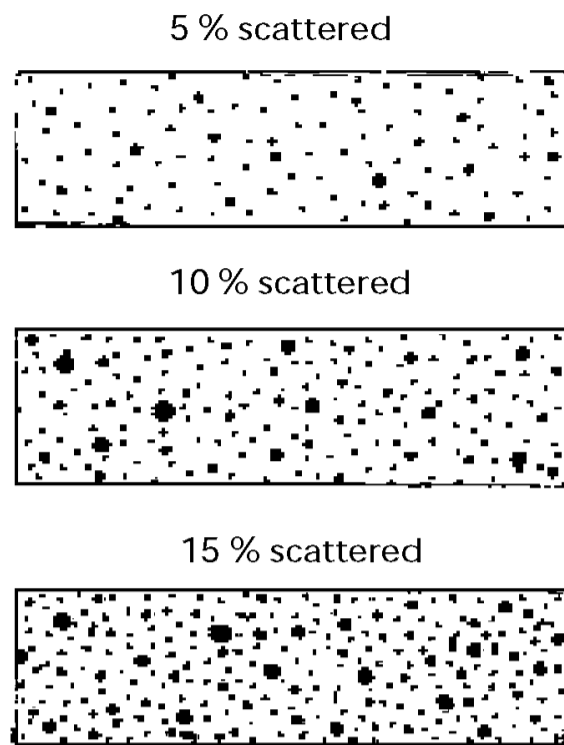
**Figure 6 Pitting intensity diagrams (from 5% to 15% intensity)**

- 4.1.2 If pitting intensity is lower than 15% in area (see **Figure 6**), pitting greater than  $\frac{1}{4}$  of the original thickness can be welded flush with the original surface. If deep pits are clustered together or remaining thickness is less than 6 mm, the plate should be renewed by plate inserting instead of repairing by welding.

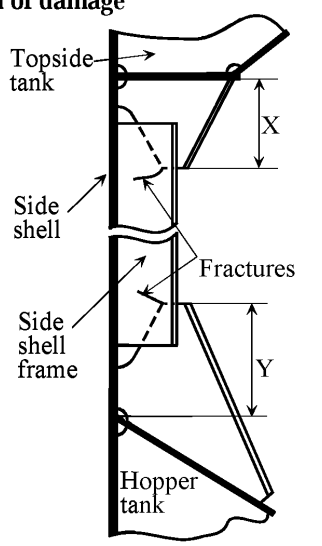
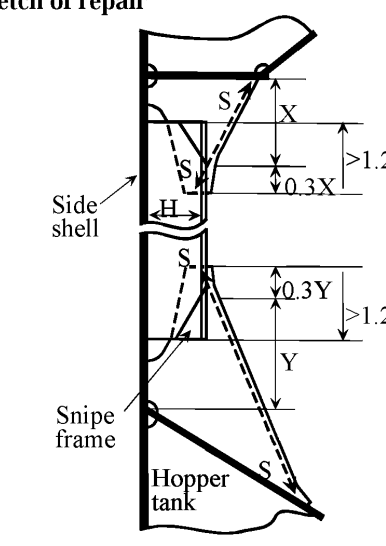
BULK CARRIERS		Guidelines for Surveys, Assessment and Repair of Hull Structure	
Part 1	Cargo hold region	Example No.	
Area 3	Cargo hold side structure	1-b	
Detail of damage		Fractures in side shell frame at bracket's toe	
<p><b>Sketch of damage</b></p>

<p><b>Separate bracket configuration</b></p>		<p><b>Sketch of repair</b></p>

<p><b>S=Snipped end</b></p>	
<p><b>Notes on possible cause of damage</b></p> <ol style="list-style-type: none"> <li>1. This type of damage is caused due to stress concentration.</li> </ol>		<p><b>Notes on repairs</b></p> <ol style="list-style-type: none"> <li>1. For small fractures, e. g. hairline fractures, the fracture can be veed-out, welded up, ground, examined by NDT for fractures, and rewelded.</li> <li>2. For larger/significant fractures consideration is to be given to cropping and partly renewing/ renewing the frame brackets. If renewing the brackets, end of frames can be snipped to soften them.</li> <li>3. If felt prudent, soft toes are to be incorporated at the boundaries of the bracket to the hopper plating.</li> <li>4. Attention to be given to the structure in wing tanks in way of the extended bracket arm. i.e. reinforcement provided in line with the bracket.</li> </ol>

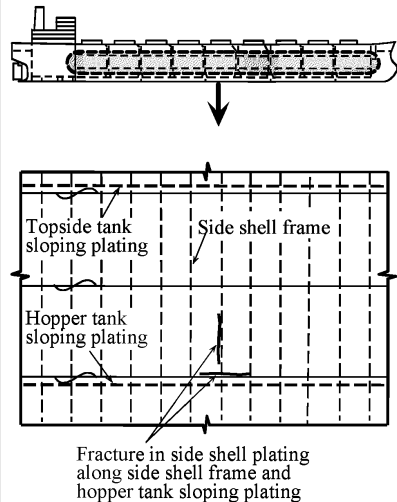
<p>Topside tank sloping plating</p> <p>Side shell frame</p> <p>Hopper tank sloping plating</p> <p>Fracture in side shell plating along side shell frame and hopper tank sloping plating</p>

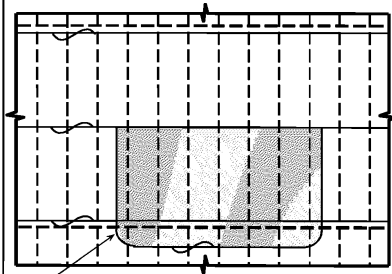
<p>Part renewal including side shell frames and hopper sloping plating, as found necessary</p>
<b>Notes on possible cause of damage</b>		<b>Notes on repairs</b>
<ol style="list-style-type: none"> <li>1. Heavy corrosion (grooving). Refer to <b>Figure 2 (c)</b>.</li> </ol>		<ol style="list-style-type: none"> <li>1. Sketch of repair applies when damage extends over several frames.</li> <li>2. Isolated fractures may be repaired by veeing-out and rewelding.</li> <li>3. Isolated cases of grooving may be repaired by build up of welding.</li> </ol>

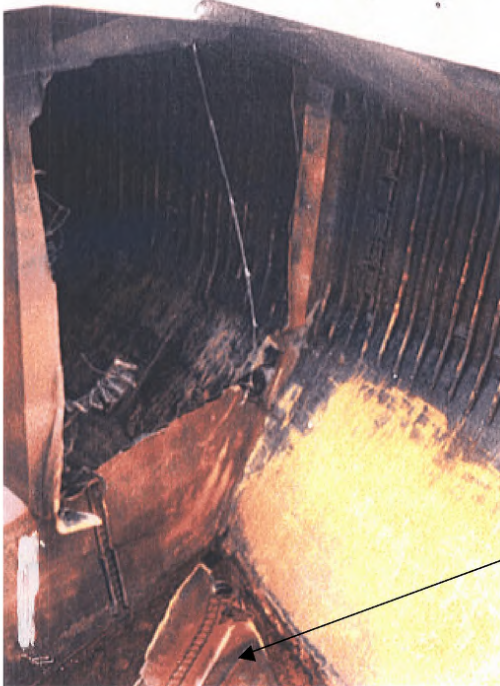
**Photograph 1**  
**Collapsed and detached transverse bulkhead**

Collapsed and detached transverse bulkhead on the tank top

- 1.4 Dry cargo holds, not designed as ballast holds, may sometimes be partially filled with water ballast in order to achieve a satisfactory air draught at the loading/discharging berths.  
The filling is restricted to a level that corresponds to the dry cargo hold scantlings, in particular the transverse bulkheads scantlings, and must only be carried out in port. In no case should these cargo holds be partially filled during voyage to save time at the berth. Such filling at sea may cause sloshing resulting in catastrophic failure such as indicated in **Photograph 1**.

- 1.5 Heavy corrosion may lead to collapse of the structure under extreme load, such as indicated in **Photograph 1** if it is not rectified properly.
- 1.6 A summary of potential problem areas is shown in **Figure 1**. It is emphasised that appropriate access arrangement as indicated in **Chapter 4 Survey planning, preparation and execution** of the guidelines, should be provided to enable a proper close-up inspection and thickness measurement as necessary.

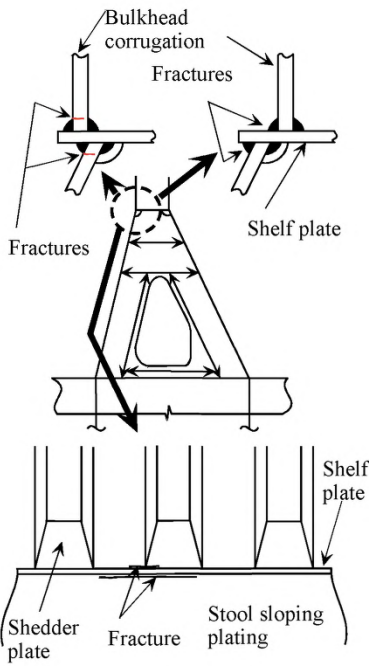
<b>BULK CARRIERS</b>		<b>Guidelines for Surveys, Assessment and Repair of Hull Structure</b>	
<b>Part 1</b>	<b>Cargo hold region</b>	<b>Example No.</b>	
<b>Area 4</b>	<b>Transverse bulkhead and associated structure in cargo hold</b>	<b>1-b</b>	
<b>Detail of damage</b>		Fractures at weld connections to stool shelf plate	
<b>Sketch of damage</b>

<p>The sketch of damage consists of two parts. The upper part is a perspective view of a bulkhead corrugation connected to a shelf plate. Arrows point to 'Bulkhead corrugation', 'Fractures' at the weld line, and 'Shelf plate'. The lower part is a plan view showing 'Shedder plate', 'Stool sloping plating', and 'Shelf plate'. Arrows indicate 'Fracture' at the weld between the stool sloping plating and the shelf plate.</p>		<b>Sketch of repair</b>

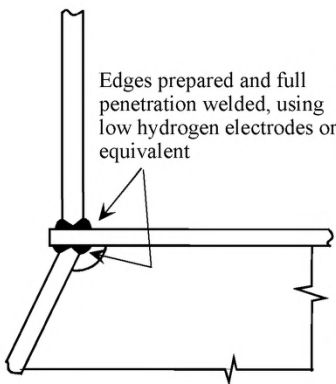
<p>The sketch of repair shows the same joint as the damage sketch, but now fully welded. An arrow points to the weld with the text: 'Edges prepared and full penetration welded, using low hydrogen electrodes or equivalent'.</p>

<b>Notes on possible cause of damage</b> <ol style="list-style-type: none"> <li>1. Misalignment between corrugation flange and sloping stool plating.</li> <li>2. Inadequate welding area connecting corrugation flange to shelf plate or similarly sloping stool plating to shelf plate.</li> </ol>		<b>Notes on repairs</b> <ol style="list-style-type: none"> <li>1. Fractures to be veed-out and rewelded.</li> <li>2. Structure to be released and misalignment rectified.</li> <li>3. Edge of the corrugated bulkhead and the stool plating on both sides of shelf plate to have full penetration welds.</li> <li>4. Where necessary an insert plate to be arranged in stool plating.</li> </ol>

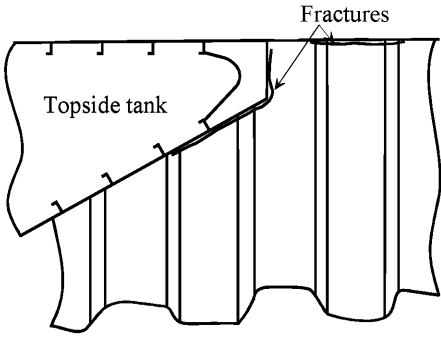
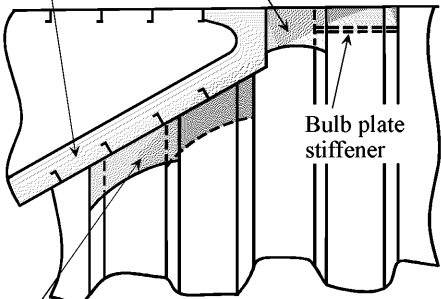
<b>BULK CARRIERS</b>		<b>Guidelines for Surveys, Assessment and Repair of Hull Structure</b>	
<b>Part 1</b>	<b>Cargo hold region</b>	<b>Example No.</b>	
<b>Area 4</b>	<b>Transverse bulkhead and associated structure in cargo hold</b>	<b>2</b>	
<b>Detail of damage</b>		Fractures at the upper boundaries to topside tanks	
<b>Sketch of damage</b>		<b>Sketch of repair</b>

<p>Continuous or intercostal reinforcement in line with flanges or gussets where not already fitted</p> <p>Adjacent to the topside tank either a gusset to a bulb plate stiffener may be</p>

<p>Gusset (similar gusset on the opposite)</p> <p>Bulb plate stiffener</p>	
<b>Notes on possible cause of damage</b>		<b>Notes on repairs</b>	
<ol style="list-style-type: none"> <li>1. Damage due to poor design and/or defective welds.</li> </ol>		<ol style="list-style-type: none"> <li>1. Fractures may be veed-out and rewelded. If necessary corrugated plating cropped and renewed.</li> <li>2. It is recommended that reinforcement as shown above be incorporated, giving due consideration to the following criteria:             <ol style="list-style-type: none"> <li>2.1 It is important to have the gusset plates well aligned with the transverse structure inside the tank. Gusset plates may be joggled to obtain this alignment.</li> <li>2.2 If there is no transverse web already existing inside the topside tank and in line with the flanges of corrugation or gusset plates, reinforcement as shown above to be fitted.</li> </ol> </li> </ol>

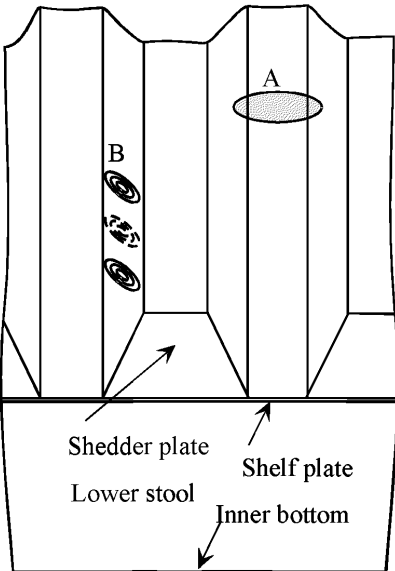
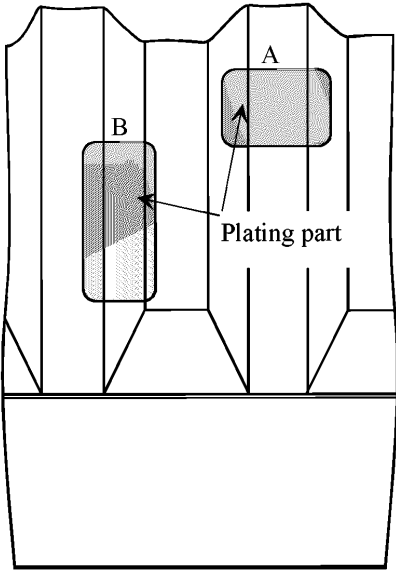
<b>BULK CARRIERS</b>		<b>Guidelines for Surveys, Assessment and Repair of Hull Structure</b>	
<b>Part 1</b>	<b>Cargo hold region</b>	<b>Example No.</b>	
<b>Area 4</b>	<b>Transverse bulkhead and associated structure in cargo hold</b>	<b>3</b>	
<b>Detail of damage</b>		Indentation and buckling of vertical corrugation	
<b>Sketch of damage</b>		<b>Sketch of repair</b>

<b>Notes on possible cause of damage</b>		<b>Notes on repairs</b>	
<ol style="list-style-type: none"> <li>1. Damages by mechanical abuse during cargo handling e.g. grab damage.</li> <li>2. Damage resulting from thickness reduction by corrosion.</li> <li>3. Buckling caused by bending or shear, see locations A and B respectively above, with a minimum reduction in thickness could be caused by underdesign or overloading. If this cause is suspected, the Classification Society concerned shall be contacted before proceeding with repairs.</li> </ol>		<ol style="list-style-type: none"> <li>1. Damage by mechanical abuse If the indentation/buckling is local and of a minor nature, the plating can be faired in place. If the deformation is more pronounced and/or in association with a generalized reduction in thickness the plating is to be cropped and renewed, as shown at locations A and B above.</li> <li>2. Damage resulting from corrosion In this case thickness measurements are to be taken at mid-span and top and bottom of corrugations, and corrugations renewed or part renewed as necessary. Particular attention is to be given to the fit and alignment at corners of flanged corrugations when being partly renewed.</li> </ol>
