**РОССИЙСКИЙ МОРСКОЙ РЕГИСТР СУДОХОДСТВА**  
**RUSSIAN MARITIME REGISTER OF SHIPPING**

**SUPPLEMENT TO RULES AND GUIDELINES**  
**OF RUSSIAN MARITIME REGISTER OF SHIPPING**

**IACS PROCEDURAL REQUIREMENTS,**  
**UNIFIED INTERPRETATIONS**  
**AND RECOMMENDATIONS**

## **GENERAL DRY CARGO SHIPS**

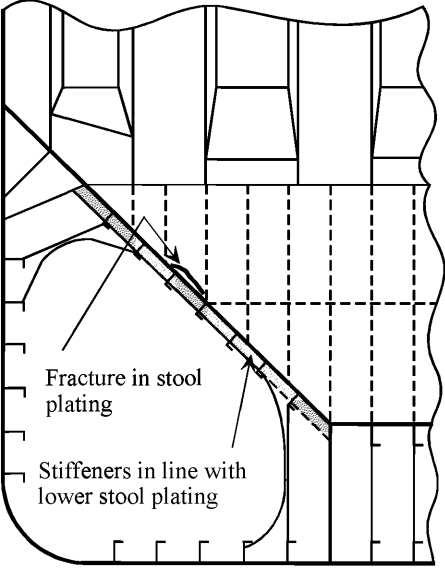
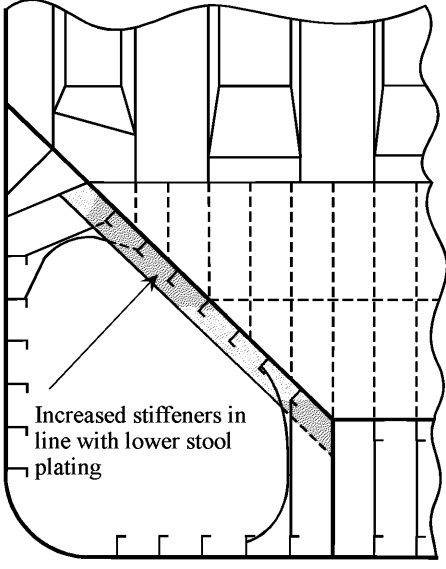
<b>BULK CARRIERS</b>		<b>Guidelines for Surveys, Assessment and Repair of Hull Structure</b>	
<b>Part 1</b>	<b>Cargo hold region</b>	<b>Example No.</b>	
<b>Area 4</b>	<b>Transverse bulkhead and associated structure in cargo hold</b>	<b>6</b>	
<b>Detail of damage</b>		Fractures at the connection of lower stool to hopper	
<b>Sketch of damage</b>		<b>Sketch of repair</b>

<p>Fracture in stool plating</p> <p>Stiffeners in line with lower stool plating</p>

<p>Increased stiffeners in line with lower stool plating</p>	
<b>Notes on possible cause of damage</b>		<b>Notes on repairs</b>	
<ol style="list-style-type: none"> <li>1. Insufficient strength of the connection</li> <li>2. Corrosion</li> </ol>		<ol style="list-style-type: none"> <li>1. Fractured stool plating should be partly cropped and renewed (thicker plate) if considered necessary.</li> <li>2. If the damage occurred due to insufficient strength, stiffeners in line with stool plating should be increased.</li> </ol>

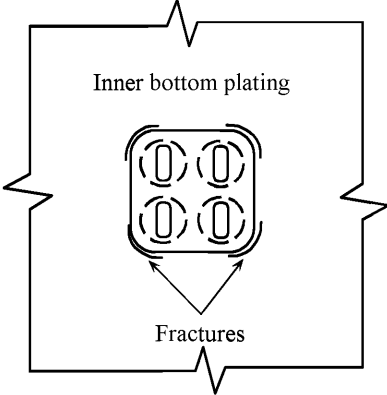
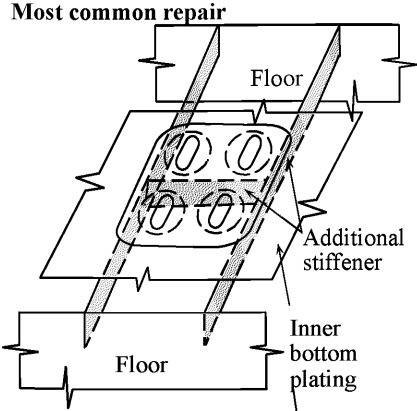
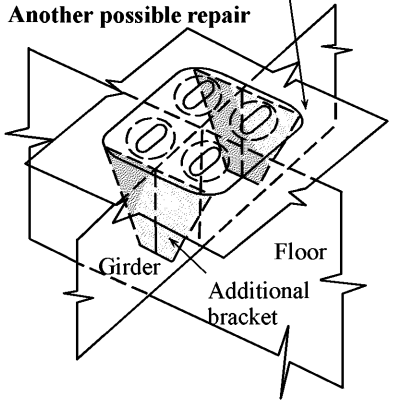
<b>BULK CARRIERS</b>	<b>Guidelines for Surveys, Assessment and Repair of Hull Structure</b>	
<b>Part 1</b>	<b>Cargo hold region</b>	<b>Example No.</b>
<b>Area 5</b>	<b>Double bottom structure including hopper</b>	<b>1</b>
<b>Detail of damage</b> Fractures in inner bottom plating around container bottom pocket		
<p><b>Sketch of damage</b></p>

<p><b>Sketch of repair</b></p> <p><b>Most common repair</b></p>

<p><b>Another possible repair</b></p>

<p><b>Notes on possible cause of damage</b></p> <ol style="list-style-type: none"> <li>1. Pocket is not supported correctly by floor, longitudinal and/or stiffener.</li> </ol>	<p><b>Notes on repairs</b></p> <ol style="list-style-type: none"> <li>1. Fractured plating should be cropped and part renewed.</li> <li>2. Adequate reinforcement should be considered.</li> </ol>

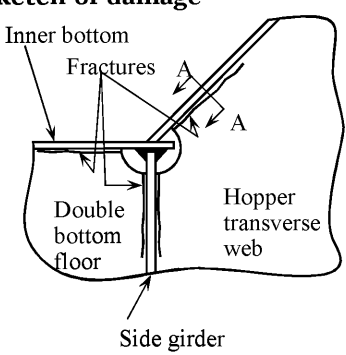
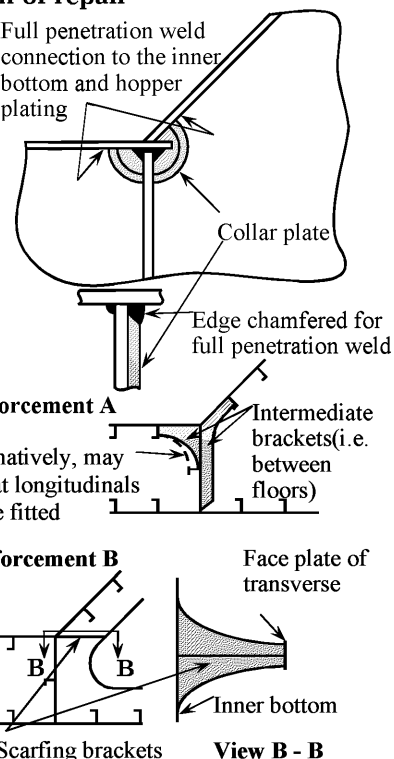
<b>BULK CARRIERS</b>		<b>Guidelines for Surveys, Assessment and Repair of Hull Structure</b>	
<b>Part 1</b>	<b>Cargo hold region</b>	<b>Example No.</b>	
<b>Area 5</b>	<b>Double bottom tank structure including hopper</b>	<b>4</b>	
<b>Detail of damage</b>		Fractures at weld connections of floors in way of hopper/inner bottom interface (welded knuckle)	
<p><b>Sketch of damage</b></p>

<p><b>View A - A</b> Transverse fractures in hopper web plating into possibly extending into the hopper sloping plating</p>

<p><b>Reinforcement A</b> Alternatively, may stop at longitudinals where fitted</p> <p><b>Reinforcement B</b></p> <p><b>View B - B</b></p>	
<p><b>Notes on possible cause of damage</b></p> <ol style="list-style-type: none"> <li>1. The damage is partly due to stress concentration at the edges of the weld .created by the presence of the deflections in the inner bottom/hopper plating.</li> </ol>		<p><b>Notes on repairs</b></p> <ol style="list-style-type: none"> <li>1. The fracture in the weld and/or plating is veed-out/cropped and renewed as appropriate.</li> <li>2. The cut-outs are eliminated by introducing suitable collar plates with emphasis on edge preparation and sequence of welding as shown above.</li> <li>3. Further reinforcements may be incorporated as shown above and depending on the judged cause of damage.</li> </ol>

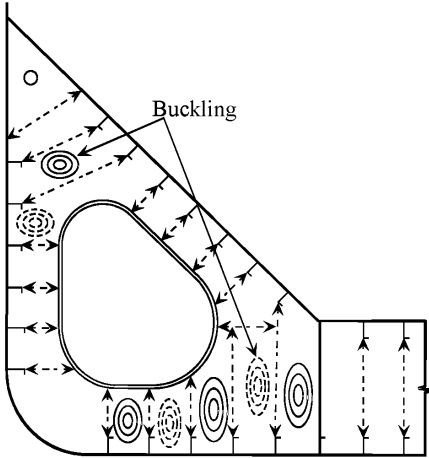
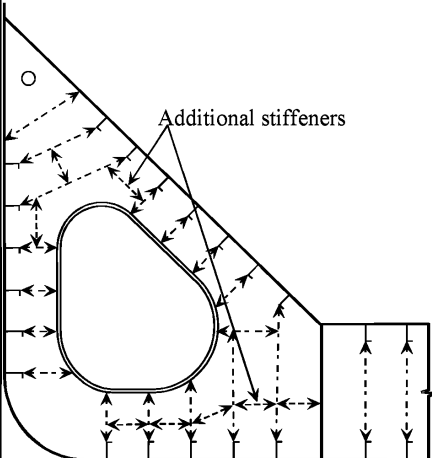
<b>BULK CARRIERS</b>		<b>Guidelines for Surveys, Assessment and Repair of Hull Structure</b>	
<b>Part 1</b>	<b>Cargo hold region</b>	<b>Example No. 10</b>	
<b>Area 5</b>	<b>Double bottom tank structure including hopper</b>		
<b>Detail of damage</b>		Buckling of transverse web	
<b>Sketch of damage</b>		<b>Sketch of repair</b>

<b>Notes on possible cause of damage</b>		<b>Notes on repairs</b>	
<ol style="list-style-type: none"> <li>1. Insufficient buckling strength of transverse web plating.</li> <li>2. Corrosion of high stress area.</li> </ol>		<ol style="list-style-type: none"> <li>1. If the buckling occurred without significant corrosion, adequate reinforcement is to be carried out.</li> <li>2. If the buckling occurred due to corrosion of high stress (shear stress) area, damaged area is to be cropped and part renewed. Adequate reinforcement and protective measures should be considered.</li> </ol>

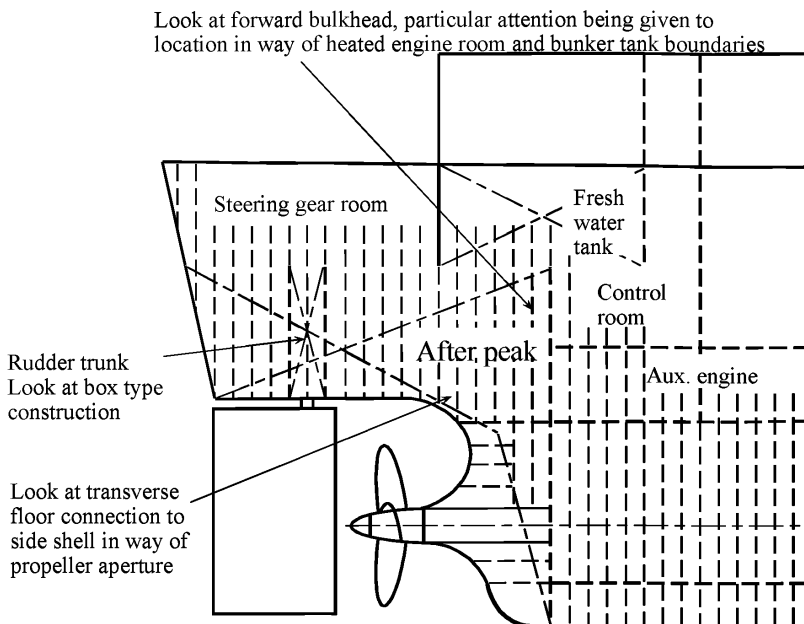
**Figure 1 Aft end structure - Potential problem areas**

- 2.3.1 Fractures in weld at floor connections and other locations in the aft peak tank and rudder trunk space can normally only be found by close-up inspection.
- 2.3.2 The structure supporting the rudder carrier may fracture and/or deform due to excessive load on the rudder. Bolts connecting the rudder carrier to the steering gear flat may also suffer damage under such load.

- 2.1.1 Wastage (and possible subsequent fractures) is more likely to be initiated at in the locations as indicated in **Figure 1**. A close-up inspection should be carried out with selection of representative thickness measurements to determine the extent of corrosion. Particular attention should be given to bunker tank boundaries and spaces adjacent to heated engine room.

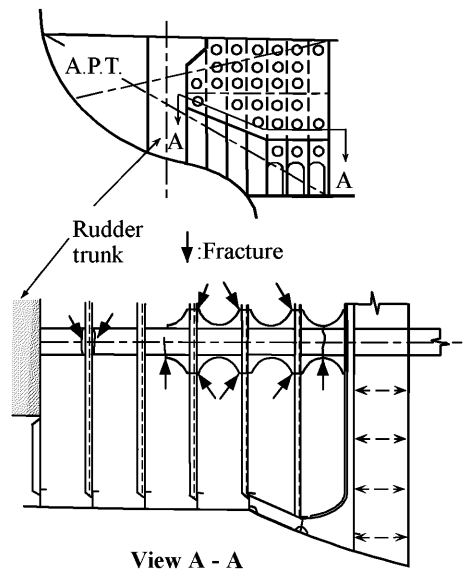
<b>BULK CARRIERS</b>		<b>Guidelines for Surveys, Assessment and Repair of Hull Structure</b>	
<b>Part 2</b>	<b>Fore and aft end regions</b>	<b>Example No.</b>	
<b>Area 2</b>	<b>Aft end structure</b>	<b>2</b>	
<b>Detail of damage</b>		Fractures at the connection of floors and girders/side brackets	
<b>Sketch of damage</b>		<b>Sketch of repair</b>

<p>The sketch shows a cross-section of the hull structure. At the top, a curved section is labeled 'A.P.T.'. Below it, a horizontal structure is labeled 'Rudder trunk'. A vertical line indicates a 'Fracture' at the connection of the rudder trunk to the hull structure. The view is labeled 'View A - A'.</p>

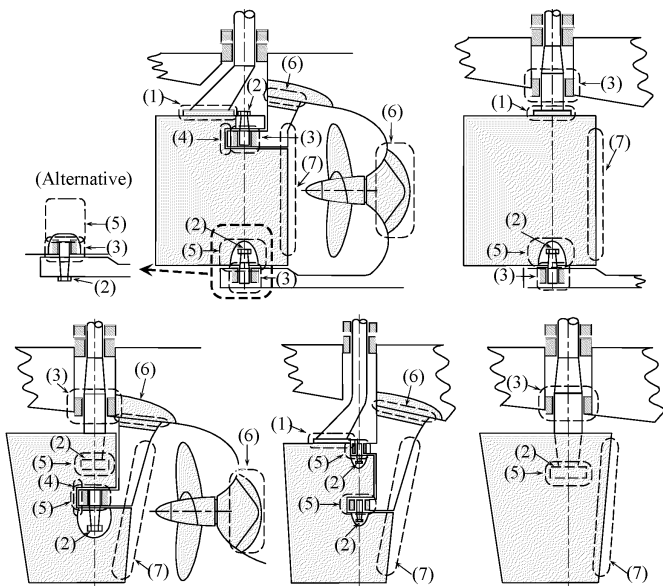
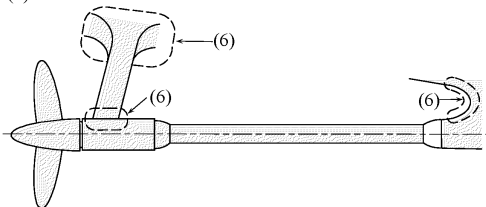
**Figure 2 Potential problem areas**

**Damage to look for:**

- (1) Fractures and loose coupling bolts
- (2) Loose nut
- (3) Wear (excessive bearing clearance)
- (4) Fractures in way of pintle cutout
- (5) Fractures in way of removable access plate
- (6) Fractures
- (7) Erosion

- 1.6 Pre-existing manufacturing internal defects in cast pieces may lead to fatigue cracking.
- 1.7 A summary of potential problem areas is shown in **Figure 2**.

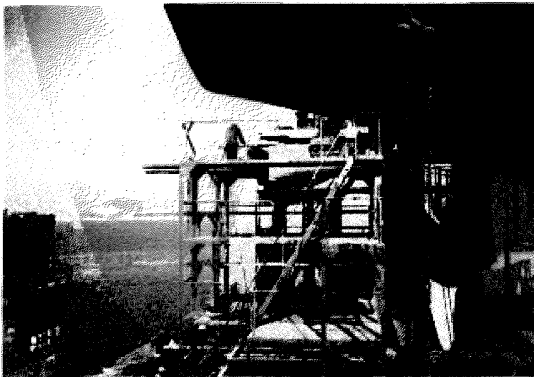
**Photograph 1  
Fractured rudder**

- 2.3.1 Corrosion/erosion (such as deep pitting corrosion) should be looked for in rudder/rudder horn plating, especially in welds. In extreme cases the corrosion /erosion may cause a large fracture as shown in **Photograph**

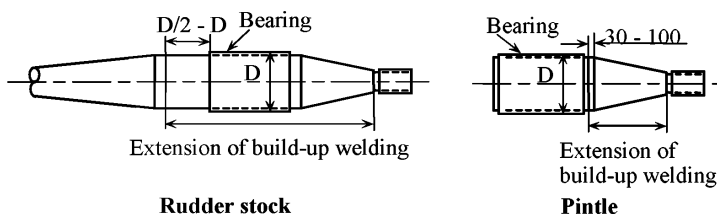
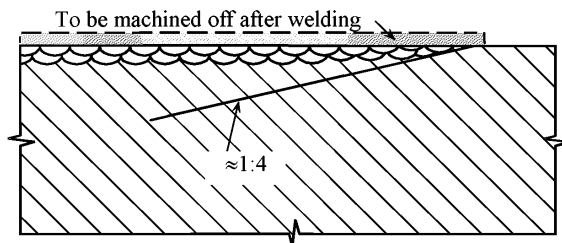
**Figure 3 Rudder stock repair by welding**

- Removal of the wasted area by machining and/or grinding, non-destructive examination for fractures (magnetic particle inspection preferred)
- Build-up welding by automatic spiral welding (turning device) according to an approved welding procedure (weld process, preheating, welding consumables, etc.)
- Extension of build-up welding over the area of **large bending moments (shafts)** according to the sketch

- Sufficient number of weld layers to compensate removed material, at least one layer in excess (heat treatment of the remaining layer)
- Transition at the end of the build-up welding according to the following sketch

- Post weld heat treatment if required in special cases (never for stainless steel cladding on ordinary steel)
- Final machining, at least two layers of welding material have to remain on the rudder stock (See the above sketch)
- Non-destructive fracture examination

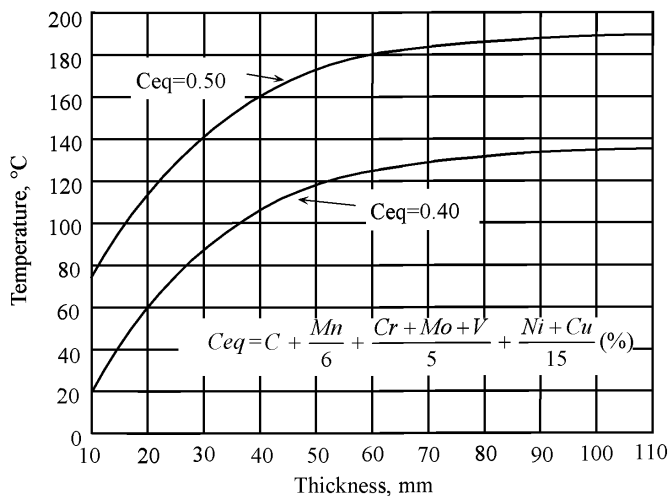
**Diagram 1 Preheating temperature**

- chemical composition (carbon equivalent  $C_{eq}$ )
  - thickness of the structure
  - hydrogen content in the welding consumables
  - heat input
- 3.2.5** As a guide, the preheating temperature can be obtained from **Diagram 1** using the plate thickness and carbon equivalent of the thicker structure.

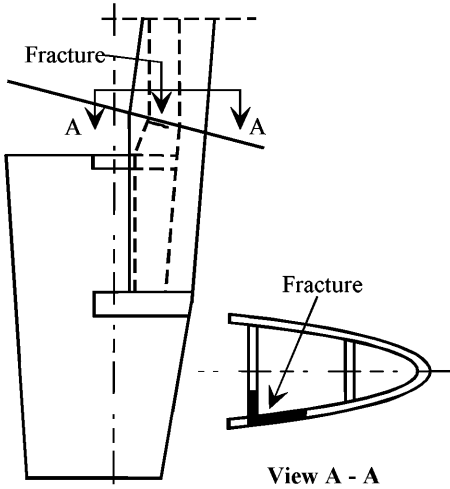
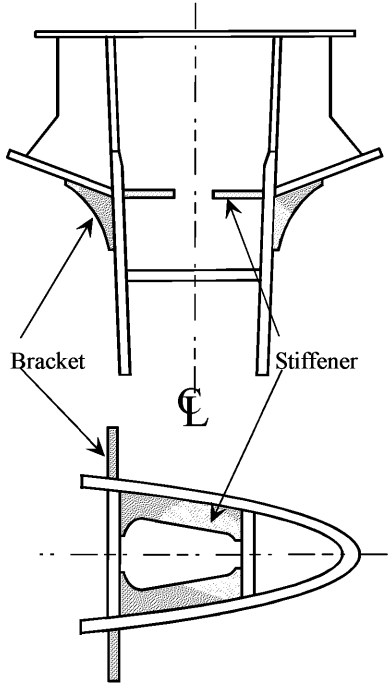
<b>BULK CARRIERS</b>		<b>Guidelines for Surveys, Assessment and Repair of Hull Structure</b>	
<b>Part 2</b>	<b>Fore and aft end regions</b>		<b>Example No.</b>
<b>Area 3</b>	<b>Stern frame, rudder arrangement and propeller shaft support</b>		<b>1</b>
<b>Detail of damage</b>		Fractures in rudder horn along bottom shell plating	
<b>Sketch of damage</b>		<b>Sketch of repair</b>

<b>Notes on possible cause of damage</b>		<b>Notes on repairs</b>	
<ol style="list-style-type: none"> <li>1. Insufficient strength due to poor design.</li> </ol>		<ol style="list-style-type: none"> <li>1. Fractured plating to be veed-out and rewelded.</li> <li>2. Fractured plating to be cropped and renewed if considered necessary.</li> <li>3. Reinforcement should be considered if considered necessary.</li> </ol>

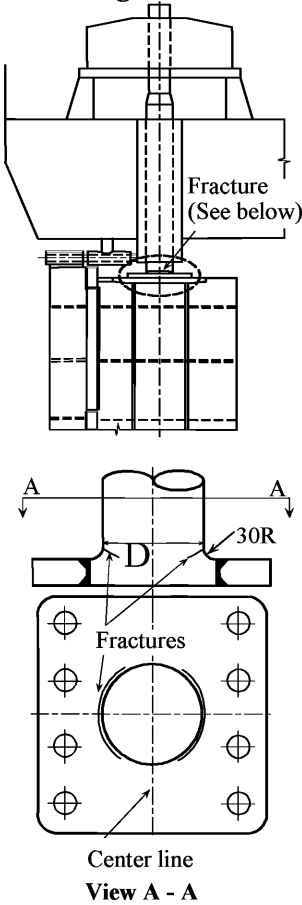
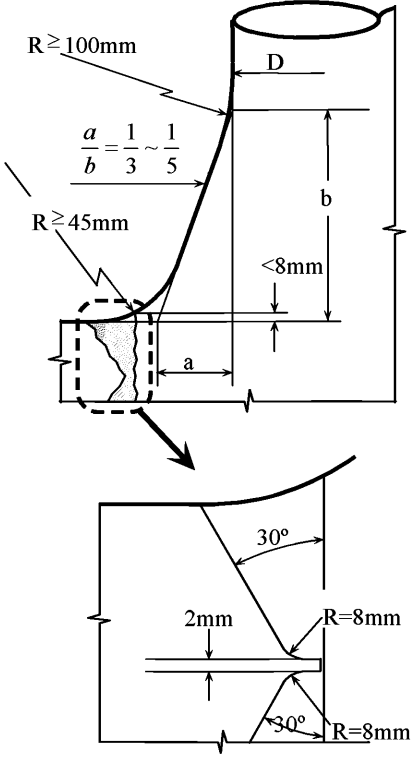
<b>BULK CARRIERS</b>	<b>Guidelines for Surveys, Assessment and Repair of Hull Structure</b>	
<b>Part 2</b>	<b>Fore and aft end regions</b>	<b>Example No.</b>
<b>Area 3</b>	<b>Stern frame, rudder arrangement and propeller shaft support</b>	<b>2</b>
<b>Detail of damage</b> Fractures in rudder stock		
<p><b>Sketch of damage</b></p>

<p>Center line View A - A</p>		<p><b>Sketch of repair</b></p>

<p><b>Notes on possible cause of damage</b></p> <ol style="list-style-type: none"> <li>Inadequate design for stress concentration in rudder stock.</li> </ol>		<p><b>Notes on repairs</b></p> <ol style="list-style-type: none"> <li>Modification of detail design of rudder stock to reduce the stress concentration.</li> </ol>

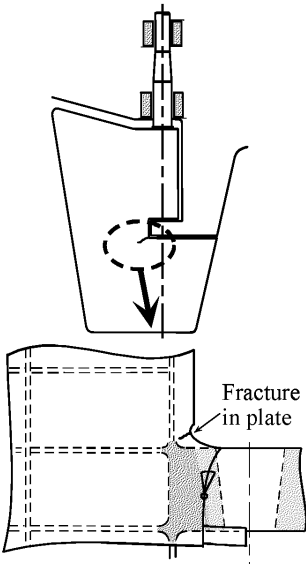
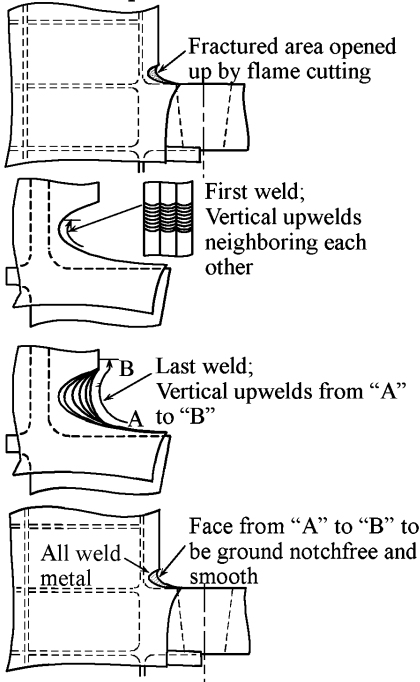
BULK CARRIERS		Guidelines for Surveys, Assessment and Repair of Hull Structure	
Part 2	Fore and aft end regions	Example No.	
Area 3	Stern frame, rudder arrangement and propeller shaft support	4	
Detail of damage		Fractures in rudder plating of semi-spade rudder (short fracture with end located forward of the vertical web)	
<p><b>Sketch of damage</b></p>

<p><b>Notes on possible cause of damage</b></p> <ol style="list-style-type: none"> <li>1. Stress concentration due to inadequate local design and/or fabrication notches in way of the butt weld between cast piece and plating.</li> </ol>		<p><b>Notes on repairs</b></p> <ol style="list-style-type: none"> <li>1. Grooving-out and welding of the fracture is not always adequate (metallurgical notch in way of a high stressed area).</li> <li>2. In the proposed repair procedure the metallurgical notches are shifted into a zone exposed to lower stresses.</li> <li>3. After welding a modification of the radius according to the proposal in <b>Example 5</b> is to be carried out.</li> <li>4. In case of very small crack it can be ground off by increasing the radius.</li> </ol>

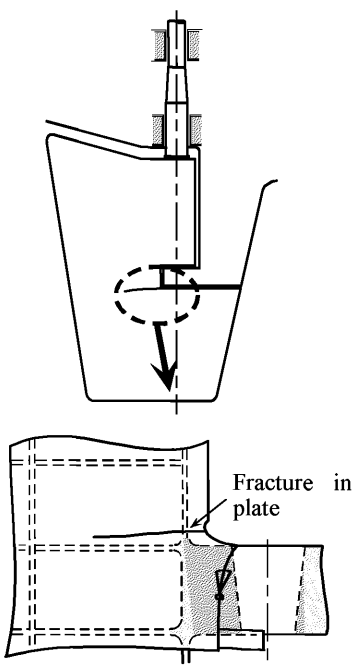
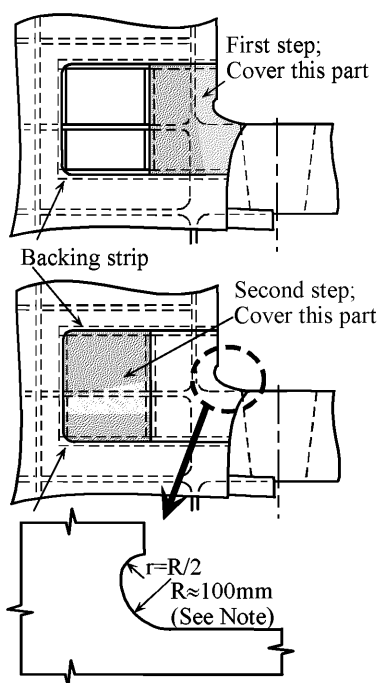
<b>GENERAL CARGO SHIPS</b>		<b>Guidelines for Surveys, Assessment and Repair of Hull Structure</b>
<b>Part 2</b>	<b>Fore and aft end regions</b>	<b>Example No.</b>
<b>Area 3</b>	<b>Stern frame, rudder arrangement and propeller shaft support</b>	<b>5</b>
<b>Detail of damage</b>	Fractures in rudder plating of semi-spade rudder extending beyond the vertical web	
<b>Sketch of damage</b>

<b>Notes on possible cause of damage</b> 1. Stress concentration due to inadequate local design and/or fabrication notches in way of the butt weld between cast piece and plating.		<b>Notes on repairs</b> 1. Fractured plating is to be cut-out. 2. Internal structures are to be checked. 3. Cut-out is to be closed by an insert plating according to the sketch (welding only from one side is demonstrated). 4. Modification of the radius. 5. In case of a new cast piece, connection with the plating is to be shifted outside the high stress area.

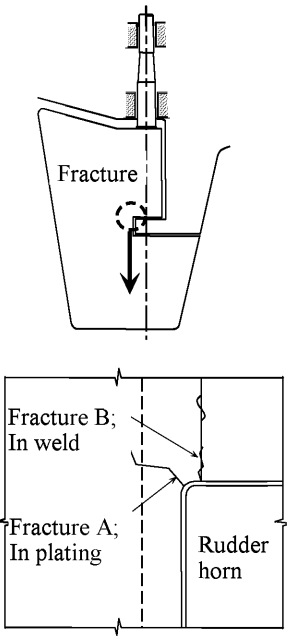
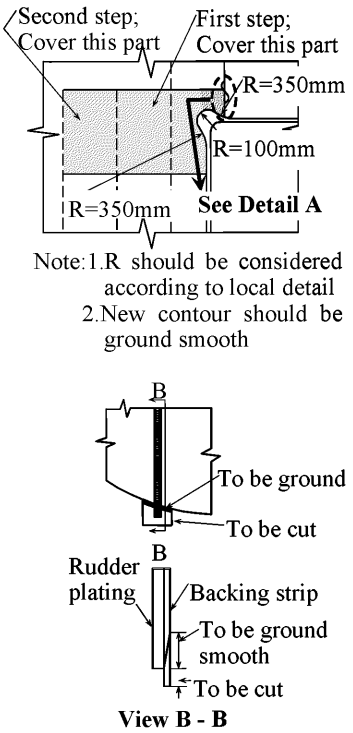
<b>BULK CARRIERS</b>		<b>Guidelines for Surveys, Assessment and Repair of Hull Structure</b>	
<b>Part 2</b>	<b>Fore and aft end regions</b>	<b>Example No.</b>	
<b>Area 3</b>	<b>Stern frame, rudder arrangement and propeller shaft support</b>	<b>6</b>	
<b>Detail of damage</b>	Fractures in rudder plating of semi-spade rudder in way of pintle cutout		
<p><b>Sketch of damage</b></p>

<p>The sketch shows a semi-spade rudder with a fracture in the plating. A detail view shows 'Fracture B; In weld' and 'Fracture A; In plating' near the 'Rudder horn'.</p>		<p><b>Sketch of repair</b></p>

<p>The repair sketch shows two steps: 'Second step; Cover this part' and 'First step; Cover this part'. It includes radii <math>R=350\text{mm}</math> and <math>R=100\text{mm}</math>, and a reference to 'See Detail A'. A note states: 'Note: 1.R should be considered according to local detail. 2.New contour should be ground smooth'. 'View B - B' shows 'Rudder plating', 'Backing strip', and areas 'To be ground' and 'To be cut'.</p>

<p><b>Notes on possible cause of damage</b></p> <ol style="list-style-type: none"> <li>1. Inadequate design for stress concentration in way of pintle bearing (<b>Fracture A</b>).</li> <li>2. Imperfection in welding seam (<b>Fracture B</b>).</li> </ol>		<p><b>Notes on repairs</b></p> <ol style="list-style-type: none"> <li>1. Fractured part to be cropped off.</li> <li>2. Repair by two insert plates of modified, stress releasing contour. For the vertical seam no backing strip is used 100mm off contour, welding from both sides, to be ground after welding.</li> <li>3. Variant (See <b>Detail A</b>): Repair as mentioned under 2 with the use of backing strip for the complete vertical seam. After welding backing strip partly removed by grinding.</li> </ol>

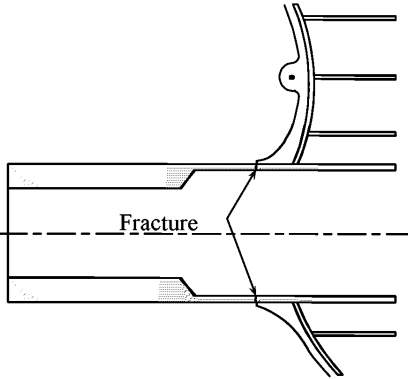
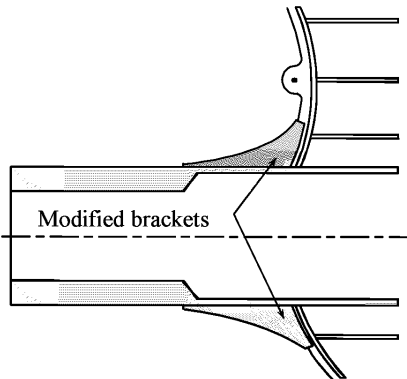
<b>BULK CARRIERS</b>		<b>Guidelines for Surveys, Assessment and Repair of Hull Structure</b>	
<b>Part 2</b>	<b>Fore and aft end regions</b>		<b>Example No.</b>
<b>Area 3</b>	<b>Stern frame, rudder arrangement and propeller shaft support</b>		<b>8</b>
<b>Detail of damage</b>		Fractures in stern tube at the connection to stern frame	
<b>Sketch of damage</b>		<b>Sketch of repair</b>

<b>Notes on possible cause of damage</b>		<b>Notes on repairs</b>	
<ol style="list-style-type: none"> <li>1. Fatigue fracture due to vibration.</li> </ol>		<ol style="list-style-type: none"> <li>1. Fractured tube is to be veed-out and welded from both sides.</li> <li>2. Brackets are to be replaced by modified brackets with soft transition.</li> </ol>

Repair examples for propeller boss and stern tube are shown in **Examples 7 and 8**. Regarding the welding reference is made to **3.1.4**, **3.2.4** and **3.2.5**.

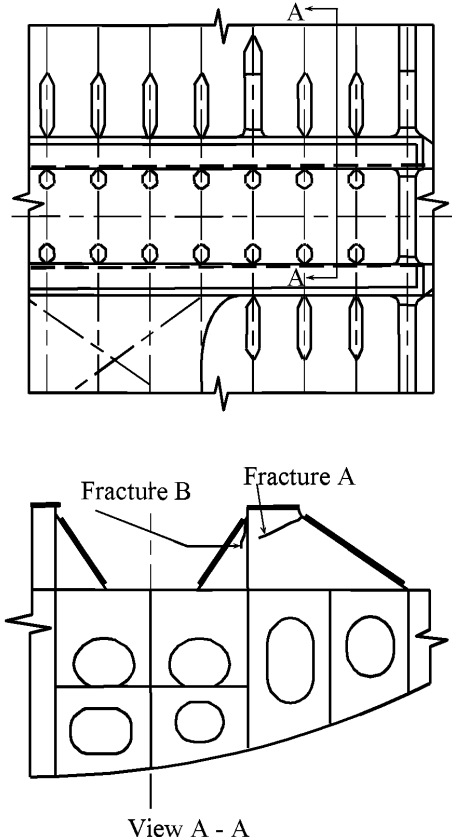
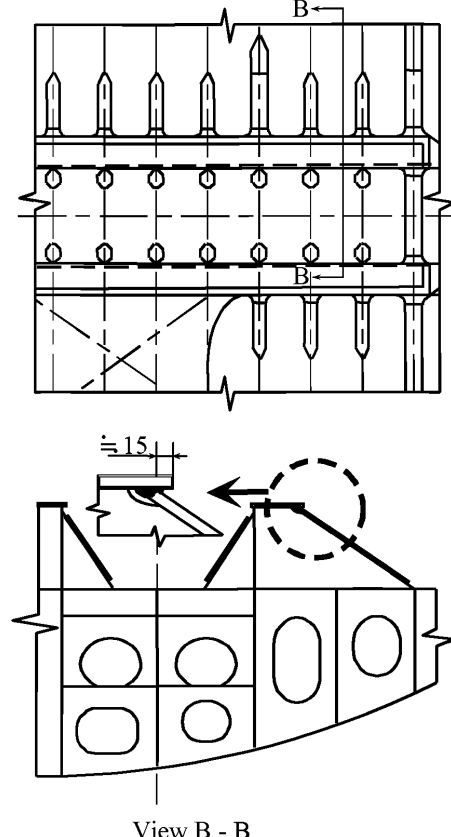
<b>BULK CARRIERS</b>		<b>Guidelines for Surveys, Assessment and Repair of Hull Structure</b>	
<b>Part 3</b>	<b>Machinery and accommodation spaces</b>	<b>Example No.</b>	
<b>Area 1</b>	<b>Engine room structure</b>	<b>1</b>	
<b>Detail of damage</b>		Fractures in brackets at main engine foundation	
<b>Sketch of damage</b>		<b>Sketch of repair</b>

<b>Notes on possible cause of damage</b>		<b>Notes on repairs</b>	
<ol style="list-style-type: none"> <li>1. Vibration of main engine.</li> <li>2. Insufficient strength of brackets at main engine foundation.</li> <li>3. Insufficient pre-load bolts.</li> </ol>		<ol style="list-style-type: none"> <li>1. Fractures are to be veed-out and rewelded.</li> <li>2. New modified brackets at main engine foundation.</li> <li>3. Or insert pieces and additional flanges to increase section modulus of the brackets.</li> </ol>

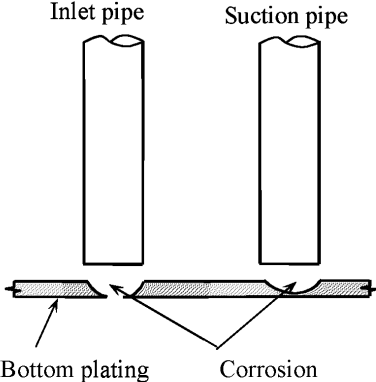
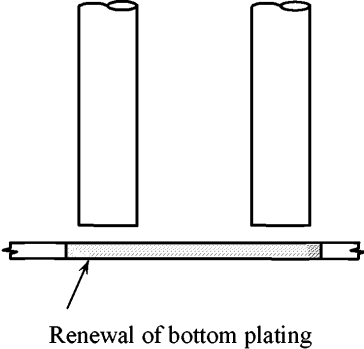
<b>BULK CARRIERS</b>		<b>Guidelines for Surveys, Assessment and Repair of Hull Structure</b>	
<b>Part 3</b>	<b>Machinery and accommodation spaces</b>		<b>Example No.</b>
<b>Area 1</b>	<b>Engine room structure</b>		<b>3</b>
<b>Detail of damage</b>	Corrosion in bottom plating under inlet/suction/pipe in way of bilge tank in engine room		
<b>Sketch of damage</b>		<b>Sketch of repair</b>

<p>Inlet pipe      Suction pipe</p> <p>Bottom plating      Corrosion</p>

<p>Renewal of bottom plating</p>	
<b>Notes on possible cause of damage</b>		<b>Notes on repairs</b>	
<ol style="list-style-type: none"> <li>1. Heavy corrosion of bottom plating under the inlet/suction pipe.</li> </ol>		<ol style="list-style-type: none"> <li>1. Corroded bottom plating is to be cropped and part renewed. Thicker plate is preferable.</li> <li>2. Replacement of pipe end by enlarged conical opening (similar to suction head in ballast tank) is preferable.</li> </ol>

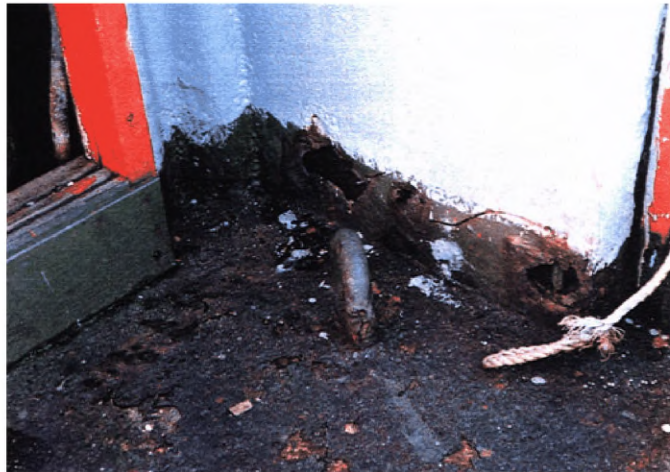
**Photograph 1** Corroded accommodation house side structure

Severe corrosion may be found in exposed deck plating and deck house side structure adjacent to the deck plating where water is liable to accumulate (See **Photograph 1**). Corrosion may also be found in accommodation bulkheads around cutout for fittings, such as doors, side scuttles, ventilators, etc., where proper maintenance of the area is relatively difficult. Deterioration of the bulkheads including fittings may impair the integrity of weathertightness.

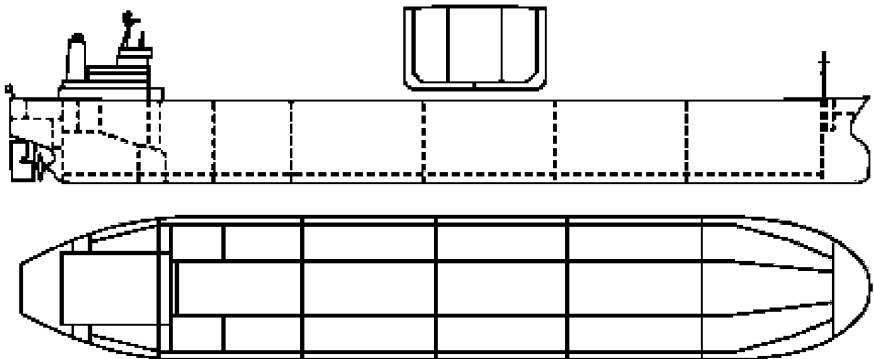
**Figure 1** General view of a typical double hull oil tanker (150,000 DWT and greater)

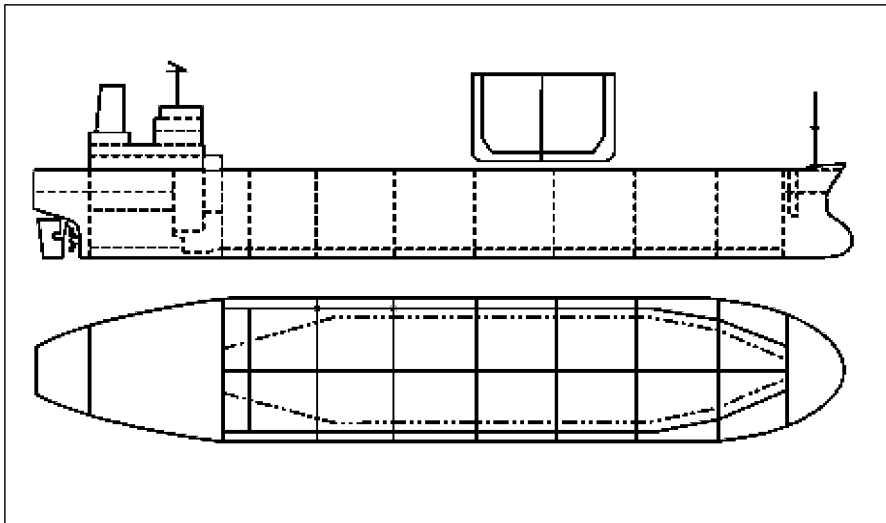
**Figure 2** General view of a typical double hull oil tanker (150,000 DWT or less)

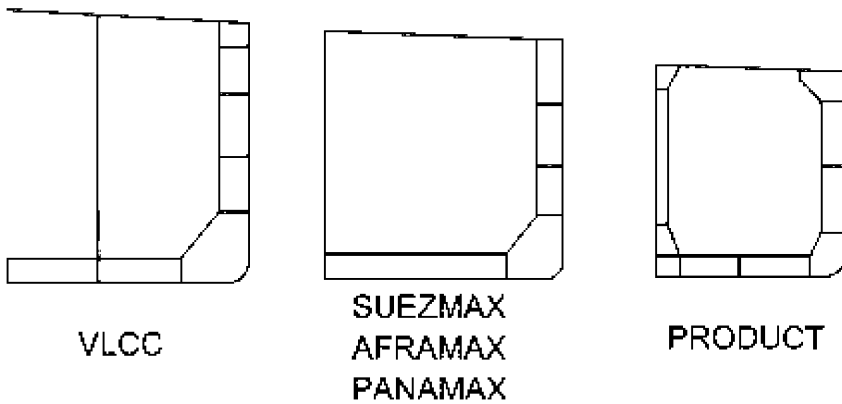
**Figure 3** Categories of Bulkhead Configurations

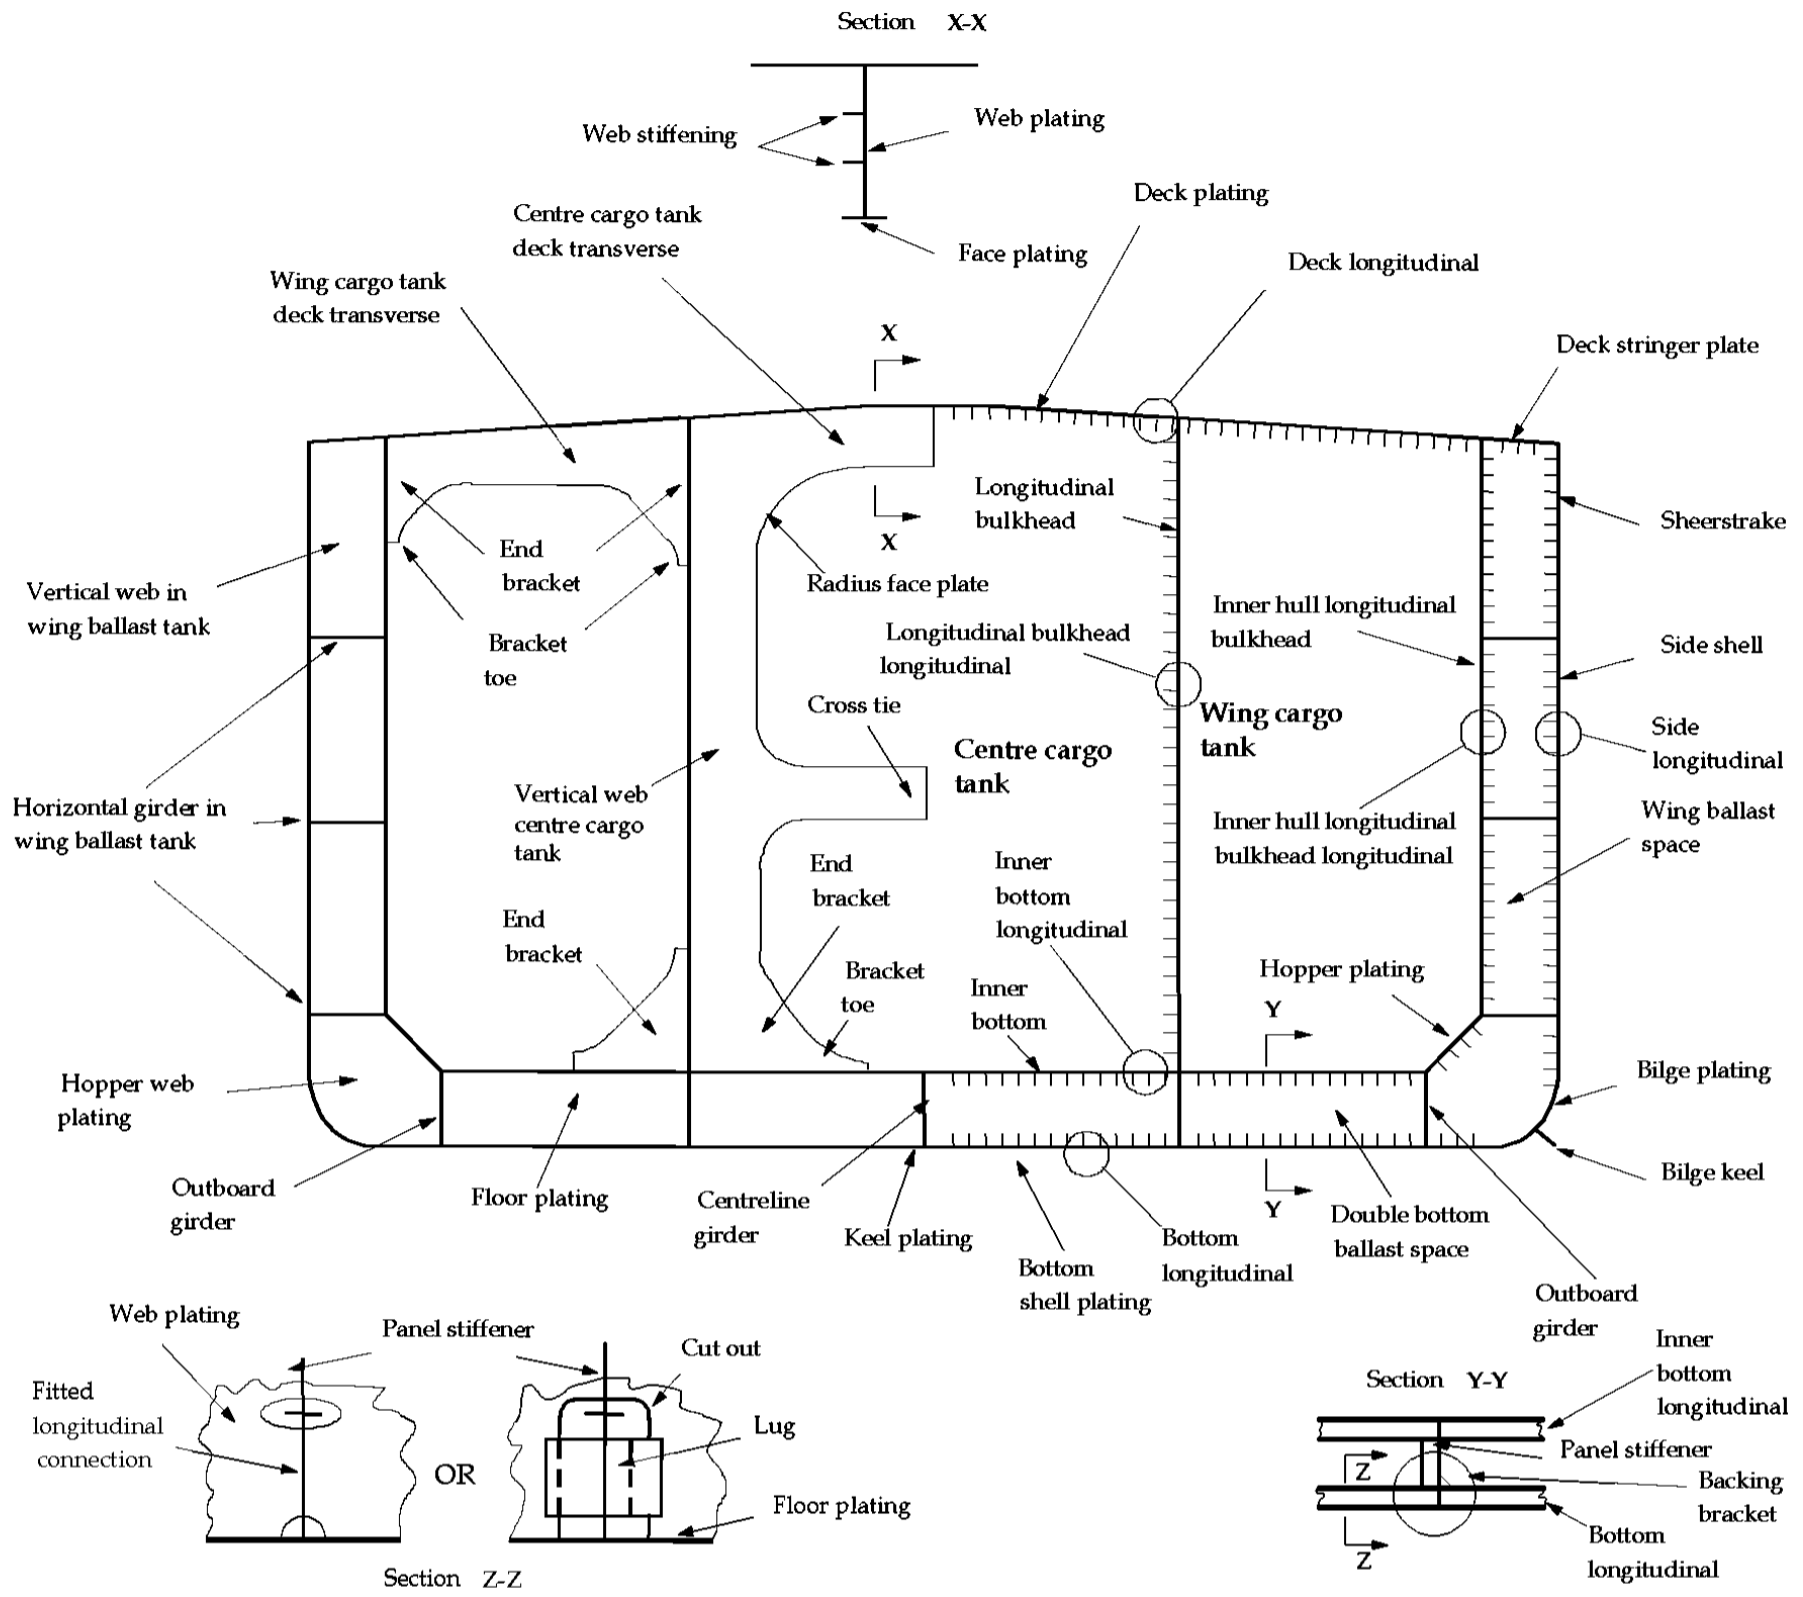
**Figure 4** Typical midship section of a double hull oil tanker with two longitudinal bulkheads including nomenclature

Figures 4 to 6 show the typical nomenclature used for the midship section and transverse bulkhead.

**3.2.1** For clarity of definition and reporting of survey data, it is recommended that standard nomenclature for structural elements be adopted. A typical midship section is illustrated in **Figures 4 to 6**. These figures show the generally accepted nomenclature.

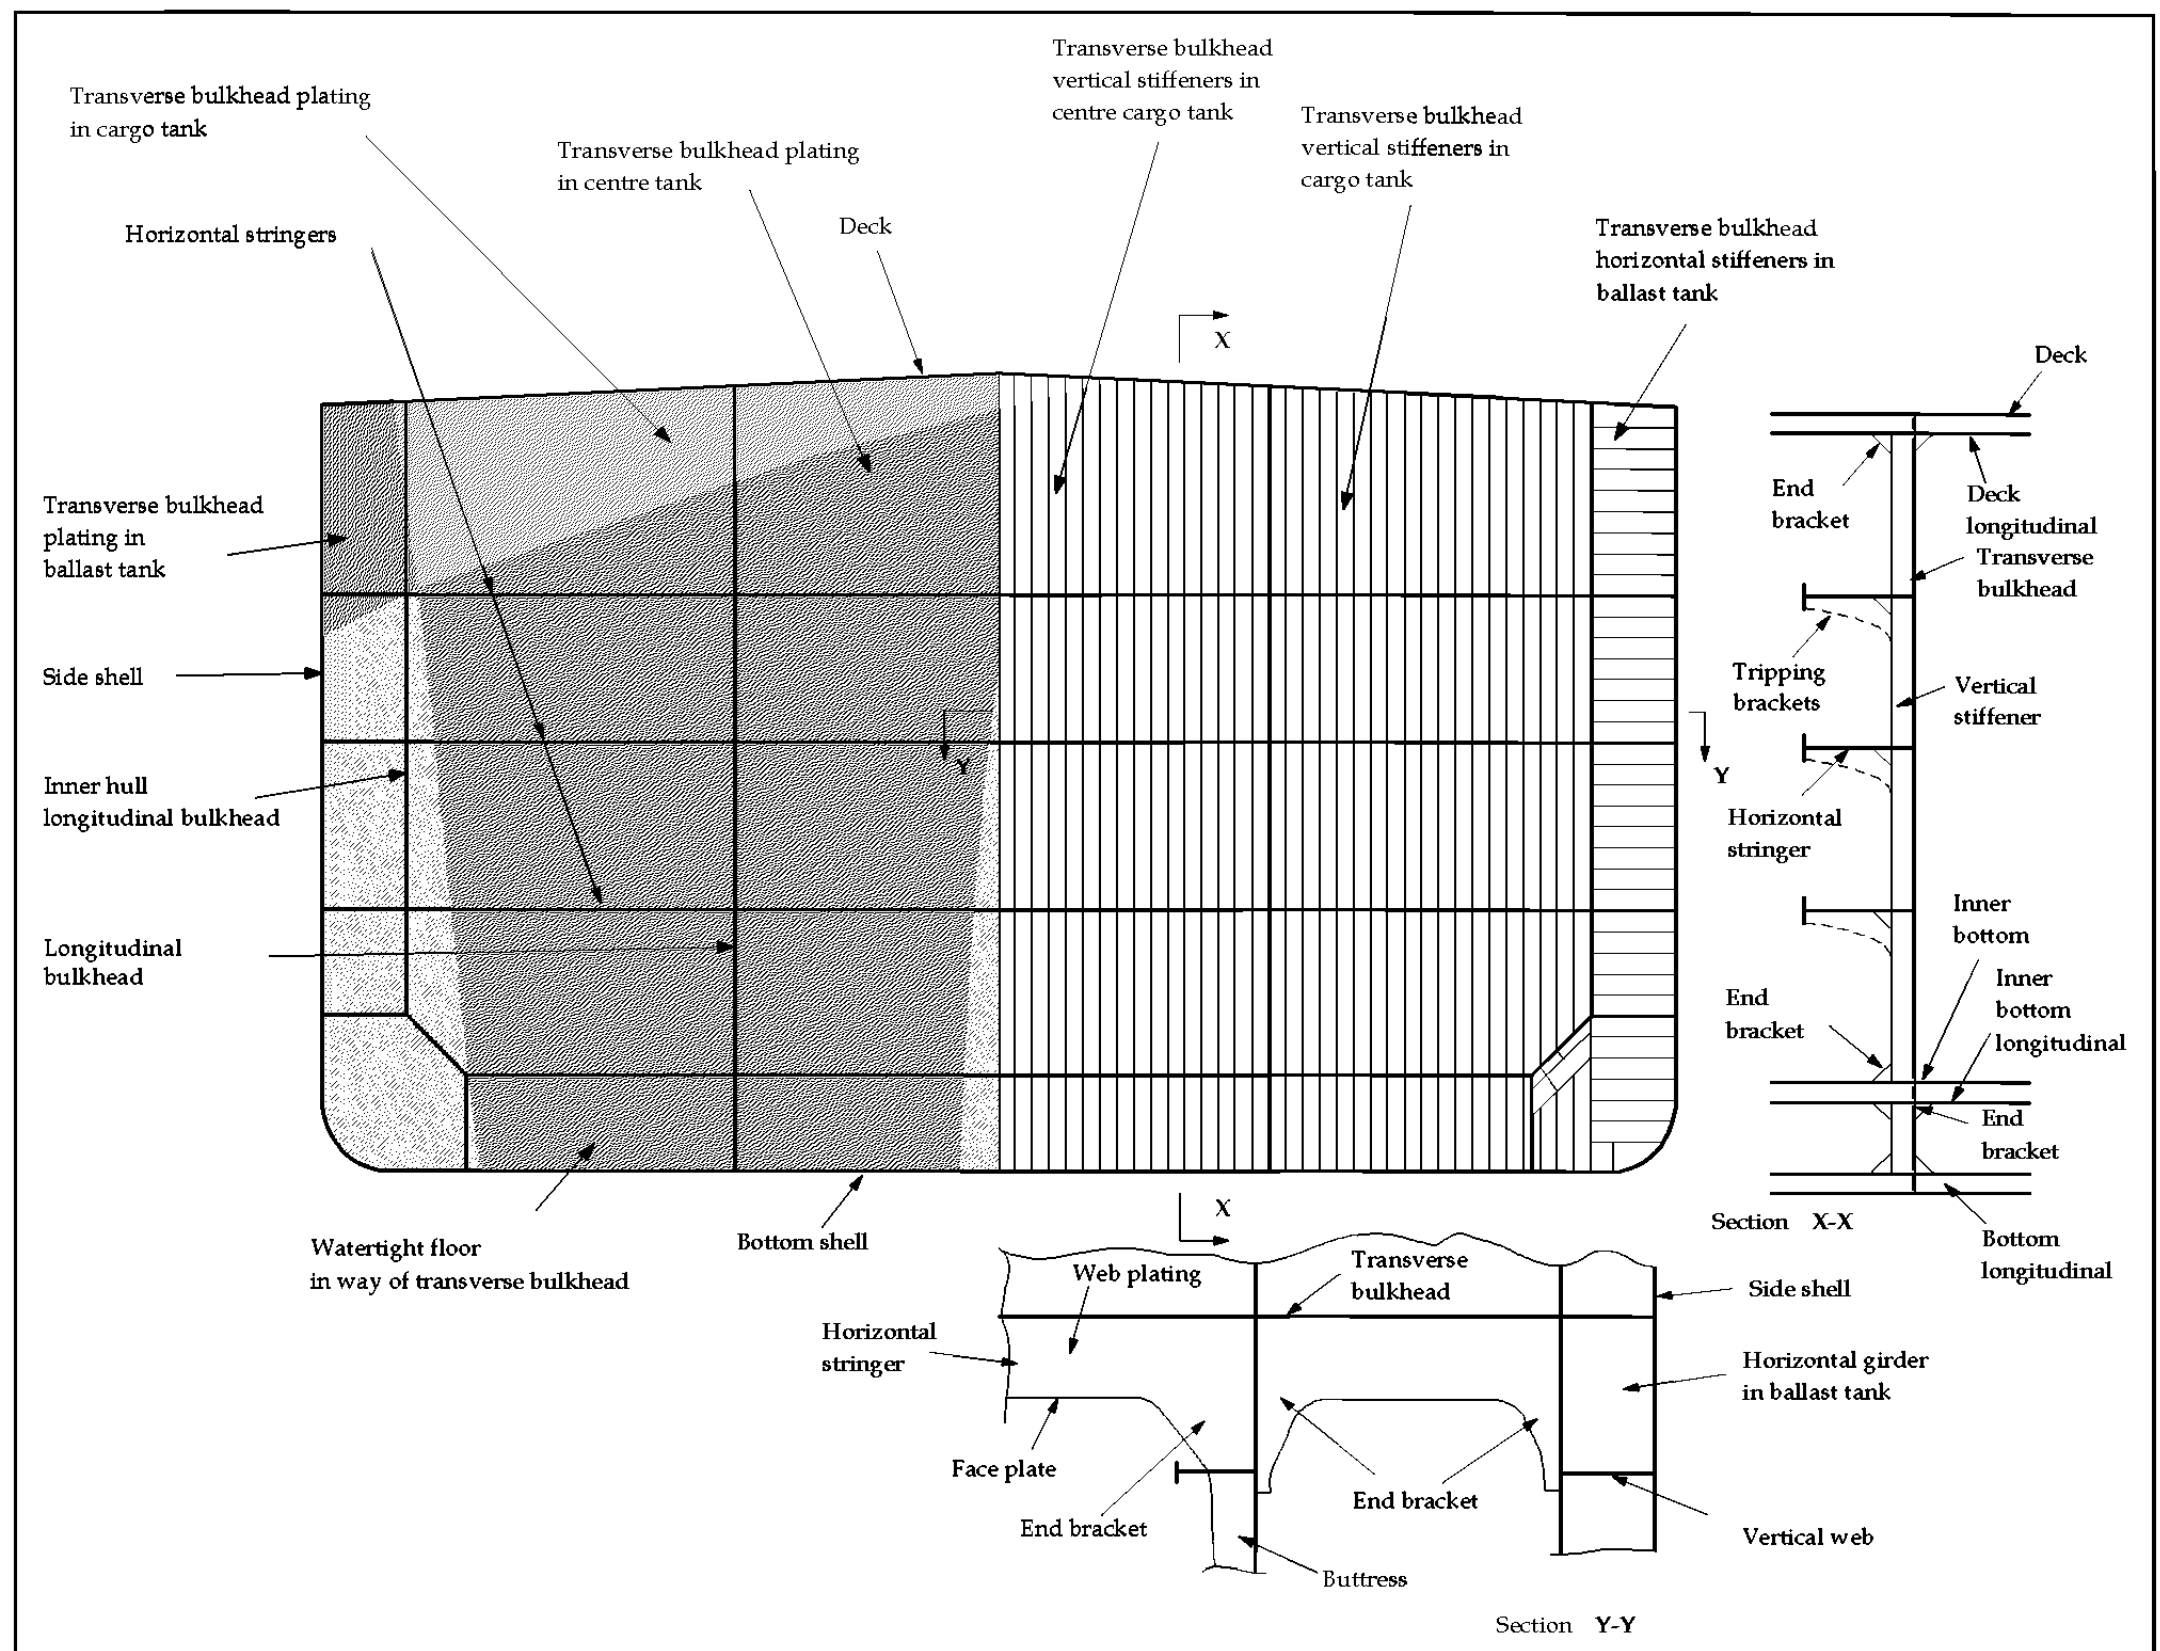
**Figure 5 Double Hull Tanker – Typical Transverse Bulkhead**

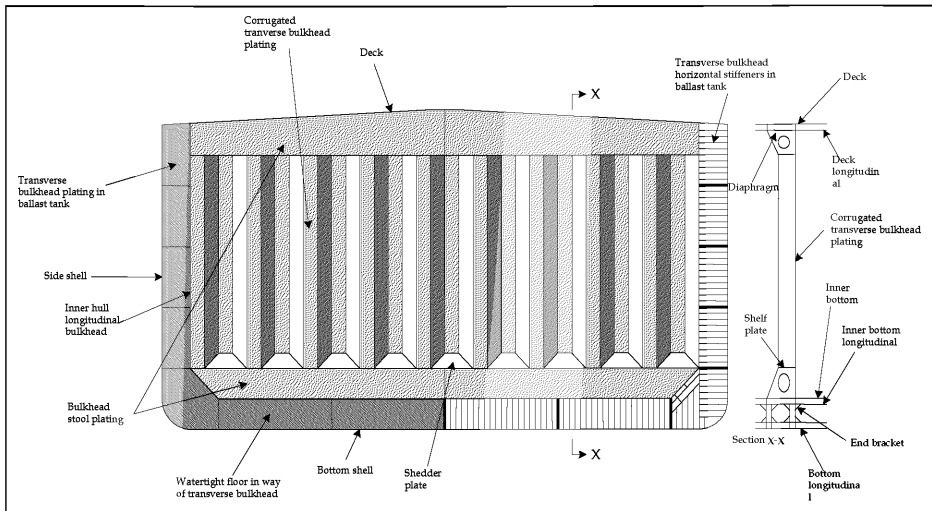
**Figure 6 Corrugated Transverse Bulkhead Nomenclature**

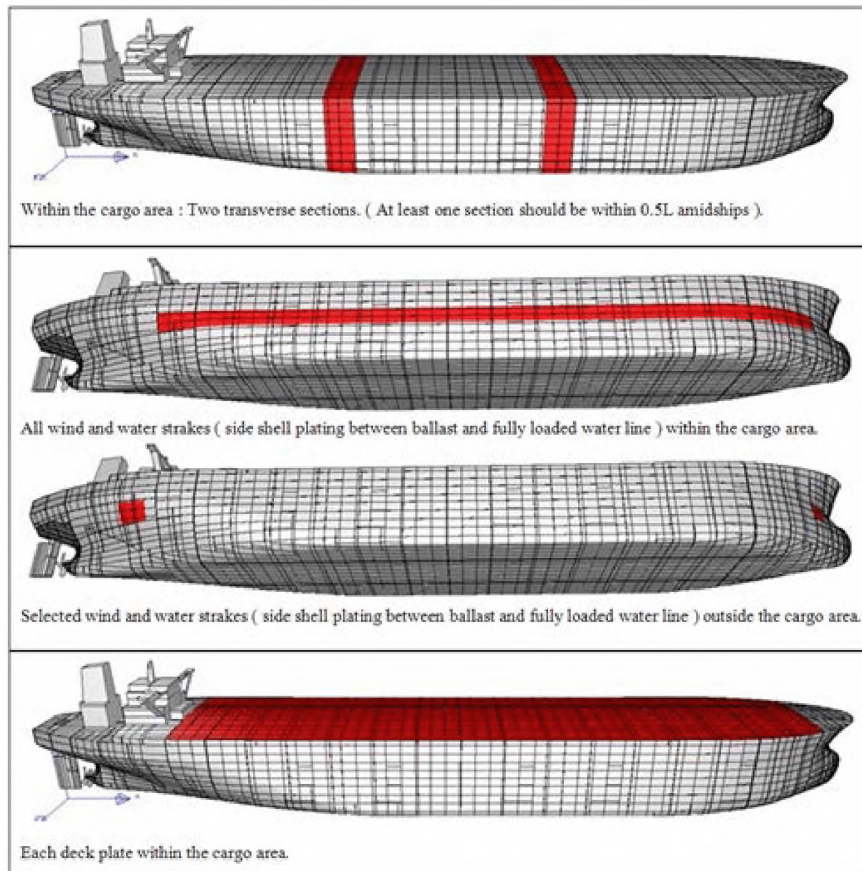
**Figure 7** Example of Transverse Sections of Shell Plating and Main Deck Thickness Measurement Requirements for an oil tanker 15 years of age.

**2.4.2** The Special Survey concentrates on close-up surveys in association with thickness measurements and is aimed at detecting fractures, buckling, corrosion and other types of structural deterioration. See Figure 7.

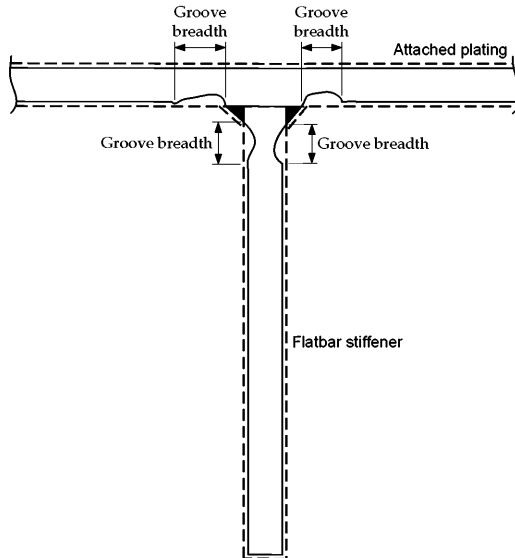
**Figure 8 Grooving Corrosion**

Grooving corrosion is often found in or beside welds, especially in the heat affected zone. This corrosion is sometimes referred to as 'inline pitting attack' and can also occur on vertical members and flush sides of bulkheads in way of flexing. The corrosion is caused by the galvanic current generated from the difference of the metallographic structure between the heat affected zone and base metal. Coating of the welds is generally less effective compared to other areas due to roughness of the surface, which exacerbates the corrosion. Grooving corrosion may lead to stress concentrations and further accelerate the corrosion process. Grooving corrosion may be found in the base material where coating has been scratched or the metal itself has been mechanically damaged. An example of grooving corrosion is shown in Figure 8.

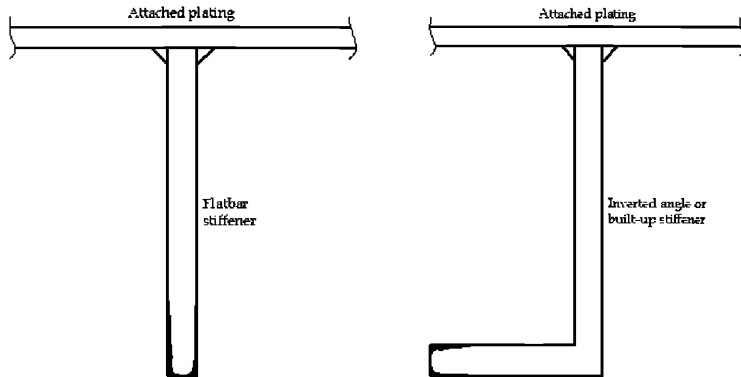
**Figure 9 Edge Corrosion**

Edge corrosion is defined as local corrosion at the free edges of plates, stiffeners, primary support members and around openings. An example of edge corrosion is shown in Figure 9.
