**РОССИЙСКИЙ МОРСКОЙ РЕГИСТР СУДОХОДСТВА**  
**RUSSIAN MARITIME REGISTER OF SHIPPING**

**SUPPLEMENT TO RULES AND GUIDELINES**  
**OF RUSSIAN MARITIME REGISTER OF SHIPPING**

**IACS PROCEDURAL REQUIREMENTS,**  
**UNIFIED INTERPRETATIONS**  
**AND RECOMMENDATIONS**

## **GENERAL DRY CARGO SHIPS**

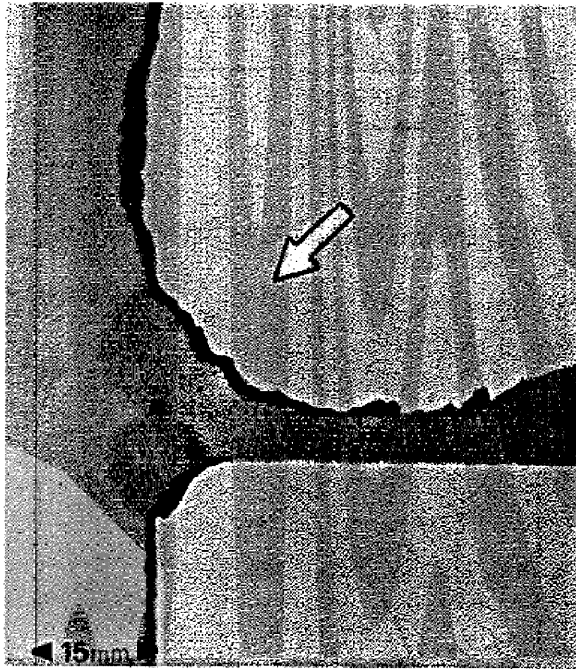
**Figure 10** Detail of Necking Effect

at their junctures accelerates the corrosion rate. As the steel thins and weakens, the flexing consequently increases and hence corrosion accelerates (see Figure 10). The similar necking effect could also occur in the transverse bulkhead plating and stiffeners, or in the inner bottom plating and longitudinals inside the double bottom space. In the coated water ballast tanks, the plating is the principally affected area due to local corrosion in way of coating failure.

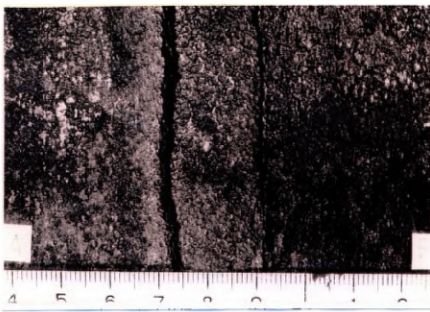
**Photograph 1**  
Grooving corrosion of welding of bottom plating

**4.1.2** Severe grooving along welding of bottom plating is often found (See **Photographs 1 and 2**). This grooving can be accelerated by poor maintenance of the protective coating and/or sacrificial anodes fitted to the bottom plating.

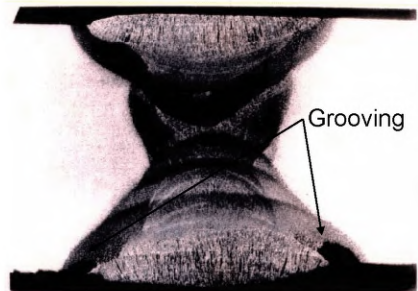
**Photograph 2**  
Section of the grooving shown in Photograph 1

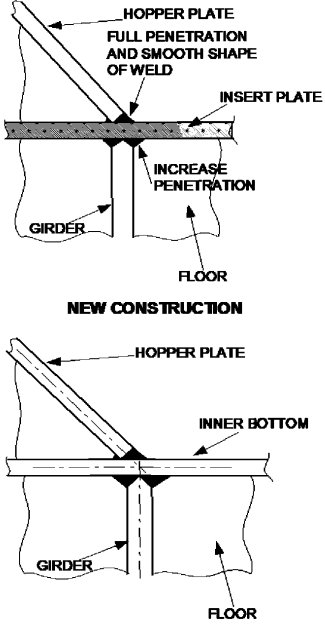
<p><b>Notes: Plate midlines intersect</b></p>	
<b>Factors which may have caused damage</b> 1. Stress concentration at juncture of hopper plate to inner bottom. 2. Insufficient welding connection. 3. Misalignment between hopper plate, inner bottom and girder.		<b>Notes on repairs</b> See Sketch.

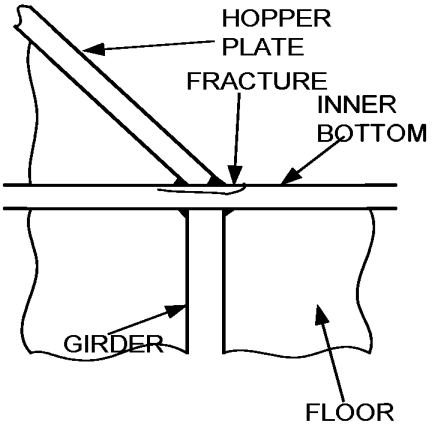
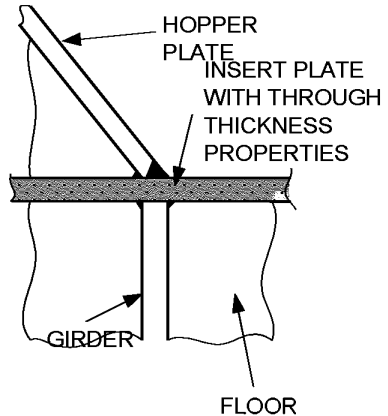
OIL Tankers		Guidelines for Surveys, Assessment and Repair of Hull Structure	
Group 1	Cargo area	Example No.	
	Hopper and double bottom ballast tank	2	
<b>Detail of damage</b>		Fracture at connection of bilge hopper plate and inner bottom	
<b>Sketch of damage</b>

<b>Notes:</b> Plate midlines intersect	
<b>Factors which may have caused damage</b> 1. Stress concentration at the knuckle.		<b>Notes on repairs</b> See Sketch.

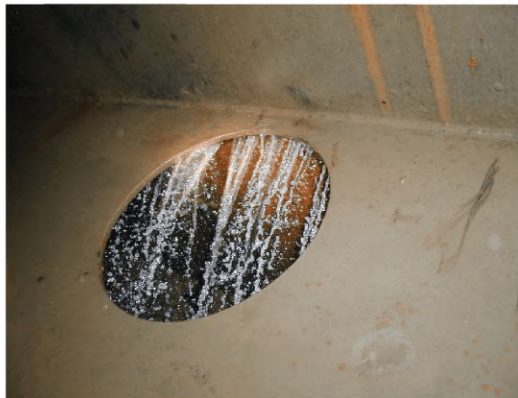
**Photograph 1 Side shell fracture in way of horizontal stringer weld**

- (a) Areas subjected to stress concentration
  - Welded joints of faceplate of transverse at corners
  - Connection of the lowest longitudinal to transverse web frame, especially with reduced scantlings.
  - Termination of longitudinal in fore and aft wing tanks
- (b) Areas subjected to dynamic wave loading
  - Connection of side longitudinal to watertight bulkhead
  - Connection of side longitudinal to transverse web frame

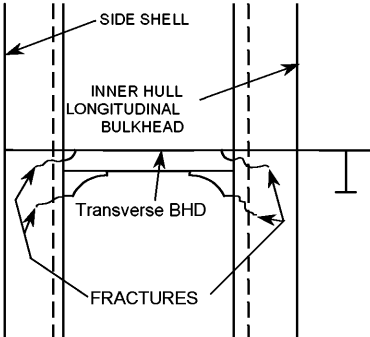
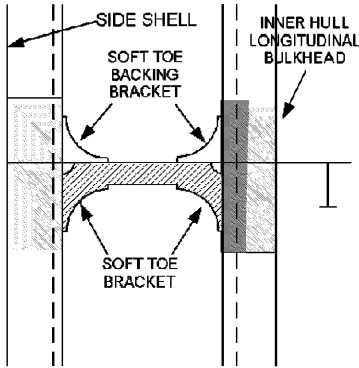
OIL Tankers		Guidelines for Surveys, Assessment and Repair of Hull Structure
Group 2	Cargo area	Example No.
	<b>Wing ballast tank</b>	<b>1</b>
<b>Detail of damage</b>		Crack in way of connection of longitudinals to transverse bulkhead
<p><b>Sketch of damage</b></p>

<p><b>Factors which may have caused damage</b></p> <ol style="list-style-type: none"> <li>1. Asymmetrical connection of bracket without backing bracket.</li> <li>2. Relative deflection of adjoining transverse web against transverse bulkhead.</li> <li>3. Additional biaxial bending stresses due to asymmetry of the angle bar longitudinal instead of symmetric T section.</li> <li>4. Dynamic load in the vicinity of the water line.</li> <li>5. Large upstand at bracket toe.</li> </ol>		<p><b>Notes on repairs</b></p> <p>See Sketch.</p>

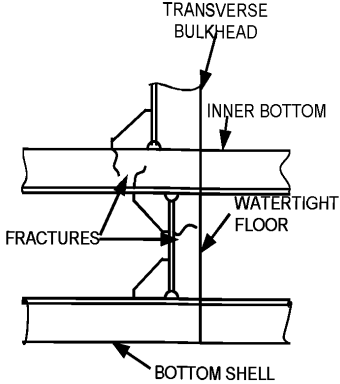
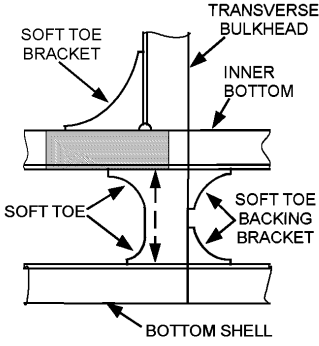
OIL Tankers		Guidelines for Surveys, Assessment and Repair of Hull Structure
Group 3	Cargo area	Example No.
	<b>Bottom ballast tank</b>	<b>1</b>
<b>Detail of damage</b>		Cracks in way of longitudinals connected to watertight floors
<b>Sketch of damage</b>		<b>Sketch of repair</b>

<b>Factors which may have caused damage</b> <ol style="list-style-type: none"> <li>1. Asymmetrical connection of bracket in association with a backing bracket, which is too small.</li> <li>2. Relative deflection between adjacent floor and transverse bulkhead.</li> <li>3. Inadequate shape of the brackets.</li> <li>4. High stresses in the inner bottom longitudinal and the floor stiffener.</li> </ol>		<b>Notes on repairs</b> See Sketch.

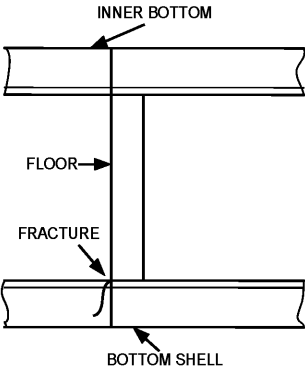
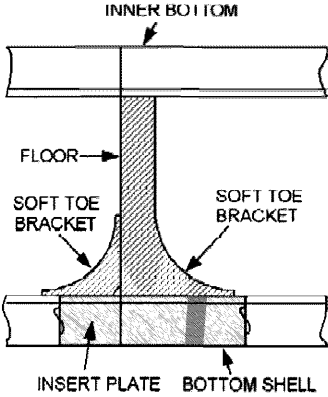
OIL Tankers		Guidelines for Surveys, Assessment and Repair of Hull Structure	
Group 3	Cargo area	Example No.	
	Bottom ballast tank	4	
Detail of damage		Connection of longitudinals to ordinary floors	
<p><b>Sketch of damage</b></p>

<p><b>Factors which may have caused damage</b></p> <ol style="list-style-type: none"> <li>1. Stress concentration at the connection of bottom longitudinal and stiffener on floor.</li> </ol>		<p><b>Notes on repairs</b></p> <p>See Sketch.</p> <ol style="list-style-type: none"> <li>1. Butt welds in bottom longitudinal should be kept clear of the soft toe bracket toes.</li> <li>2. If possible soft toe bracket and vertical stiffener should be integral.</li> </ol>

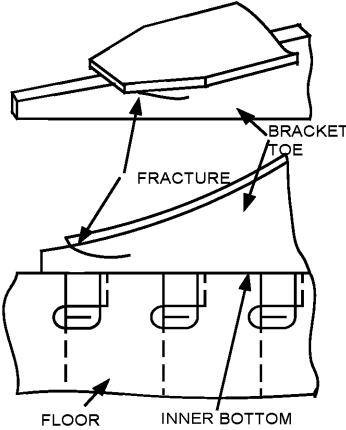
OIL Tankers		Guidelines for Surveys, Assessment and Repair of Hull Structure
<b>Group 4</b>	Cargo area	Example No.
	Web Frame in cargo tank	1
<b>Detail of damage</b>		Fracture at toe of web frame bracket connection to inner bottom.
<b>Sketch of damage</b>		<b>Sketch of repair</b>

<p>The sketch shows a perspective view of a bracket attached to a horizontal web frame. A crack, labeled 'FRACTURE', is shown at the 'BRACKET TOE' where the bracket meets the web frame. Below this, a plan view shows the 'FLOOR' and 'INNER BOTTOM' with three brackets. An arrow points from the fracture location in the perspective view to the corresponding bracket location in the plan view.</p>		<p>Modify Face Taper</p> <ol style="list-style-type: none"> <li>1. Breadth taper 20 degrees.</li> <li>2. Breadth at toe as small as practical.</li> <li>3. Thickness taper 1 in 3 to 10mm.</li> </ol>

<b>Factors which may have caused damage</b>		<b>Notes on repairs</b>
<ol style="list-style-type: none"> <li>1. Inadequate tapering the toe end.</li> <li>2. Insufficient tapering of flange.</li> <li>3. Lateral flexing of the bracket.</li> </ol>		<p>See Sketch.</p>

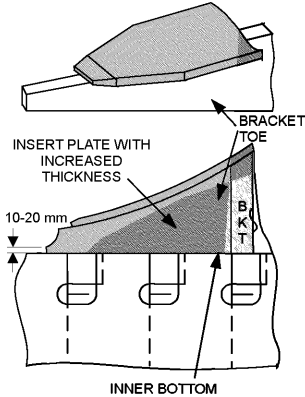
<p>The repair sketch shows a perspective view of the bracket with a shaded 'INSERT PLATE WITH INCREASED THICKNESS' at the 'BRACKET TOE'. A dimension line indicates a thickness of '10-20 mm'. Below, a plan view shows the 'INNER BOTTOM' with three brackets. An arrow points from the repair location in the perspective view to the corresponding bracket location in the plan view.</p>

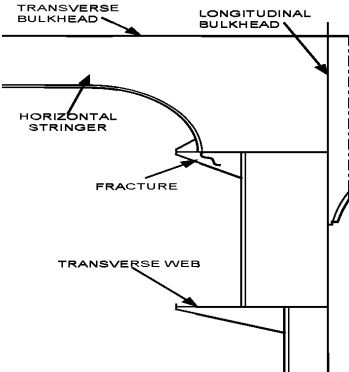
<b>OIL Tankers</b>		<b>Guidelines for Surveys, Assessment and Repair of Hull Structure</b>
<b>Group 5</b>	<b>Cargo area</b>	<b>Example No.</b>
	<b>Transverse Bulkhead in cargo tank</b>	<b>1</b>
<b>Detail of damage</b>	Fracture in way of connection of transverse bulkhead stringer to transverse web frames and longitudinal bulkhead stringer	
<b>Sketch of damage</b>

<b>Factors which may have caused damage</b>	<ol style="list-style-type: none"> <li>1. Stress concentration due to discontinuous structure.</li> <li>2. High shear stress in the horizontal stringer.</li> </ol>	
<b>Notes on repairs</b>	See Sketch.

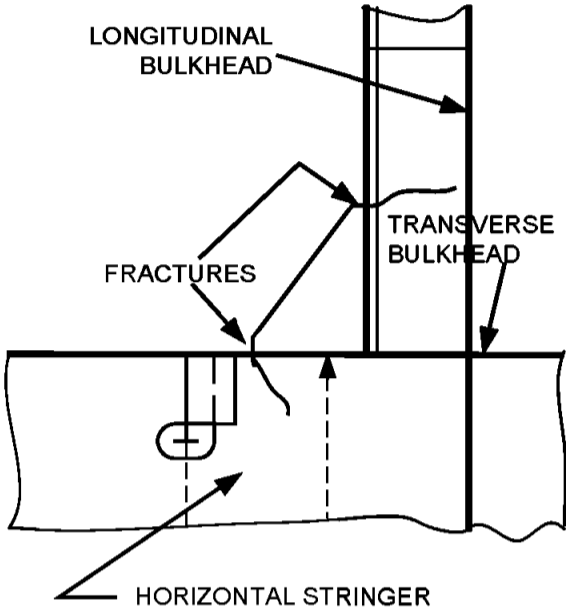
OIL Tankers		Guidelines for Surveys, Assessment and Repair of Hull Structure	
Group 5	Cargo area	Example No.	
	Transverse Bulkhead in cargo tank	3	
Detail of damage		Connection of longitudinals to horizontal stringers.	
<p><b>Sketch of damage</b></p>

<p>LONGITUDINAL BULKHEAD</p> <p>TRANSVERSE BULKHEAD</p> <p>FRACTURES</p> <p>HORIZONTAL STRINGER</p>		<p><b>Sketch of repair</b></p>

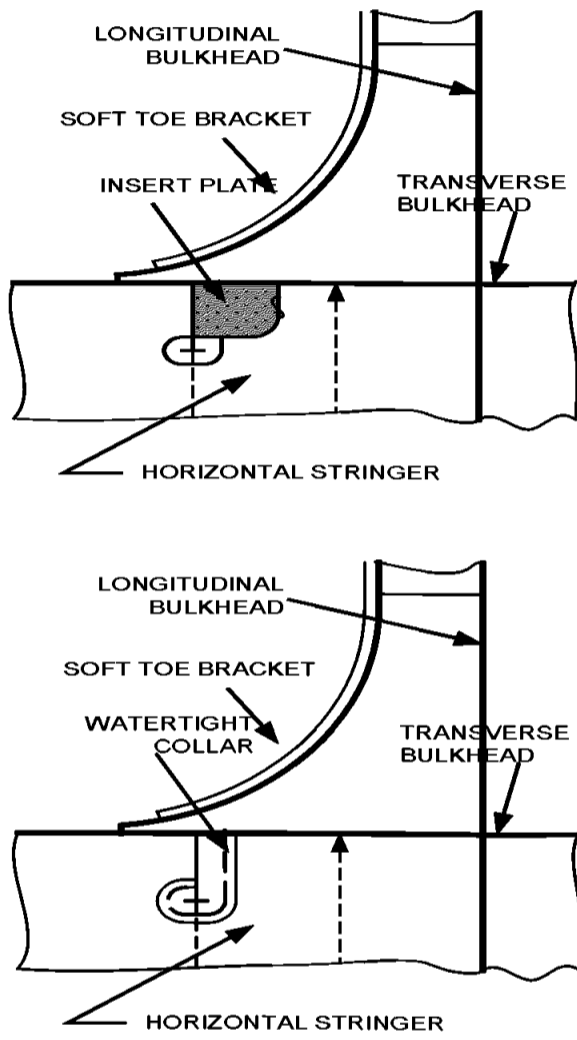
<p>LONGITUDINAL BULKHEAD</p> <p>SOFT TOE BRACKET</p> <p>INSERT PLATE</p> <p>TRANSVERSE BULKHEAD</p> <p>HORIZONTAL STRINGER</p> <p>LONGITUDINAL BULKHEAD</p> <p>SOFT TOE BRACKET</p> <p>WATERTIGHT COLLAR</p> <p>TRANSVERSE BULKHEAD</p> <p>HORIZONTAL STRINGER</p>	
<p><b>Factors which may have caused damage</b></p> <ol style="list-style-type: none"> <li>1. Stress concentration due to inadequate shape of the bracket.</li> <li>2. Relative deflection of adjoining transverse web against transverse bulkhead.</li> </ol>		<p><b>Notes on repairs</b></p> <p>See Sketch</p>

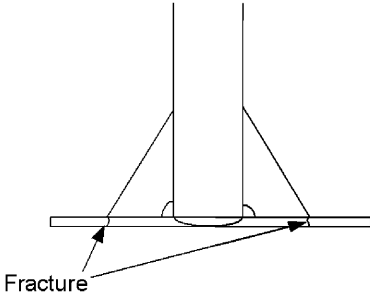
OIL Tankers		Guidelines for Surveys, Assessment and Repair of Hull Structure	
Group 6	Deck Structure		Example No.
			<b>5</b>
<b>Detail of damage</b>		Fractured deck plating in way of deck pipe support stanchions (midships)	
<p><b>Sketch of damage</b></p>

<p>Fracture</p>		<p><b>Sketch of repair</b></p>

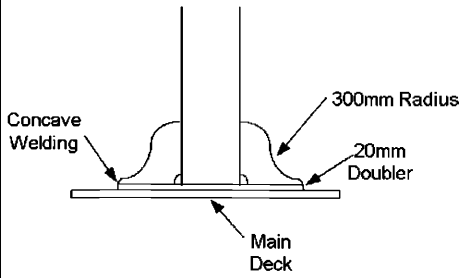
<p>Concave Welding</p> <p>300mm Radius</p> <p>20mm Doubler</p> <p>Main Deck</p>	
<p><b>Factors which may have caused damage</b></p> <p>1. Stanchions experience more severe relative displacements from hull girder bending.</p>		<p><b>Notes on repairs</b></p> <p>See Sketch.</p>

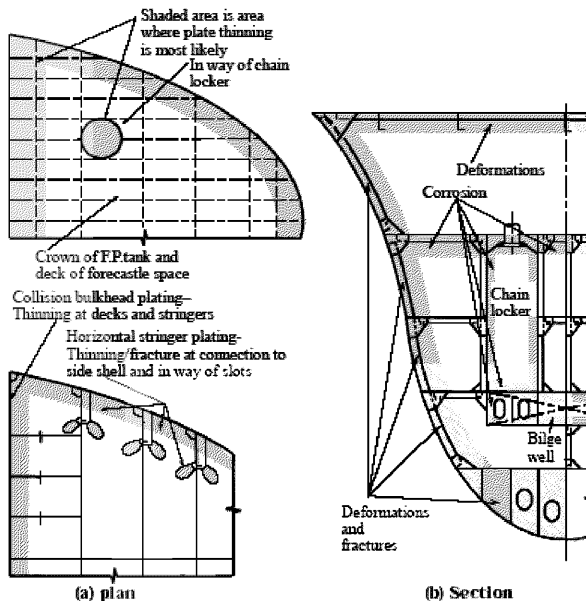
**Fig 1** Fore end structure - Potential problem areas

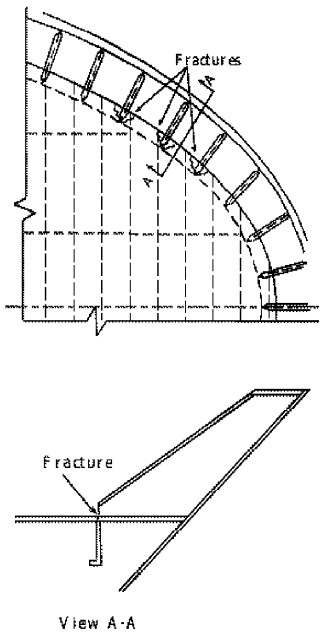
<b>OIL Tankers</b>		<b>Guidelines for Surveys, Assessment and Repair of Hull Structure</b>
<b>Group 7</b>	Fore region	<b>Example No.</b>
<b>Area 1</b>	Forecastle	<b>1</b>
<b>Detail of damage</b>		Fracture in forecastle deck plating at bulwark
<p><b>Sketch of damage</b></p>

<p><b>Factors which may have caused damage</b></p> <ol style="list-style-type: none"> <li>1. Bow Flare effect in heavy weather.</li> <li>2. Stress concentration due to poor design.</li> </ol>		<p><b>Notes on repairs</b></p> <ol style="list-style-type: none"> <li>1. Fractured deck plating should be cropped and renewed.</li> <li>2. Bracket in line with the bulwark stay to be fitted to reduce stress concentration.</li> </ol>

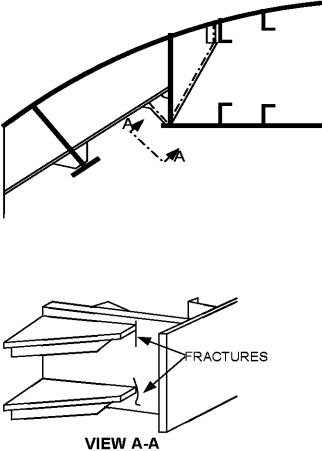
OIL Tankers		Guidelines for Surveys, Assessment and Repair of Hull Structure
Group 7	Fore region	Example No.
Area 1	Forepeak ballast tank	4
Detail of damage	Fractured vertical web at the longitudinal stiffener ending in way of the parabolic bow structure.	
Sketch of damage	Sketch of repair

<p>VIEW A-A</p>

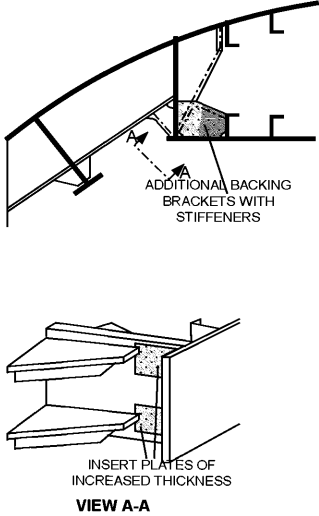
<p>VIEW A-A</p>	
<b>Factors which may have caused damage</b> <ol style="list-style-type: none"> <li>1. Stress concentrations at bracket ending due to inadequate support at bracket toes in way of connection to web frame members.</li> <li>2. Localised thinning in way of coating failure at bracket endings due to flexing of the structure.</li> <li>3. Dynamic seaway loadings at bow causing flexing at bracket endings.</li> </ol>	<b>Notes on repairs</b> See Sketch.

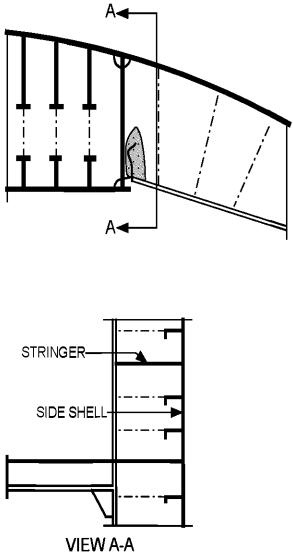
OIL Tankers		Guidelines for Surveys, Assessment and Repair of Hull Structure
Group 7	Fore region	Example No.
Area 1	Forepeak ballast tank	5
Detail of damage	Fractured stringer end connection in way of the parabolic bow structure	
<b>Sketch of damage</b>

<b>Factors which may have caused damage</b> <ol style="list-style-type: none"> <li>1. High stress concentration of stringer to stiff girder/deep web intersection due to discontinuity of faceplate.</li> <li>2. Localised thinning in way of coating failure at stringer connection due to flexing of the structure.</li> <li>3. Dynamic seaway loadings at bow causing flexing in way of detail.</li> </ol>		<b>Notes on repairs</b> See Sketch.

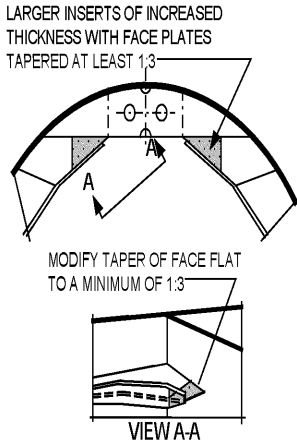
<p>The repair sketch shows the same structure as the damage sketch, but with larger inserts of increased thickness and face plates tapered at least 1:3. A detail view labeled 'VIEW A-A' shows the taper of the face plate. Text labels include: 'LARGER INSERTS OF INCREASED THICKNESS WITH FACE PLATES TAPERED AT LEAST 1:3', 'MODIFY TAPER OF FACE PLAT TO A MINIMUM OF 1:3', and 'VIEW A-A'.</p>

Factors which may have caused damage	Notes on repairs	
<ol style="list-style-type: none"> <li>1. Inadequate brackets forming the longitudinal endings at bow structure.</li> <li>2. Localised thinning in way of coating failure at longitudinal endings due to flexing of the structure.</li> <li>3. Dynamic seaway loadings at bow causing flexing at longitudinal endings.</li> </ol>	<p>See Sketch.</p>

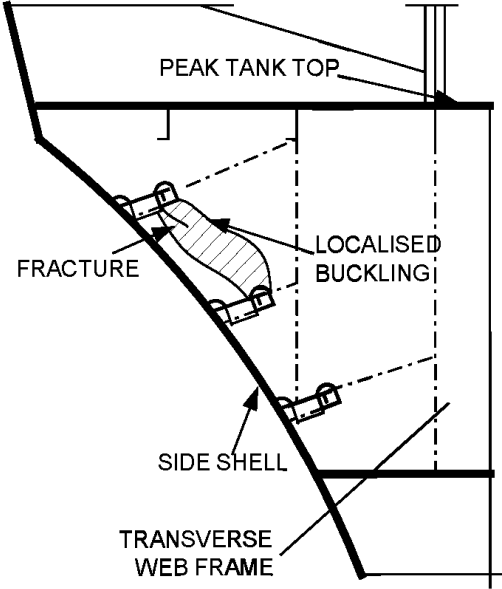
OIL Tankers		Guidelines for Surveys, Assessment and Repair of Hull Structure	
Group 7	Fore region	Example No.	
Area 1	Forepeak ballast tank	7	
Detail of damage		Fracture and buckle of bow transverse web frame in way of longitudinal cut-outs.	
Sketch of damage		Sketch of repair

<p>The sketch shows a cross-section of the forepeak ballast tank. Labels include: PEAK TANK TOP, FRACTURE (pointing to a break in the transverse web frame), LOCALISED BUCKLING (pointing to a distorted area of the web frame), SIDE SHELL, and TRANSVERSE WEB FRAME.</p>

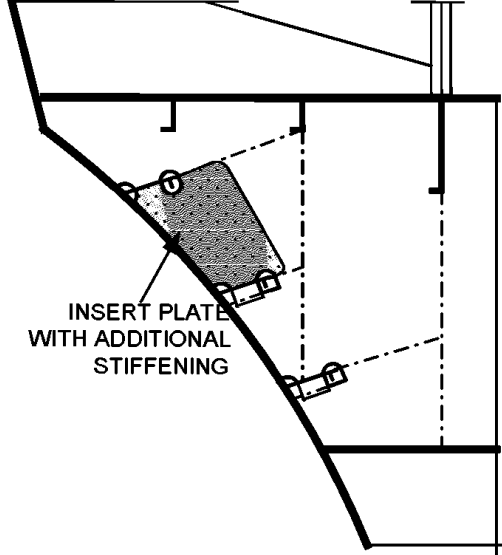
<p>The sketch shows the same cross-section as the damage sketch, but with a shaded rectangular area labeled 'INSERT PLATE WITH ADDITIONAL STIFFENING' applied to the damaged portion of the transverse web frame.</p>	
<p><b>Factors which may have caused damage</b></p> <ol style="list-style-type: none"> <li>1. Localised thinning in way of coating failure at cut-outs and sharp edges due to working of the structure.</li> <li>2. Dynamic seaway loadings in way of bow flare.</li> </ol>		<p><b>Notes on repairs</b></p> <p>See Sketch.</p>

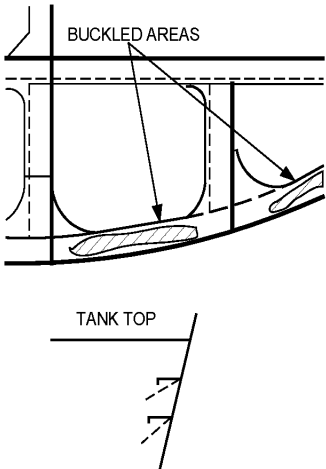
<b>OIL Tankers</b>		<b>Guidelines for Surveys, Assessment and Repair of Hull Structure</b>	
<b>Group 7</b>	<b>Fore region</b>	<b>Example No.</b>	
<b>Area 1</b>	<b>Fore peak ballast tank</b>	<b>8</b>	
<b>Detail of damage</b>		<b>Buckled and tripped breathhooks</b>	
<b>Sketch of damage</b>		<b>Sketch of repair</b>

<p>The sketch shows a cross-section of a fore peak ballast tank. The top structure is labeled 'BUCKLED AREAS' with arrows pointing to distorted regions. Below the tank, a section labeled 'TANK TOP' shows a sloped surface with several small rectangular protrusions.</p>

<ol style="list-style-type: none"> <li>1. Bow impact load.</li> <li>2. Low buckling resistance.</li> </ol>		<p>See Sketch.</p>

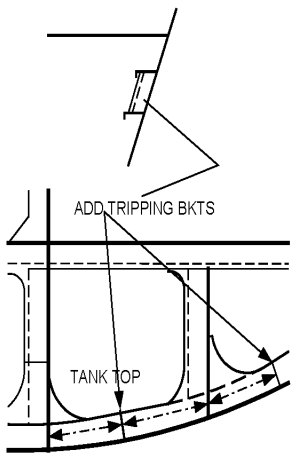
<p>The repair sketch shows the same tank structure. A detail at the top shows a bracket being added to a sloped surface. The main sketch is labeled 'ADD. TRIPPING BKTS' with arrows pointing to new brackets. The 'TANK TOP' is also indicated.</p>	
<b>Factors which may have caused damage</b>		<b>Notes on repairs</b>

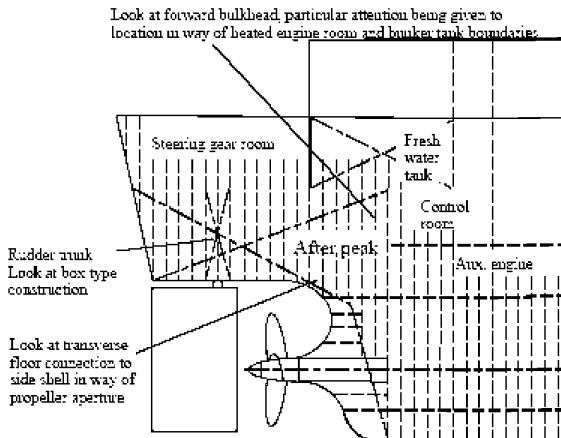
Figure 1 Aft end structure - Potential problem areas

**2.3.2** The structure supporting the rudder carrier may fracture and/or deform due to excessive load on the rudder. Bolts connecting the rudder carrier to the steering gear flat may also suffer damage under such load.

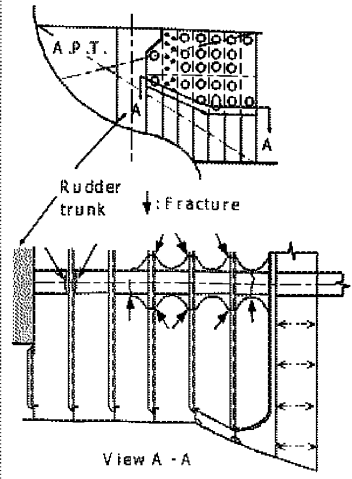
<b>OIL Tankers</b>		<b>Guidelines for Surveys, Assessment and Repair of Hull Structure</b>	
<b>Group 7</b>	<b>Aft region</b>	<b>Example No.</b>	
<b>Area 2</b>	<b>Aft peak ballast tank</b>	<b>10</b>	
<b>Detail of damage</b>		<b>Fractures at the connection of floors and girders/side brackets</b>	
<b>Sketch of damage</b>		<b>Sketch of repair</b>

<p>The sketch of damage shows a cross-section of the hull structure. At the top, a curved section is labeled 'A.P.T.'. Below it, a horizontal structure is labeled 'Rudder trunk'. A vertical line indicates a 'Fracture' at the connection point. Below this, 'View A - A' shows a detailed view of the structure with several vertical girders and horizontal floors. Arrows indicate the location of the fracture and the direction of the view.</p>

<b>Factors which may have caused damage</b>		<b>Notes on repairs</b>	
<ol style="list-style-type: none"> <li>1. Vibration.</li> </ol>		<ol style="list-style-type: none"> <li>1. The fractured plating should be cropped and renewed.</li> <li>2. Natural frequency of the panel should be changed, e.g. reinforcement by additional strut.</li> </ol>

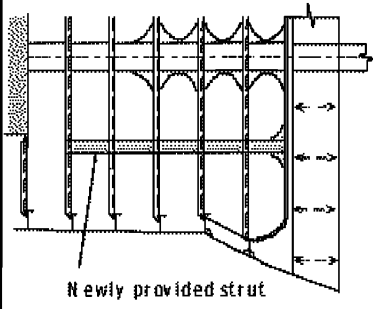
<p>The sketch of repair shows the same structure as the damage sketch, but with a 'Newly provided strut' added. The strut is a vertical member that provides additional support to the structure. Arrows indicate the direction of the view and the location of the new strut.</p>

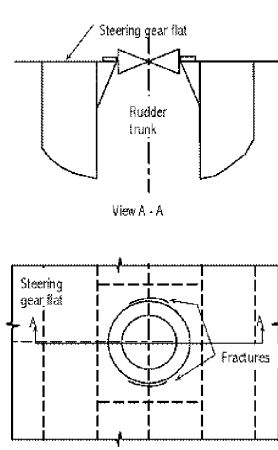
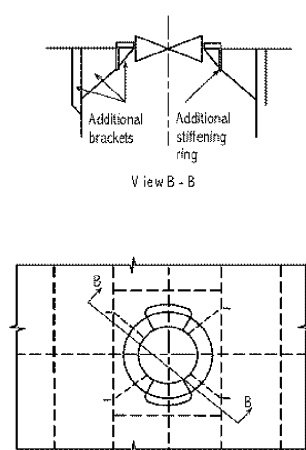
OIL Tankers		Guidelines for Surveys, Assessment and Repair of Hull Structure	
Group 7	Aft region	Example No.	
Area 2	Machinery space outside Engine room	11	
Detail of damage		Fractures in flat where rudder carrier is installed in steering gear room	
<p><b>Sketch of damage</b></p>

<p>View A - A</p>		<p><b>Sketch of repair</b></p>

<p>View B - B</p>	
<p><b>Factors which may have caused damage</b></p> <ol style="list-style-type: none"> <li>1. Inadequate design.</li> </ol>		<p><b>Notes on repairs</b></p> <ol style="list-style-type: none"> <li>1. Fractured plating should be cropped and renewed.</li> <li>2. Additional brackets and stiffening ring should be fitted for reinforcement.</li> </ol>

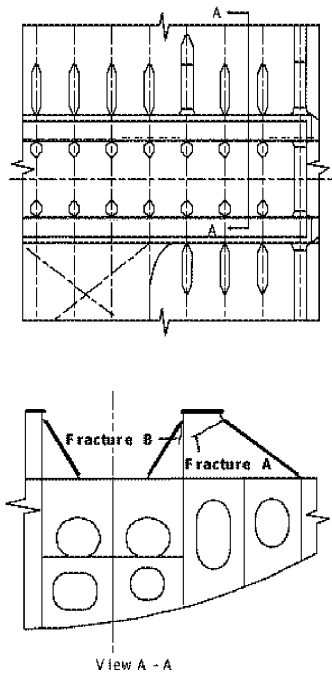
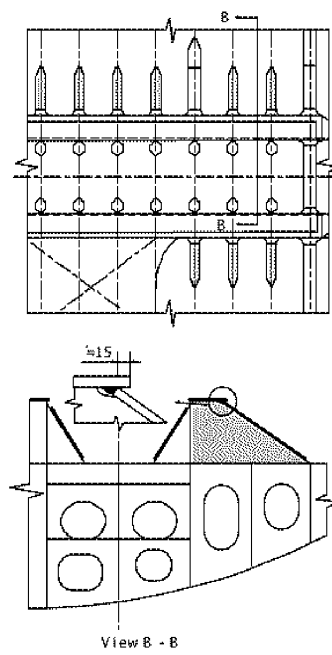
<b>OIL Tankers</b>		<b>Guidelines for Surveys, Assessment and Repair of Hull Structure</b>	
<b>Group 8</b>	Machinery and accommodation spaces	<b>Example No.</b>	
<b>Area 1</b>	Engine room	<b>1</b>	
<b>Detail of damage</b>		Fractures in brackets at main engine foundation	
<b>Sketch of damage</b>		<b>Sketch of repair</b>

<b>Factors which may have caused damage</b>		<b>Notes on repairs</b>	
<ol style="list-style-type: none"> <li>1. Vibration of main engine.</li> <li>2. Insufficient strength of brackets at main engine foundation.</li> <li>3. Insufficient pre-load of the bolts.</li> </ol>		<ol style="list-style-type: none"> <li>1. Fractures may be veed-out and rewelded.</li> <li>2. New modified brackets at main engine foundation.</li> <li>3. Or insert pieces and additional flanges to increase section modulus of the brackets.</li> </ol>

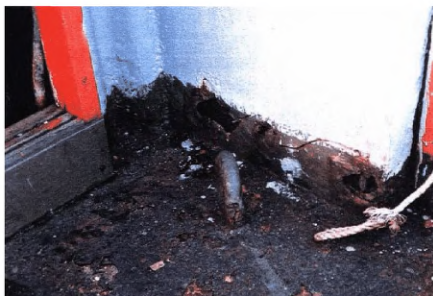
**Photograph 1 Corroded accommodation house side structure**

Severe corrosion may be found in exposed deck plating and deck house side structure adjacent to the deck plating where water is liable to accumulate (See **Photograph 1**). Corrosion may also be found in accommodation bulkheads around cut-out for fittings, such as doors, side scuttles, ventilators, etc., where proper maintenance of the area is relatively difficult. Deterioration of the bulkheads including fittings may impair the integrity of weathertightness.

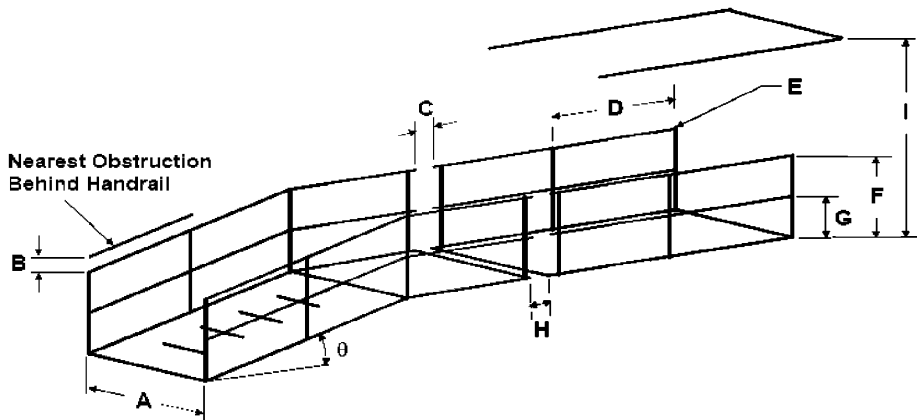
Notes:

- 1 Toeboard omitted for clarity
- 2 The walkway width may be diminished to ≥ 500 mm around a walkway structure web frames

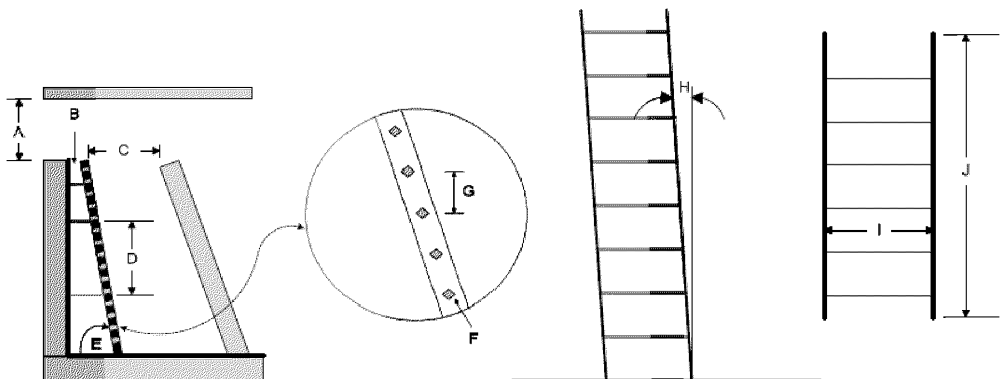
**Figure 2 Vertical Ladders (General Criteria)**

<i>Dimension</i>		<i>Recommendation</i>
A	Overhead Clearance	2130 mm (84.0 in.)
B	Ladder distance (gap accommodating toe space) from surface (at 90 degrees)	≥ 175 mm (7.0 in.) ≤ 200 mm (8.0 in.)
C	Horizontal Clearance (from ladder face and obstacles)	≥ 750 mm (29.5 in.) or ≥ 600 mm (23.5 in.) (in way of openings)
D	Distance between ladder attachments / securing devices	≤ 2.5 m (8.0 ft)
E	Ladder angle of inclination from the horizontal	80 to 90 degrees
F	Rung Design – (Can be round or square bar; where square bar is fitted, orientation should be edge up)	Square bar 25 mm (1.0 in.) x 25 mm (1.0 in.)  Round bar 25 mm (1.0 in.) diameter
G	Distance between ladder rungs (rungs evenly spaced throughout the full run of the ladder)	≥ 275 mm (11.0 in.) ≤ 300 mm (12.0 in.)
H	Skew angle	≤ 2 degrees
I	Stringer separation	400 to 450 mm (16.0 to 18.0 in.)
J	Ladder height: Ladders over 6 m (19.7 ft) require intermediate/linking platforms)	≤ 6.0 m (19.5 ft)

- Figure 2 – Vertical Ladders (General Criteria)
- Figure 3 – Staggered Vertical Ladders
- Figure 4 – Vertical Ladders to Landings (Side Mount)
- Figure 5 – Vertical Ladders to Landings (Ladder through Platform)

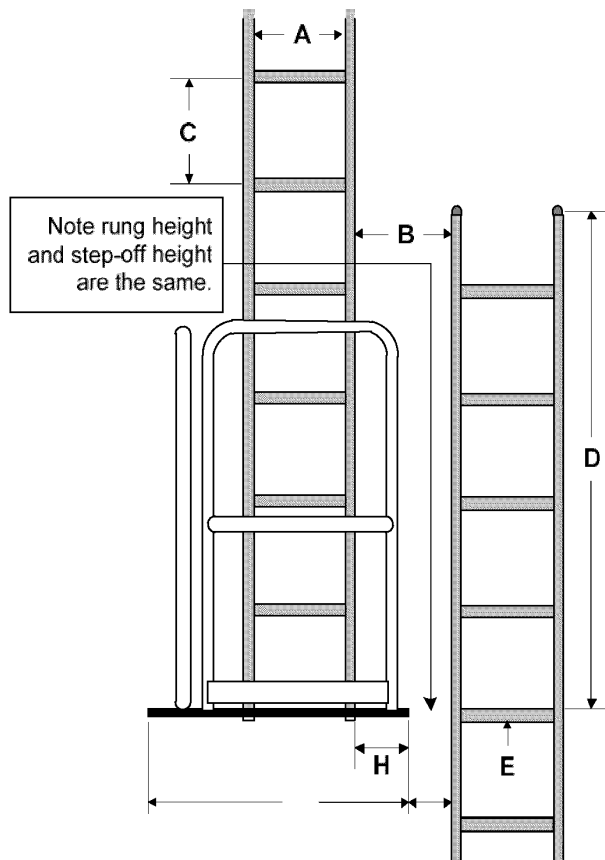
**Figure 3 Staggered Vertical Ladders**

<i>Dimension</i>		<i>Recommendation</i>
A	Stringer separation	400 to 450 mm (16.0 to 18.0 in.)
B	Horizontal separation between two vertical ladders, stringer to stringer	≥ 225 mm (9 in.) ≤ 450 mm (18 in.)
C	Distance between ladder rungs (rungs evenly spaced throughout the full run of the ladder)	≥ 275 mm (11.0 in.) ≤ 300 mm (12.0 in.)
D	Stringer height above landing or intermediate platform	≥ 1350 mm (53.0 in.)
E	Rung design – (Can be round or square bar; where square bar is fitted, orientation should be edge up)	Square bar 22 mm (0.9 in.) x 22 mm (0.9 in.)  Round bar 25 mm (1.0 in.) diameter
F	Horizontal separation between ladder and platform	≥ 150 mm (6.0 in.) ≤ 300 mm (12.0 in.)
G	Landing or intermediate platform width	≥ 925 mm (36.5 in.)
H	Platform ladder to Platform ledge	≥ 75 mm (3.0 in.) ≤ 150 mm (6.0 in.)

\*Note: Left side guardrail of platform omitted for clarity.

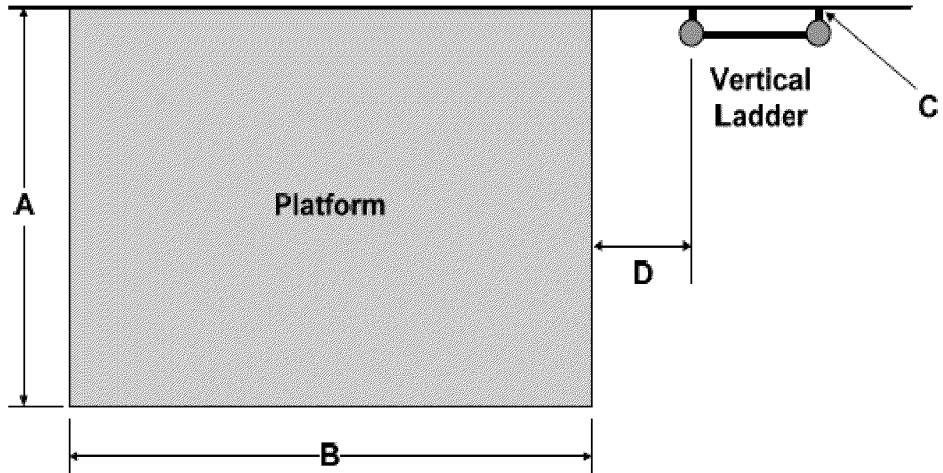
**Figure 4 Vertical Ladders to Landings (Side Mount)\***

<i>Dimension</i>		<i>Recommendation</i>
A	Platform depth	≥ 750 mm (29.5 in.)
B	Platform width	≥ 925 mm (36.5 in.)
C	Ladder distance from surface	≥ 175 mm (7.0 in.)
D	Horizontal separation between ladder and platform	≥ 150 mm (6.0 in.) and ≤ 300 mm (12.0 in.)

\* Notes: Top view. Guardrails/Handrails not shown.

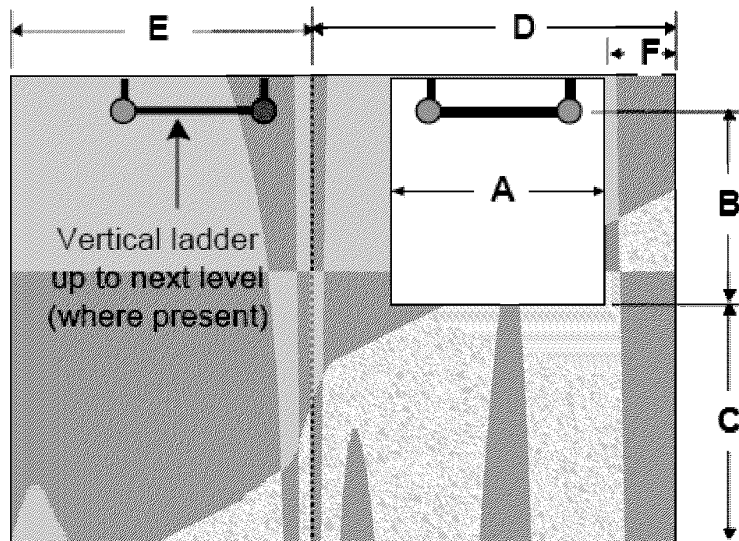
**Figure 5 Vertical Ladders to Landings (Ladder through Platform)\***

<i>Dimension</i>	<i>Recommendation</i>
A	Vertical ladder opening	≥ 750 mm (29.5 in.)
B	Distance from front of vertical ladder to back of platform opening	≥ 750 mm (29.5 in.)
C	Minimum clear standing area in front of ladder opening – Depth	≥ 750 mm (29.5 in.)
D	Minimum clear standing area in front of ladder opening – Width	≥ 925 mm (36.5 in.)
E	Additional platform width for intermediate landing (where present)	≥ 925 mm (36.5 in.)
F	Horizontal separation between ladder and platform	≥ 150 mm (6.0 in.) and ≤ 300 mm (12.0 in.)

\*Notes: Top view. Guardrails/Handrails not shown.

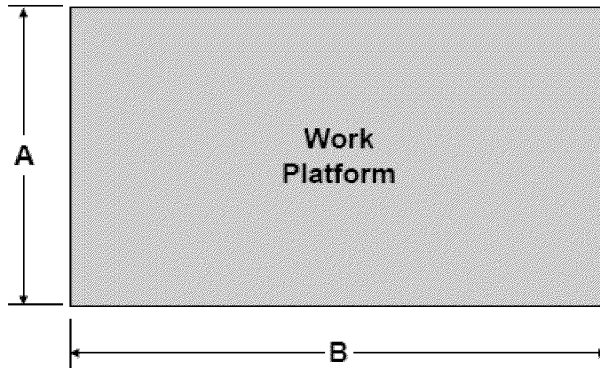
**Figure 6 Work Platform Dimensions**

<i>Dimension</i>		<i>Recommendation</i>
A	Work platform width	≥ 750 mm (29.5 in.)
	Work platform width (if used for standing only)	≥ 380 mm (15.0 in.)
B	Work platform length	≥ 925 mm (37.0 in.)
	Work platform length (if used for standing only)	≥ 450 mm (18.0 in.)

In addition to the recommendations for Work Platforms presented in Section 4.6 Access & Egress Design, the following recommended dimensions relating to the design of Work Platforms are presented in Figure 6 'Work Platform Dimensions'.

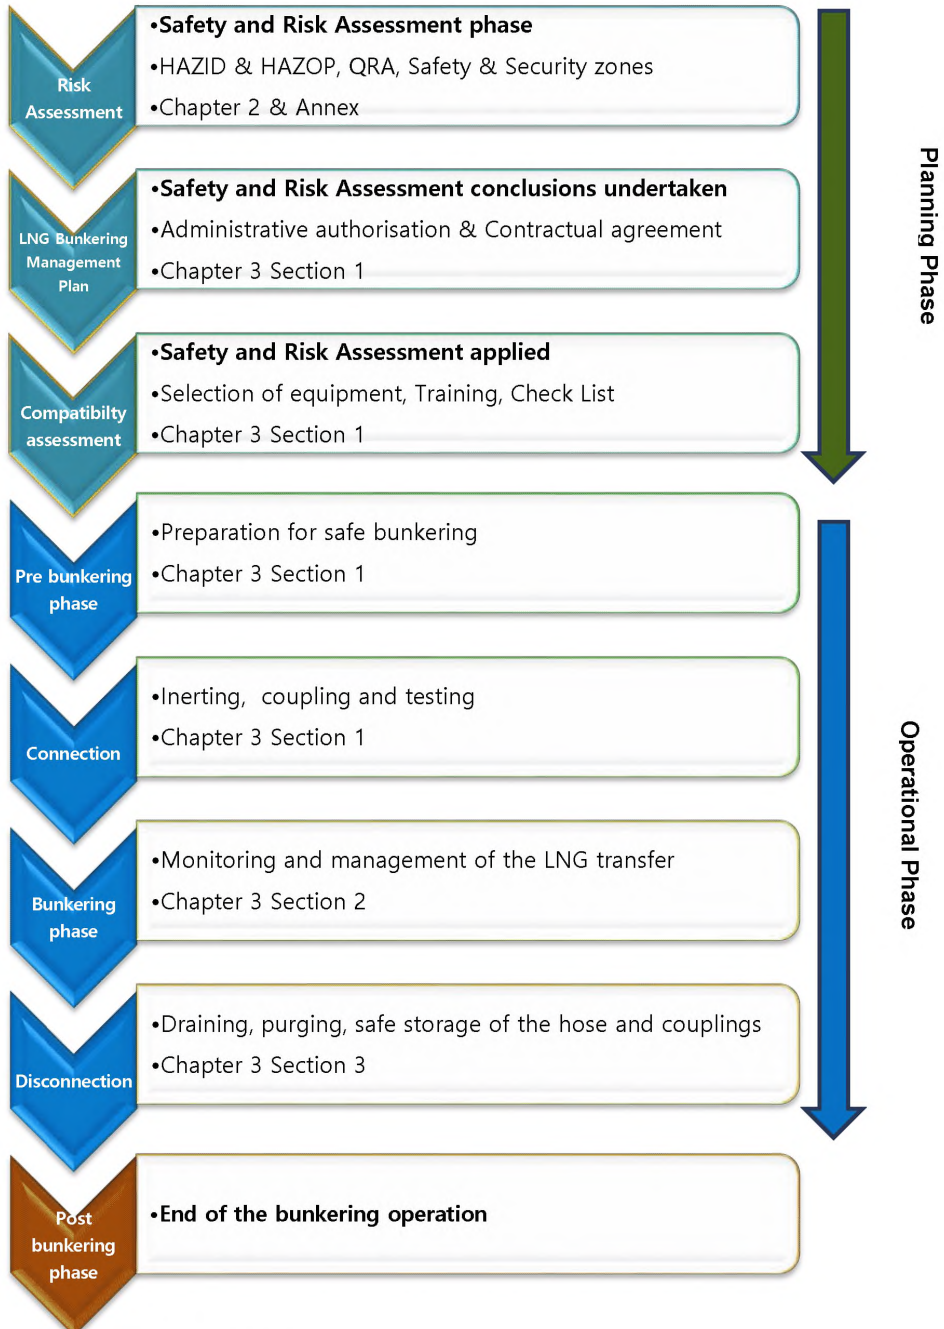
The sequence for a bunkering operation carried out between two parties for the first time is described in the following diagram; the references identify the applicable sections of the guideline.

Figure 1: Bunkering process

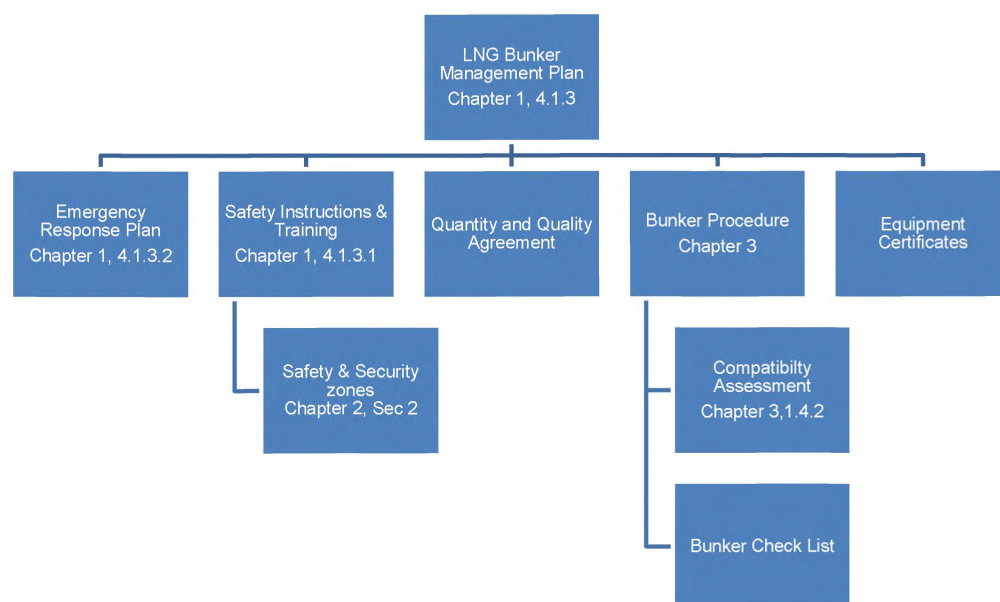
**Figure 2: Breakdown of LNGBMP content showing related sections of this guide**

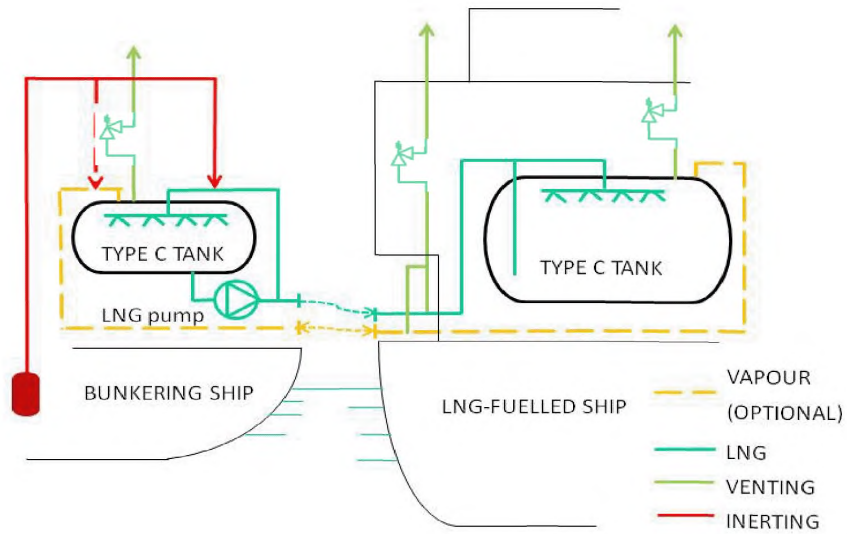
Figure 3: Ship-to-ship bunkering - typical arrangement of bunkering ship and LNG fuelled ship with type C tank

Note: For small scale bunker supply using Type C tanks, the LNG supply pressure may be generated by pump (as shown in the figures below) or by a Pressure Built Up unit.

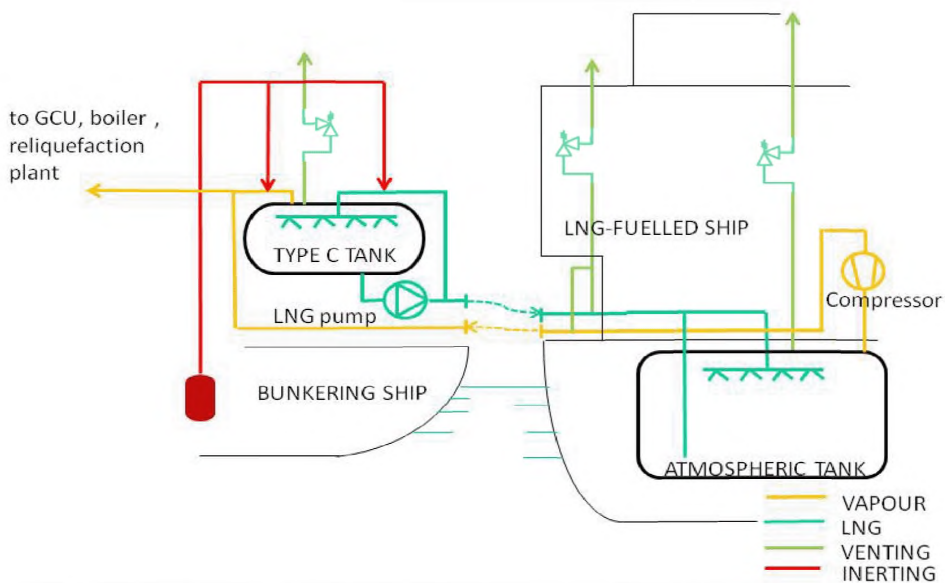
Figure 4: Ship-to-ship bunkering - typical arrangement of bunkering ship with type C tank and LNG fuelled ship with atmospheric tank

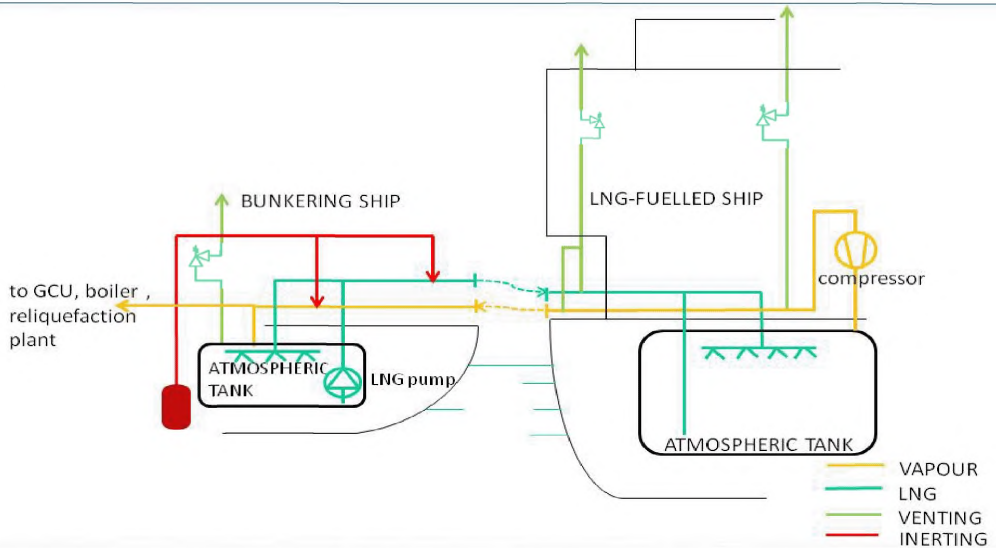
**Figure 5: Ship-to-ship bunkering - typical arrangement of bunkering ship and LNG fuelled ship with atmospheric tank**

\* Compressor is optional, only necessary if free flow is not possible. Normally there is no need for a compressor if the bunker ship uses atmospheric tanks or uses type C tanks operated at very low pressure (using discharge pump and not PBU). It is only required in cases where there is likely to be large quantities of flash gas generated during bunkering and the pressure gradient between the bunker ship and receiving ship does not allow free flow of vapour.

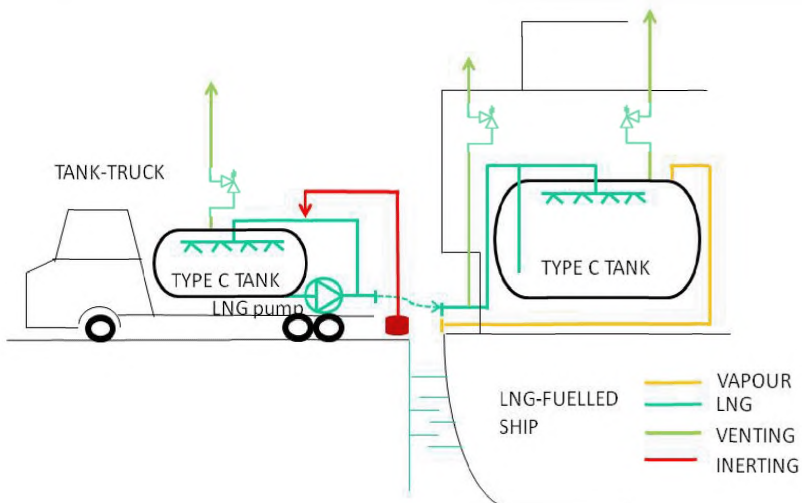
**Figure 6: Truck-to-ship bunkering - typical arrangement of LNG fuelled ship with type C tank**

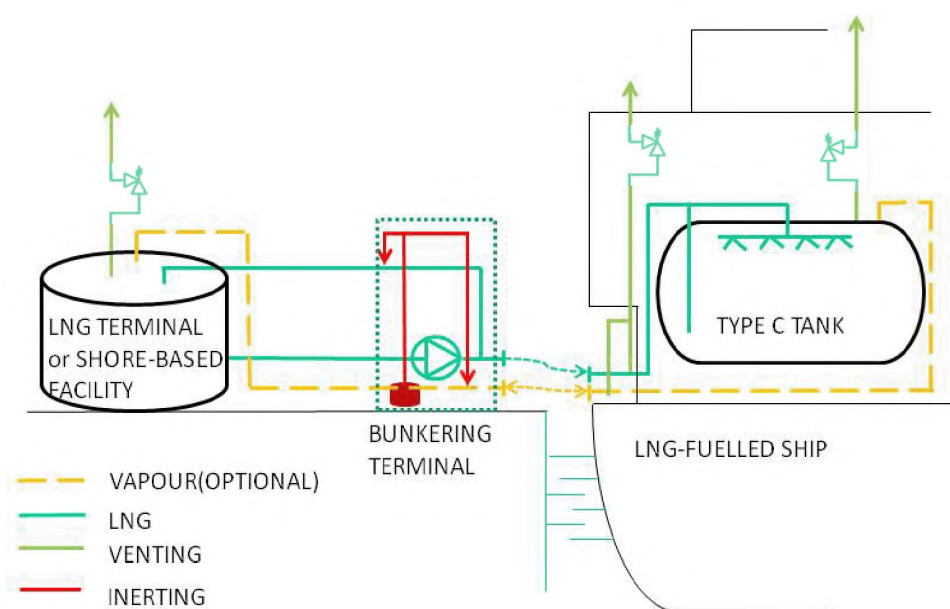
Figure 7: Terminal to ship bunkering - typical arrangement of LNG fuelled ship with type C tank

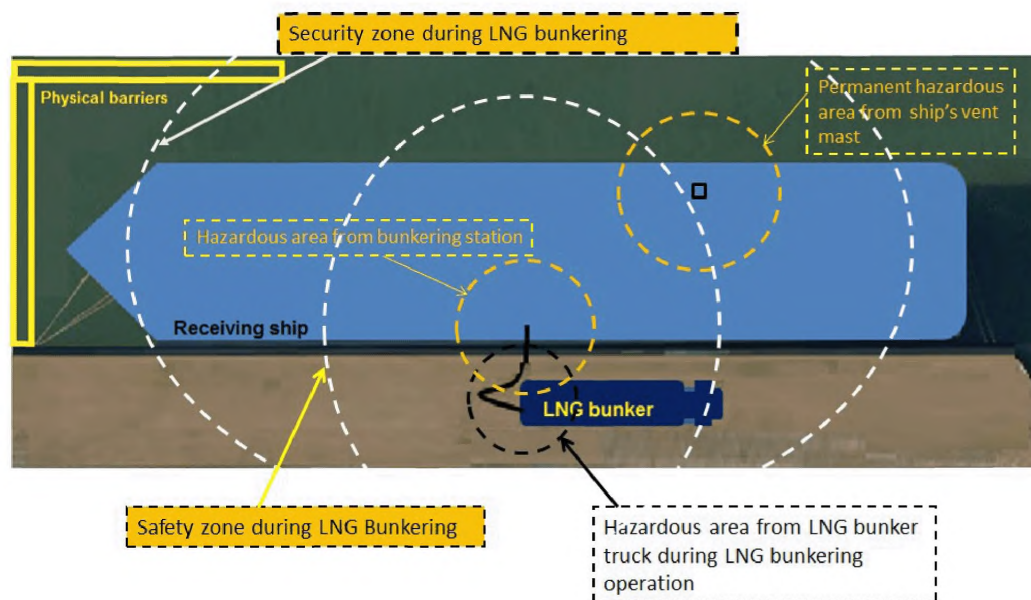
A safety zone and a security zone should be established around the bunkering operation in accordance with ISO/TS 18683. These zones are in addition to the established practice of setting hazardous area classification zones that will be required around areas with potential for explosive atmospheres such as the bunkering connections. A pictorial example of these zones is illustrated below.

Both the safety and security zones should be enforced and monitored at all times during bunkering, at all other times these zones are not enforced.

The purpose of the safety zone is to set an area within which only essential personnel are allowed and potential ignition sources are controlled. Essential personnel are those required to monitor and control the bunkering operation. Similarly, the purpose of the security zone is to set an area within which ship/port traffic is monitored and controlled.

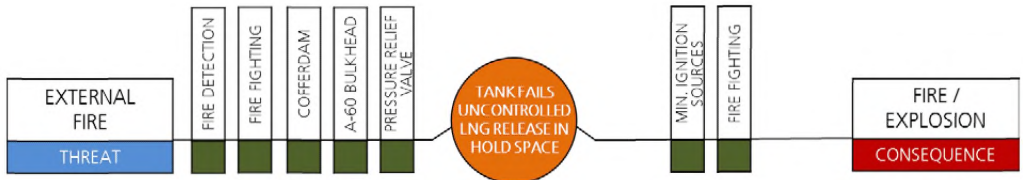
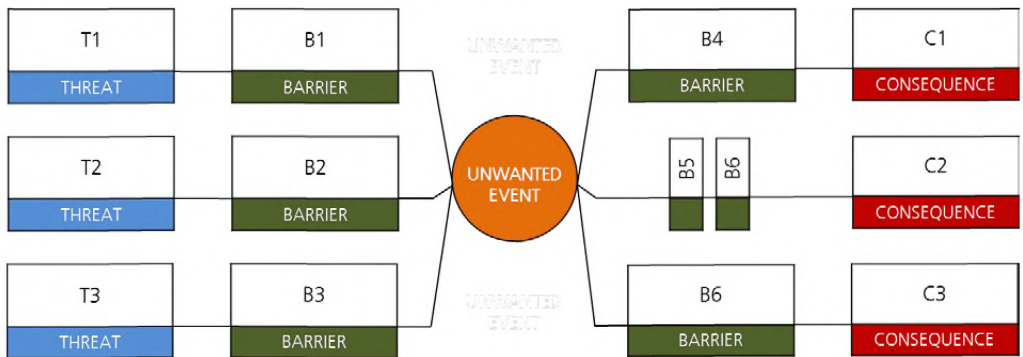
- Threat** – A cause that can potentially lead to the unwanted event.
- Barrier** – A mitigation measure that can potentially prevent the unwanted event or its consequences.
- Unwanted Event** – A situation to be avoided e.g. a release of fuel or a loss of ship propulsion.
- Consequence** – An outcome of a threat and an unwanted event not being mitigated by the barriers.

*In respect of ‘mitigation measures’ (i.e. barriers) those prior to the unwanted event are often referred to as preventative barriers or prevention measures.*
